ENVIRONMENTAL IMPACT ASSESSMENT REPORT

Bruintjieslaagte Dam – Devil's Creek –
Schoemanskloof

MDARDLEA Reference Number 1/3/1/16/1E-91

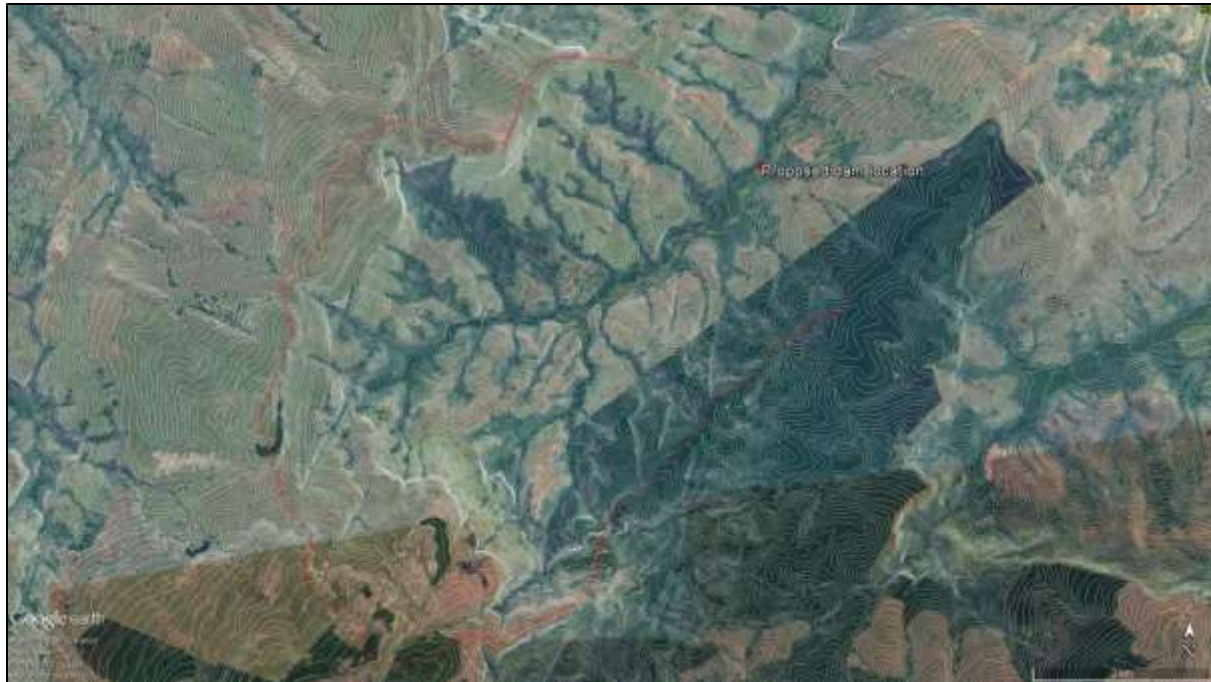
Open valley in a mountainous area with steep slopes. Devil’s Creek, with several tributaries, draining the catchment area towards the north and Crocodile River. The watershed is on approximately 2000m-, the dam at 1100m- and the confluence with the Crocodile River at 870m- above sea-level.

Figure 4.1.1. Topography of dam catchment.

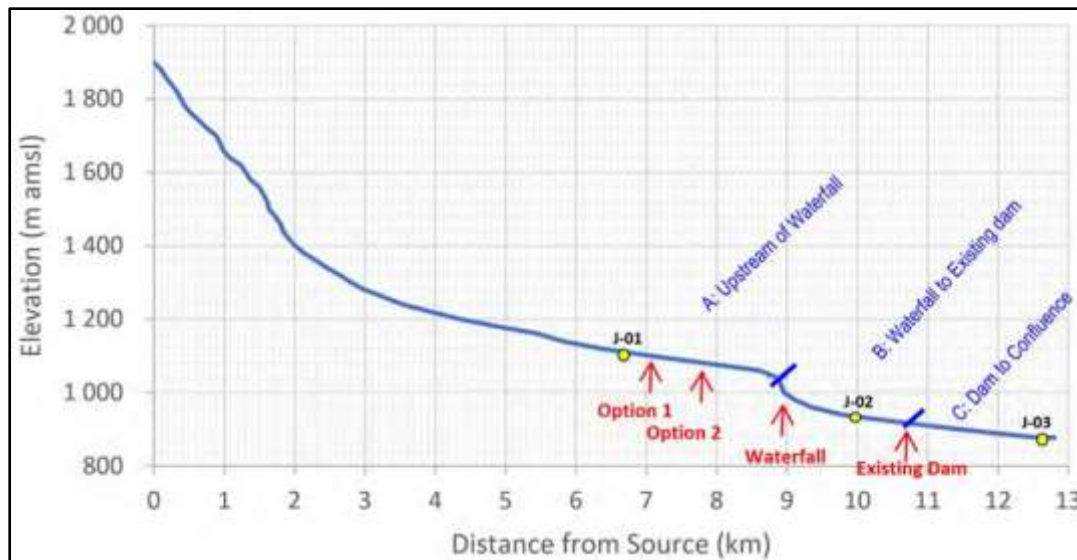
Three river reaches, A to C, were identified along the length of Devil’s Creek for the purposes of this report, as indicated in Figure 4.4.2. The delineation was based on a waterfall and existing dam, both of which constitute significant barriers to upstream migration of fish (Figure 4.4.3).

Figure 4.4.2. Longitudinal Profile of Devil's Creek Showing River Reaches.

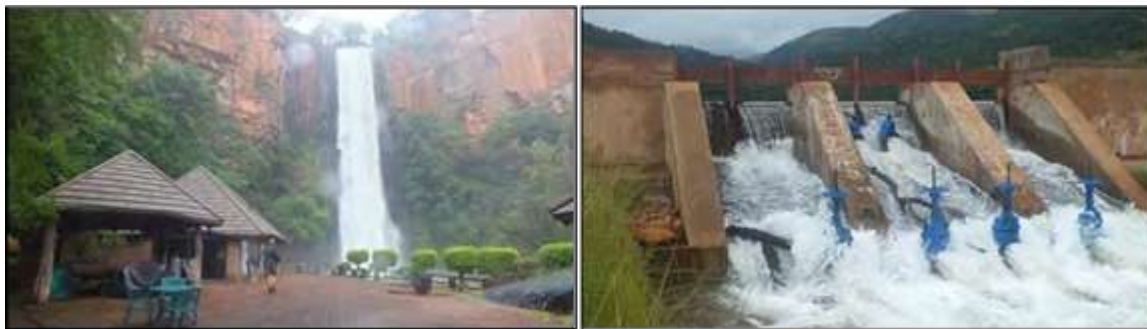
Figure 4.4.3. Fish Migration Barriers in Devil's Creek: Waterfall (A), and Existing Dam (B).

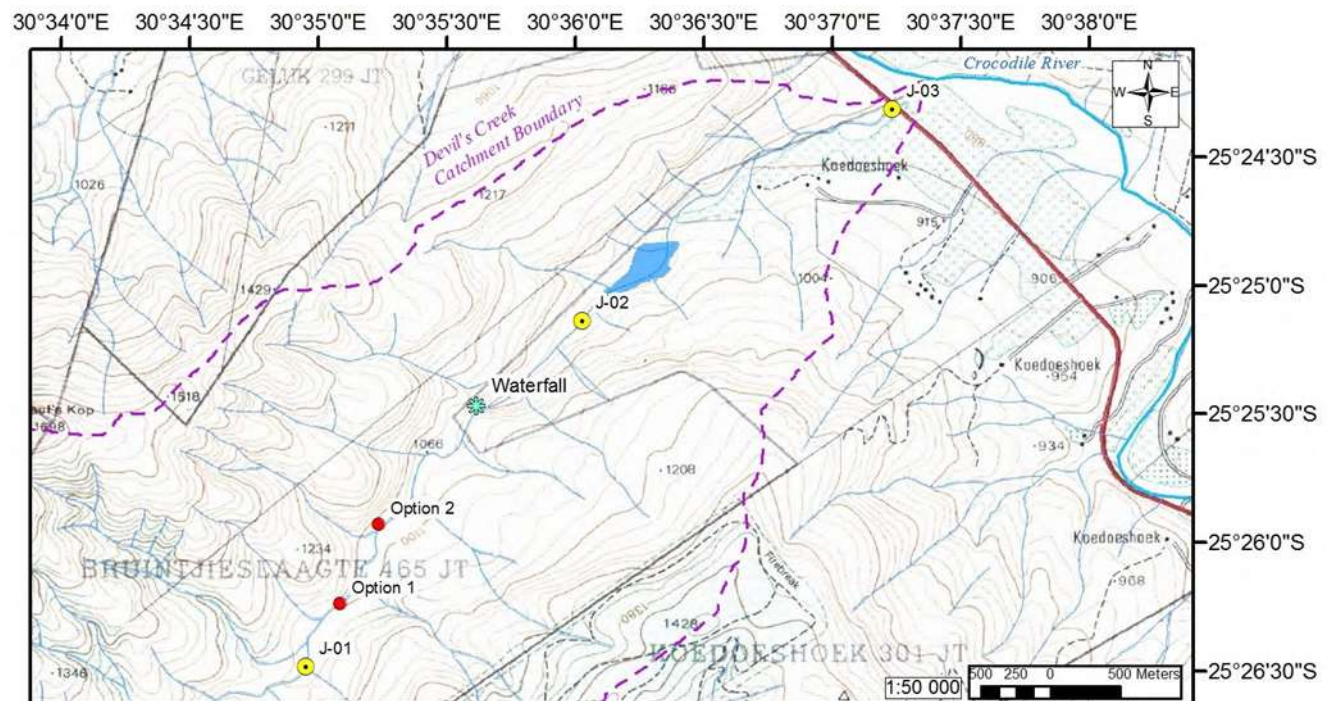
Figure 4.4.4. Topographical Map (extracted from 1:50 000 scale map 2530BC).

- Lower portion of Devil's Creek between the existing dam and the confluence with the Crocodile River, a distance of 2.2 km (Figure 4.4.4).

The total zone of influence of the proposed dam on river ecosystems is therefore 5.2 or 5.8 km portion of Devil's Creek for Options 2 and 1 respectively, plus an unknown length of river upstream of the Full Supply Level. The most likely extent of this stretch would be to the base of the Mountain Headwaters, which is about 3 km.

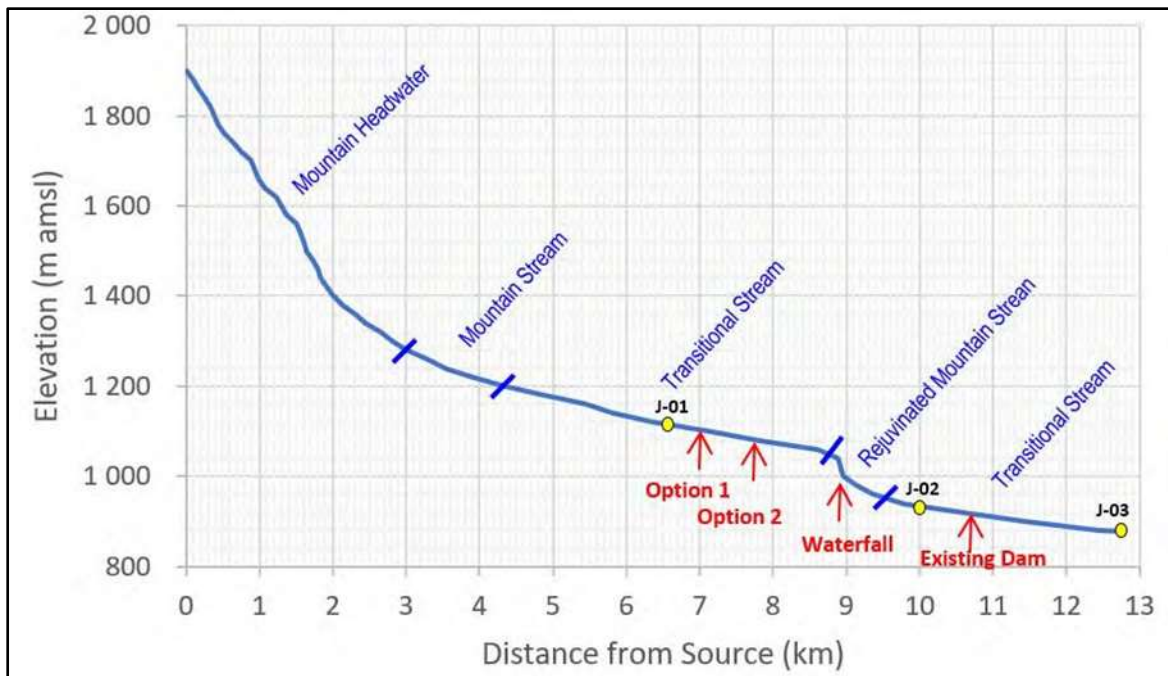
Four geomorphological zones were identified along the length of Devil's Creek, two of which are located within the potential zone of influence of the proposed dam, namely Transitional Stream and a short section of Rejuvenated Mountain Stream (Figures 4.4.5). The three sites sampled for this report were located in the Transitional Zone. A detailed ecological classification of the three sites is included in Appendix 6. Biotopes were dominated by rapids, riffles, runs and glides. Riparian vegetation cover comprised open and closed-canopy indigenous forest with dense growth of herbs, grasses and shrubs. Alien invasive vegetation was present at all three sites, but prevalent only at Site J-03. Marginal and emergent vegetation was dominated by River grass *Cenchrus macrourus*. Bed substrates at all three sites were dominated by large and small cobbles, with smaller patches of coarse gravel, while fine gravel and coarse sands present along the margins.

Figure 4.4.5. Longitudinal Profile of Devil's Creek showing Geomorphological Zones.

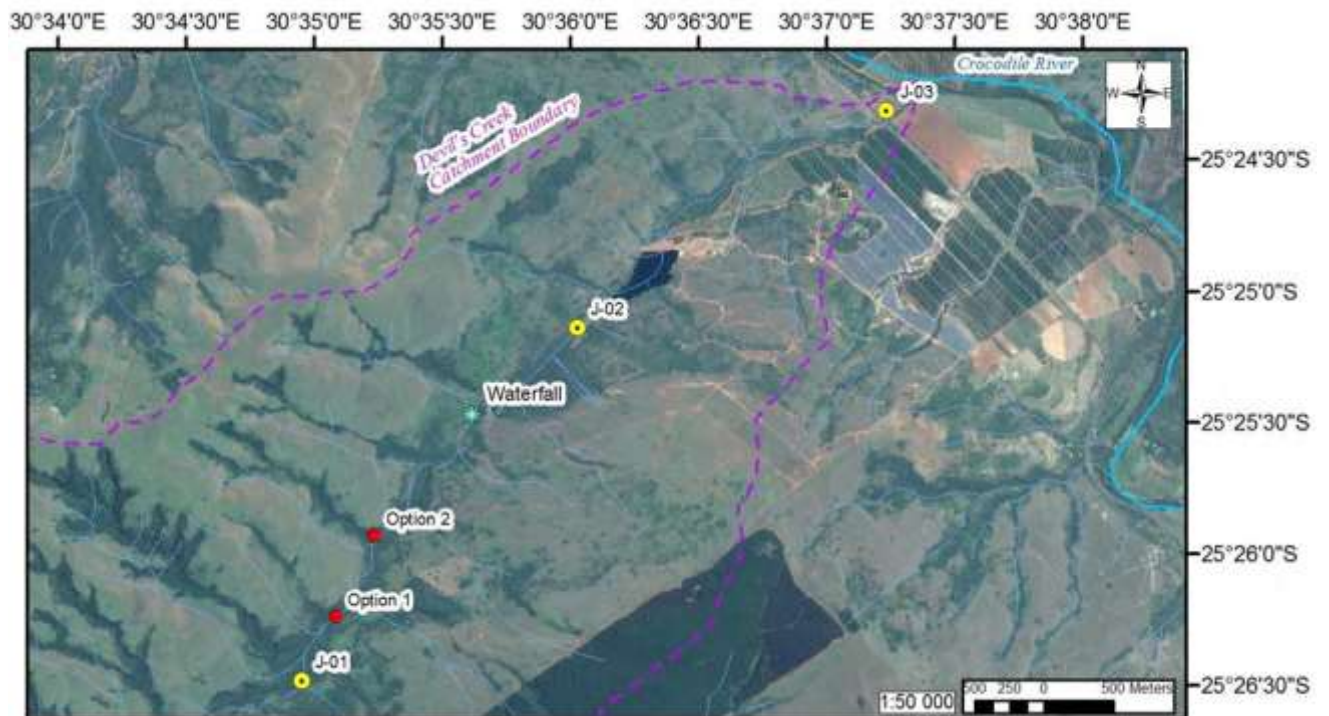
Figure 4.4.6. Google Earth Satellite image showing location of aquatic sampling sites.

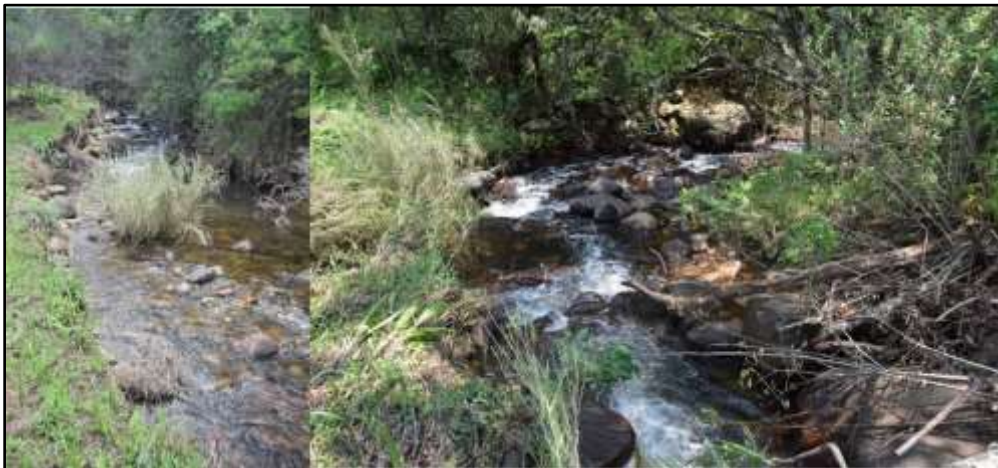
The marginal zone of the 2^o stream is narrow (single channel) to broader (braided channels) and is characterized by small chutes, riffles and boulder-bed and alluvial in-stream pools.

Figure 4.5.2. a) The marginal zone. b) The marginal zone and part of non-marginal zone.

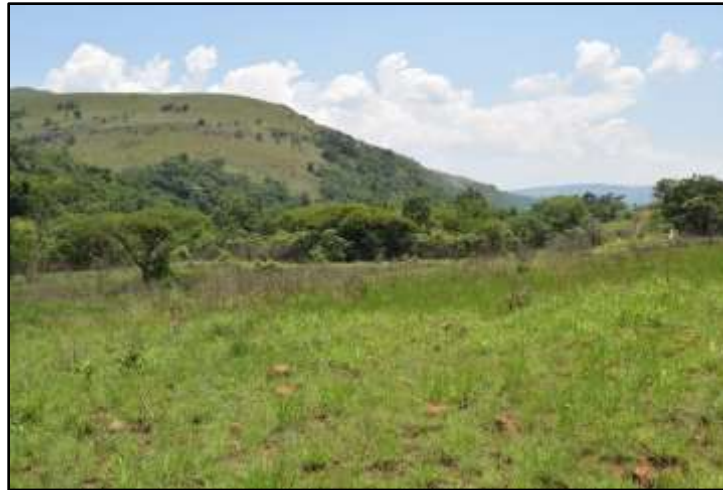
The lower non-marginal zone along the Left Bank (LB) is short and steep and characterized by dense riverine woody vegetation. The zone is primarily undisturbed by anthropogenic activity and relatively inaccessible. The zone along the Right Bank (RB) is relatively flat and broader. There is historical anthropogenic activity along the RB. There is clear evidence of contouring and the construction of earthen canals and berms. The anthropogenic activity is likely to have been the cultivation of crops and stock farming.

Figure 4.5.3. The upper non-marginal and terrestrial zones adjacent to the Right Bank of the stream in the impact area of the dam.

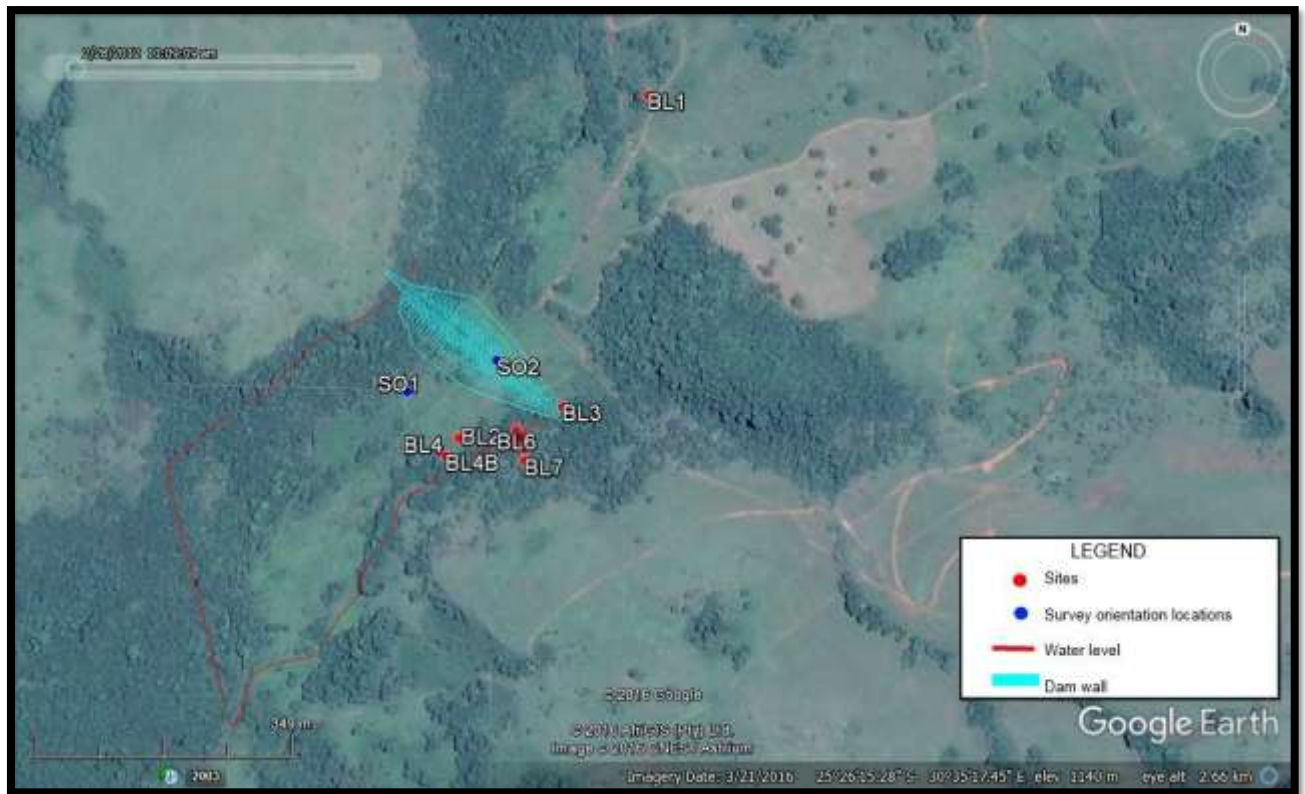
Figure 4.8.1. Location of sites

BL 7	LIA site perimeter	Poor	Poor	Archaeology: Poor Historically: Poor	1	None. Not located near project area.

Table 4.8.2. Site Condition Assessment and Management Recommendations.

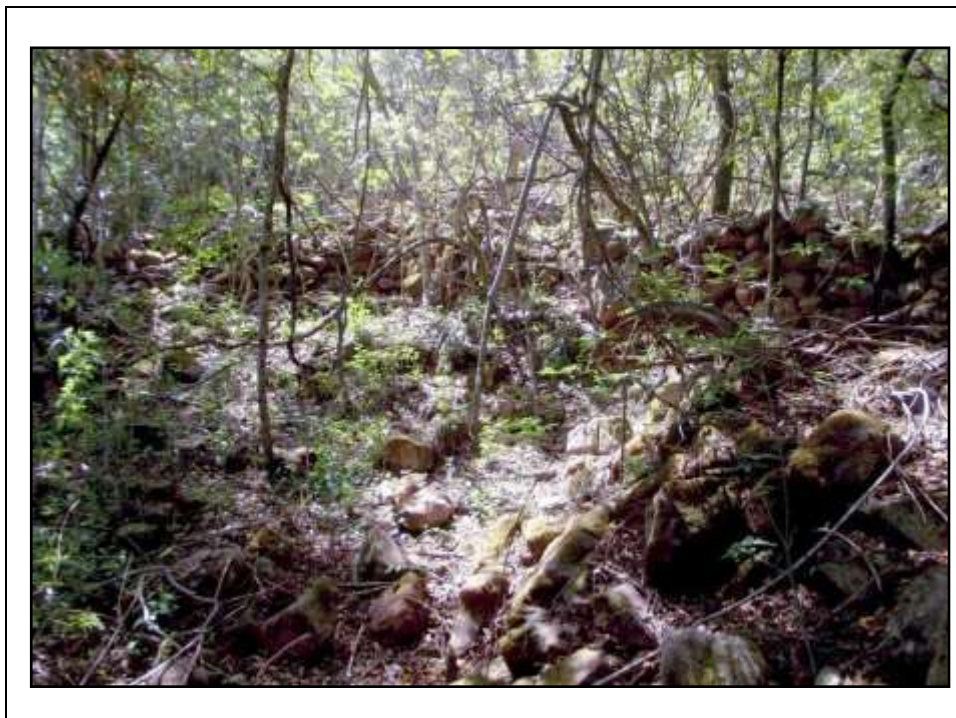
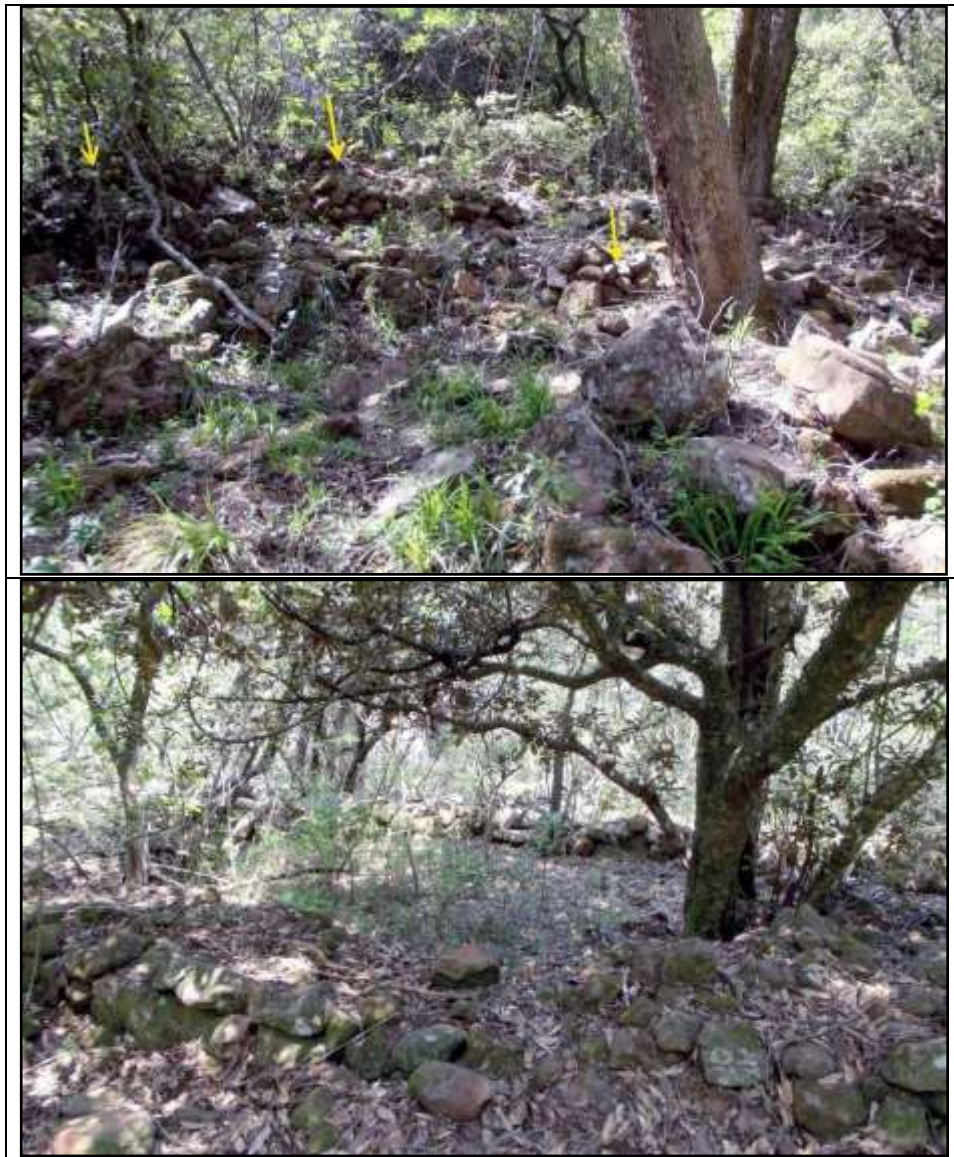
Figure 4.8.2. Typical stonewall structures.

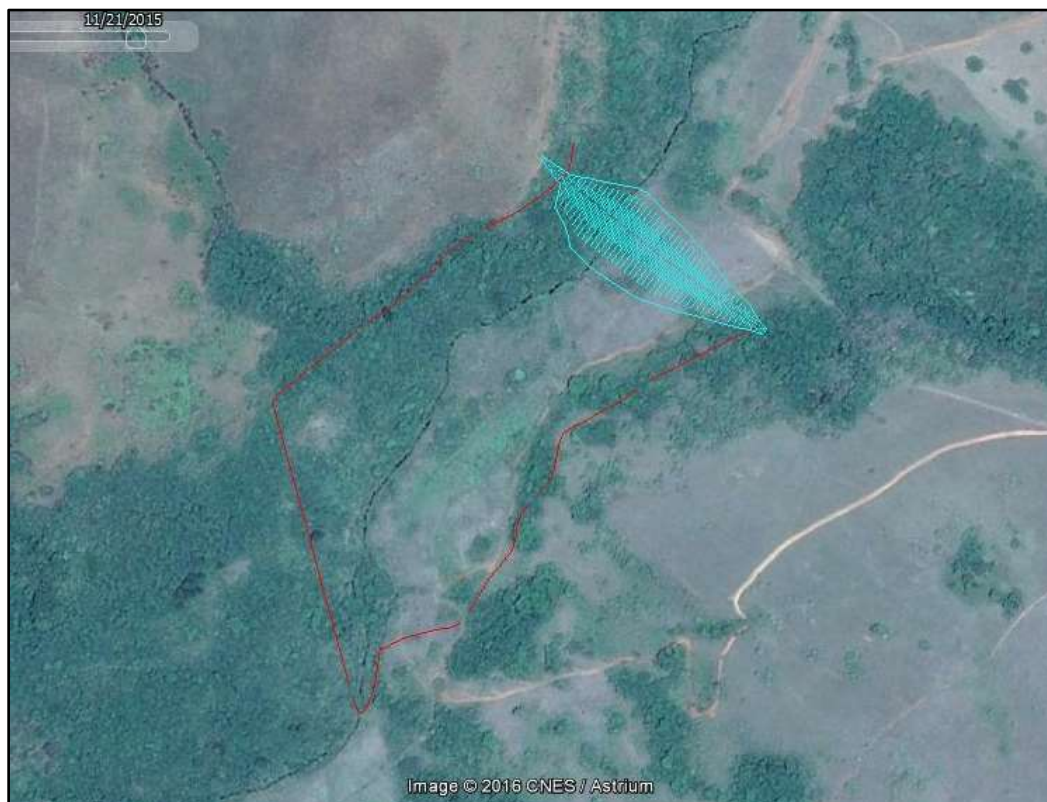
Figure 6.2.3. Preferred dam wall site and footprint area- full supply level (FSL).
