AQUATIC BIO-MONITORING SURVEY AND WETLAND DELINEATION FOR THE PROPOSED BRONKHORSTSPRUIT DEVELOPMENT

28 October 2016

**AQUATIC ASSESSMENT FOR THE PROPOSED
BRONKHORSTSPRUIT DEVELOPMENT**

REPORT NO 30200307/09

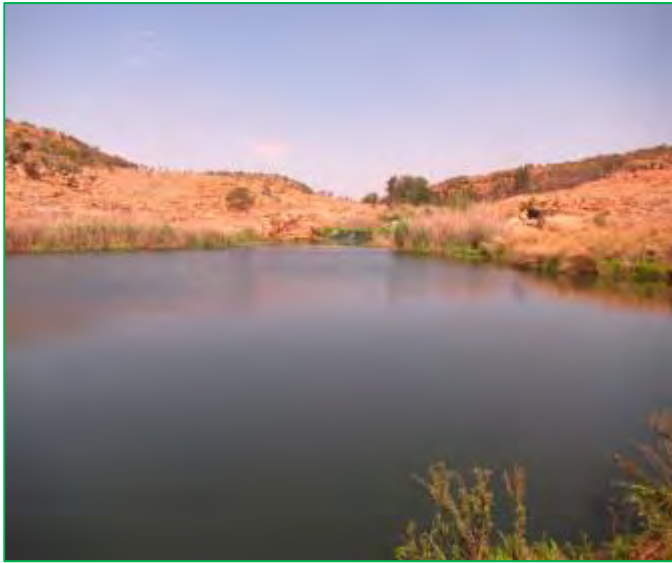
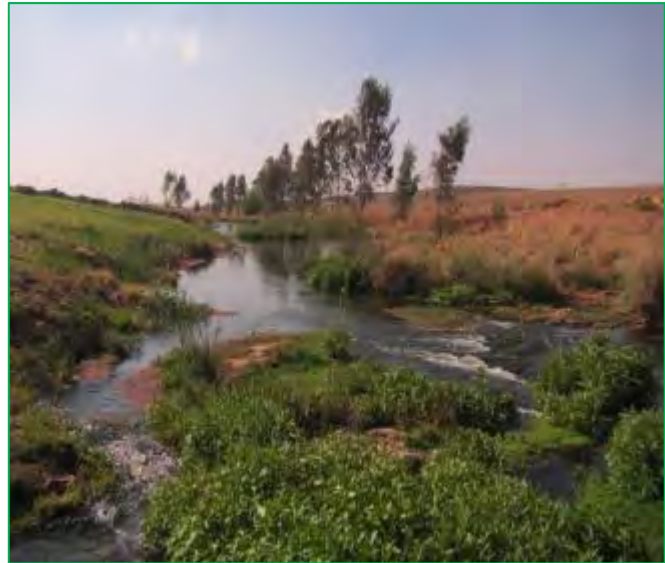
Plate 1: Upstream of site BRD 01

Plate 2: Downstream BRD 01

BRD 01 located upstream of the proposed construction site within the Bronkhorstspruit was sampled as a control site. The site was accessed through the Jumanji Equestrian and Eco Estate. The sample site had an open, deep channel that limited sampling to areas which were accessible. The surrounding impacts include the clearing of vegetation, developments and some agricultural activities on the eastern side.

The IHAS score for site BRD 01 indicated that inadequate habitat was available for macro-invertebrates with a score of 47 %. The sample site had limited availability of gravel, sand and mud (GSM) biotope. The alternative method utilised according to the SASS 5 methodology indicate a 29 % suitability score.

A SASS 5 score of 102 was obtained with an ASPT of 4.6 across 22 taxa recorded during the survey. Site BRD 01 was categorised as a category D (Largely Modified), which may be attributed to inadequate habitat being available for macro invertebrates. The most sensitive taxa present include Baetidae >2 sp., Aeshnidae (Hawkers & Emperors), Atyidae (Freshwater Shrimps) and Hydracarina (Mites).

- Site BRD 01 located upstream of proposed construction site served as control site
- The *in-situ* water quality parameters for the upstream point indicated no exceedances to the DWAF Ecosystem guidelines
- BRD 01 had inadequate habitat suitability for macro-invertebrates. The sample site had limited availability of gravel, sand and mud (GSM) biotope
- The invertebrate PES for the site was rated as a category D (Largely Modified)
- BRD 01 was rated as a category F (Critically modified) for the Fish Assembly index.

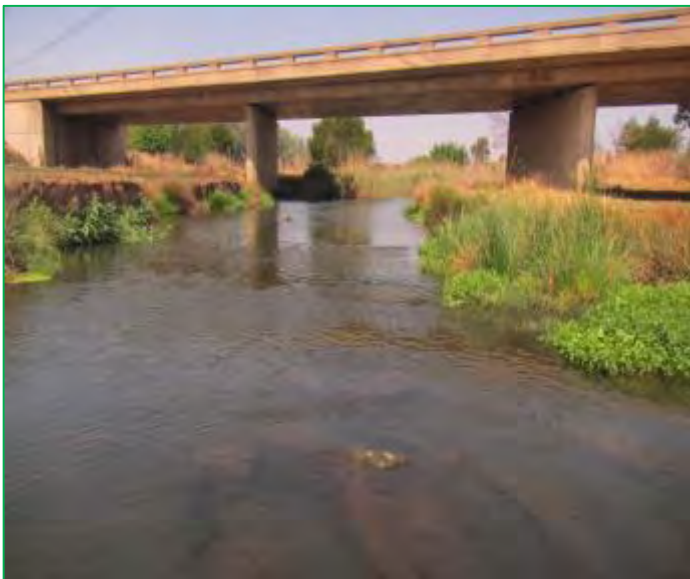
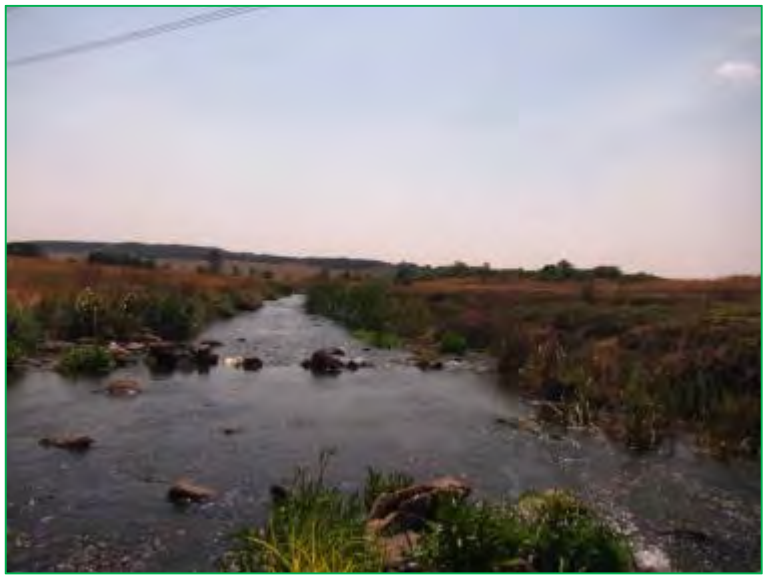
Plate 3: Upstream of site BRD 02

Plate 4: Downstream of site BRD 02

Site BRD 02 (impact site) was located adjacent to the proposed development site at the R25 Bridge. The impact site provided all biotopes for sampling with the only surrounding impact being small scale livestock farming. The river substrate was dominated by the stone substrate with some isolated stretches of sand. The site had moderate water levels and flow.

Site BRD 02 indicated had inadequate macro-invertebrate habitat availability, obtaining an IHAS score of 54 %. Both bedrock and mud biotopes were not present at this site. The alternative SASS method provided a 33 % habitat suitability score.

The site provided good aquatic and marginal vegetation cover for fish species with a variation between deeper pools and shallow moderate flowing water. Three of the expected twelve fish species were present at BRD 02, namely *Chiloglanis pretoriae* (Sawfin Suckermouth), *Clarias gariepinus* (Sharptooth Catfish) and *Tilapia sarrmanii* (Banded Tilapia). The FAIL score obtained for this site was 29.9 %, therefore BRD 02 obtained a PES rating of category E (Severely modified).

- BRD 02 had inadequate habitat suitability for macro-invertebrates with representatives of all three biotopes not being available
- The invertebrate PES was categorised as category D (Largely Modified)
- The Fish Assembly Index categorised BRD 02 as category E (Severely Modified)

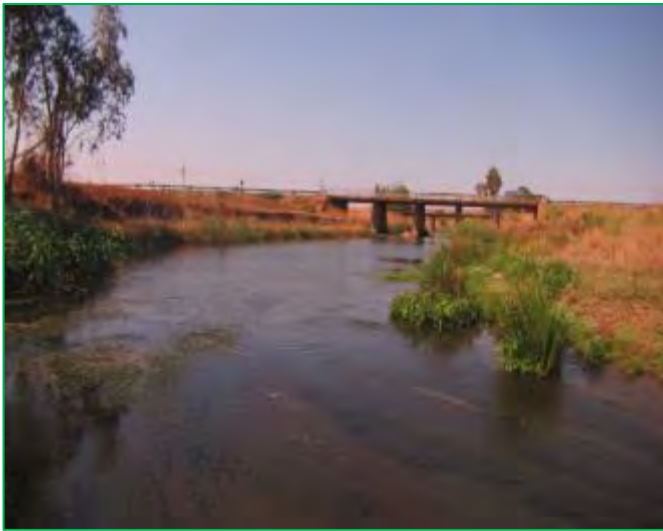
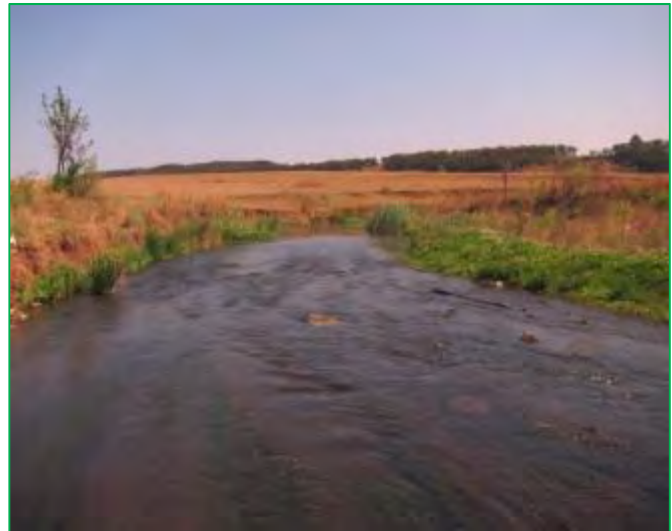
Plate 5: Upstream of site BRD 03

Plate 6: Downstream of site BRD 03

- Site BRD 03 was located further downstream of the proposed construction site
- The DO concentration at Site BRD 03 is below the guideline value of 5.0 mg/l and could be due to the algal growth present at the site. All other parameters were within guideline values
- The IHAS score for BRD 03 found the habitat suitability to be adequate with all three biotopes available
- The invertebrate PES was categorised as C category (Moderately Modified)
- The Fish Assembly Index categorised BRD 03 as category F (Critically Modified).

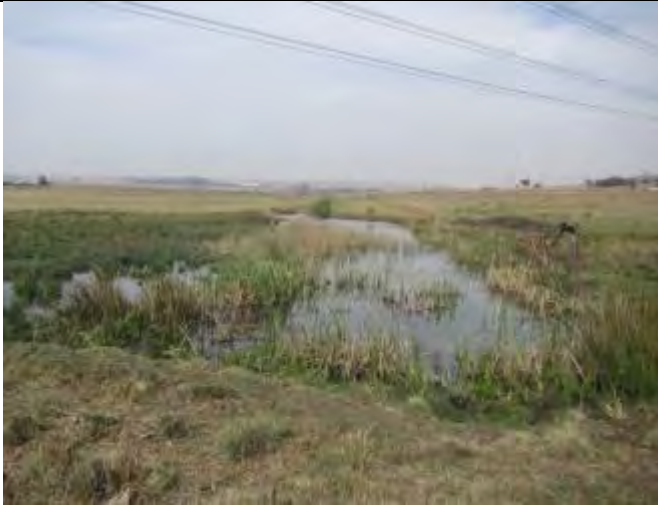
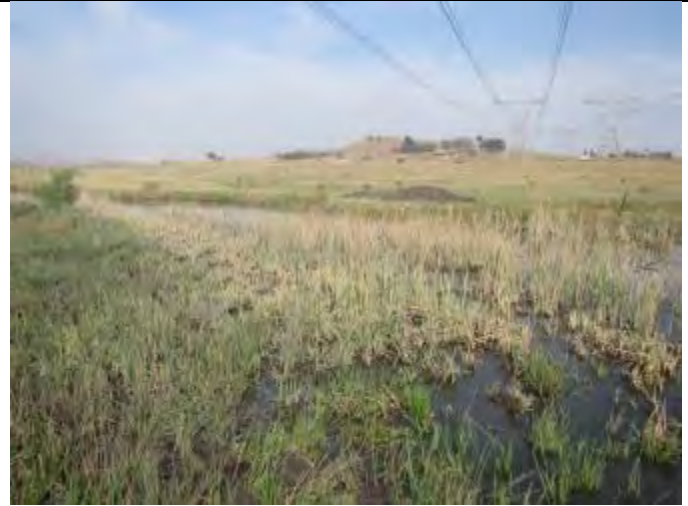
One wetland area was identified within a 500 m radius of the proposed development area, a valley bottom wetland. The wetland area is located approximately 360 m to the north-west of the project area on an adjacent cattle farm. The wetland area was created due to the impoundment of the drainage line flowing from the west to the Bronkhorstspruit. The impoundment overflows during the rainy season creating a small channel and surrounding soil wetness.

Plate 7: Impoundment of drainage line

Plate 8: Wetland area below the impoundment area

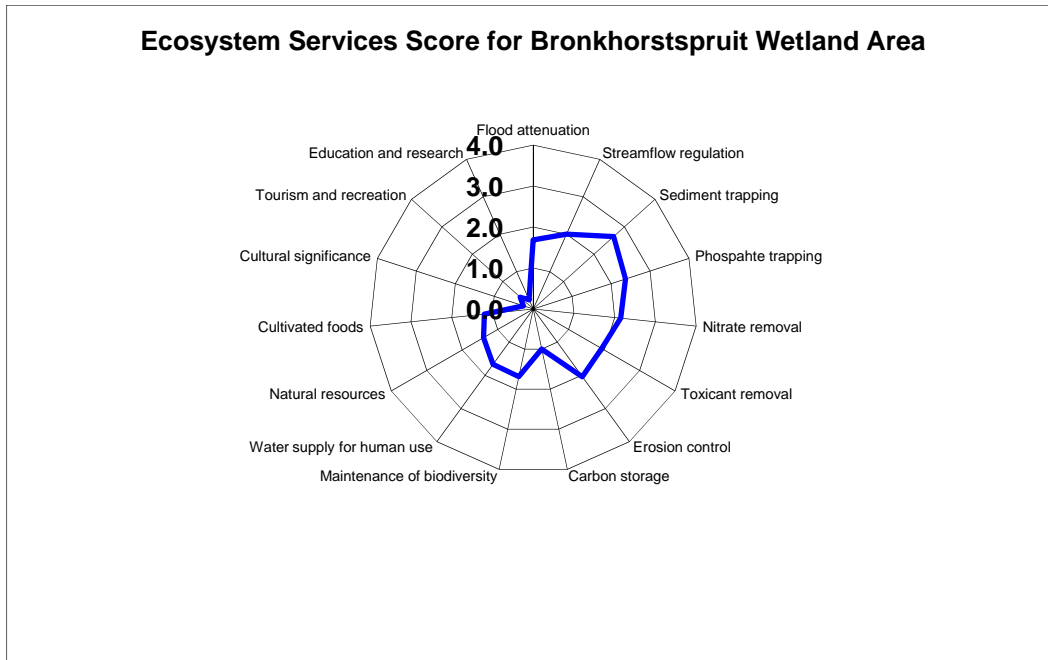
Figure 7: Radial plot indicating ecosystem functions associated with the wetland

The figure below shows a summary of the functions expected to be performed by the valley bottom wetland.

The main ecosystem services associated with the wetland area is sediment trapping and erosion control from increased associated surface water runoff into the wetland.

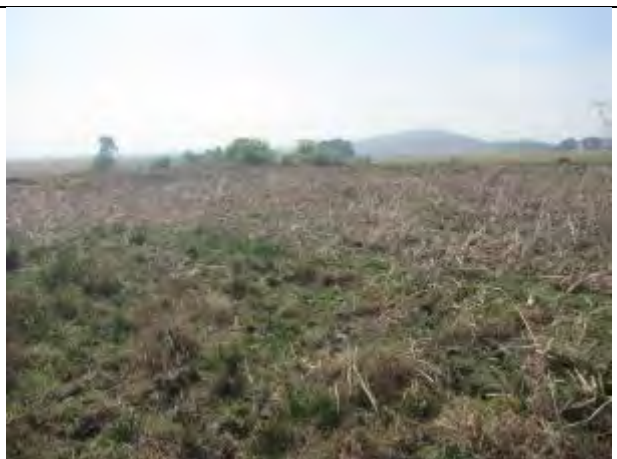
Plate 13: Temporary zone of wetland

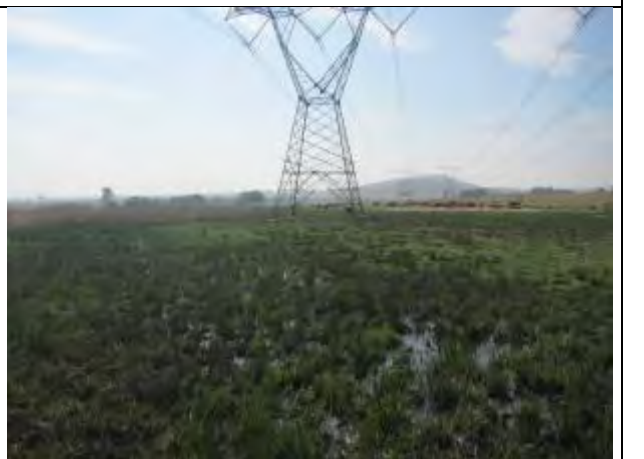
Plate 14: Seasonal zone of wetland
