CONSULTATION IN TERMS OF SECTION 40 OF THE MINERAL AND PETROLEUM RESOURCES DEVELOPMENT ACT 2002, (ACT 28 OF 2002) IN RESPECT OF AGGREGATE STONES FOR THE APPROVAL OF AN ENVIRONMENTAL MANAGEMENT PLAN FOR A BORROW PIT ON RE WINCANTON NO.472, PORTION 2 OF PORTION 6 OF WINCANTON NO.472 AND A PORTION OF THE REMAINDER OF PORTION 1 OF LIME BANK NO.471 SITUATED IN THE MAGISTERIAL DISTRICT OF DIBENG, NORTHERN CAPE REGION.

APPLICANT: TRANSNET (SOC) LTD

ENVIRONMENTAL MANAGEMENT PLAN

**Transnet Capital Projects
Ngqura 16 Mtpa Manganese Project**

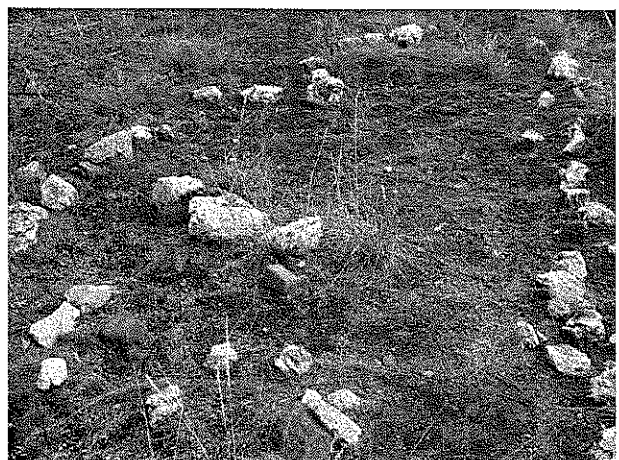
Possible ceremonial and grave site areas.

Degrees (DD)	Minutes (MM)	Seconds (SS.ss)		Degrees (DD)	Minutes (MM)	Seconds (SS.ss)
S	27	34	52.31	E	22	56	26.9 (Possible grave site)
S	27	34	52.91	E	22	56	27.3 (Possible grave site)
S	27	34	51.32	E	22	56	26.5 (Ceremonial site)

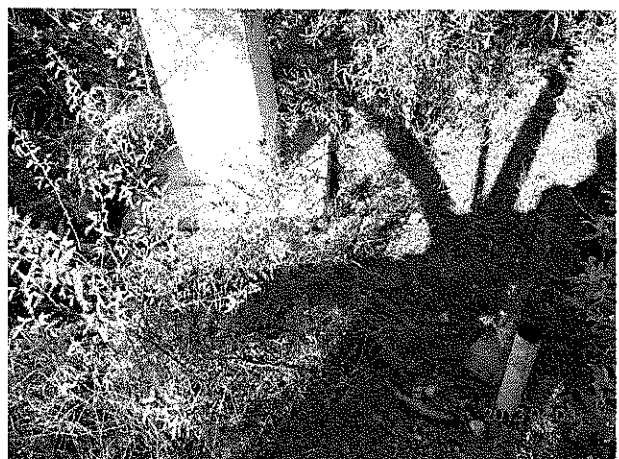
Discarded pipe for the borehole & Jojo stands.

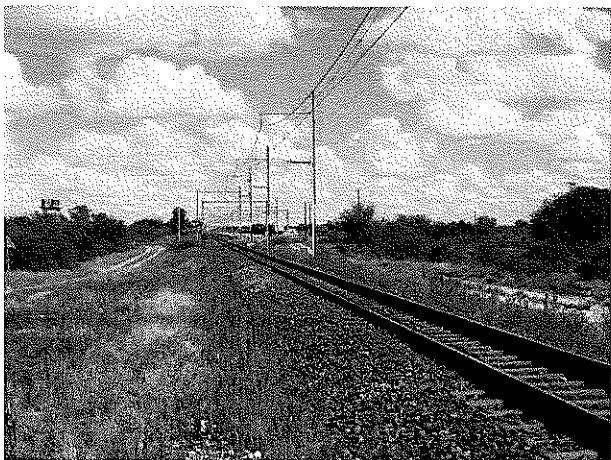
Distance to closest receptor (aprox 350 m to farm house, and 25 m to railway line).

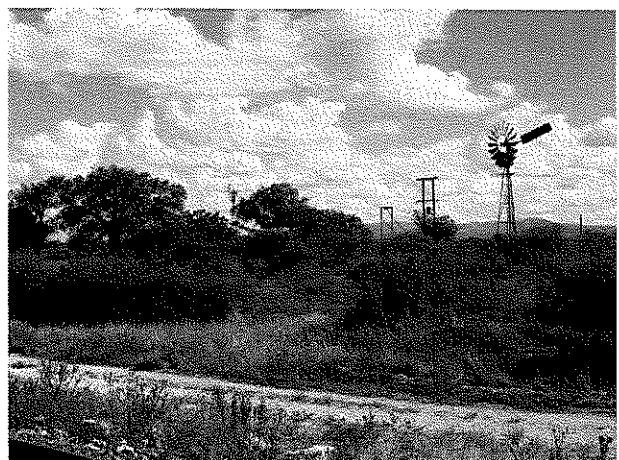
Existing water users (wind-pumps).

From the field investigation, boreholes, Jojo tanks and wind pumps were observed. Groundwater and rainwater are used by the local farmers for potable use and livestock watering.
