**DR ANDREW DEACON**  
May 2020

**ASPHALT PLANT – ECOLOGICAL ASSESSMENT**

**THE RECTIFICATION OF THE UNLAWFUL COMMENCEMENT  
OF A LISTED ACTIVITY: THE ESTABLISHMENT OF AN  
ASPHALT PLANT.**

**A SPECIALIST STUDY: AN ECOLOGICAL EVALUATION TO  
ASSIST IN THE RISK ASSESSMENT PROCESS**

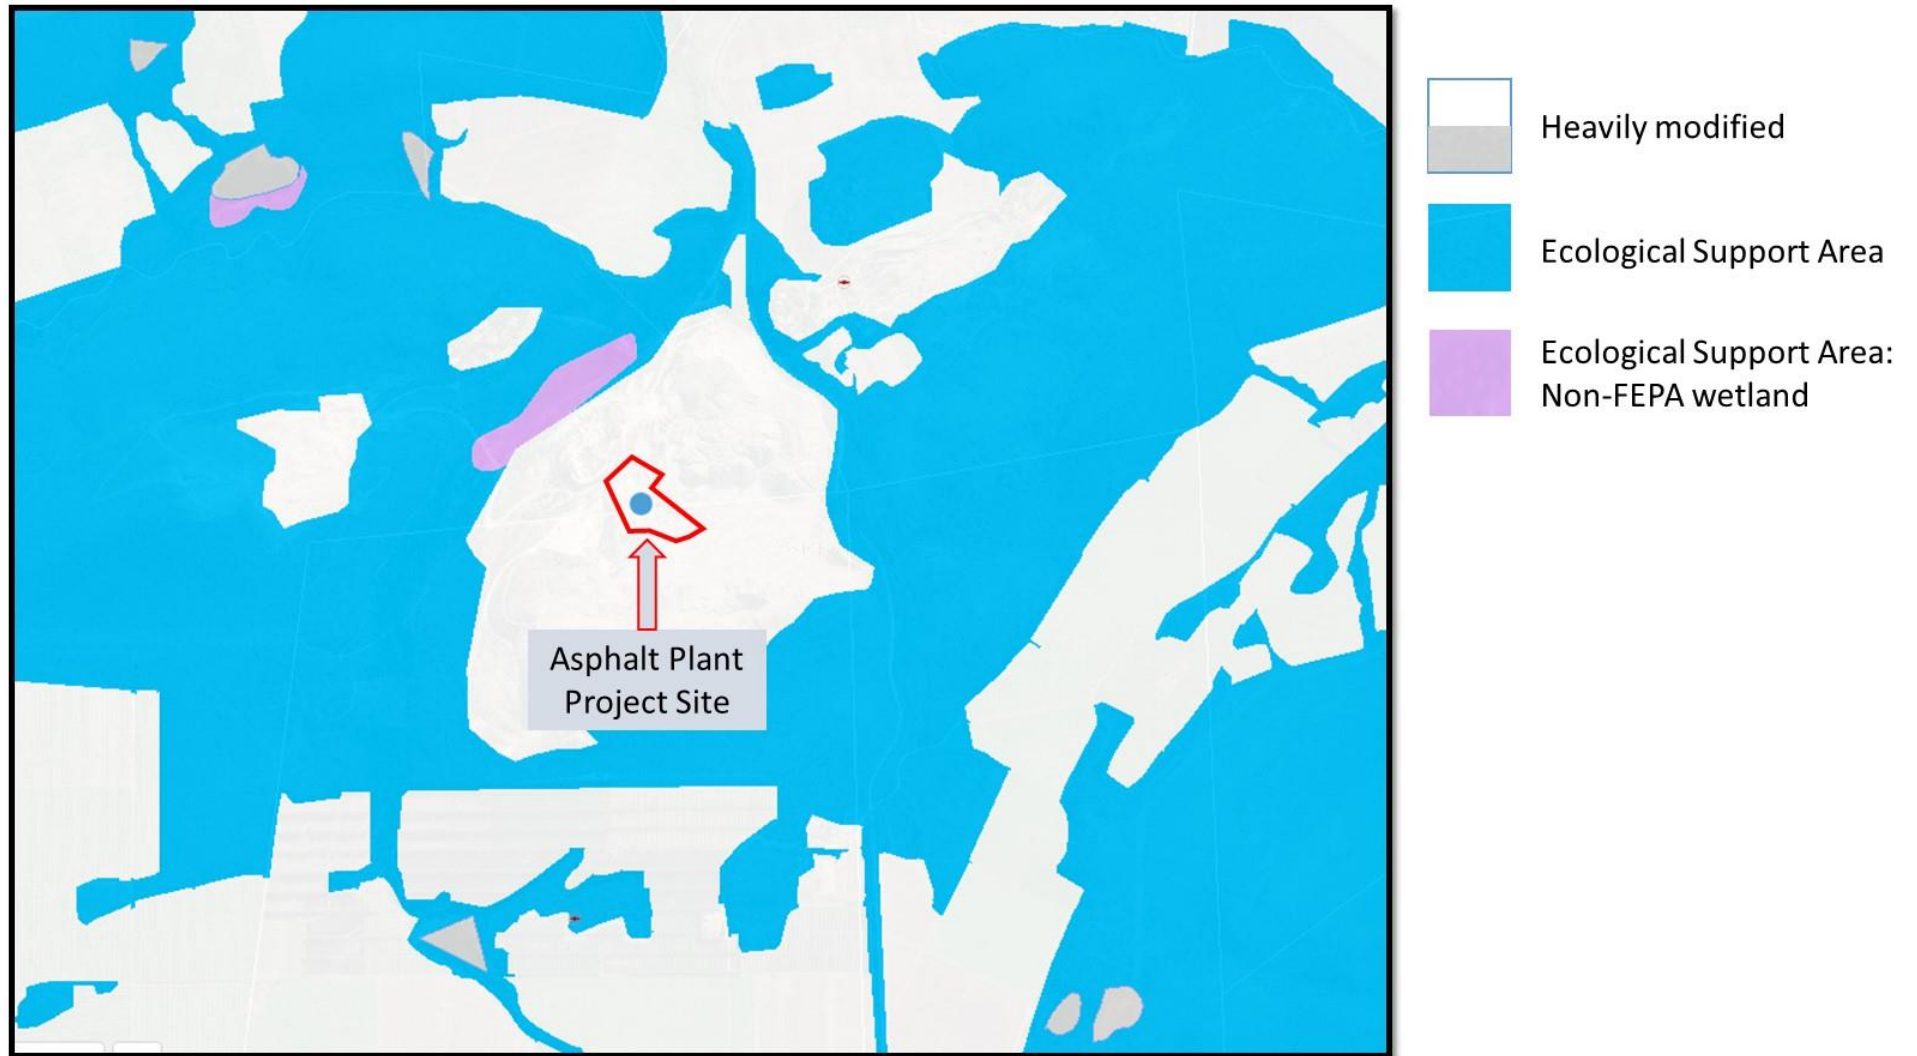
**Figure 8:** A map of the Asphalt Plant project site, indicating the project locations (red circles) to illustrate the Freshwater CBAs and ESAs (Mpumalanga Biodiversity Sector Plan, 2014).

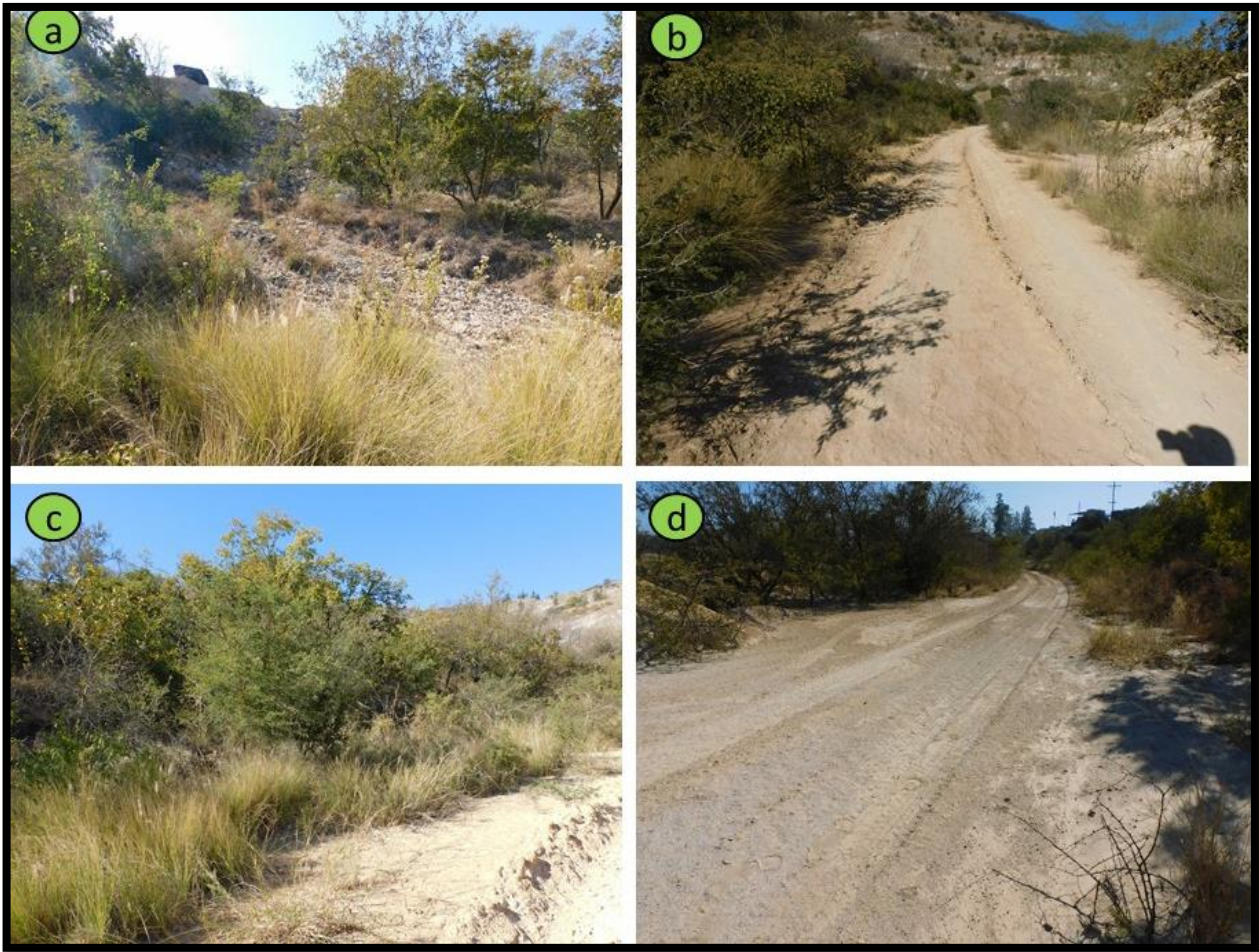
During the site visit, it was established that there are two areas of concern in the project area should an accident occur at the site. A spill on the premises of the Asphalt Plant could potentially impact on the small copse of natural woodland adjacent to the plant, as well as the riverine environment of the Salt Creek, approximately 663 m further down the slope of the mining area. A plant and fauna survey were completed in the grove of natural woodland (Figures 9a-d and 10) and the following biota were observed:

According to Table 3, the plants observed in the grove were all common and local species, similar to the area surrounding the mining area. There are no threatened or rare species present, and the eleven bird species observed were also all common, local species. It is expected that more animal species will frequent the island of isolated woodland (0.53 ha), but due to the isolation and size of the area, very few species will settle in the copse.

**Figure 9a-d:** Different views of the small copse of natural woodland adjacent to the Salt Creek Asphalt Plant.

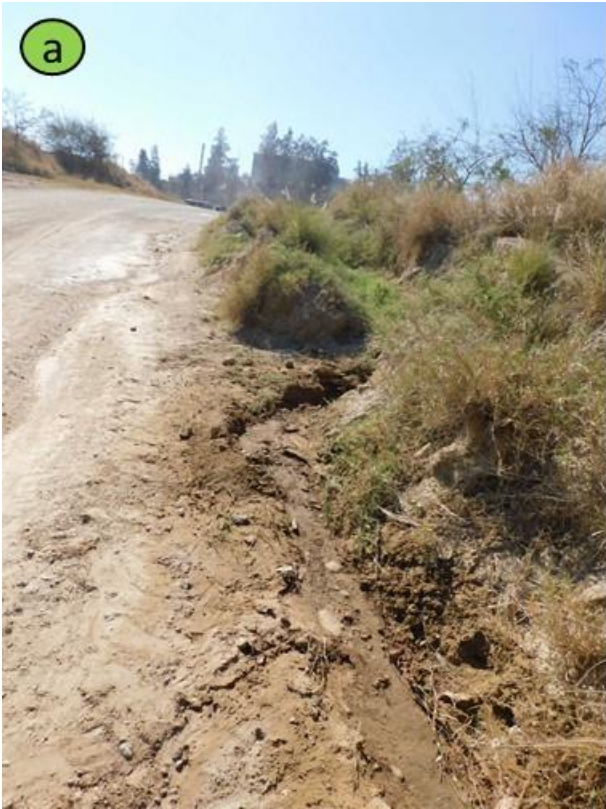
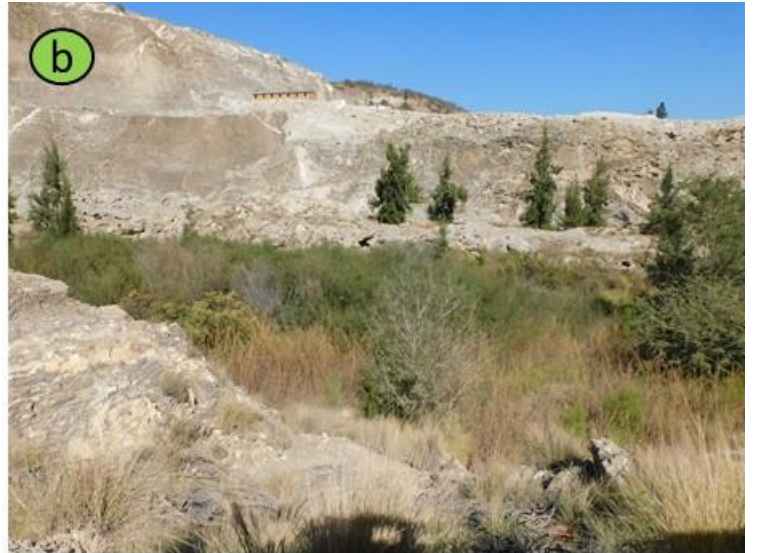
**Figure 11:**

- a. The drainage along the dirt road towards the south-east of the site.
- b. The dead-end of the drainage into a isolated hollow in the mining area (see also Figure 10).

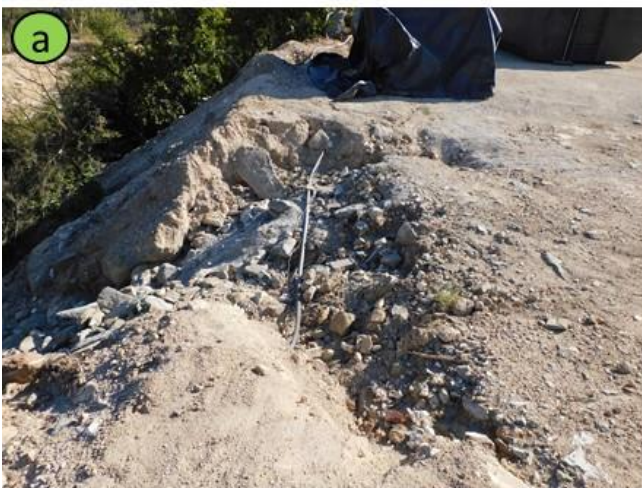
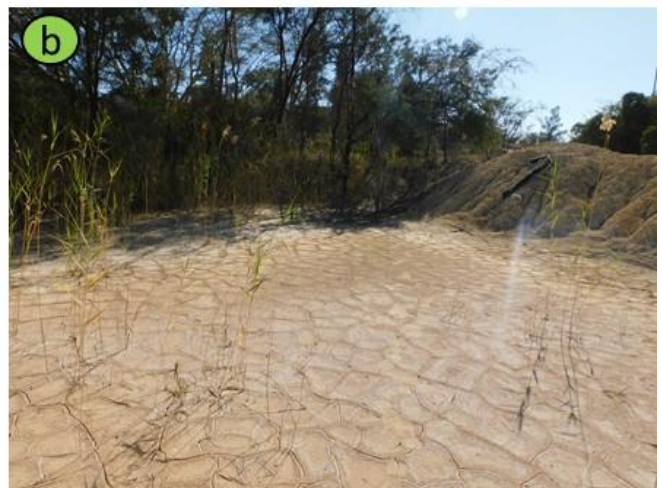
**Figure 12:**

Route 2 (Figures 12a-b and 10) will follow a storm-water chute down the embankment to the west of the plant site and the spill will be contained in a area surrounded by earthen barriers.

- a. A drainage nick created by storm water will release the spill off to the west the project site.
- b. A dead-end of the drainage is created by a confined area to the west of the plant site.

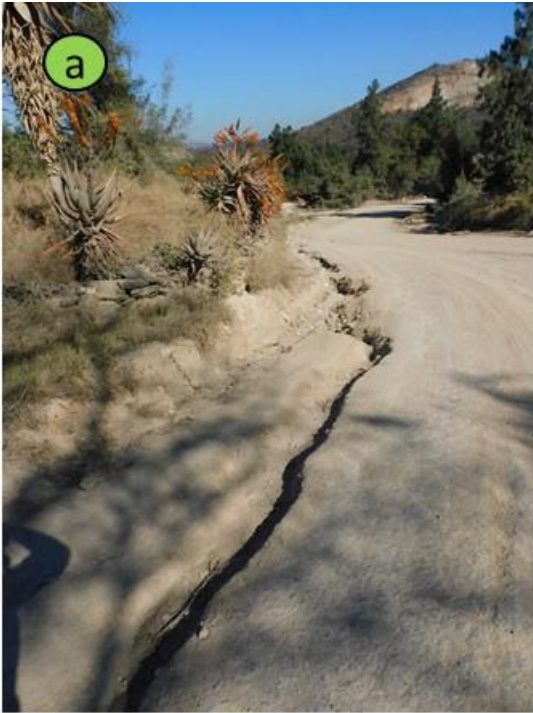
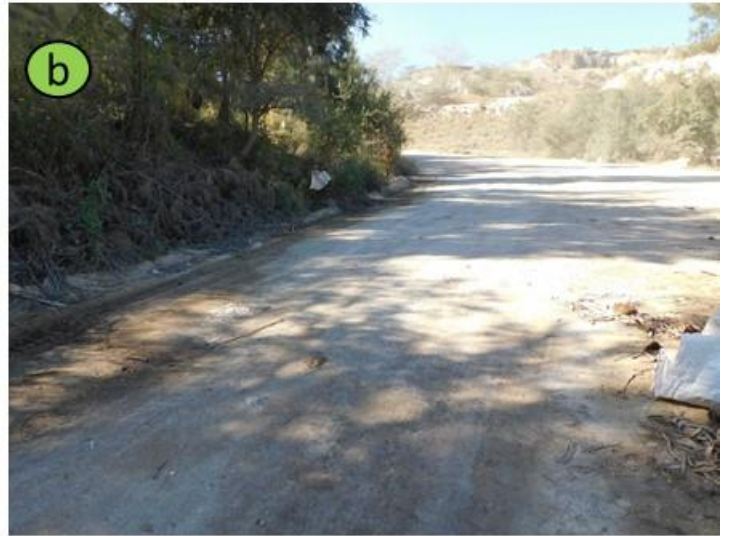
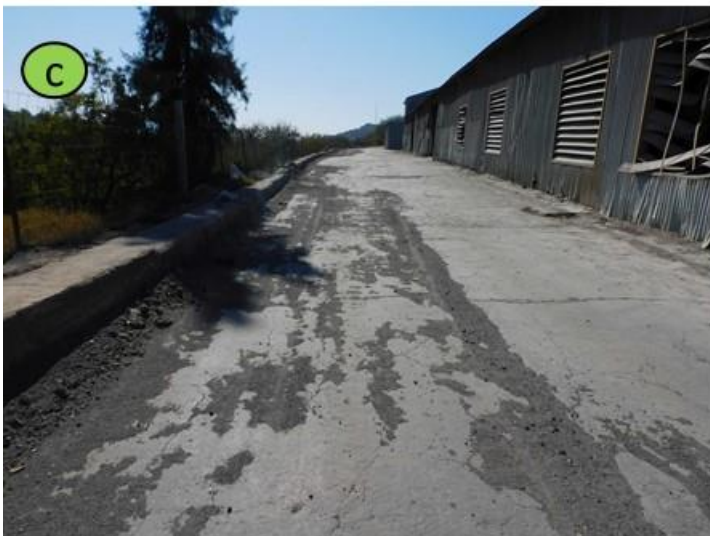
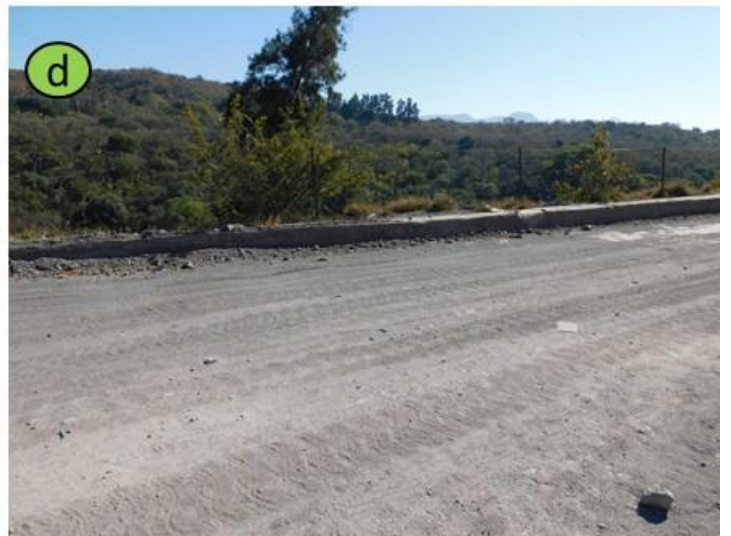
**Figure 13:**

Route 3 (Figures 13a-d and 10) drains along the dirt road towards the northern part of the mine complex as it follows the edges of the road. The most northern boundary of the mining complex is edged by a concrete wall of approximate 30cm high. The walled edge will contain fluids and prevent it from spilling directly into the Strathmoore Dam.

- a. The drainage along the dirt road towards the northern part of the mine complex.
- b. The drainage following the edges of the road.
- c. The most northern boundary of the mining complex is edged by a concrete wall of approximate 30cm high.
- d. The walled edge will contain fluids and prevent it from spilling directly into the Strathmoore Dam.

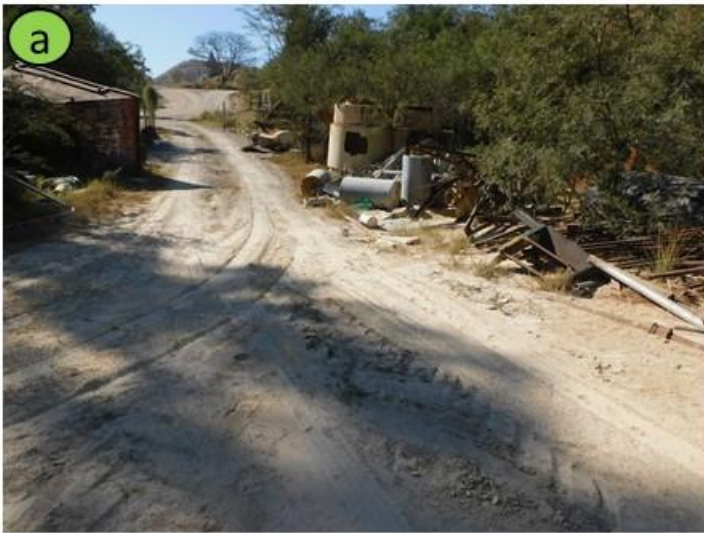
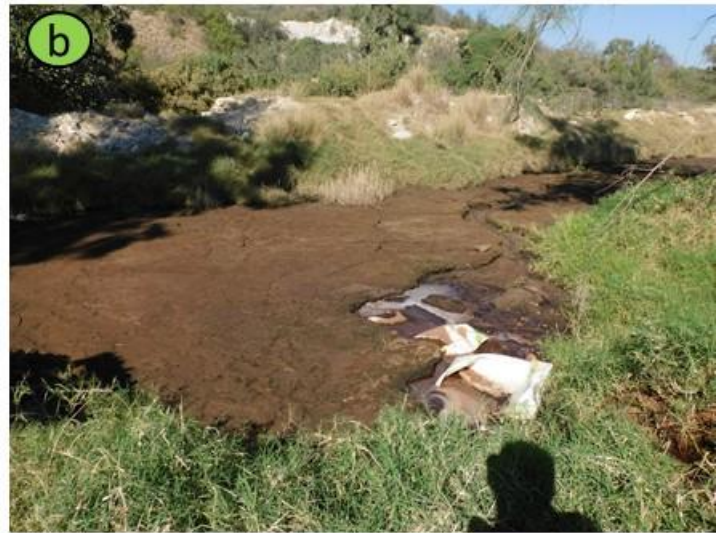
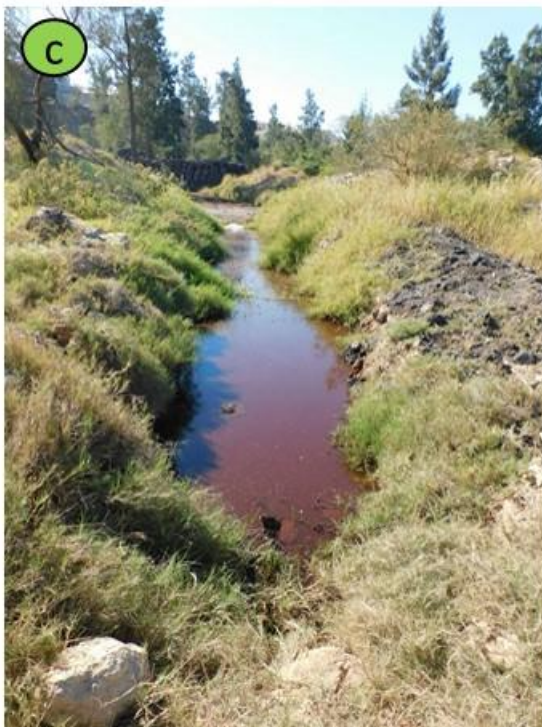
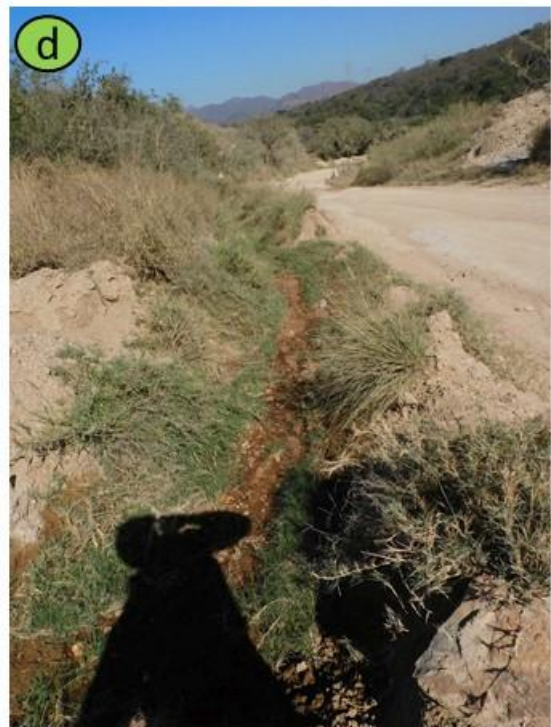
**Figure 14:**

- a. The storm-water drainage to the east (Route 4) runs through a mine scrap yard.
- b. The drainage enters a settling pool of a compost company on the Magnesite mine property.
- c. The “settling pool” has no direct outflow.
- d. Should the “settling pool” top its low wall or breach the wall, the effluent will be flowing down to the Salt Creek, 266 m down the road.

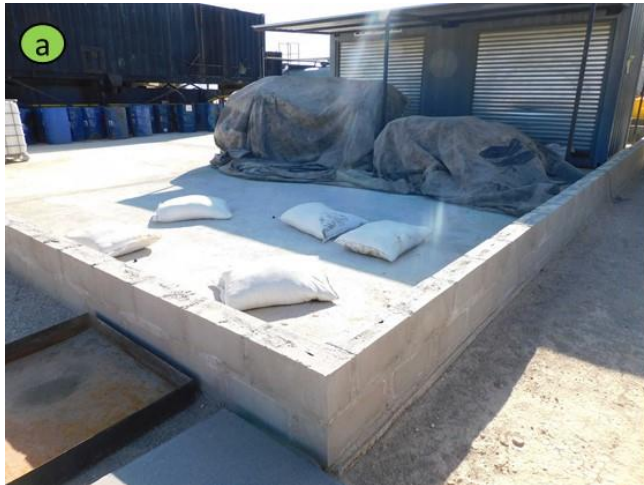
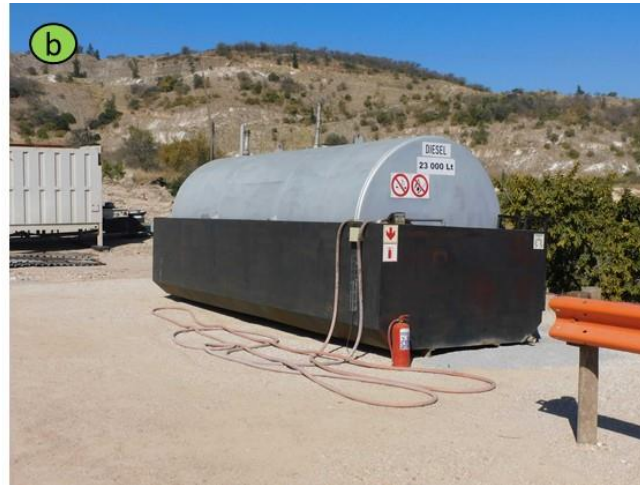
**Figure 15:**

Bunding, also called a bund wall, is a constructed retaining wall around storage "where potentially polluting substances are handled, processed or stored, for the purposes of containing any unintended escape of material from that area until such time as a remedial action can be taken.

- a. A constructed retaining wall around storage at the Salt Creek Asphalt Plant.
- b. Metal bunding encapsulating a container.
