# DPR

## **Report on the ecological and wetland assessment for the proposed establishment of irrigated cropfields adjacent to the Vaal River near the town of Riverton, Northern Cape Province.**

September 2018

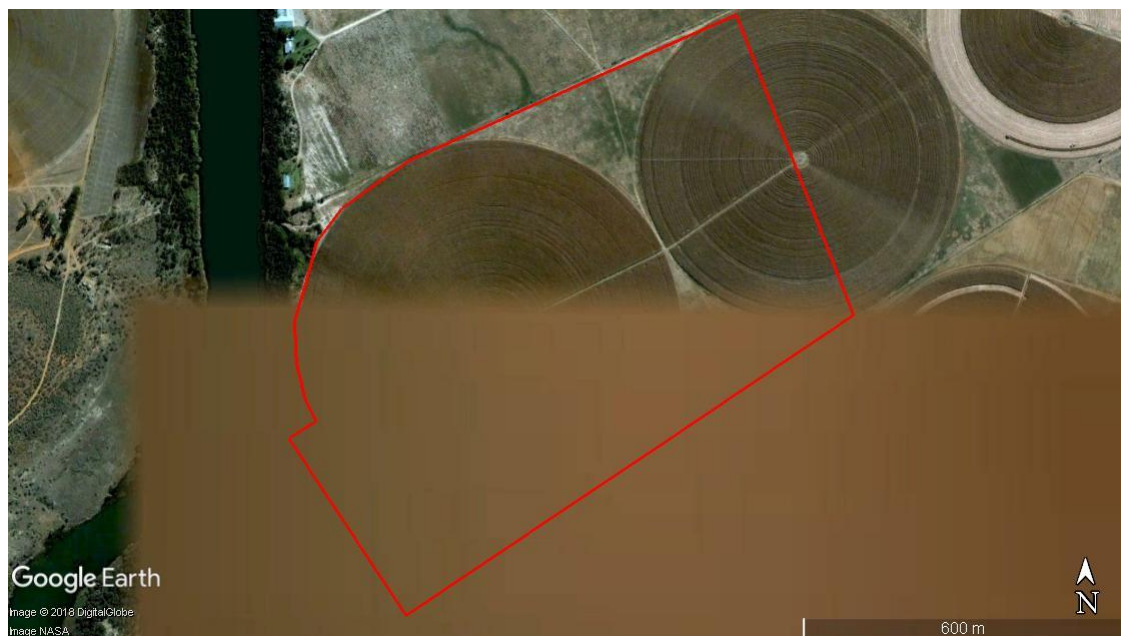
Figure 1: Aerial view of the proposed site (Google Earth 2005). Although a portion of the imagery is not yet available it is clear that two centre-pivot irrigation fields dominate the site and has cleared the natural vegetation.

From the study of aerial imagery (Google Earth 2005 – 2018) it can clearly be seen how and where the natural vegetation was transformed. The earliest available aerial image dating from 2005 indicates that the site was at that time actively cultivated and two centre-pivot irrigation areas are present (Figure 1). In 2007 (Figure 2) cultivation was ceased but it is clear that a large portion of the north east of the site was then subjected to excavation for alluvial diamond mining. This was apparently ceased some time before 2010 (Figure 3) and the site consequently left to re-vegetate itself through succession.

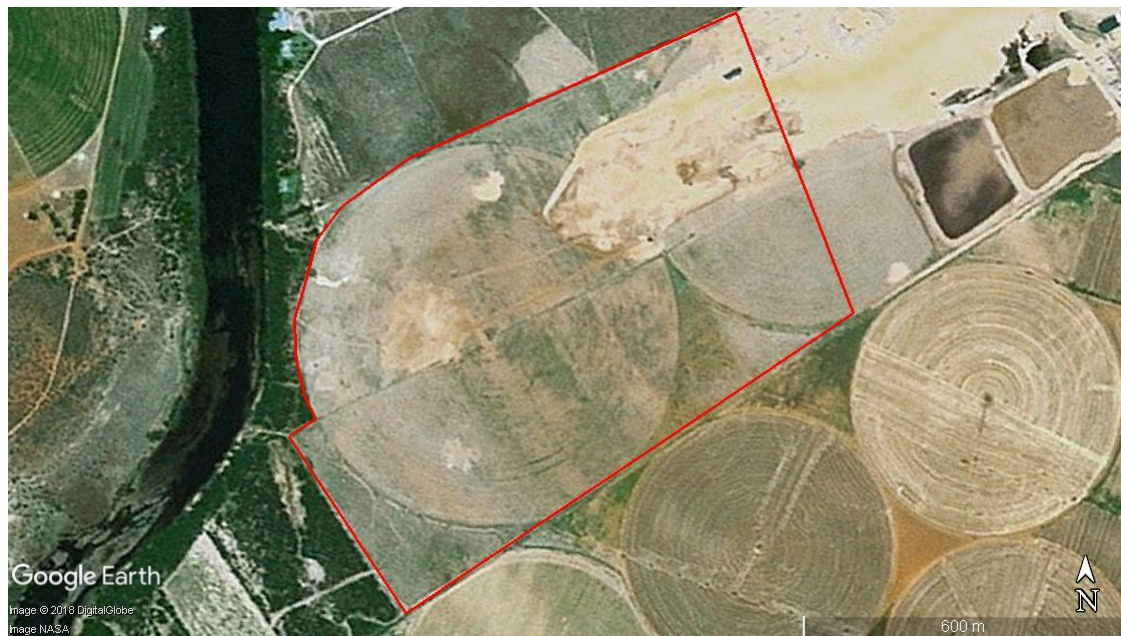
Figure 2: Aerial view of the proposed site (Google Earth 2007). The centre-pivot footprints are clearly visible but it is evident that cultivation is not taking place anymore. A large mining scar is clearly visible in the northern corner of the site.

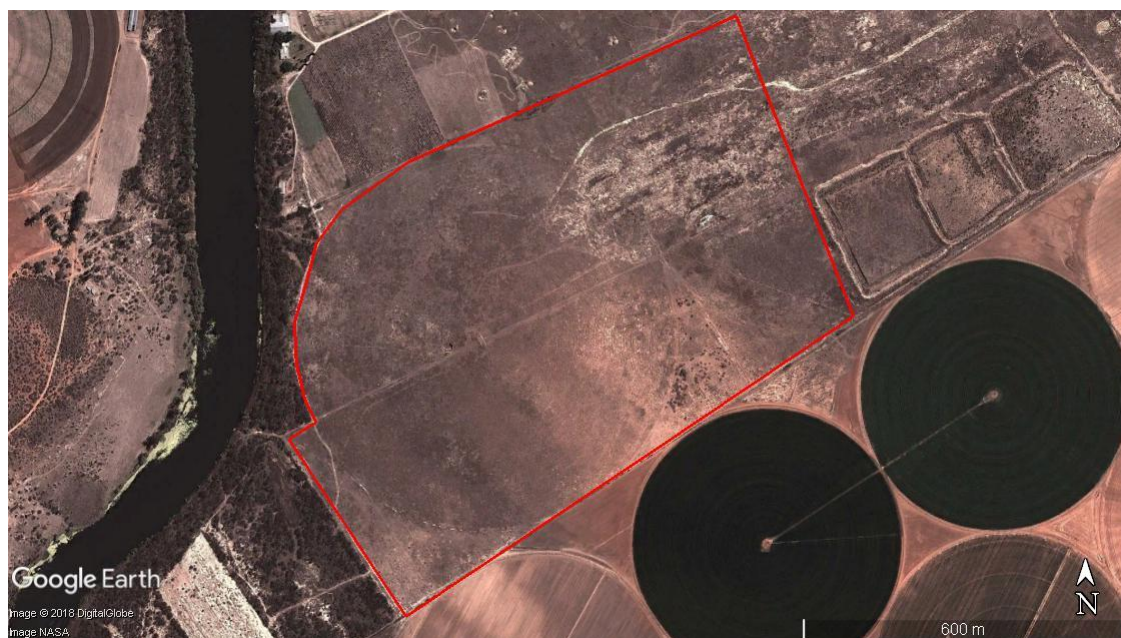
Figure 3: Aerial view of the proposed site (Google Earth 2010). It is clear that both irrigation and mining has ceased and the site left to re-vegetate itself.

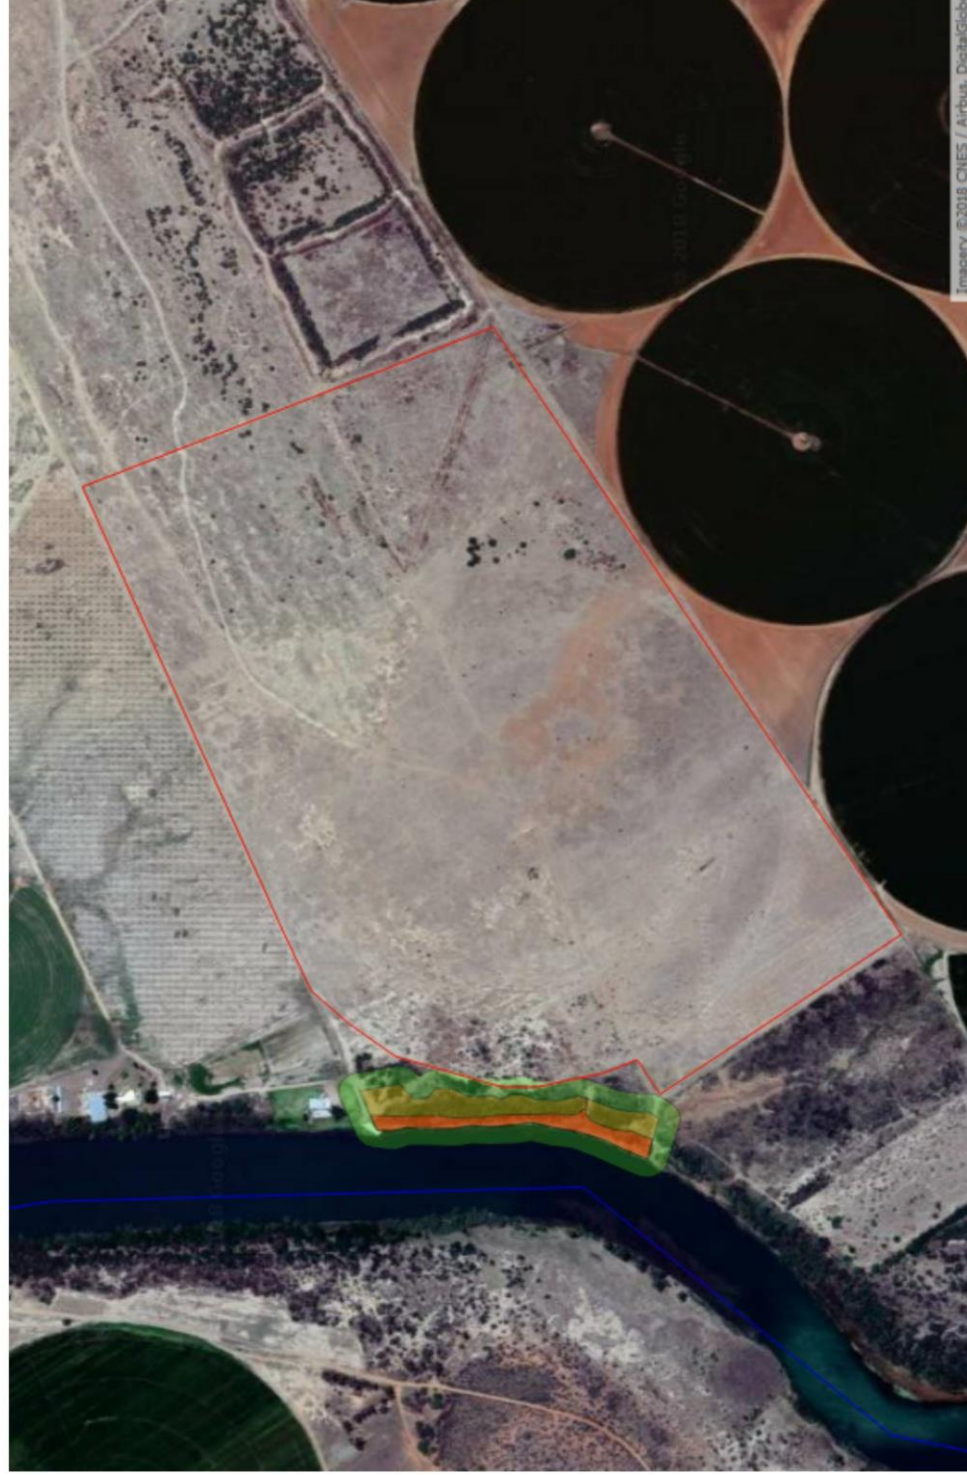
## Wetland delineation for the proposed establishment of irrigated cropfields adjacent to the Vaal River near the town of Riverton, Northern Cape Province.

Map 1: Wetland delineation for the proposed establishment of irrigated cropfields adjacent to the Vaal River. The wetland conditions and riparian zone associated with the river and recommended buffer zone is indicated. Note extensive centre-pivot systems in surroundings.

In order to establish a suitable buffer for the river the Buffer Zone Tool for the Determination of Aquatic Impact Buffers and Additional Setback Requirements for Wetland Ecosystems (2014) was utilised (Appendix F). This determination was also done in conjunction with Macfarlane *et al* (2014). It should be noted that the buffers determined by this model only caters for impacts associated with diffuse-source surface runoff and will not take into account groundwater movement. By using the above tools a suitable buffer was determined at 26 meters for the Vaal River (Map 1). This buffer should be applied from the edge of the riparian zone.

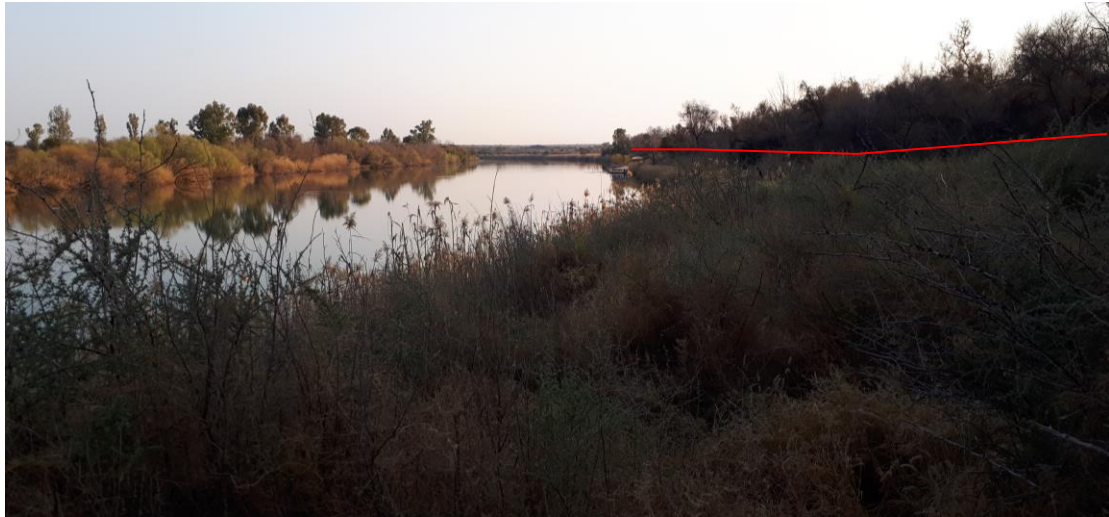
Figure 1: View of the Vaal River adjacent to the western border of the site. Note the dense reedbed at the waters edge. The border is easily discernible by the present of a dense riparian tree layer (red).

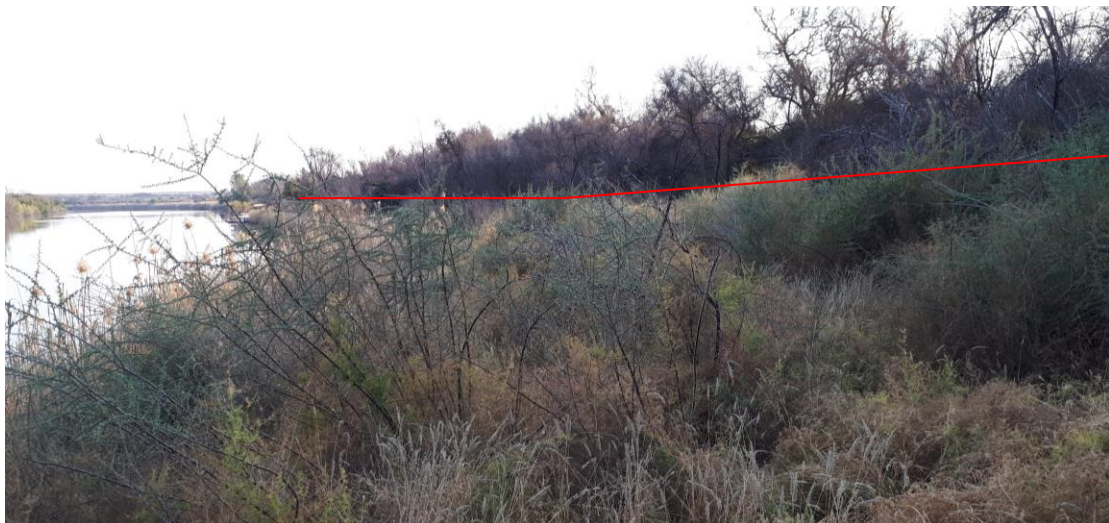
Figure 2: View of the lower zone of the river. Note the dominant low shrub and grass layer. The upper zone is again clearly visible (red).

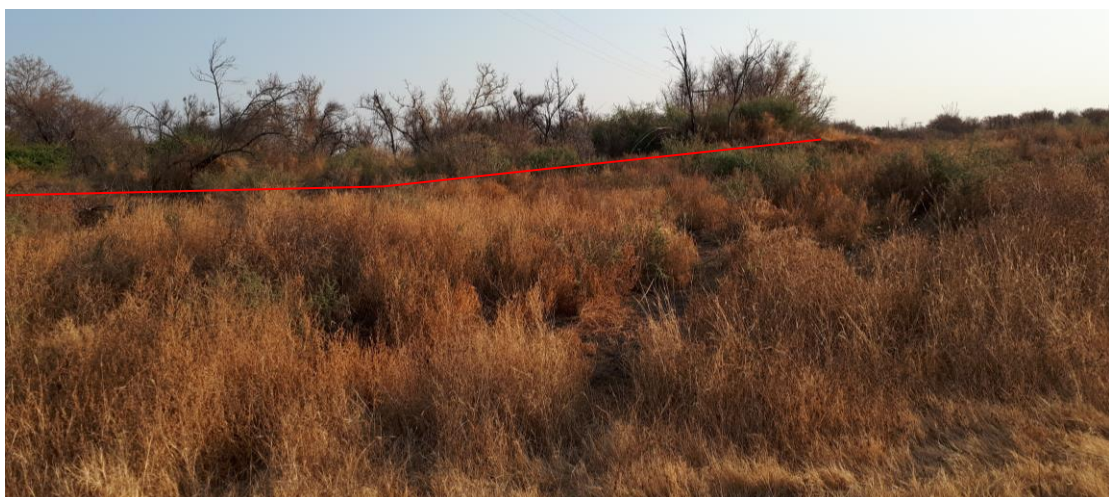
Figure 3: The floodplain of the river has clearly been affected by the previous crop cultivation. The border of the upper zone and floodplain is clearly visible (red).

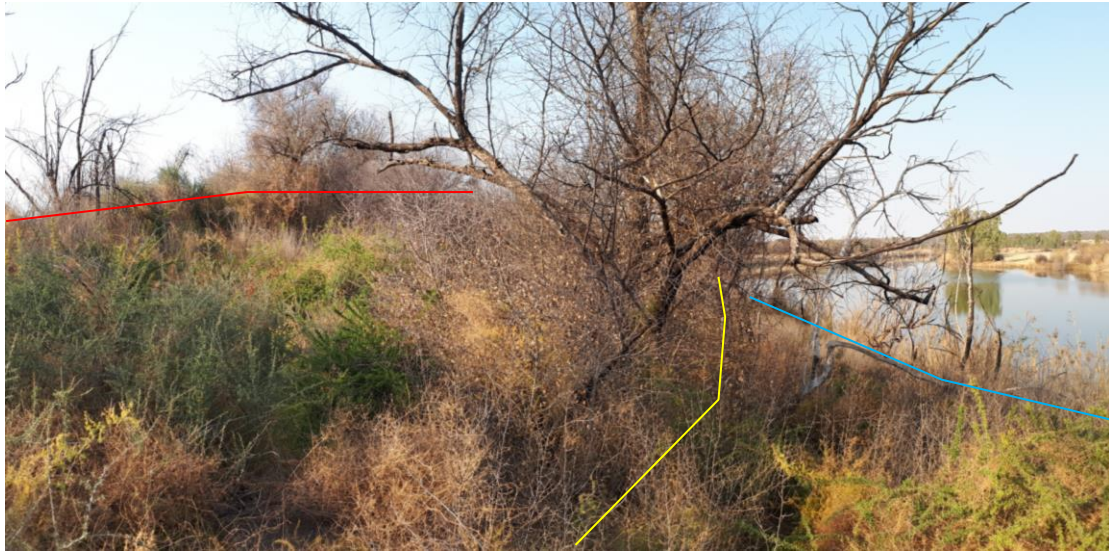
Figure 4: View of the Vaal River adjacent to the north western corner of the site. The upper (red), Lower (yellow) and marginal (blue) zones are indicated.

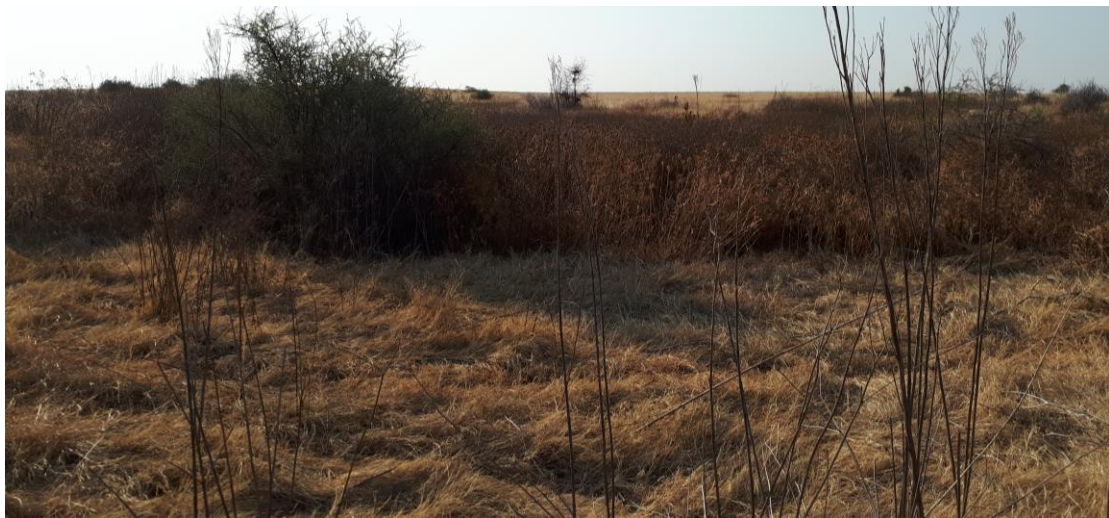
Figure 5: Another view of the floodplain. Transformation by previous crop cultivation is again prominent.

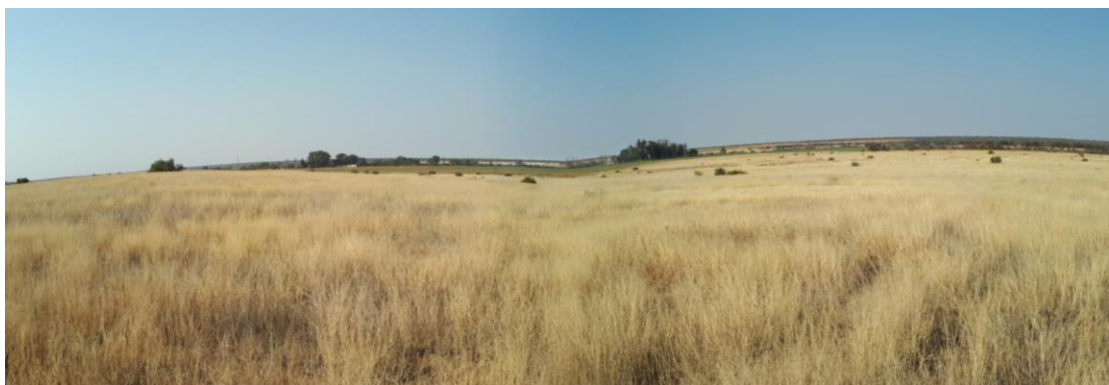
Figure 6: Panorama of the interior of the site. Note the dense grass layer with shrubs and trees largely absent.

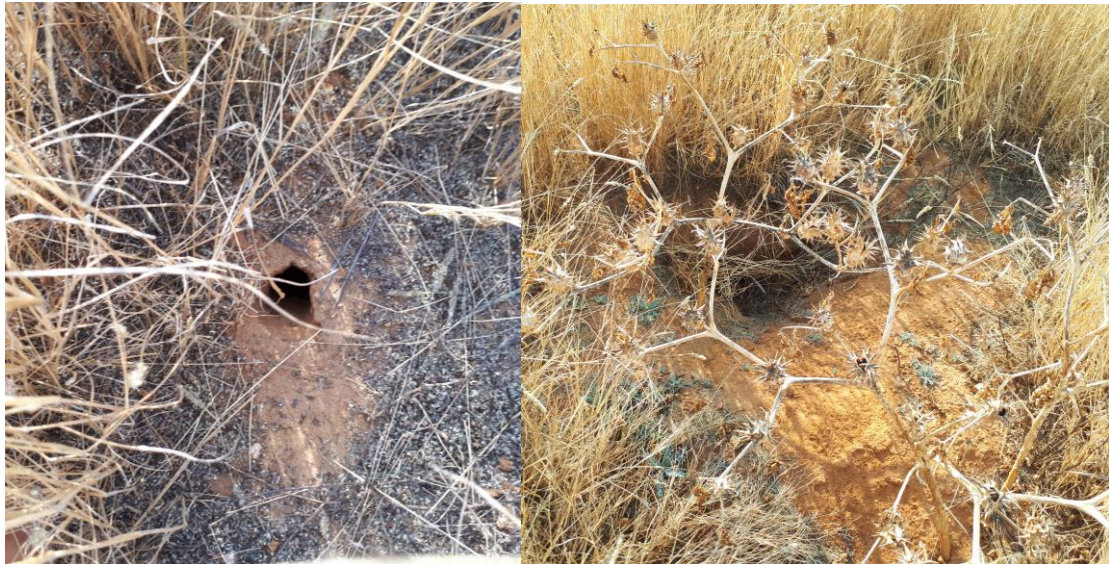
Figure 7: Numerous burrows of small unidentified mammals were observed on the site.

Numerous small burrows occur on the site and is most likely those of small rodents. These burrows are most likely those of the Multimammate Mouse (*Mastomys coucha*) and the Striped Mouse (*Rhabdomys pumilio*). According to Avenant (2000) where extensive disturbance of grassland occur these species dominate. It has also been shown that these rodent species can be used as indicators of grassland degradation (Avenant & Cavallini 2007, MacFadyen *et al.* 2012). In light of the transformed and pioneer condition of the grassland on the site this is considered the most likely occupants of the small burrows.

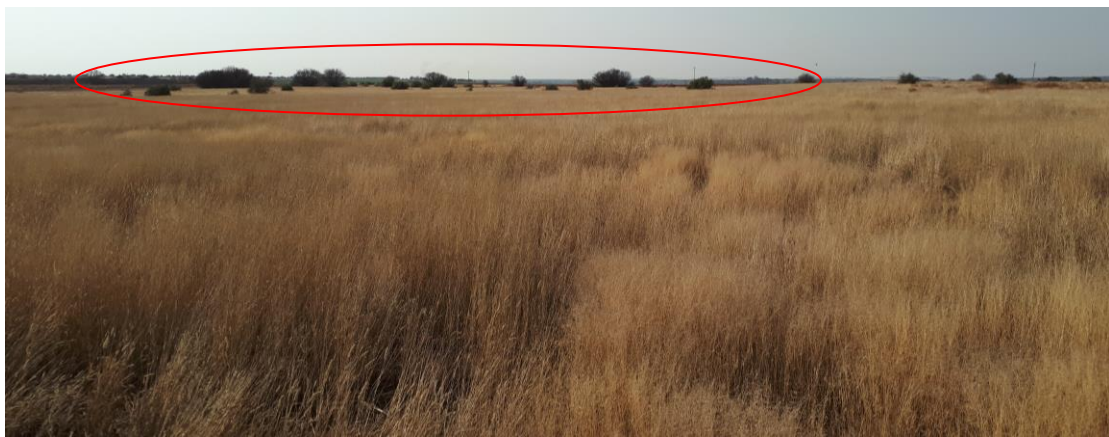
Figure 8: View of the eastern corner of the site where scattered trees has become established (red).

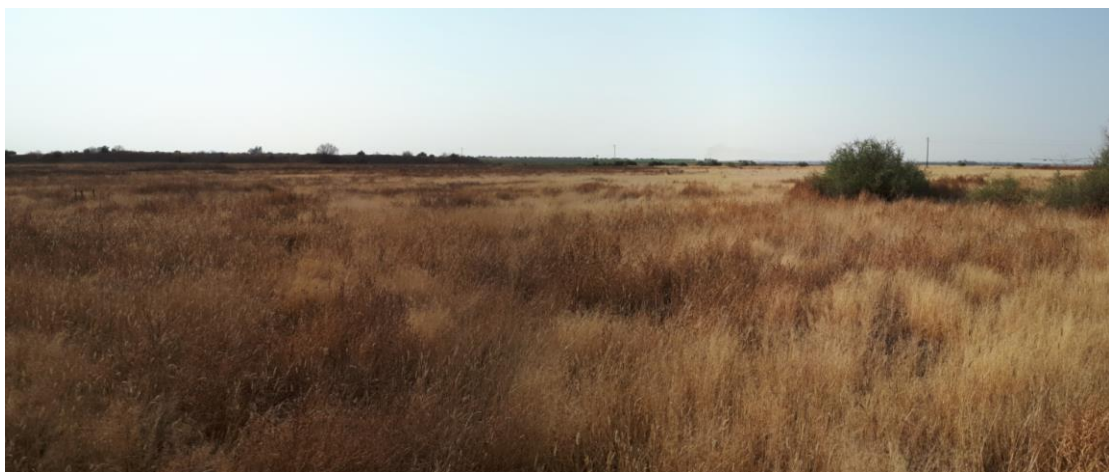
Figure 9: Panorama of the eastern portion of the site. Disturbance here is higher as result of previous diamond mining activities.

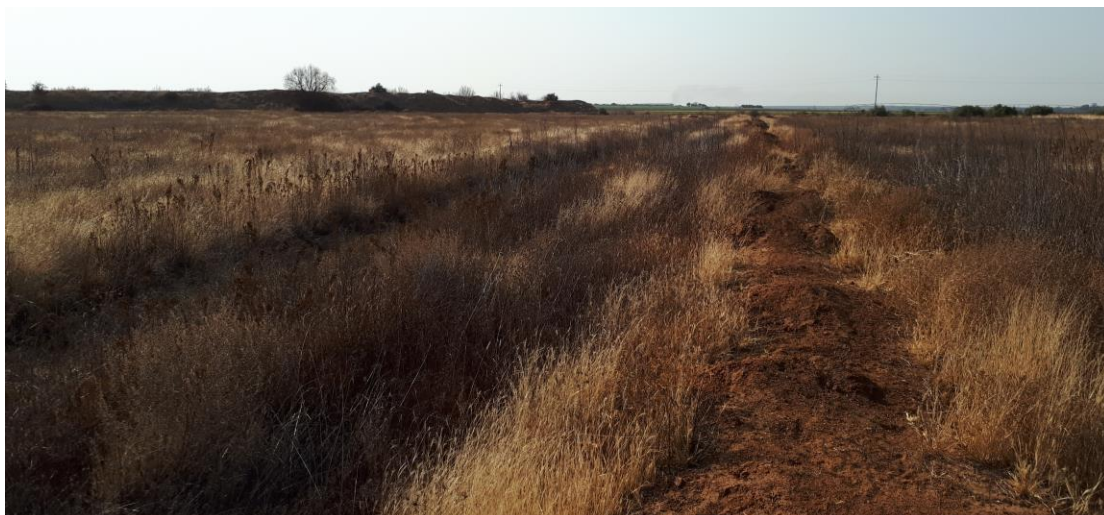
Figure 10: View of the artificial trench/canal in the eastern portion of the site.

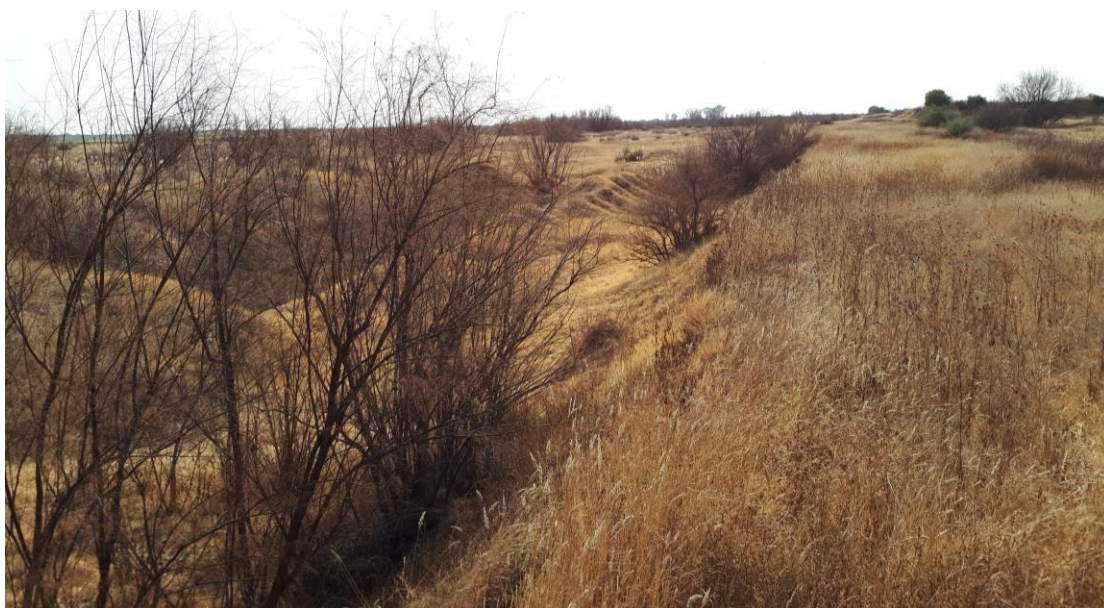
Figure 11: Another view of artificial excavations on the site, most likely associated with previous diamond mining activities.

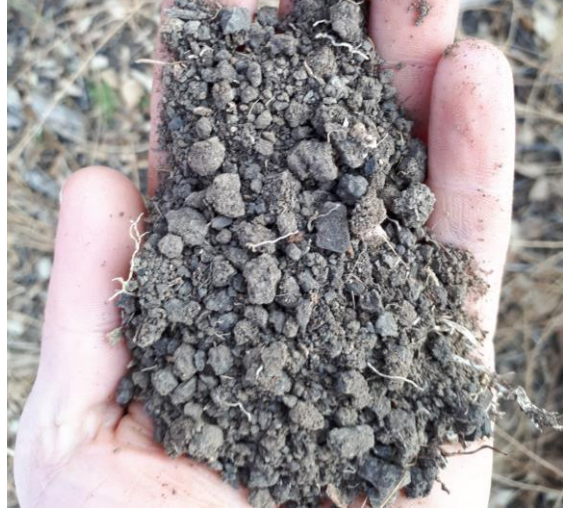
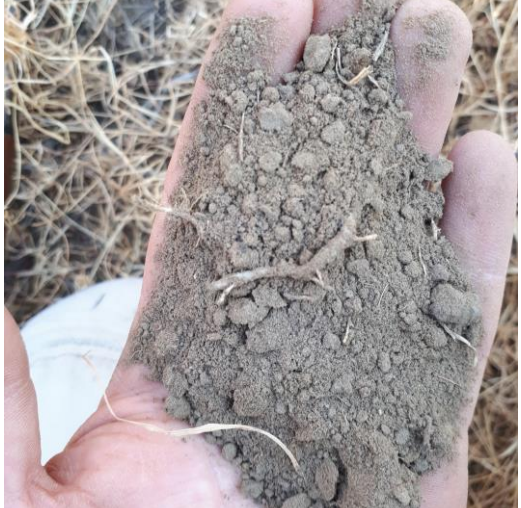
Table 2: Soil samples taken along a lateral transect of the Vaal River adjacent to the site (S 28.491118°, E 24.650001°).

<p>Soil sample taken in the marginal zone of the river. A prominent grey matrix (&gt;10%) is clear and mottling is present indicating a permanent zone of wetness. Wetland conditions are therefore clearly present.</p>	<p>Soil sample taken in the lower zone of the river bank. A grey matrix (&lt;10%) is clear and mottling is prominent indicating a seasonal zone of wetness. Wetland conditions are therefore clearly present.</p>

<p>Soil sample taken at the upper end of the lower zone of the river bank. A grey matrix is not clear and faint mottling may be present. This is taken as the border of wetland conditions.</p>	<p>Soil sample taken in the upper zone of the river bank. A grey matrix and mottling is clearly absent and wetland conditions are not present. A high silt content does indicate it still forming part of the floodplain.</p>

<p>Soil sample taken in the upper zone of the river bank.</p> <p>A grey matrix and mottling is clearly absent and wetland conditions are not present. A high silt content does indicate it still forming part of the floodplain.</p>	<p>Soil sample taken in the floodplain of the river.</p> <p>A grey matrix and mottling is clearly absent and wetland conditions are not present. A high silt content does indicate it still forming part of the floodplain.</p>

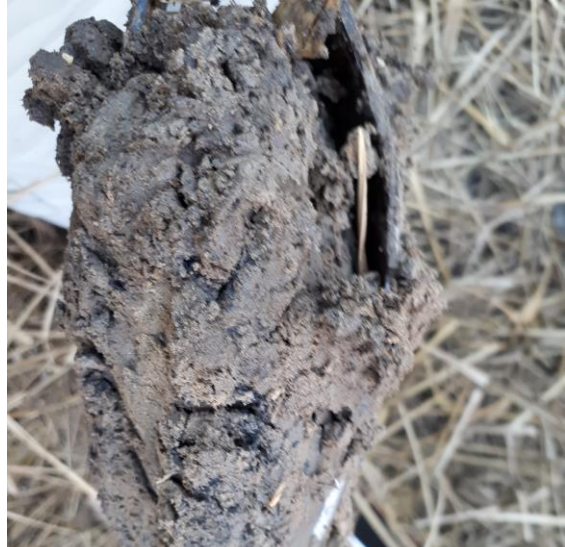
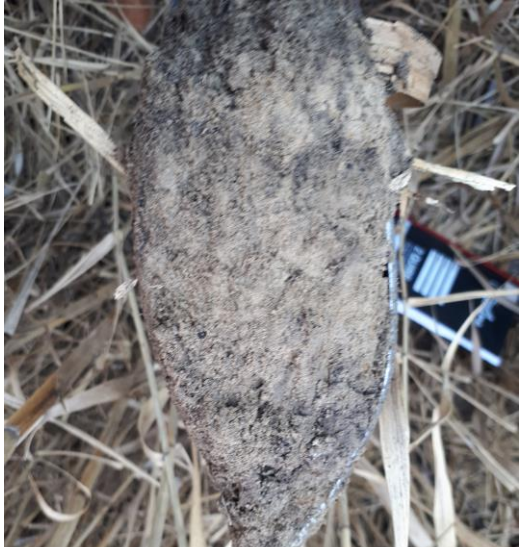
<p>Soil sample taken in the marginal zone of the river.</p> <p>A prominent grey matrix (&gt;10%) is clear and mottling is present indicating a permanent zone of wetness. Wetland conditions are therefore clearly present.</p>	<p>Soil sample taken in the lower zone of the river bank.</p> <p>A grey matrix (&lt;10%) is clear and mottling is prominent indicating a seasonal zone of wetness. Wetland conditions are therefore clearly present.</p>

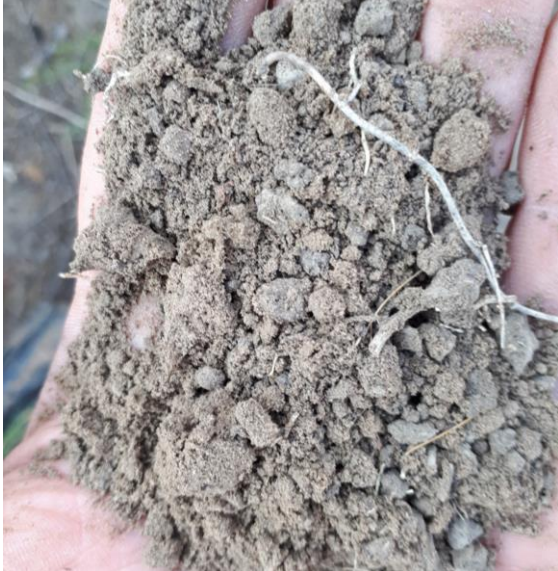
<p>Soil sample taken in the upper zone of the river bank.</p> <p>A grey matrix and mottling is clearly absent and wetland conditions are not present. A high silt content does indicate it still forming part of the floodplain.</p>

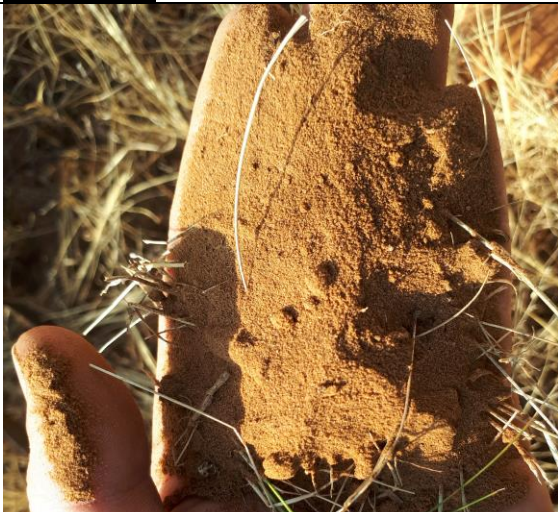
Table 3: Soil samples taken in the adjacent terrestrial environment (S 28.492963°, E 24.654224°).

<p>Soil sample taken in the surrounding terrestrial area of the site.</p> <p>A grey matrix and mottling is clearly absent and wetland conditions are not present. Note the high sand content and absence of silt.</p>
