KROMDRAAI PROJECT

**Groundwater Risk
Assessment of Gypsum
Sludge Placement in the
Yellow Buoy Section at
Blaauwkraans**

Report Number. 12481-9815-4

eMalahleni Mine Water Reclamation Project Terrestrial Ecology Report

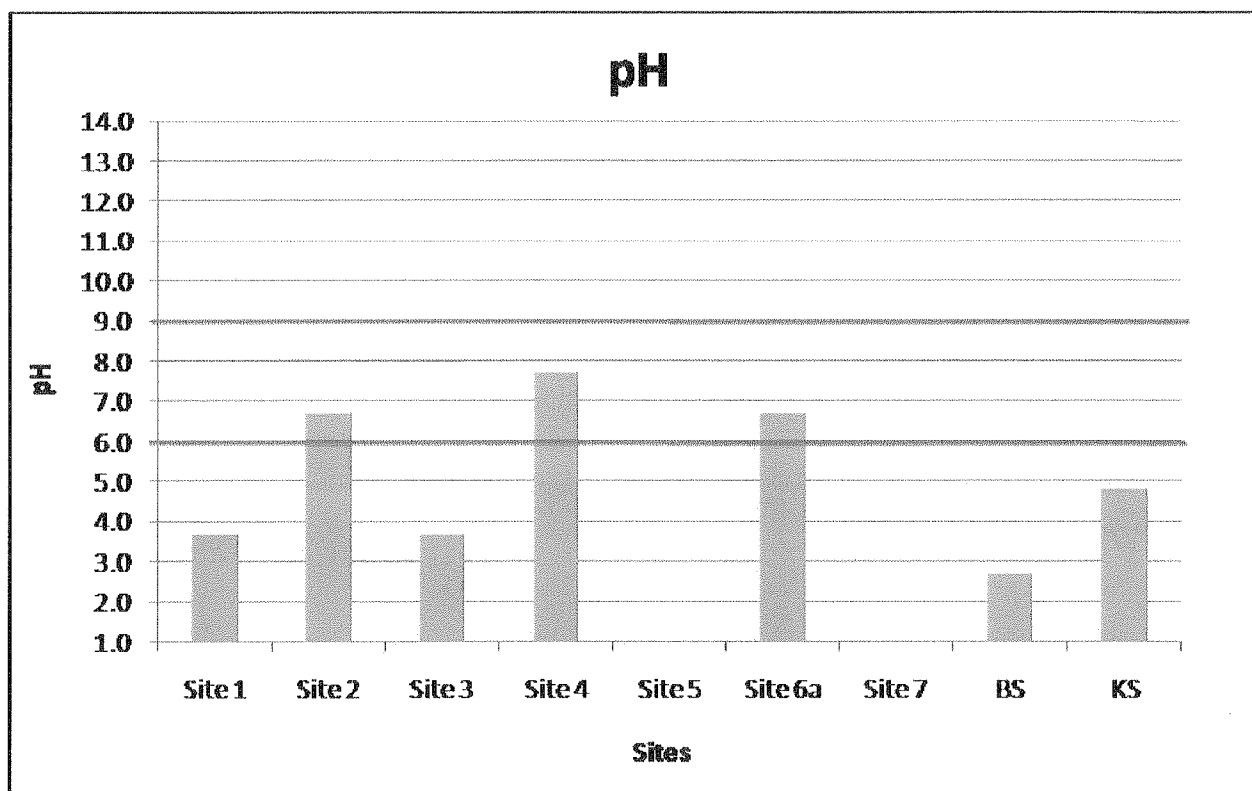
Figure 2: pH values recorded during the January 2010 survey (red lines indicate guideline values).

During the January 2010 survey, pH values were generally acidic < 7 and ranged from 7.7 at Site 4 to 2.7 at site BS (Figure 2). Human-induced acidification is the result of effluents, such as those from industries, and water draining from mines (Davies and Day, 1998). Based on the January 2010 results pH at Site 1, Site 3, BS and KS may have a limiting affect on aquatic biota, while at the remainder of the sites pH was not considered to have a limiting effect.

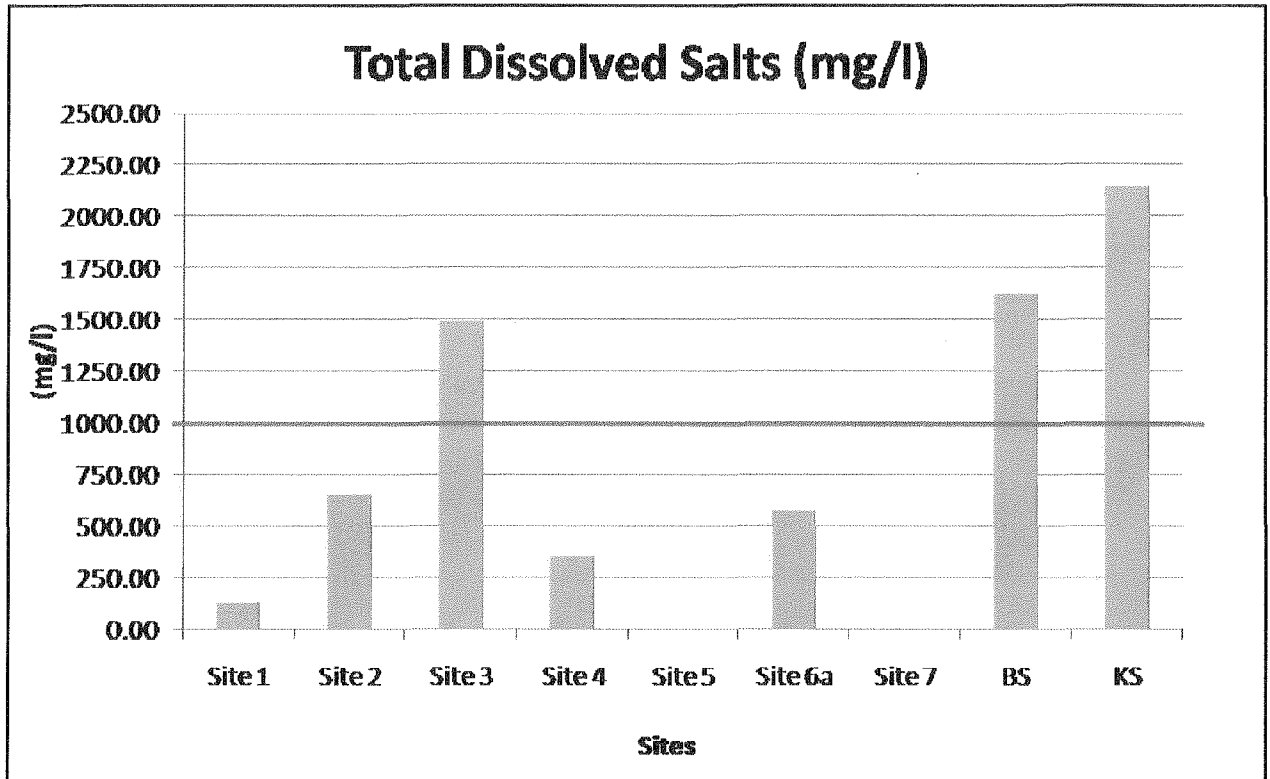
Figure 3: TDS recorded during the January 2010 survey (red line indicates guideline value).

During the January 2010 survey Total Dissolved Solid (TDS) concentrations ranged from 130 mg/l at Site 1 to 2145 mg/l at site KS (Figure 3). The TDS concentrations at Site 3, BS and KS may have a limiting affect on aquatic biota as they were observed to be above 1000 mg/l.

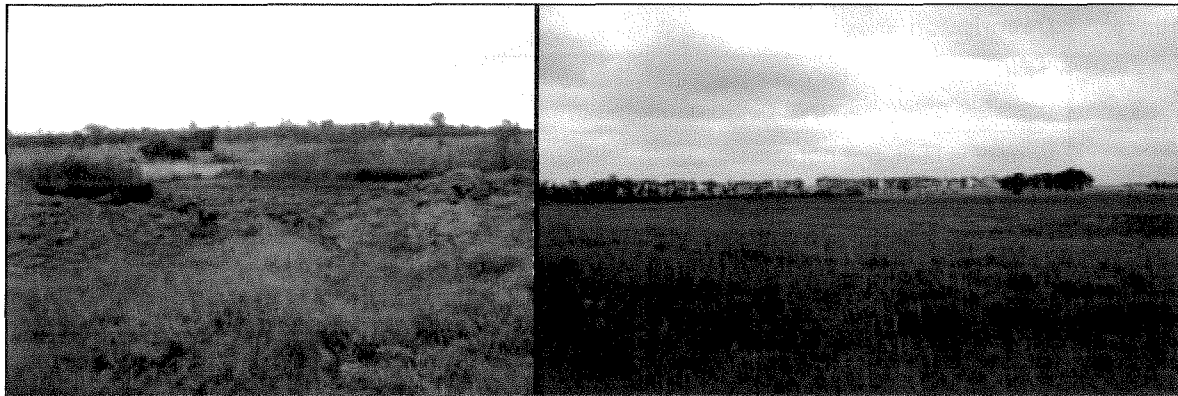
Figure 3: Site photo of KS.

Acacia trees were located on the edge of the wetland in most areas. The channel had been excavated at certain sections and there were road crossings at several locations through the channel. Sand and Gravel mounds were also present on the sides of the wetland. The permanent inundation in the wetland was due to the constant release of water from the Kromdraai mine.

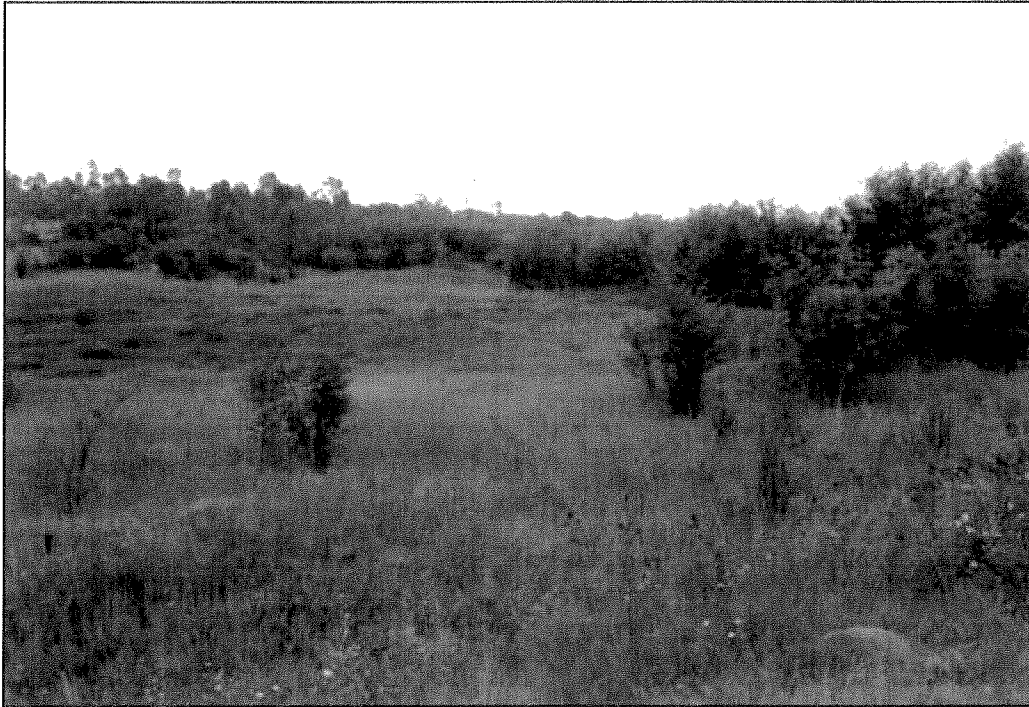
Figure 6: Photo of site WC1.

A service road for the mine runs across the wetland at the point of the proposed pipeline crossing site. There is a small channel running through the wetland with a large permanent zone. Acacia trees are encroaching onto the wetland's temporary zone and growing next to the road bridge.

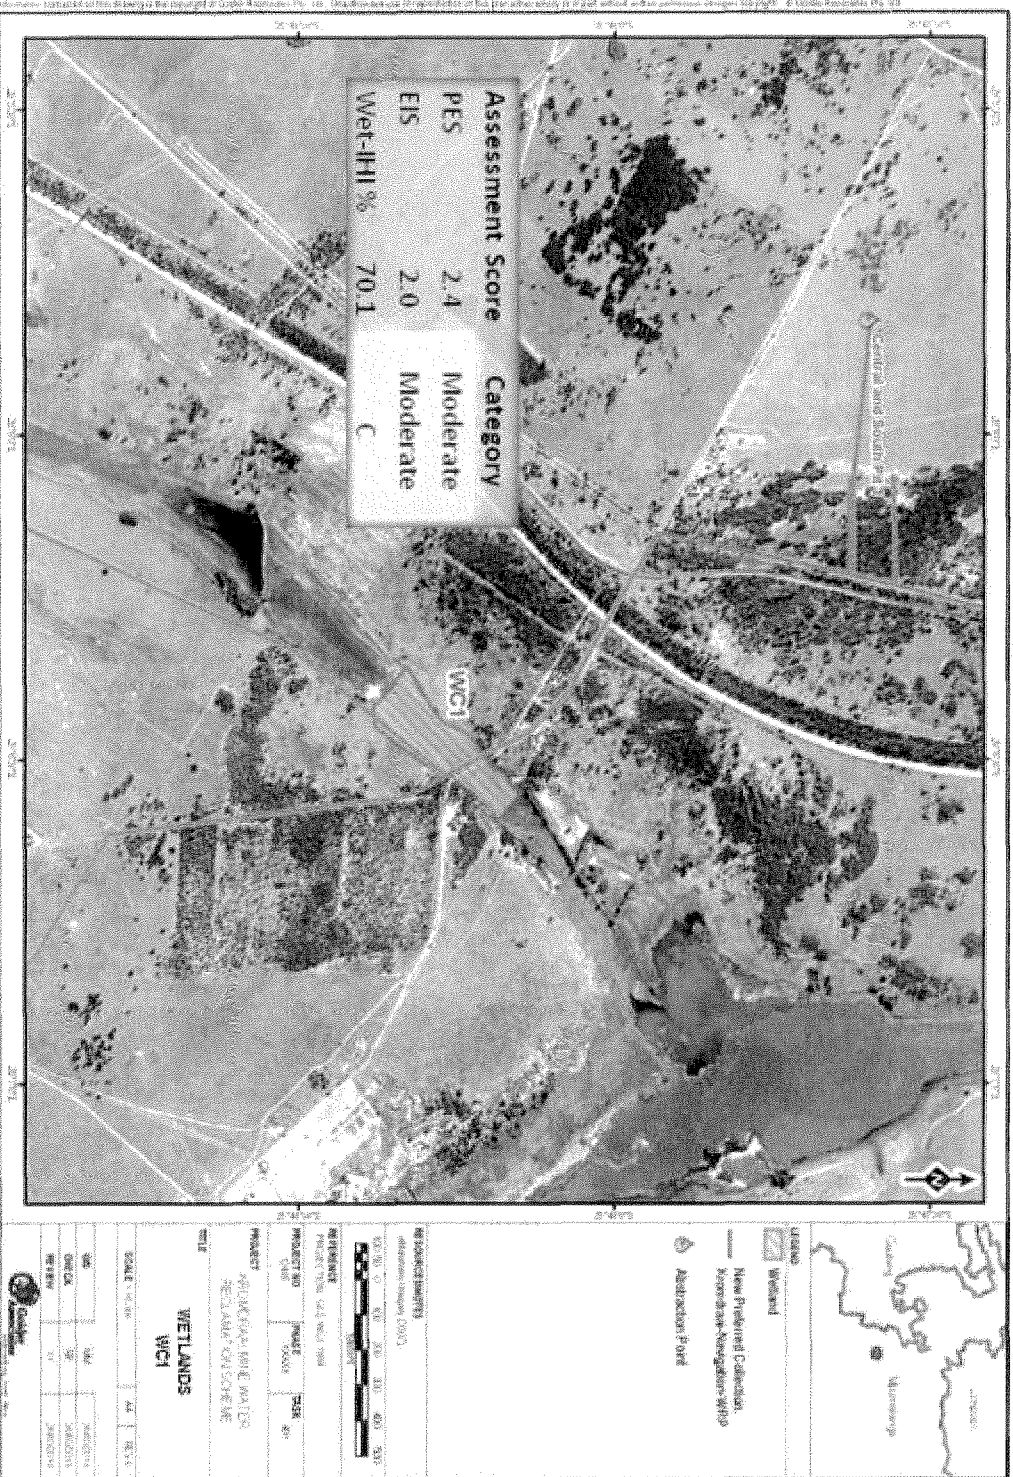
Figure 7: Site WC 1 delineation and scores.

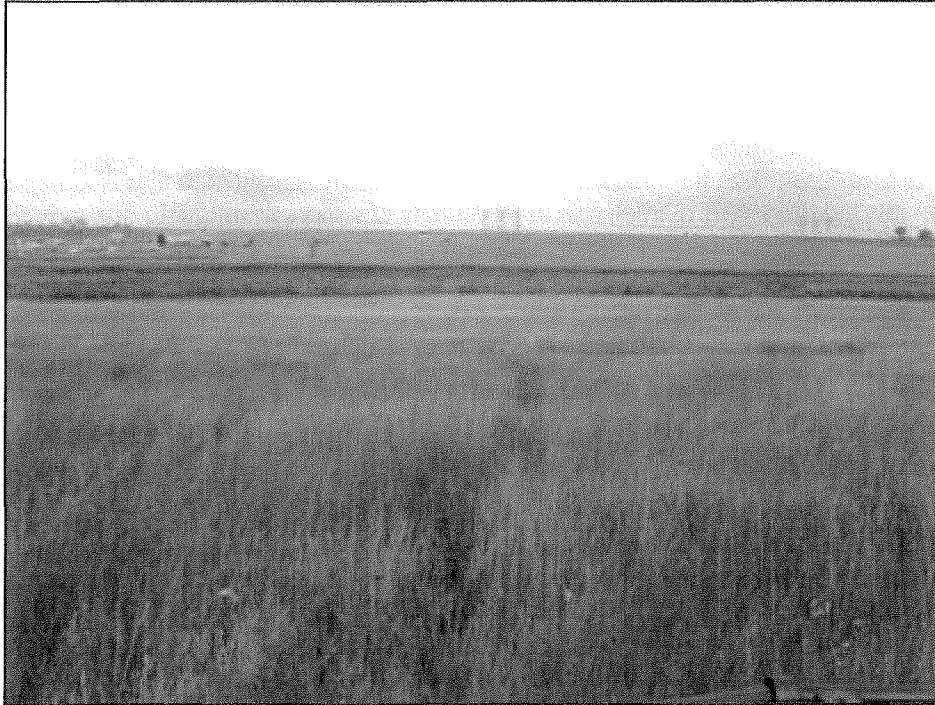
Figure 9: Site photo of WC2.

The site is situated next to a wastewater treatment works and a formal settlement is located upstream. Mining activities are taking place to the west of the wetland.

APPENDIX A lists the floral species recorded at this site. One exotic species, *Paspalum urvillei* was recorded on site. The channel was overgrown with *Typha capensis*, possibly indicating high nutrient levels that lead to the dominance of hardy species. Two faunal species were recorded at this site during the survey, the Golden Bishop (*Euplectes afer*) and the Longtailed widow (*Euplectes progne*). The Golden bishop is usually associated with wetlands where it breeds within the grass and reed stands. The Longtailed widow is occasionally associated with wet areas.

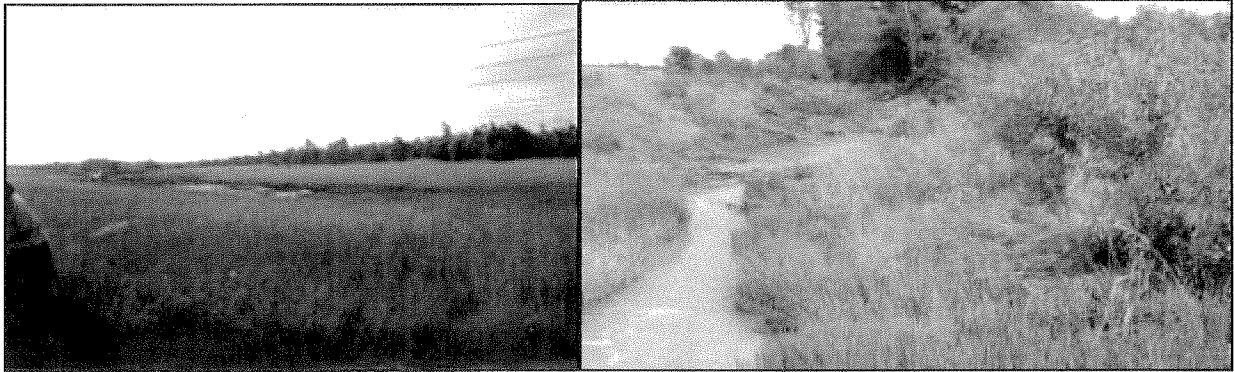
Figure 12: Site photo of WC3.

The wetland is permanently inundated due to the release of water from the upstream mine. The channel was incised due to bank erosion, becoming more deeply channelled further downstream. A small dirt road crosses the channel with culverts beneath it. Downstream of the site exotic trees line the banks.

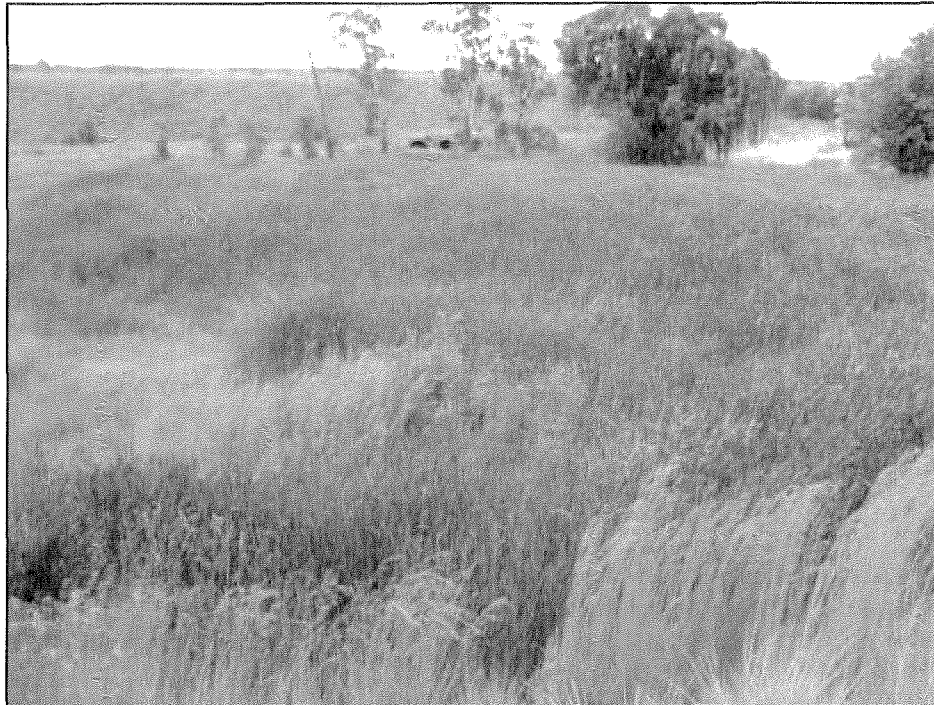
Figure 15: Site photo of WC4

This wetland forms part of the Brugspruit and falls within the Highveld Level 1 Ecoregion. The wetland is situated on a valley floor and was classified as a Channelled Valley Bottom wetland. The wetland is permanently inundated with a littoral depth class.

This wetland is situated between the R104 and the N4. The wetland is artificially inundated due to the two roads crossing it. There is a house that is informally utilized by people situated in the temporary zone on the eastern side of the wetland.

APPENDIX A lists the floral species recorded at this site. Exotic species found on site included *Salix babylonica* and *Datura stramonium*. The presence of *Hyparrhenia hirta*, *Urechloa mosambicensis* and *Setaria sphacelata* are signs of the disturbed nature of the site. Two faunal species were recorded at this site during the survey, the Golden Bishop (*Euplectes afer*) and the Southern Red Bishop (*Euplectes oryx*). These species are usually associated with wetland habitats where they breed within the grass and reed stands.

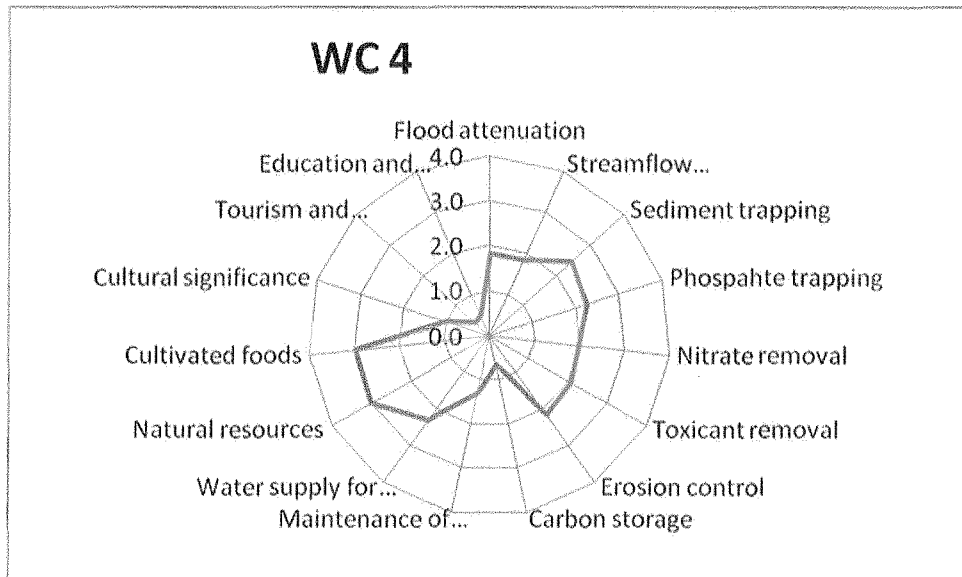
Figure 17: Ecological services scores for site WC4.

Site WC4 scored "Moderate" in terms of natural and human services. The moderate natural services score can be attributed to the loss of natural habitat diversity and site degradation due to anthropogenic impacts which has resulted in the loss of some of the natural functions provided by the wetland. The "Moderate" human services score can be ascribed to the locality of the wetland. The downstream part of the wetland is surrounded by plots and high density housing. There are therefore people in the vicinity that make use of the wetland. Figure 5 shows the ratings for the different services provided by this wetland. As can be seen, this wetland was mostly effective in sediment trapping, phosphate- and nitrate trapping, erosion control and toxicant removal. It was also a source for natural resources, used for cultivation and as a water supply.

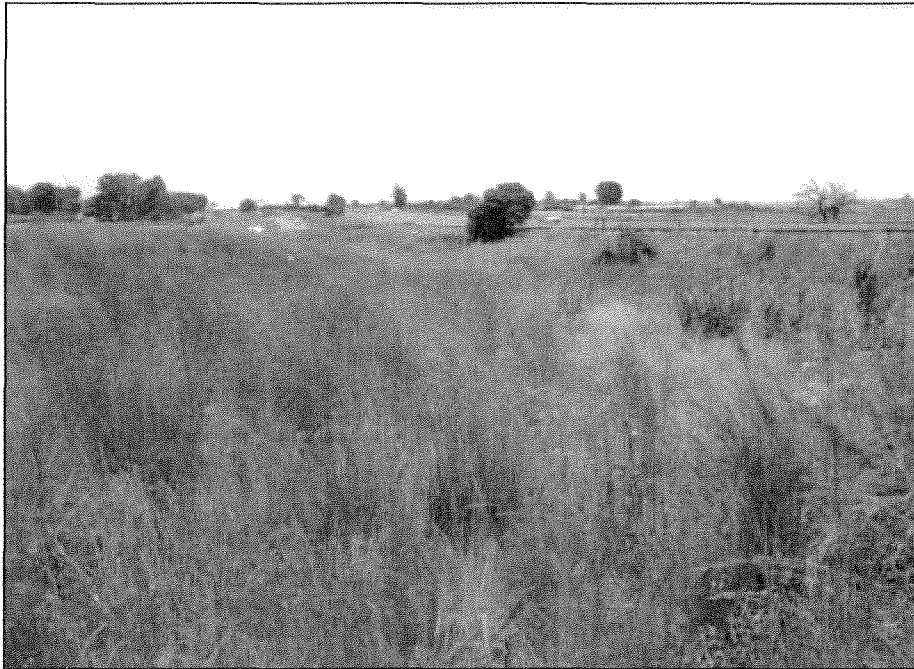
Figure 18: Site photo of WC5.

At site WC5 the wetland is situated between the R104 and the N4. The wetland is artificially inundated largely due to the two roads crossing it (Figure 18).

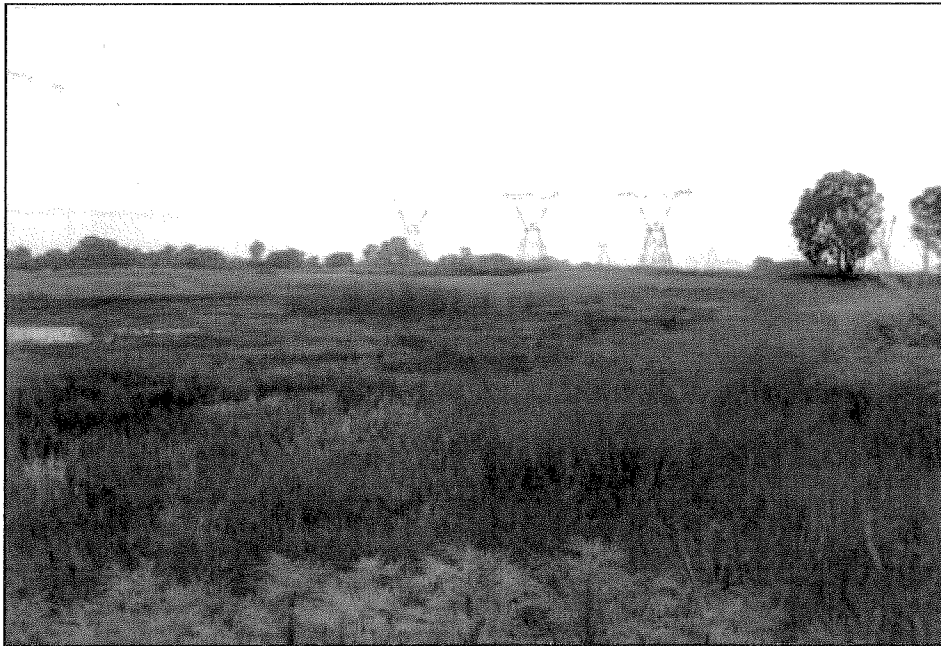
Figure 25: Site photo of WC9.

This wetland falls within the Highveld Level 1 Ecoregion. The wetland is situated on a bench (Hilltop) and was classified as an endorheic depression without channelled inflow. The depression is permanently inundated with a littoral depth class.

The existing road was possibly built through the seasonal zone of this depression as there was a wet area on the western side of the road. This wet area has been degraded by crop cultivation. The upgrading of the road is further impacting on the wetland. Further degradation of the depression is caused by surrounding cultivation and the encroachment of exotic trees.

APPENDIX A lists the floral species recorded at this site. Exotic species recorded on site included *Cyperus esculentus*, *Paspalum urvillei*, *Tagetes minuta* and *Acacia mearnsii*. The dominant species within the wetland was *Imperata cylindrica*. Two faunal species were recorded at this site during the survey namely the Golden Bishop (*Euplectes afer*) and the Southern Red Bishop (*Euplectes oryx*). These species are usually associated with wetland areas where they breed within the grass and reed stands.

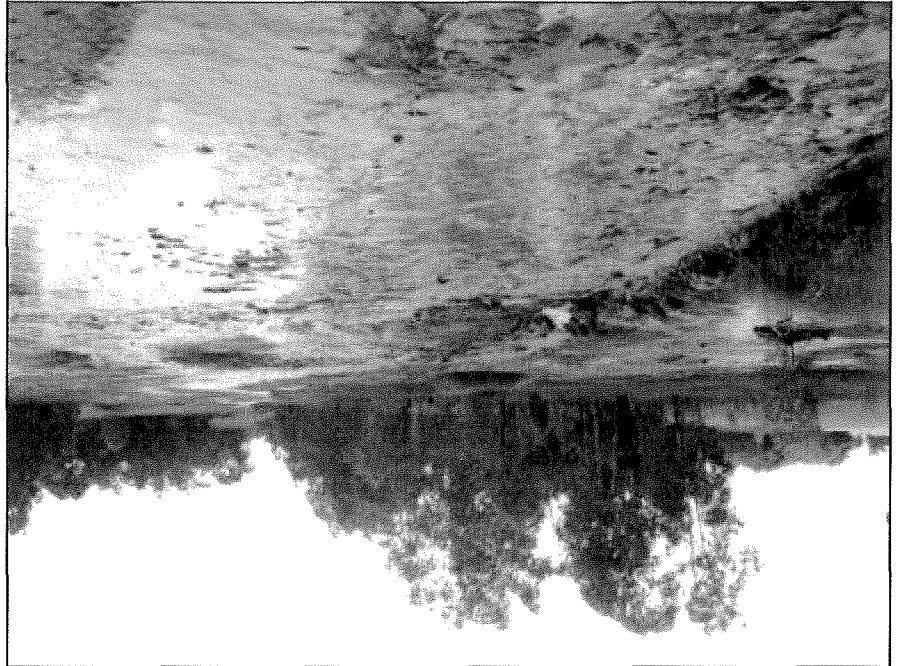
Figure 28: Site photo of WC5.

The reason for the permanent inundation is due to decant of water from the Middelburg Steam and Station Colliery. The channel is small and slightly incised, with water flowing on the slopes as well. The valley bottom is overgrown with *Eucalyptus*, indigenous vegetation is largely absent.

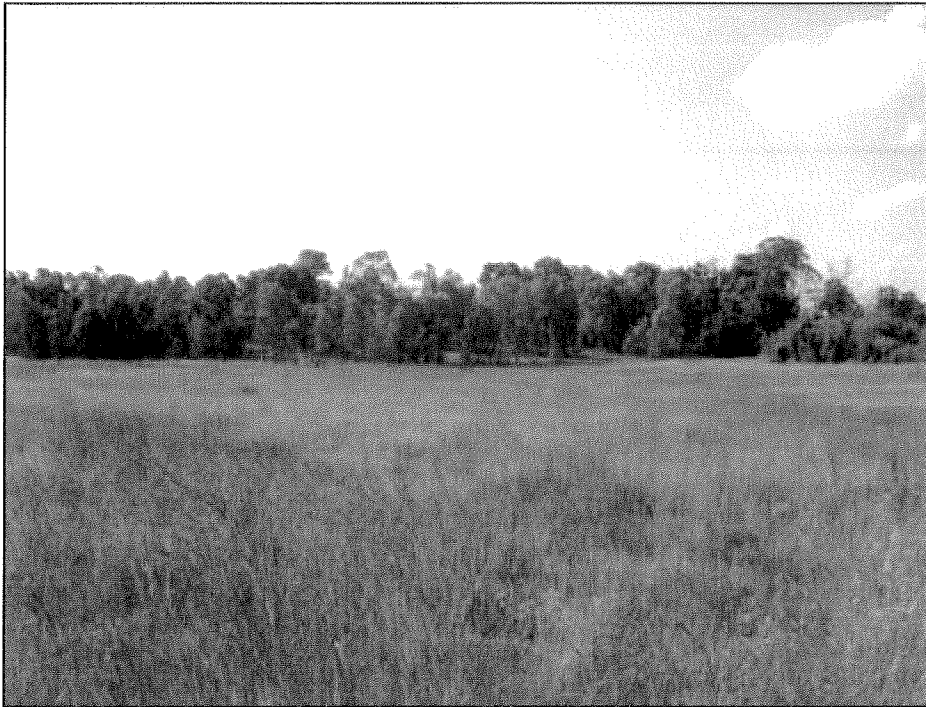
Figure 31: Site photo of BS seep.

The site is situated adjacent to the channelled valley bottom wetland and is not affected by the decanting water as the water is seeping from higher up on the slope. The vegetation at this site was abundant but not diverse.

APPENDIX A lists the floral species recorded at the site. The dominant species in the wetland was *Imperata cylindrica* and *Andropogon huillensis*. Two faunal species were recorded at this site during the survey namely the Golden Bishop (*Euplectes afer*) and the Glossy Ibis (*Plegadis falcinillus*). The Golden bishop is usually associated with wetland areas where it breeds within the grass and reed stands. The Glossy ibis is always associated with wetlands as it feeds there.

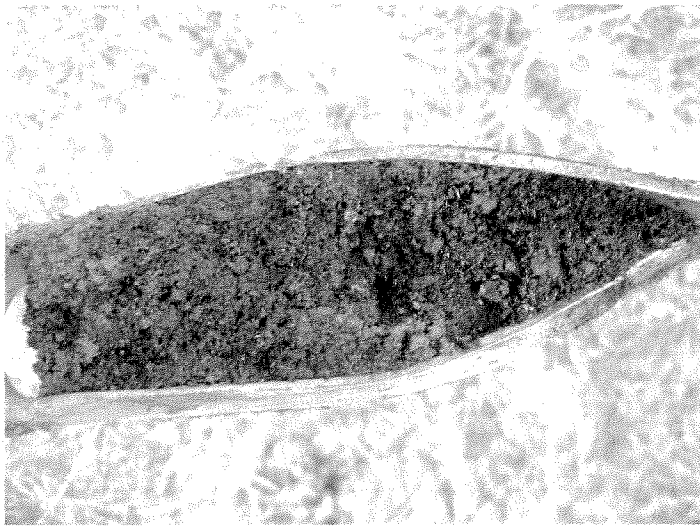
Figure 37: Soils at WC11.

During the survey this site was found to be heavily impacted upon. The soils didn't show any sign of wetland soils, and instead consisted of fine coal up to a depth of 50 cm, with a layer of red soil on top. No running surface water was found to indicate a functioning wetland and the channel was overgrown with *Eucalyptus camaldulensis*. The channel is possibly an artificial furrow that was constructed to drain water into the wetland situated further downstream.

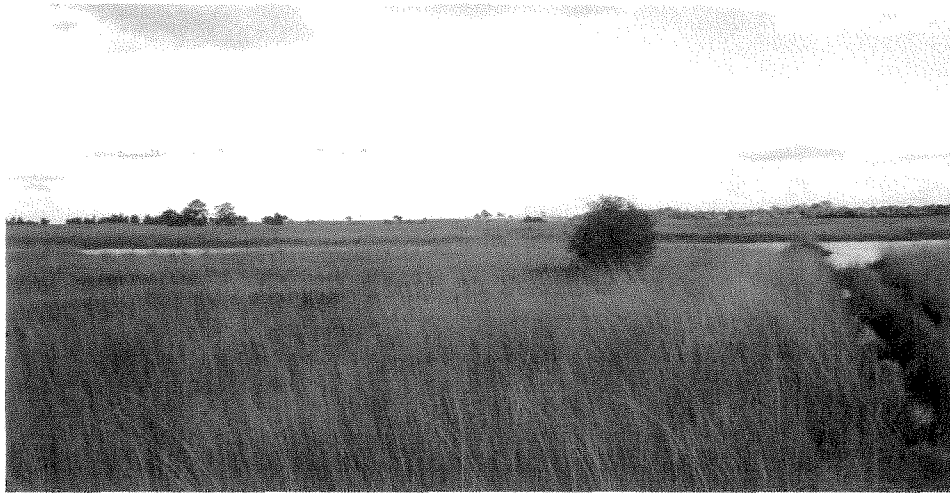
Figure 39: Site WC12 North looking South.

The northern section is surrounded by *Acacia mearnsii* on the outer edges and grass dominated in the pan itself. There are roads in the pan, but it doesn't seem to have significant impacts on the pan itself. The only noticeable erosion was seen on the road that enters the pan at a steep gradient. There were also two small manmade structures that were built in the wetland, but these also didn't seem to have a significant effect. This is possibly due to the large size of the pan. Within the pan there were open areas with water that boasted a few species of water fowl.

Due to limited access the southern section of the pan could not be surveyed in field and the ratings and integrity was thus based on desktop studies and what was found in the surrounding areas.
