07th December 2020
Our Reference: 1560/20 EC

ENVIRONMENTAL SUMMARY FOR THE PROPOSED CONSENT USE APPLICATION FOR THE MAGALIES RIVER LODGE

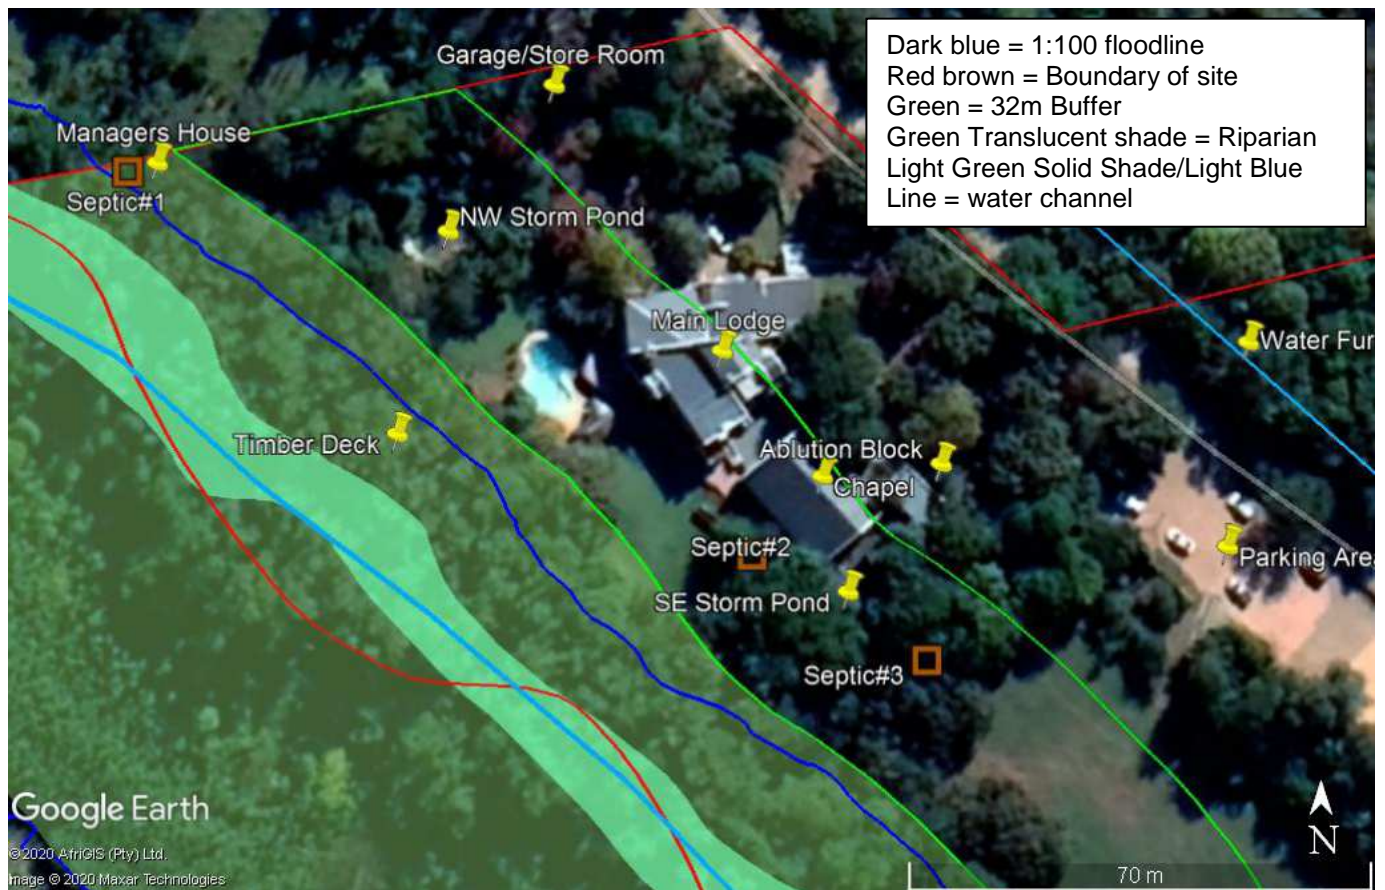
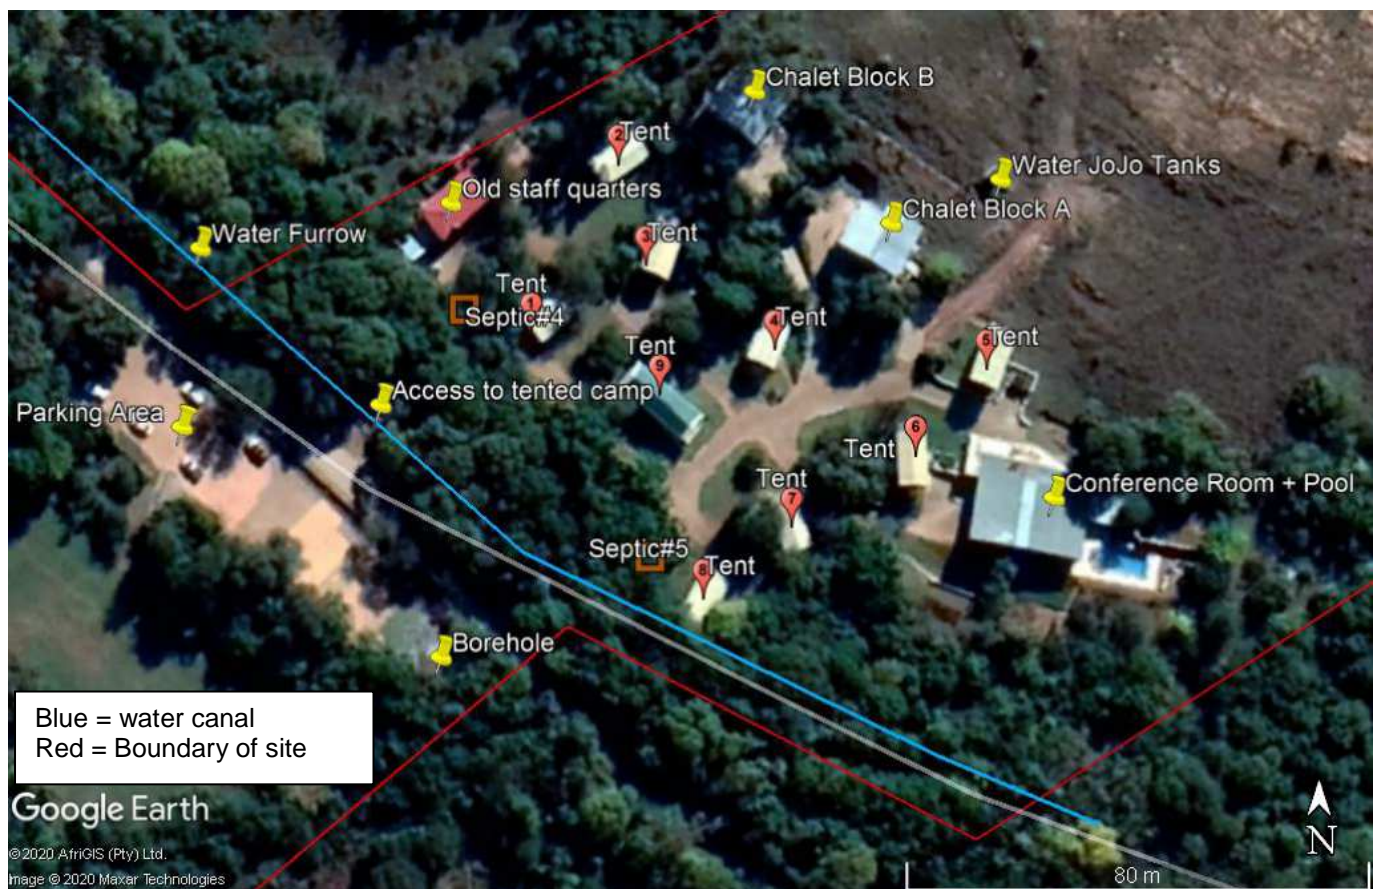
Figure 3. Aerial Map (Main Lodge Area - top; Tented Camp Terrain - bottom)

The site comprises the existing historical lodge + a camping terrain located across the road from the main lodge (Figure 3). The camping terrain offers limited accommodation and conference facilities.

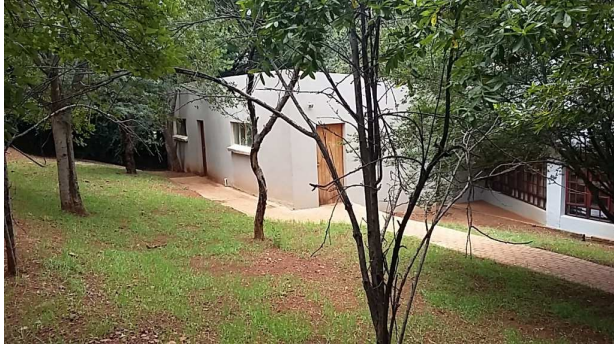
Within the existing lodge development area (i.e. the original unit), a chapel was also constructed adjacent to the lodge in 2005 and in 2016, an ablution block was constructed adjacent to the existing Lodge. This took place on transformed vegetation and in previously landscaped areas which means it did not trigger NEMA.

3. Ablution block (new) next to main lodge

There should be no waste pipes (grey water pipes) installed on surface. They must be buried underground. PVC pipes will be broken when placed on surface (such as the one at the ablution block), while a veld fire will also burn/damage these pipes.

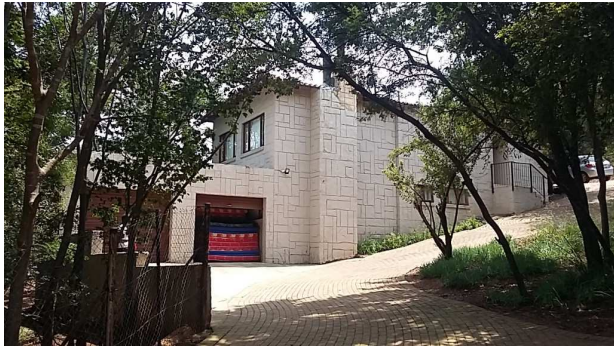
In 2015, the existing servant quarters were converted into a residence with 3 bed, 3 bath + kitchen + double garage using the existing footprint.

5. Upgraded Staff Quarters

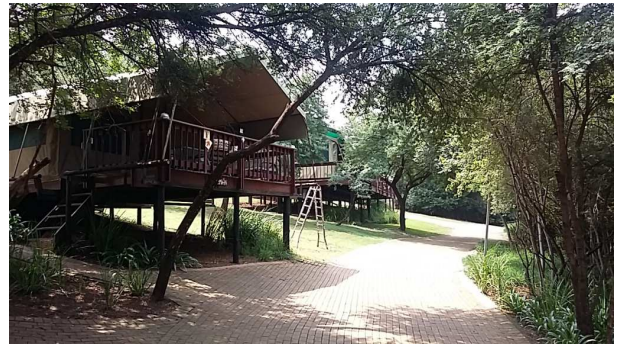
In 2005 or thereabouts, two large concrete foundations were built for tents but these were then later (in 2016) converted to two blocks of 4 chalets each. In addition, the proponent constructed four (4) temporary tent sites (elevated platform & tent) on the “camping terrain” located directly across the road from the existing lodge. This was later extended to 8 tents in total (an additional 4 being added). Tents 9 and 10 and pool with tented boma/conference centre was also created in this camping terrain. These all constitute part of the original application and exemption approval.

6. Typical example of 8 raised tented camps (with parking bay)

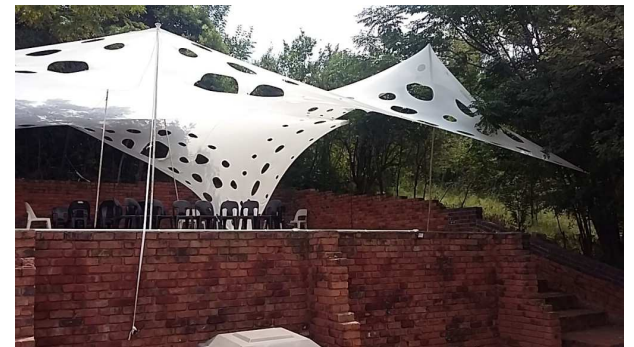
8. Deck above pool

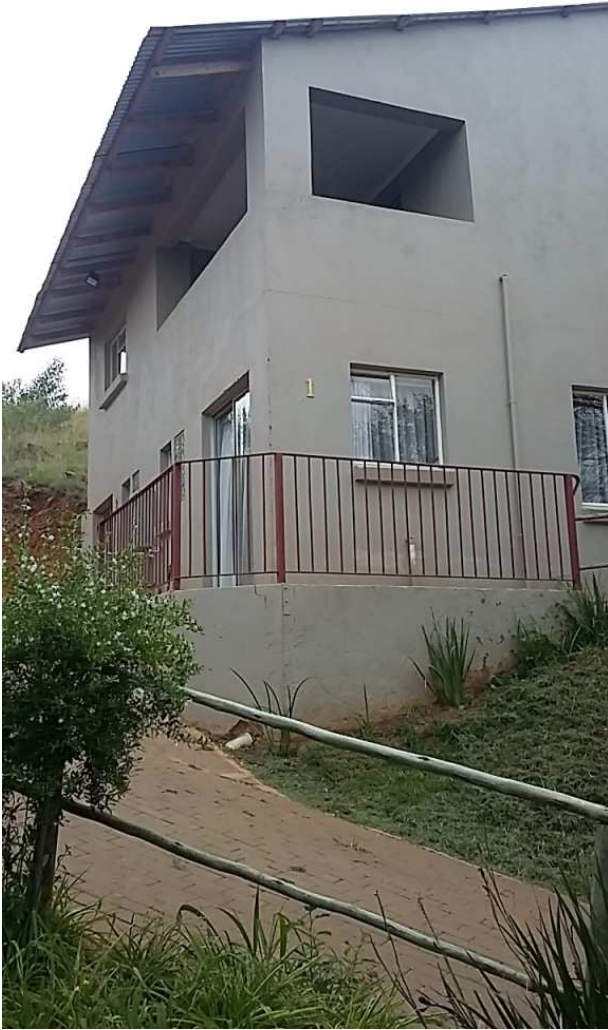
11. Chalet #1 of 2 (4 units in each chalet)
