Exemption of a Phase 1 Heritage Impact Assessment for a proposed township development at Plots 67, 68 and 69 Estoire, Bloemfontein Free State Province*.

Site: Plots 67, 68, and 69 Estoire, Bloemfontein

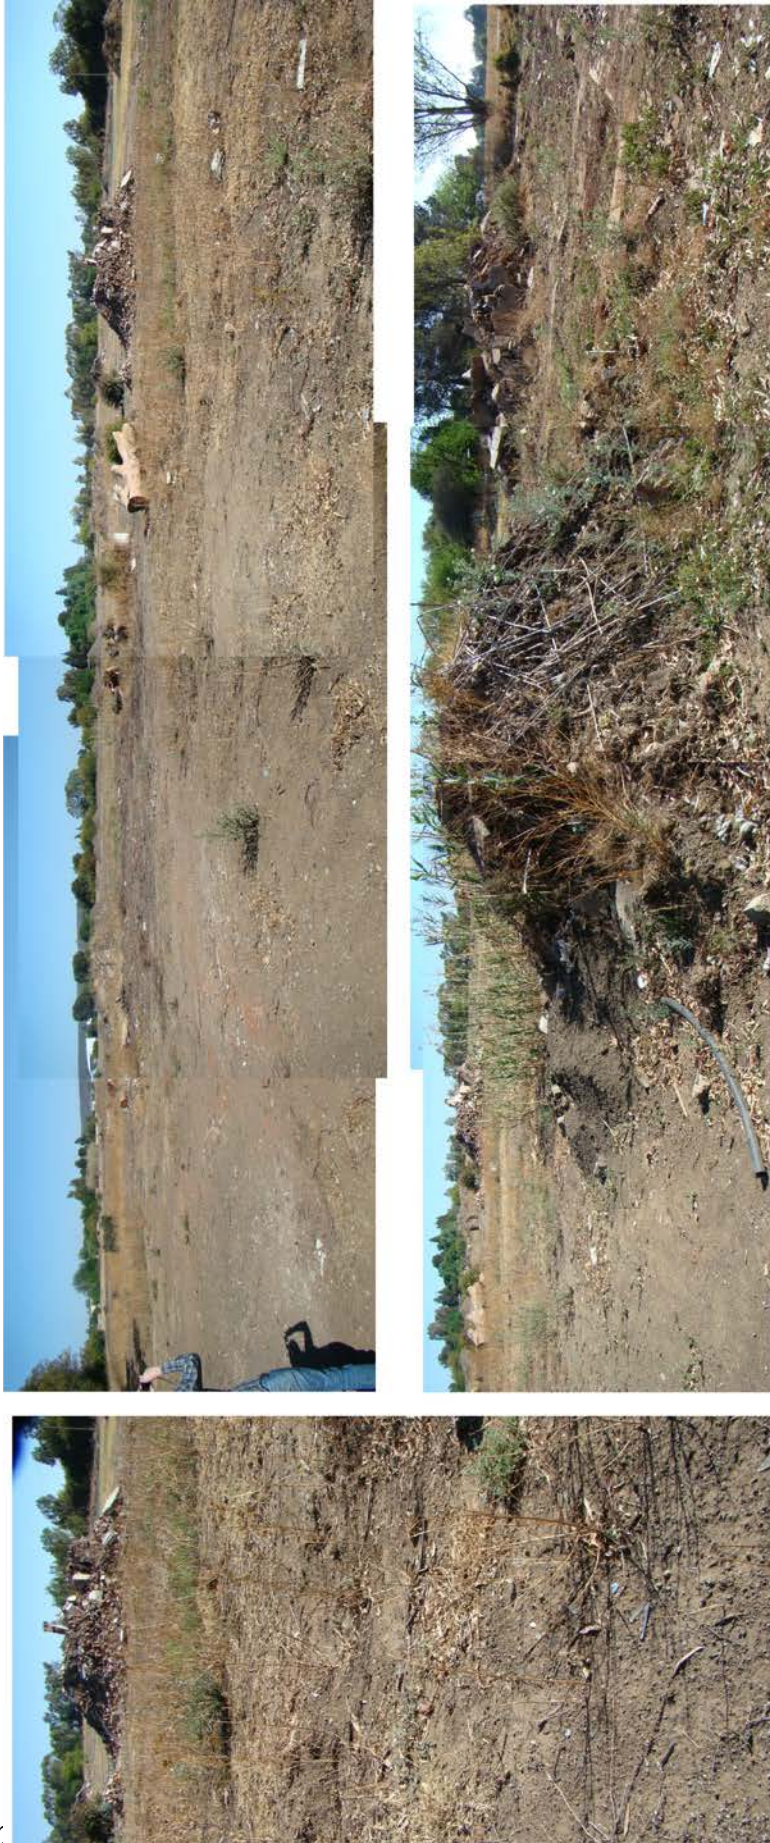
Figure 3. The condition of the terrain is largely disturbed.

Proposed development calls for township development on Plots 67, 68, and 69, Estoire in Bloemfontein (**Fig. 1 & 2; Table 1**). The proposed development will take place on land formerly altered by modern human activities and farming activities (**Fig. 3**). Existing roads will provide access to the site. Potential archaeological impact at each of the proposed site is considered to be non-existent. One residential structure older than 60 years of age has been identified at coordinates 29° 6'35.47"S 26°16'29.66"E. (**Fig. 4**).

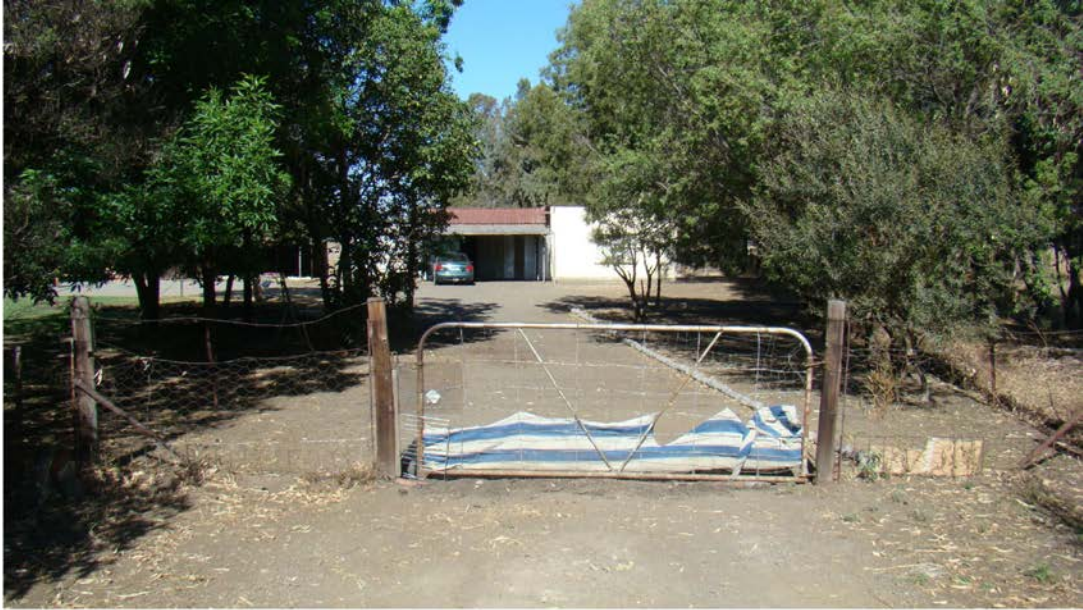
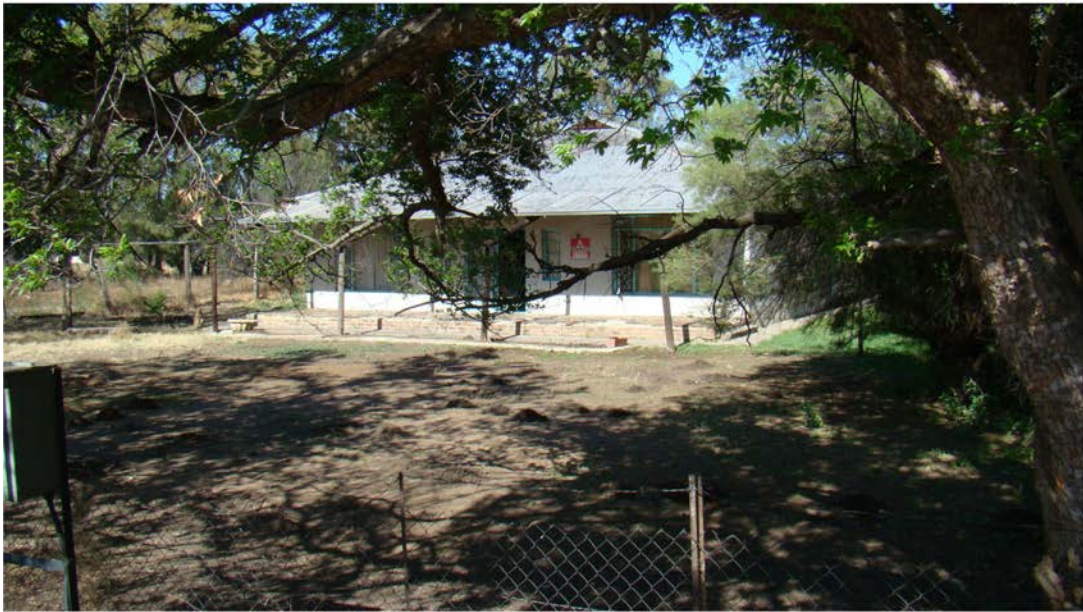
Figure 4. Residential structure

Permission to remove or alter the existing residential structure must be obtained from the relevant provincial heritage resources authority in the form of an official destruction permit.

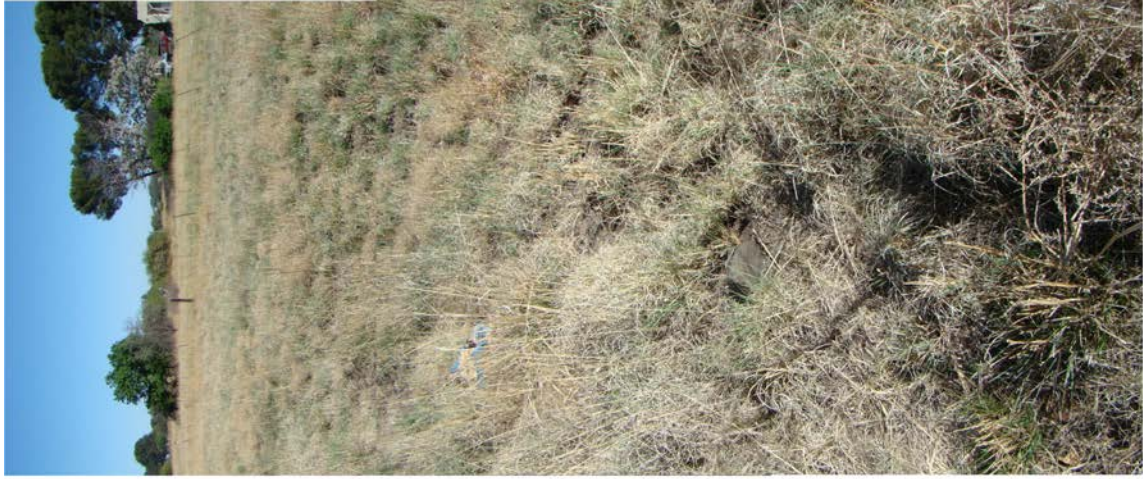
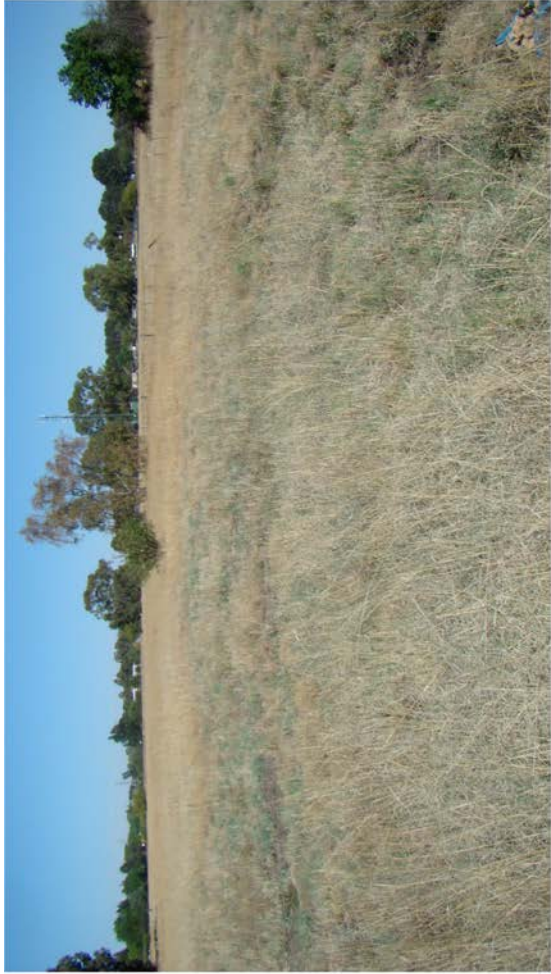
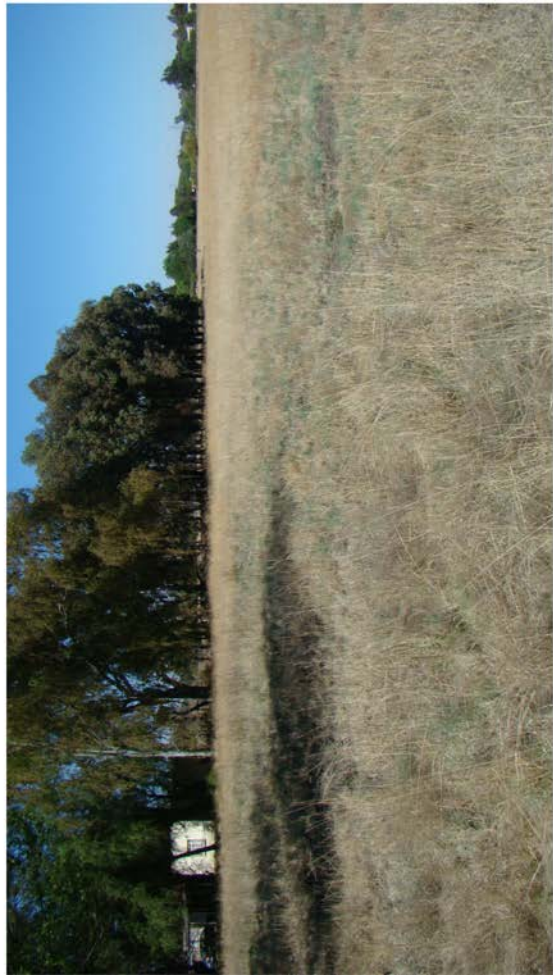
Underlying geology at the site consist of palaeontologically insignificant dolerite intrusions bounded by potentially fossil-bearing Beaufort Group (Adelaide Subgroup) strata. Superficial sediments are made up of residual soils of varying depth (**Fig. 5**). The likelihood of palaeontological impact on bedrock sediments underneath the agricultural overburden is considered to be extremely low.

Figure 5. Disturbed farmland.
