Aquatic Biodiversity Specialist Assessment

Freshwater Ecological Assessment for the proposed Maclear Sand Mine Project

Tsitsa River, Niagara 380, Elundi Local Municipality, Eastern Cape Province, South Africa

November 2022

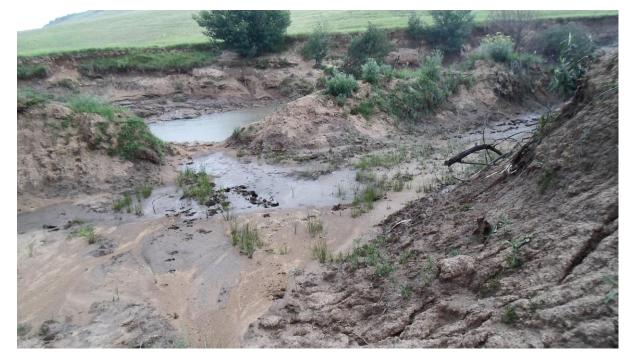
The results of the instream and riparian integrity assessment both derived a class D (largely modified) status for the considered Tsitsa River reach. Several cumulative impacts were observed within the considered river reach. Bed and channel modification (Figure 13) can be attributed to extensive proximal farming and sand mining within the river channel resulting in erosion, sedimentation and alteration of flow.

Figure 13: Photograph of the observed instream alterations of the Tsitsa River (November, 2022)

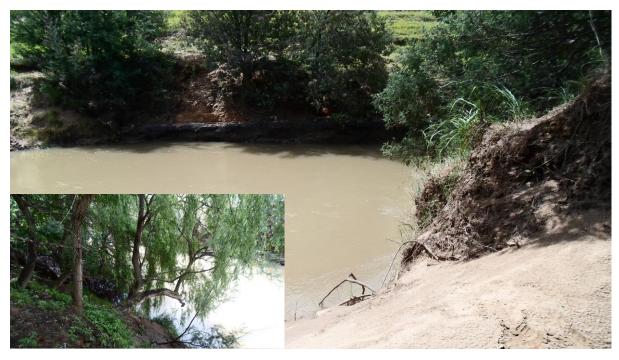
Figure 14: Photograph of the alien vegetation (Acacia dealbata and Salix babylonica) on the embankments of the Tsitsa River (November, 2022)
