**Environmental Impact Assessment for the
proposed Ubuntu Wind Energy Project near
Jeffrey's Bay, Eastern Cape:
Final Environmental Impact Assessment Report**

Chapter 13: Supporting Technical Inputs

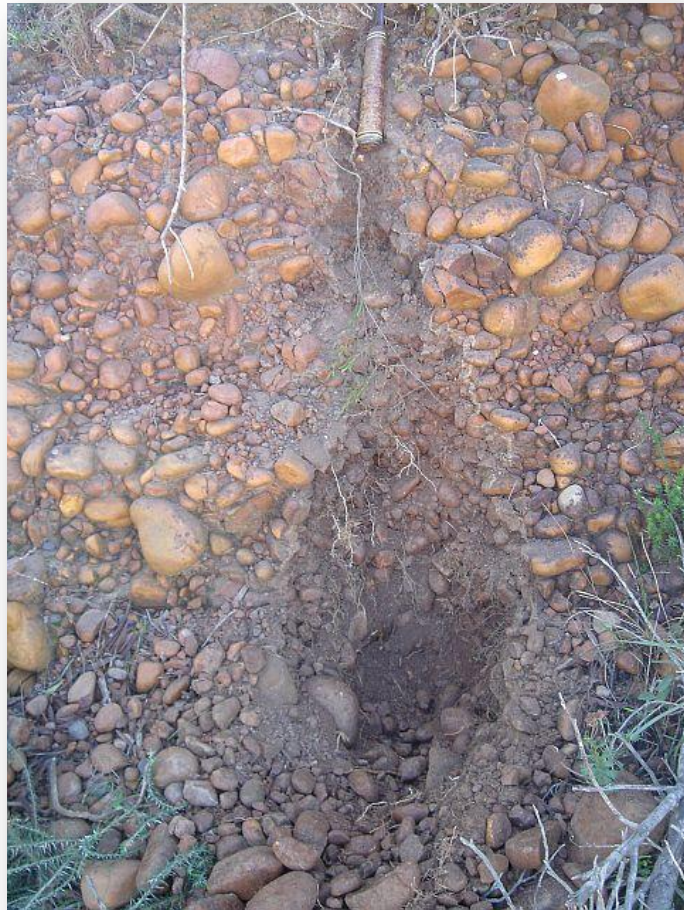
Figure 13.3: Typical Clovelly soil profile, sample 13.

The proposed wind farm is located on an elevated, flat plateau. The area is underlain by fluvial conglomerates of the Mesozoic Enon Formation (Uitenhage Group) that are characterised by an abundance of rounded cobble stones of various sizes. The soils are predominantly residual soils that have been derived from the weathering of these underlying conglomerates and are characterised by an abundance ($\pm 80\%$) of the rounded cobble stones throughout the profile. The soil material between the stones has a clay content of approximately 8% with a medium sand grade. They are well drained soils with a brown A horizon and yellow-brown to orange B horizon. Most of the soils do not have a specific depth limiting horizon within 80cm of the soil surface.

The soils are classified in terms of the South African soil classification system as Clovelly soil form. They fall within this soil form, not because of a high degree of weathering but because they are young, well drained soils derived from parent material with a low clay forming potential and consequently develop non-structured yellow-brown profiles.

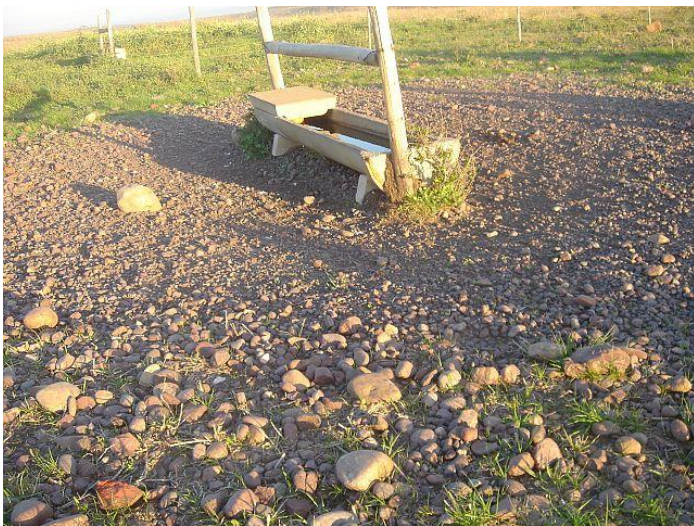
Figure 13.6: Showing abundant surface stone where it has been exposed by cattle trampling.

In terms of soil limitations to agricultural production, the soils are limited by the very high stone content which serves as a mechanical limitation to cultivation. It also severely limits the total water holding capacity and nutrient holding capacity of the soils, which is further limited by the low clay content as well. The soils are therefore categorised as medium agricultural potential.
