4. Results

4.1 Vegetation units and land cover types within the study area

Kruger Malelane Agri Estate - unique lifestyle gated community inside a high intensity agricultural farm (28.4 ha) in the Greater Malelane Town Area, Mpumalanga Province.

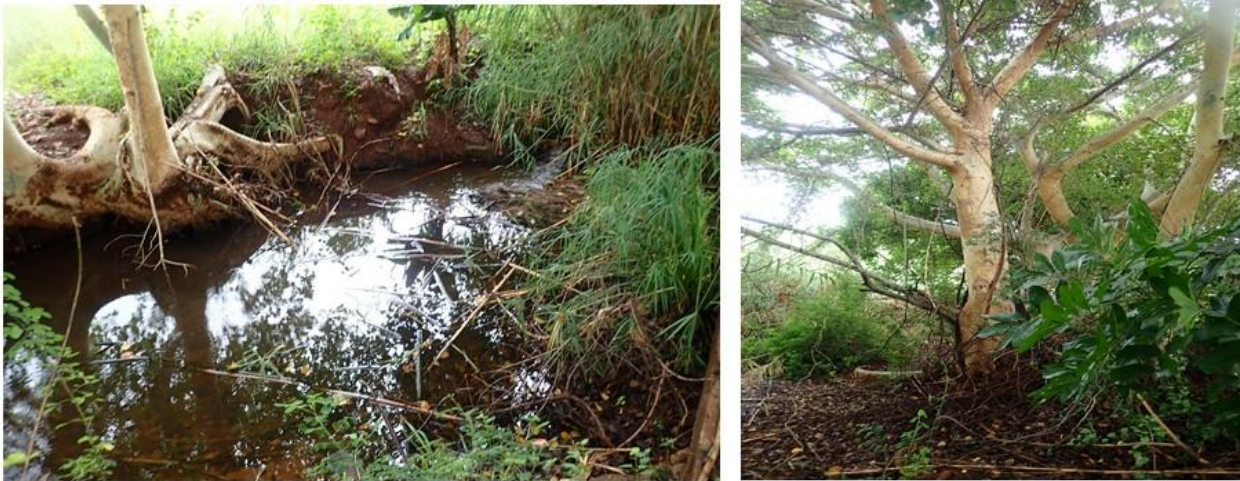
Riparian width		Riverbed		Transect	#T1
Left bank	5m	Width	1.5m	Transect length	12m
Right bank	5m				
Riparian vegetation - Left bank		Riverbed cover		Riparian vegetation - Right bank	
Natal mahogany (<i>Trichelia emetica</i>)		Cobble and sand		Sycamore fig (<i>Ficus sycamorus</i>)	
Potato bush (<i>Phyllanthus reticulatus</i>)				Pigeonwood (<i>Trema orientalis</i>)	
Brown ivory (<i>Berchemia discolor</i>)				Flame thorn (<i>Acacia ataxacantha</i>)	
Flame climbing bushwillow (<i>Combretum microphyllum</i>)				*Castor oil bush (<i>Ricinis communis</i>)	
Terrestrial					
Common spike thorn (<i>Gymnosporia buxifolia</i>)				Sickle bush (<i>Dichrostachys cinerea</i>)	
Flame thorn (<i>Acacia ataxacantha</i>)				White-berry bush (<i>Flueggea virosa</i>)	
				Russet bushwillow (<i>Combretum hereroense</i>)

Figure 31: Transect 1: Unnamed drainage line - Properties of the upstream section.

During the survey, aquatic habitats surveyed at Transect 1 consisted of moderate deep water (30cm) over mud and rock. Abundant root wad habitat is created by sycamore fig roots, and there is some overhanging vegetation habitat.

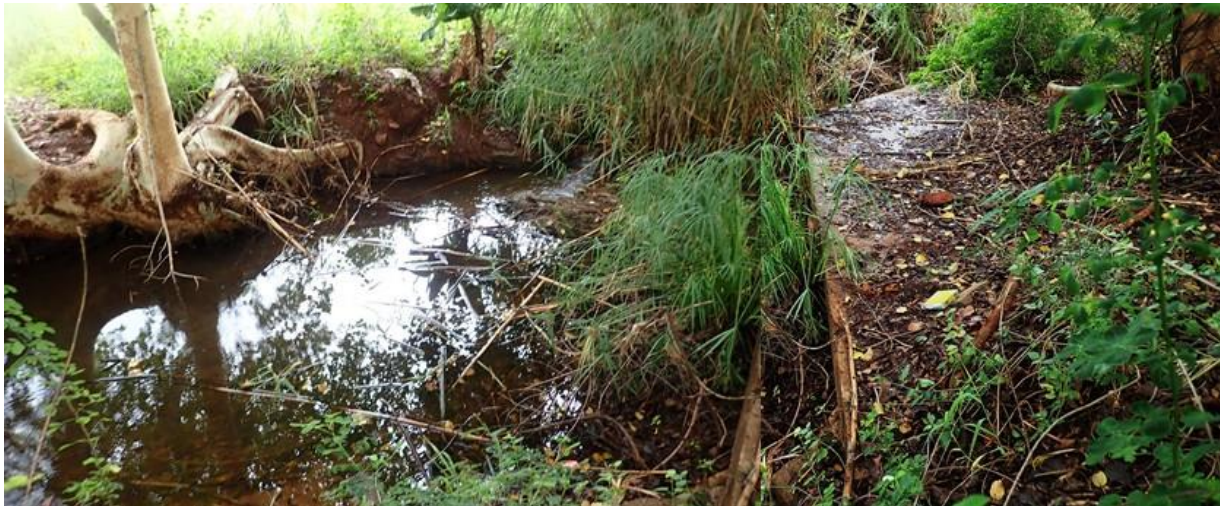
Figure 33: The lower survey site (at Transect 2) consists of a narrow cobble and rock channel with shallow water flowing in the channel.

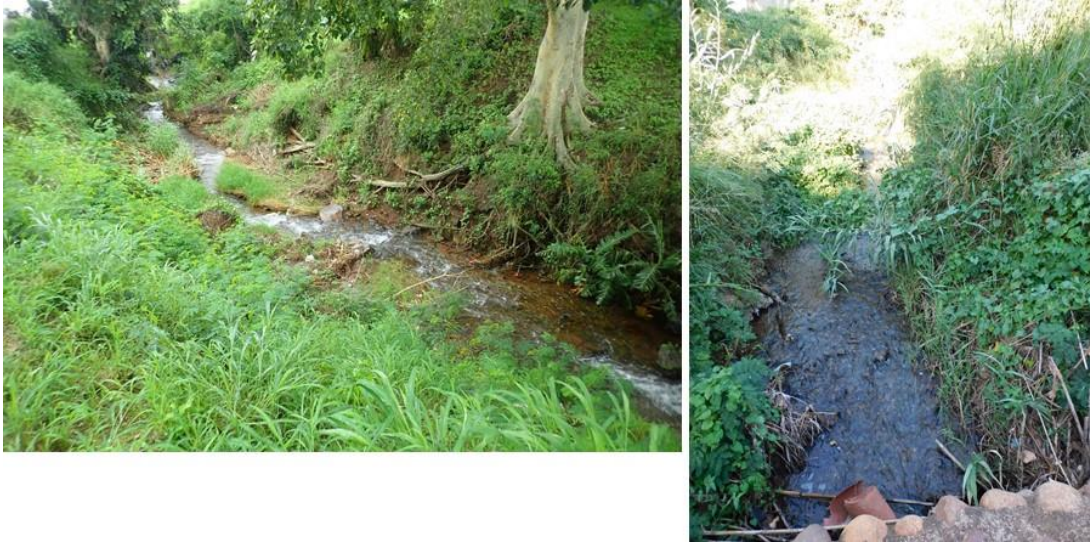
Aquatic habitats surveyed at Transect 2 consisted of a narrow cobble and rock channel flanked by forbs, reeds and large riparian trees, with shallow water flowing in the narrow channel. In areas of steeper slopes, small cobble riffles are washed open and, in some areas, small pools of deeper water are formed.

Figure 34: The lower survey site (at Transect 2) consists of a narrow cobble and rock channel with shallow water flowing in the channel.

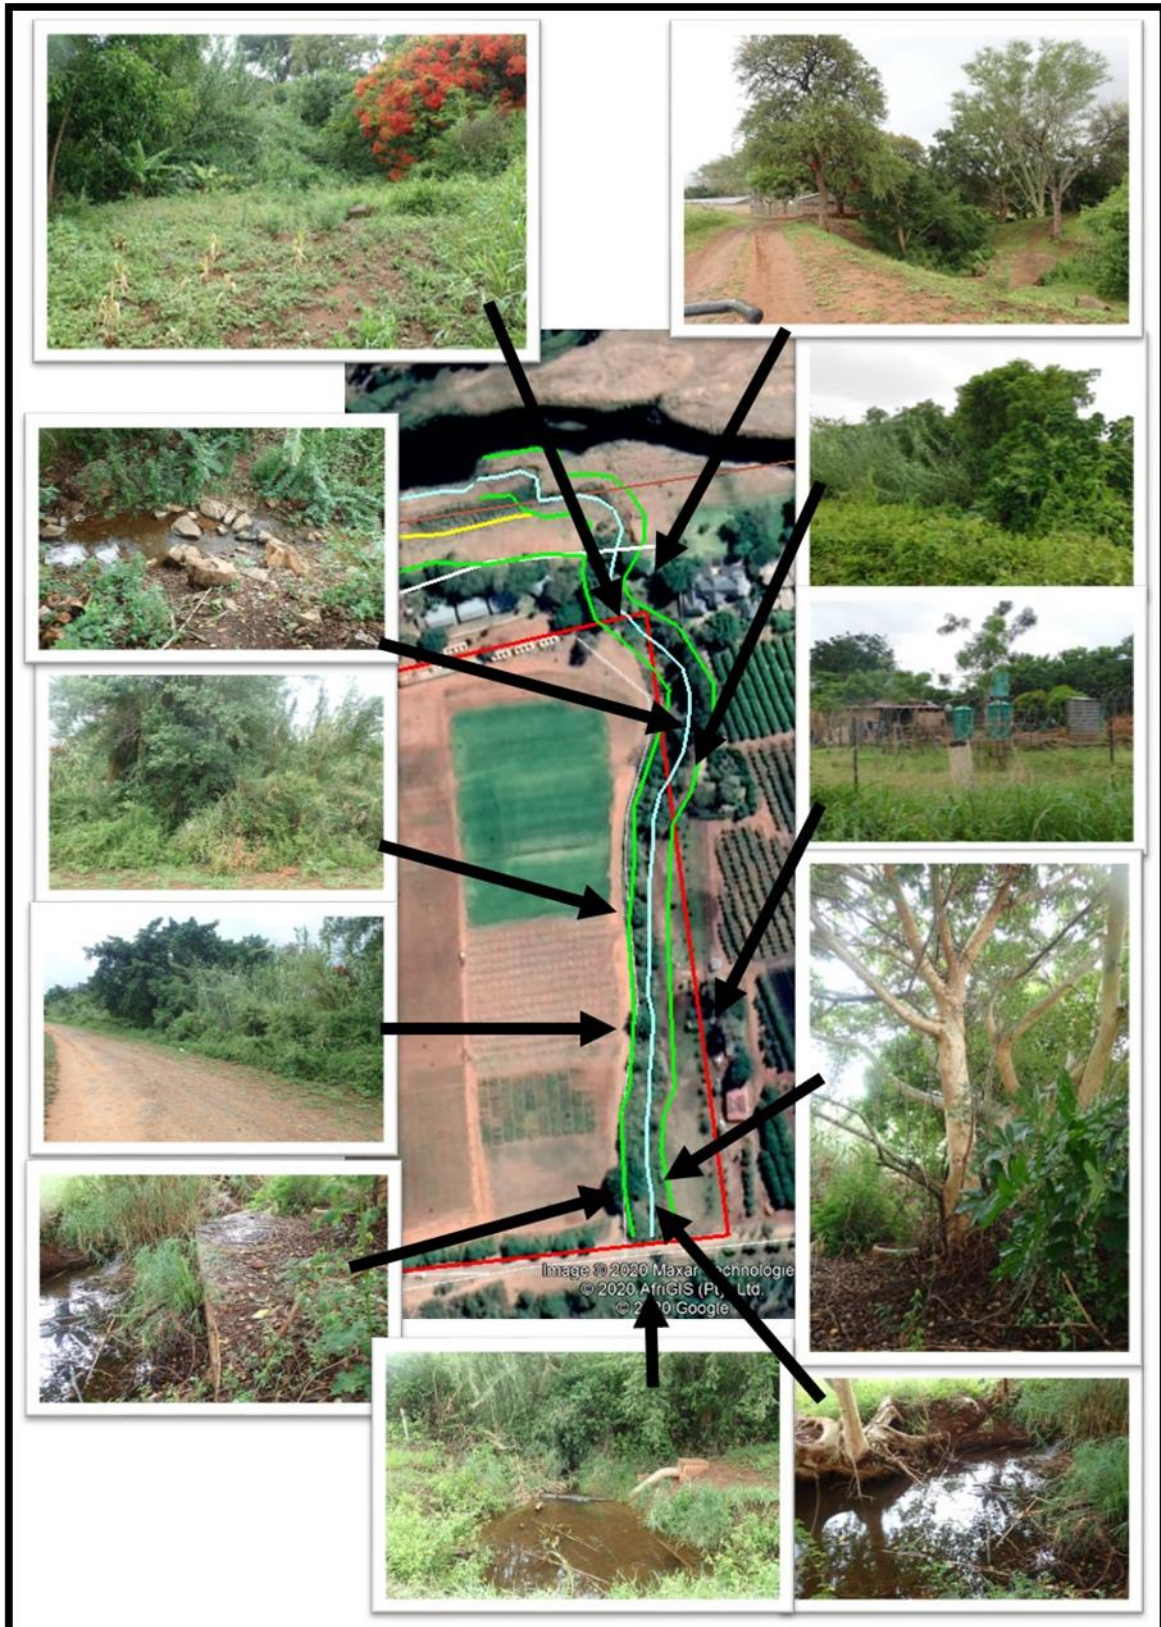
- Construction Phase: 10 m
- Operational Phase: 10 m
- Final aquatic impact buffer requirement: 10 m

Figure 43: The 10m riverine buffer zones of the unnamed tributary to the east of the proposed development

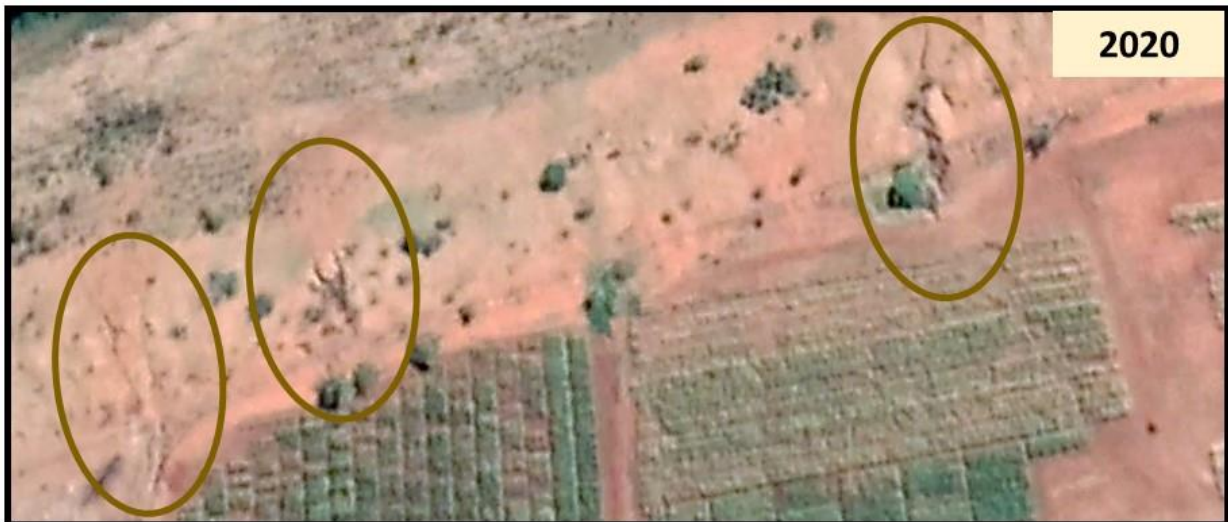
Figure 46: The scars of erosion dongas left by historical stormwater channelling between croplands.

Referring to Figure 46 (as well as Figure 15), it is clear, that historical land uses resulted in concentrated stormwater channelling between croplands and where this channelled water was released on the other side of the KNP fence, visible erosion took place, leaving the scars of erosion dongas on the floodplain.

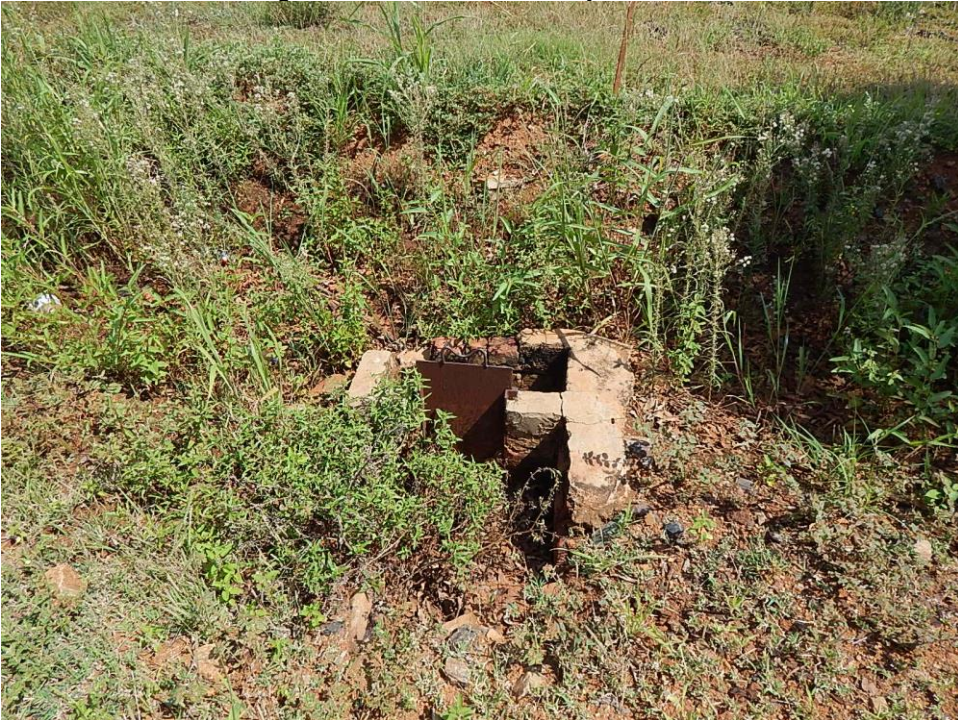
Fig. 14: Several sluices are visible within the earth canal to regulate water, on the study area.

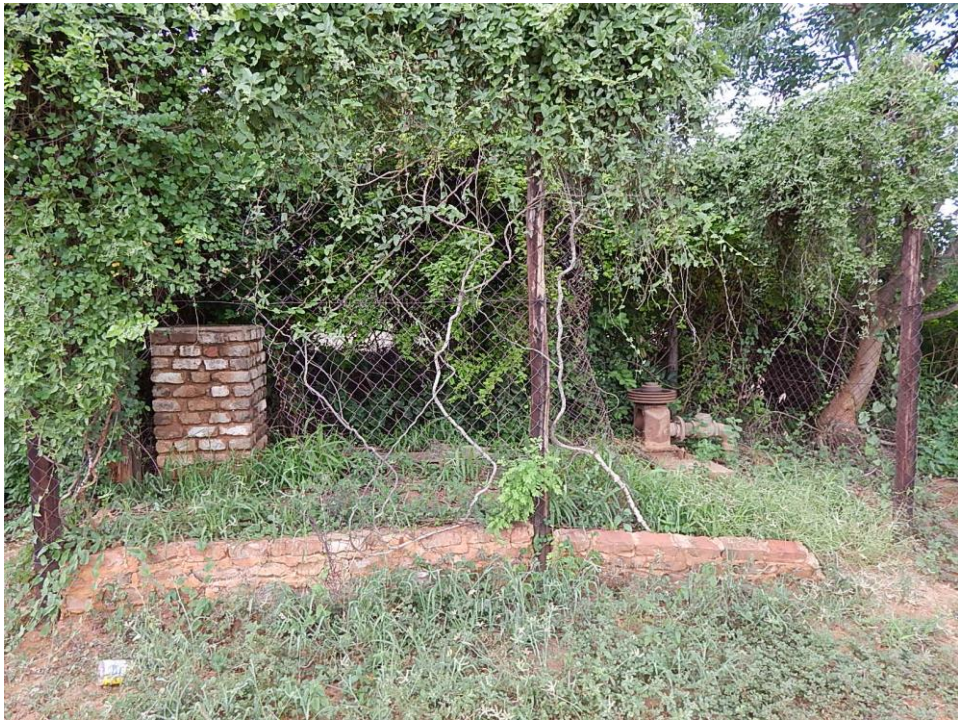
Fig. 20: The infrastructure of a water pump.

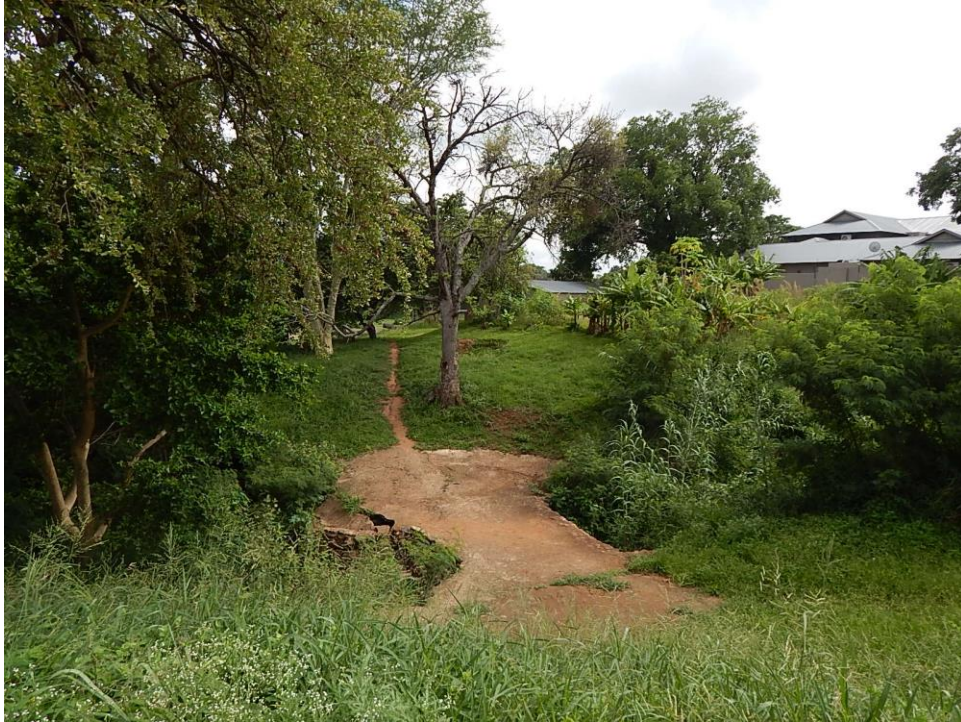
Fig. 29: The eastern section of the farm. A drainage line is visible in the foreground, with a concrete bridge to cross over to the other side. A Middle Stone Age implement was found within the drainage line.
