**CONSERVATION MANAGEMENT PLAN FOR THE SITE OF GUN
NO.2**

THE CONSERVATION MANAGEMENT PLAN FOR GUN SITE NUMBER 2 ON ROBBEN ISLAND MUSEUM.

APPENDIX I PICTURES OF GUN NO.2 & SITE

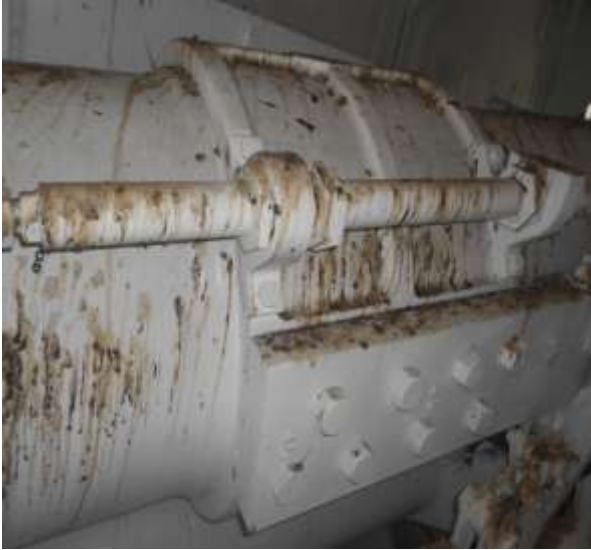
Fig 1; One side of the Gun which is tainted by birds' droppings

Solution; The problem of Birds on the island is one of a contentious issue which puts the environmentalists and heritage managers on the collision course as proposed solution by one is often seen to be to the disadvantage of the other. There is need for wider and deeper consultation between the two sides to strike a balance. In the immediate term however the best way is to make sure that the windows are thoroughly closed and the openings of the cloth at the rear of the Gun are properly closed by the Cloth so that the birds cannot find their way into the inside of the Gun .

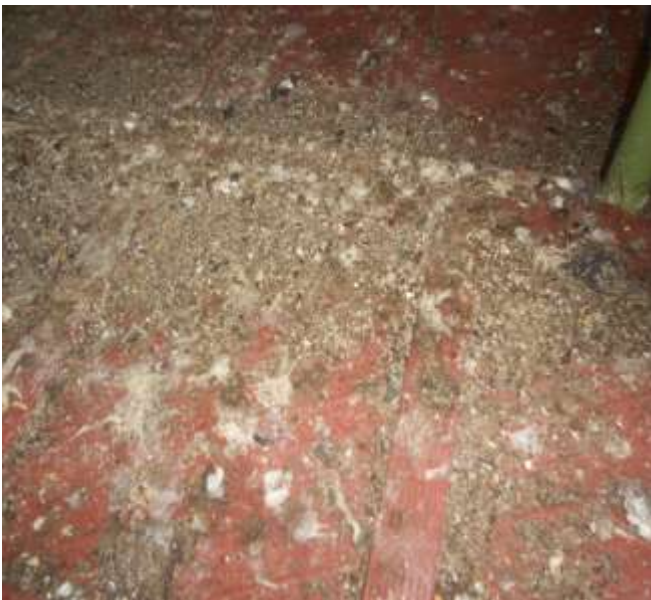
Fig 2; The inside floor which is heavily tainted with droppings of birds.

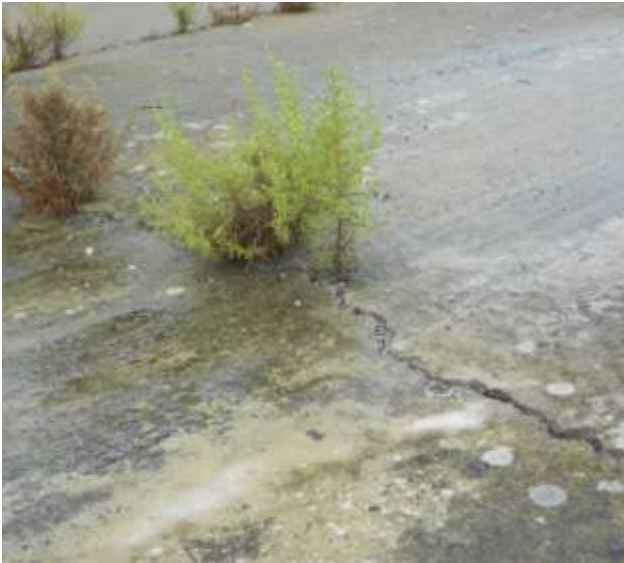
Problem; The weeds have virtually colonized the site of the park leading to the cracking and breaking of the concrete car park. These weeds also make an impression to the onlooker that the site is totally in derelict and unkempt.

Figure 3; The concrete park which is colonized by weeds

Solution; The weeds can be checked by constantly uprooting them or just sprayed with chemical fumigants to suppress their growth.

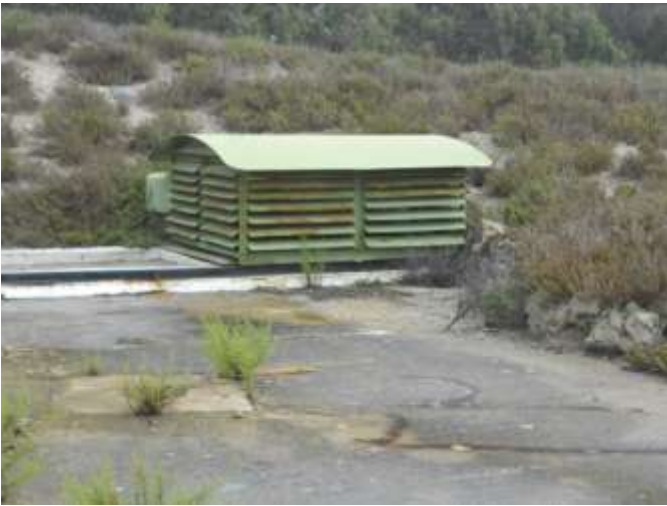
Problem; The Gun and its associated features like the air vent are hugely subjected to elements of weather like rains and sudden changes to temperature. The rain waters have led to the peeling of the paint on the concrete platform on which the Gun rests. This is also compounded due to the fact that the drainage system on this concrete platform is blocked so water stagnates leading to much of the peeling on this concrete floor. The metals of the air vent are also visibly and progressively rusting due to oxidation processes.

Fig 4, weeds and visibly rusting air vent

Solution; The blocked drainage system on the concrete platform needs to be opened by plumbers. There should be periodic painting of the concrete platform. The Air vent also needs some constant periodic painting to protect it from agents of corrosion which are water and oxygen leading to oxidation.

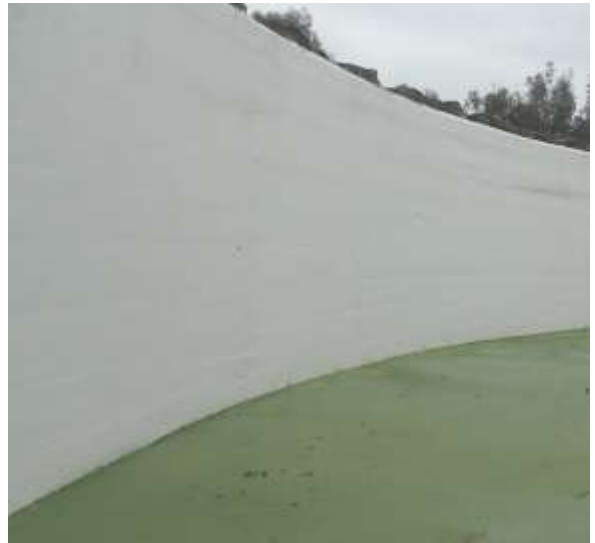
Fig 5; The plat form with no drainage
