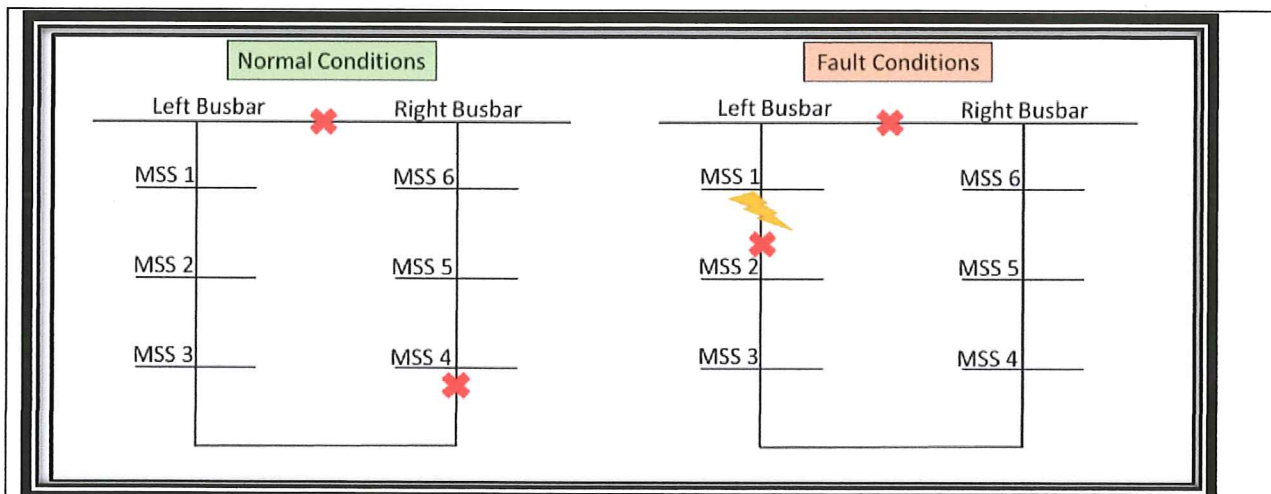
<p>MV Distribution: MV distribution will be done in accordance with the ring design philosophy as shown in the figure below. All MV distribution lines will be overhead with pole mounted transformers.</p>
--
