**HERITAGE IMPACT ASSESSMENT – PHASE 2**  
Assessment of Structures and proposed development :  
**Cato Ridge Land development and Release Project**  
**Cato Ridge, KwaZulu Natal**

Date : 30 May 2023

<i>Client Name :</i>	Cato Ridge Development Company Ltd (CRDC)
<i>Document Title:</i>	Heritage Impact Assessment of proposed development Cato Ridge Land development and Release Project
<i>Reference :</i>	Scoping Report : Zutari(Pty)Ltd 2023/01/12 Phase 1 Heritage Impact Assessment : Cato Ridge Development, Ethekwini, KwaZulu-Natal, JLB Consulting, November 2021 Addendum: Updated Impact Assessment for Phase 1 Heritage Impact Assessment: Cato Ridge Land development and Release Project: JLB Consulting 2023/10/14
<i>File Name :</i>	CRDC-HIA-2BE-2023-05-21
<i>Municipality:</i>

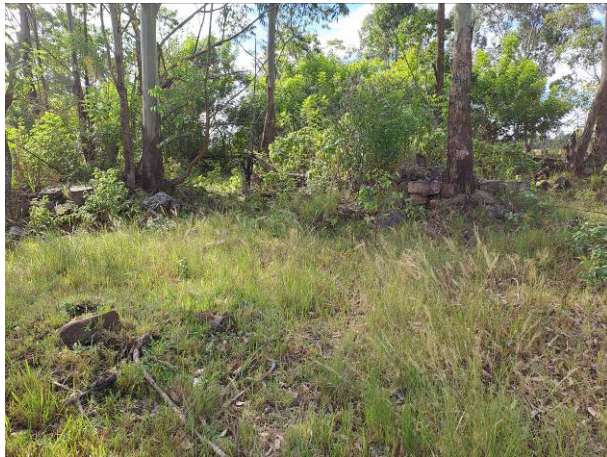
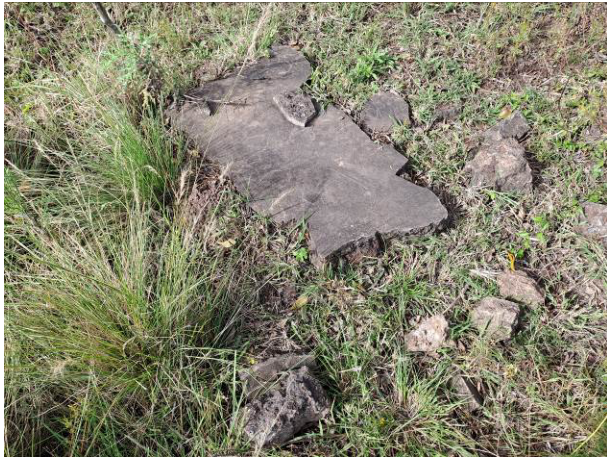
Fig.3 (1.1)

Ref.	Description	Coordinates	Significance	Mitigation
1.1	Piles of building material comprising concrete and stone aggregate and clay brick. (Remains of structures associated with Farmstead 1 in HIA-2021)	29°42'40.4" S 30°37'15.3" E	LOW A farmstead appears on 1967 aerial photograph.	Demolition permit required for the removal of the remains

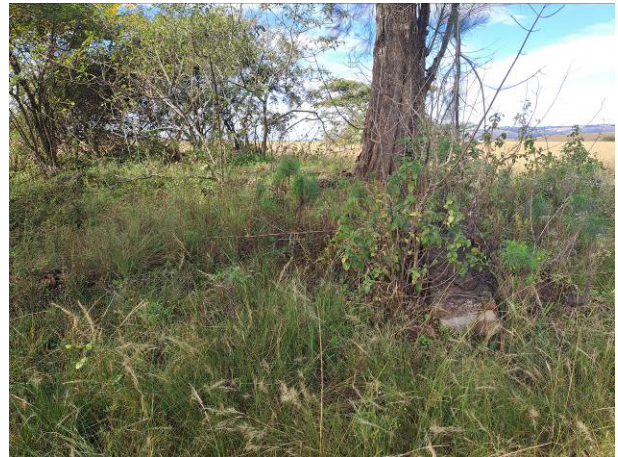
Fig.4 (1.2)

1.2	Piles of building material comprising concrete and stone aggregate and clay brick. (Remains of structures associated with Farmstead 2 in HIA-2021)	29°42'50.8" S 30°37'24.8" E	LOW A farmstead appears on 1967 aerial photograph.	Demolition permit required for the removal of the remains

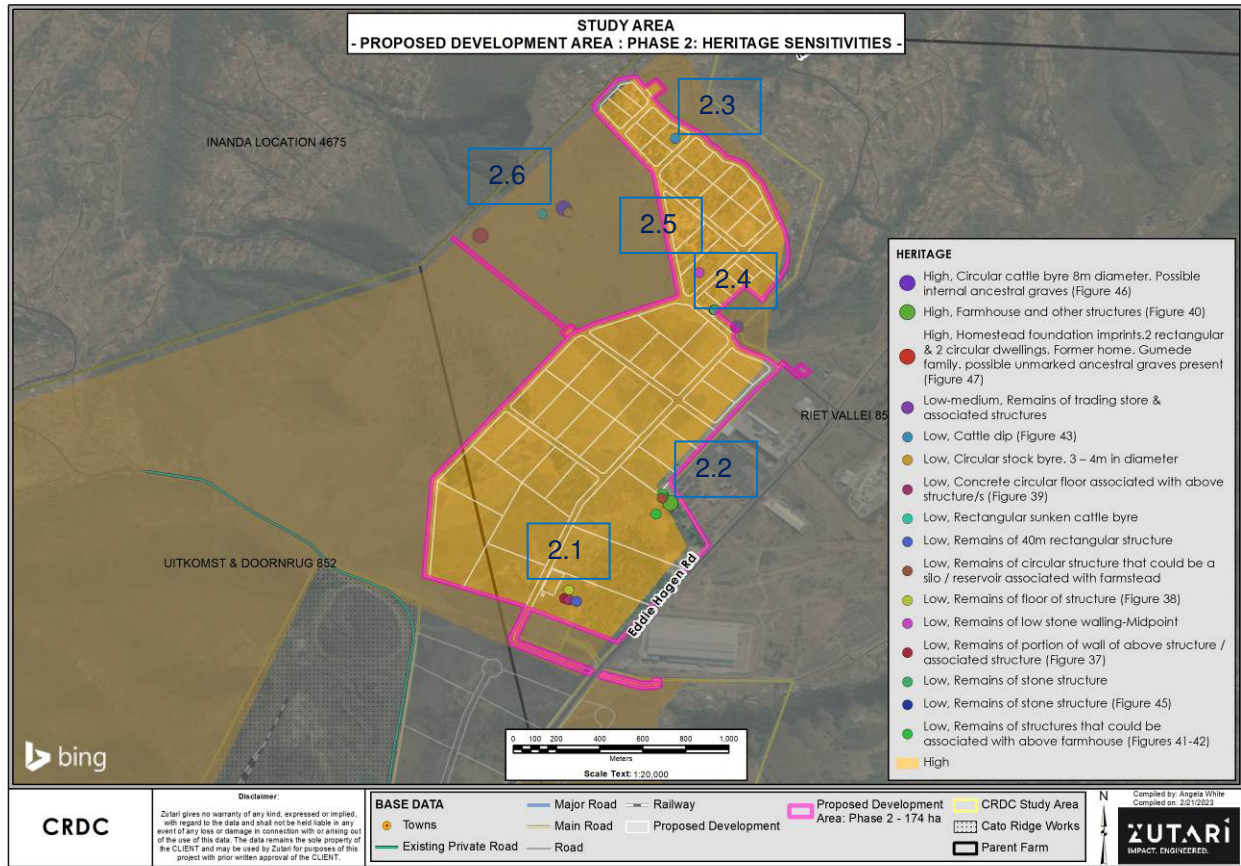
Fig.6 coloured dots recorded in HIA-1 (JLB consulting)  
Numbering added for reference to table below :

The development plans (Fig.1,2,6,11) indicate the proposed parcels and infrastructure.

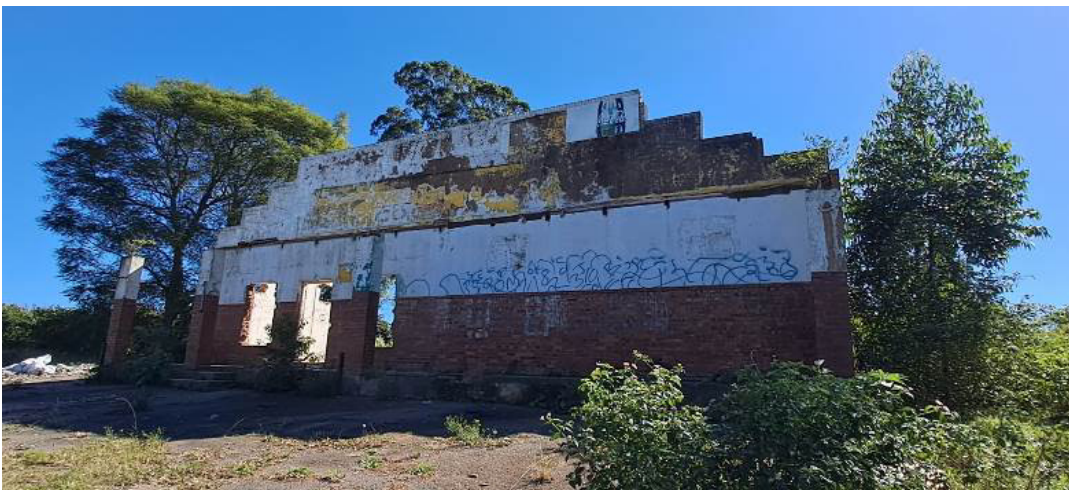
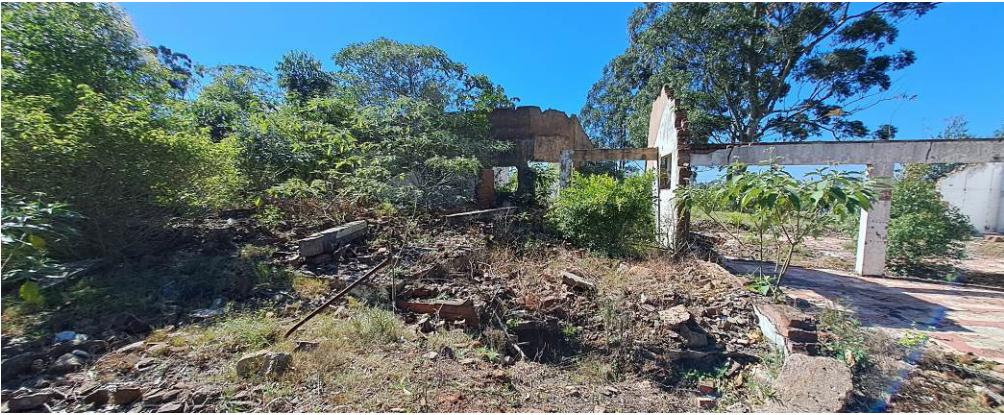
Fig.7 (2.4)

2.4	Remains of trading store, storerooms and residence behind the trading store. Low stone walling and remains of stone structures.	29°41'39.8" S 30°37'56.6" E	MEDIUM-LOW Associational significance with community and trade in the area. Was known as “Denga Trading Store” and was owned by Mr.Sulliman.	NIL Outside of the development area, but borders on the development area.

Structures over 60 years old require screening by the Heritage Authority before demolition. The findings of this study indicate that all structures have low significance, except for the remains of a Trading Store which may hold associational and landmark significance in the community. However the site of the trading store is not within the development area.

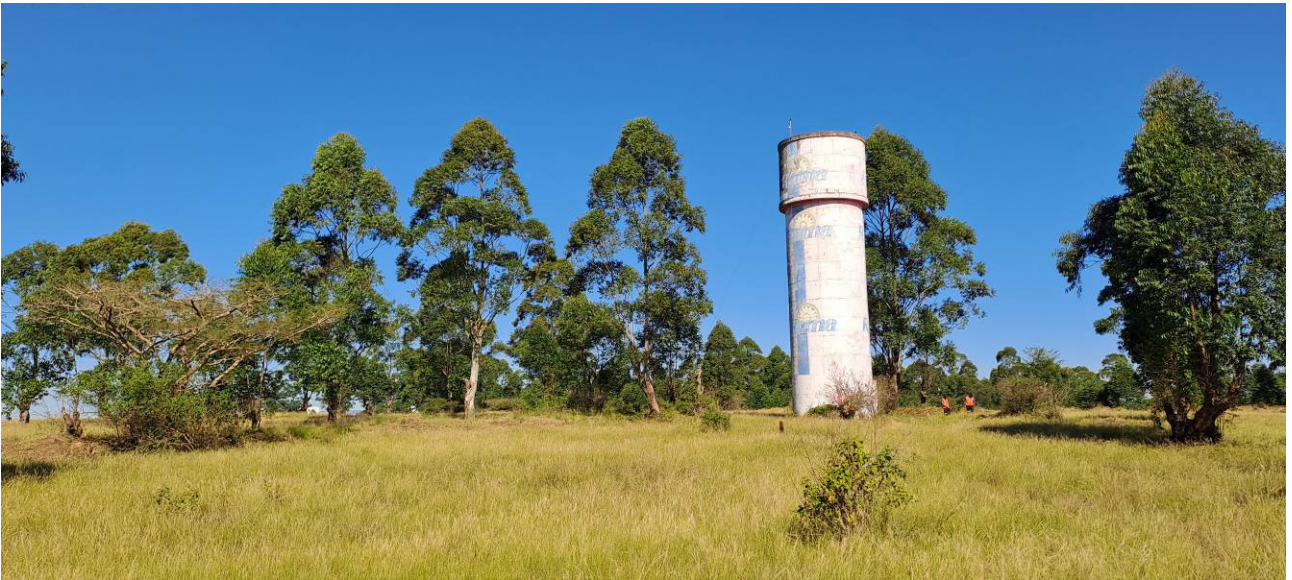
*Fig.9 (2.5)*

2.5	Grain Silo – intact, but not in use		LOW An agricultural structure no longer in use. It is not easily identified on the 1937 aerial photograph, therefore the age is unconfirmed.	The site should be included in the permit application in case the structure is confirmed or reaches 60 years during the future development.

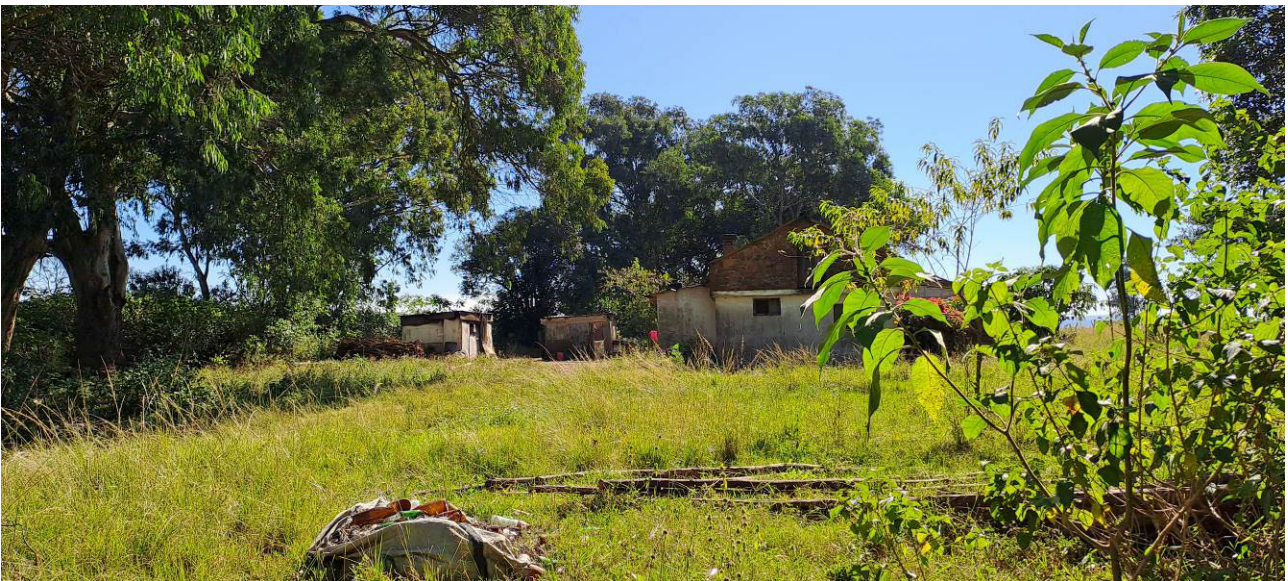
*Fig.10 (2.2)*

2.2	An occupied farmstead comprising dilapidated buildings, remains of stone structures and circular reservoir in close proximity to the farmstead. (HIA-2021 Figure 40-42)	29°42'06.3" S 30°37'46.6" E  29°42'05.6" S 30°37'45.3" E	LOW The structures that are standing are of low architectural significance. More structures are visible on the 1937 aerial (labelled farmstead 2 in Figure 36 of HIA-2021)	The site should be included in the permit application.

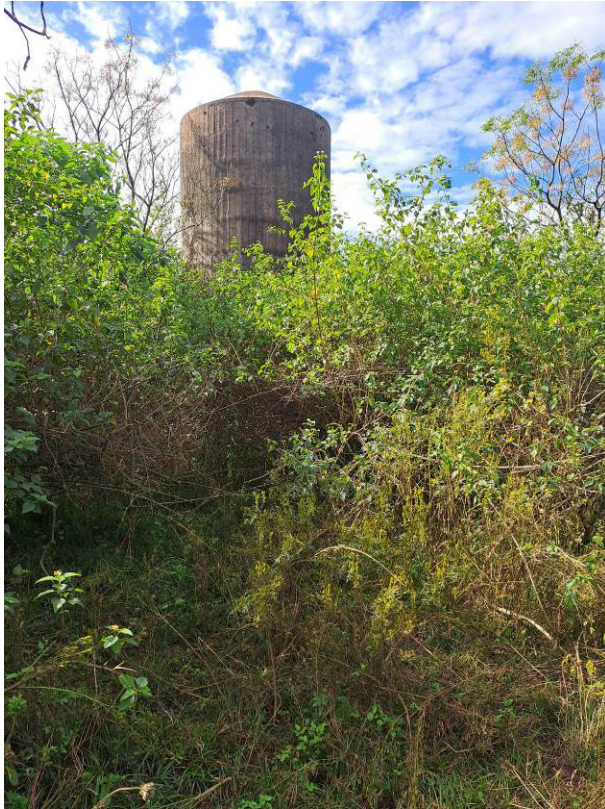
*Fig.12*

Description	Coordinates	Significance	Mitigation
3.1	Piles of building material comprising concrete and stone aggregate and steel reinforcing.	29°43'47.2" S 30°36'56.0" E	LOW A farmstead appears at this location in a 1968 aerial photograph	Demolition permit required for the removal of the remains
3.2	Silo/water tower associated with the above remains of a farmstead (HIA-2021 Figure 9)	29°43'46.1" S 30°36'54.9" E	LOW An agricultural structure no longer in use	Demolition permit required for the removal of the structure.

All structures and remains of structures are recommended as “Not Conservation Worthy”.
