FINAL NEMA BAR AND EMPr:

IN SUPPORT OF A MINING PERMIT AND
ENVIRONMENTAL AUTHORISATION APPLICATION FOR
THE ESTABLISHMENT OF A QUARRY ON REMAINDER OF
FARM DE HOOP 320, BLOEMFONTEIN, FREE STATE

November 2020

WLS Trust

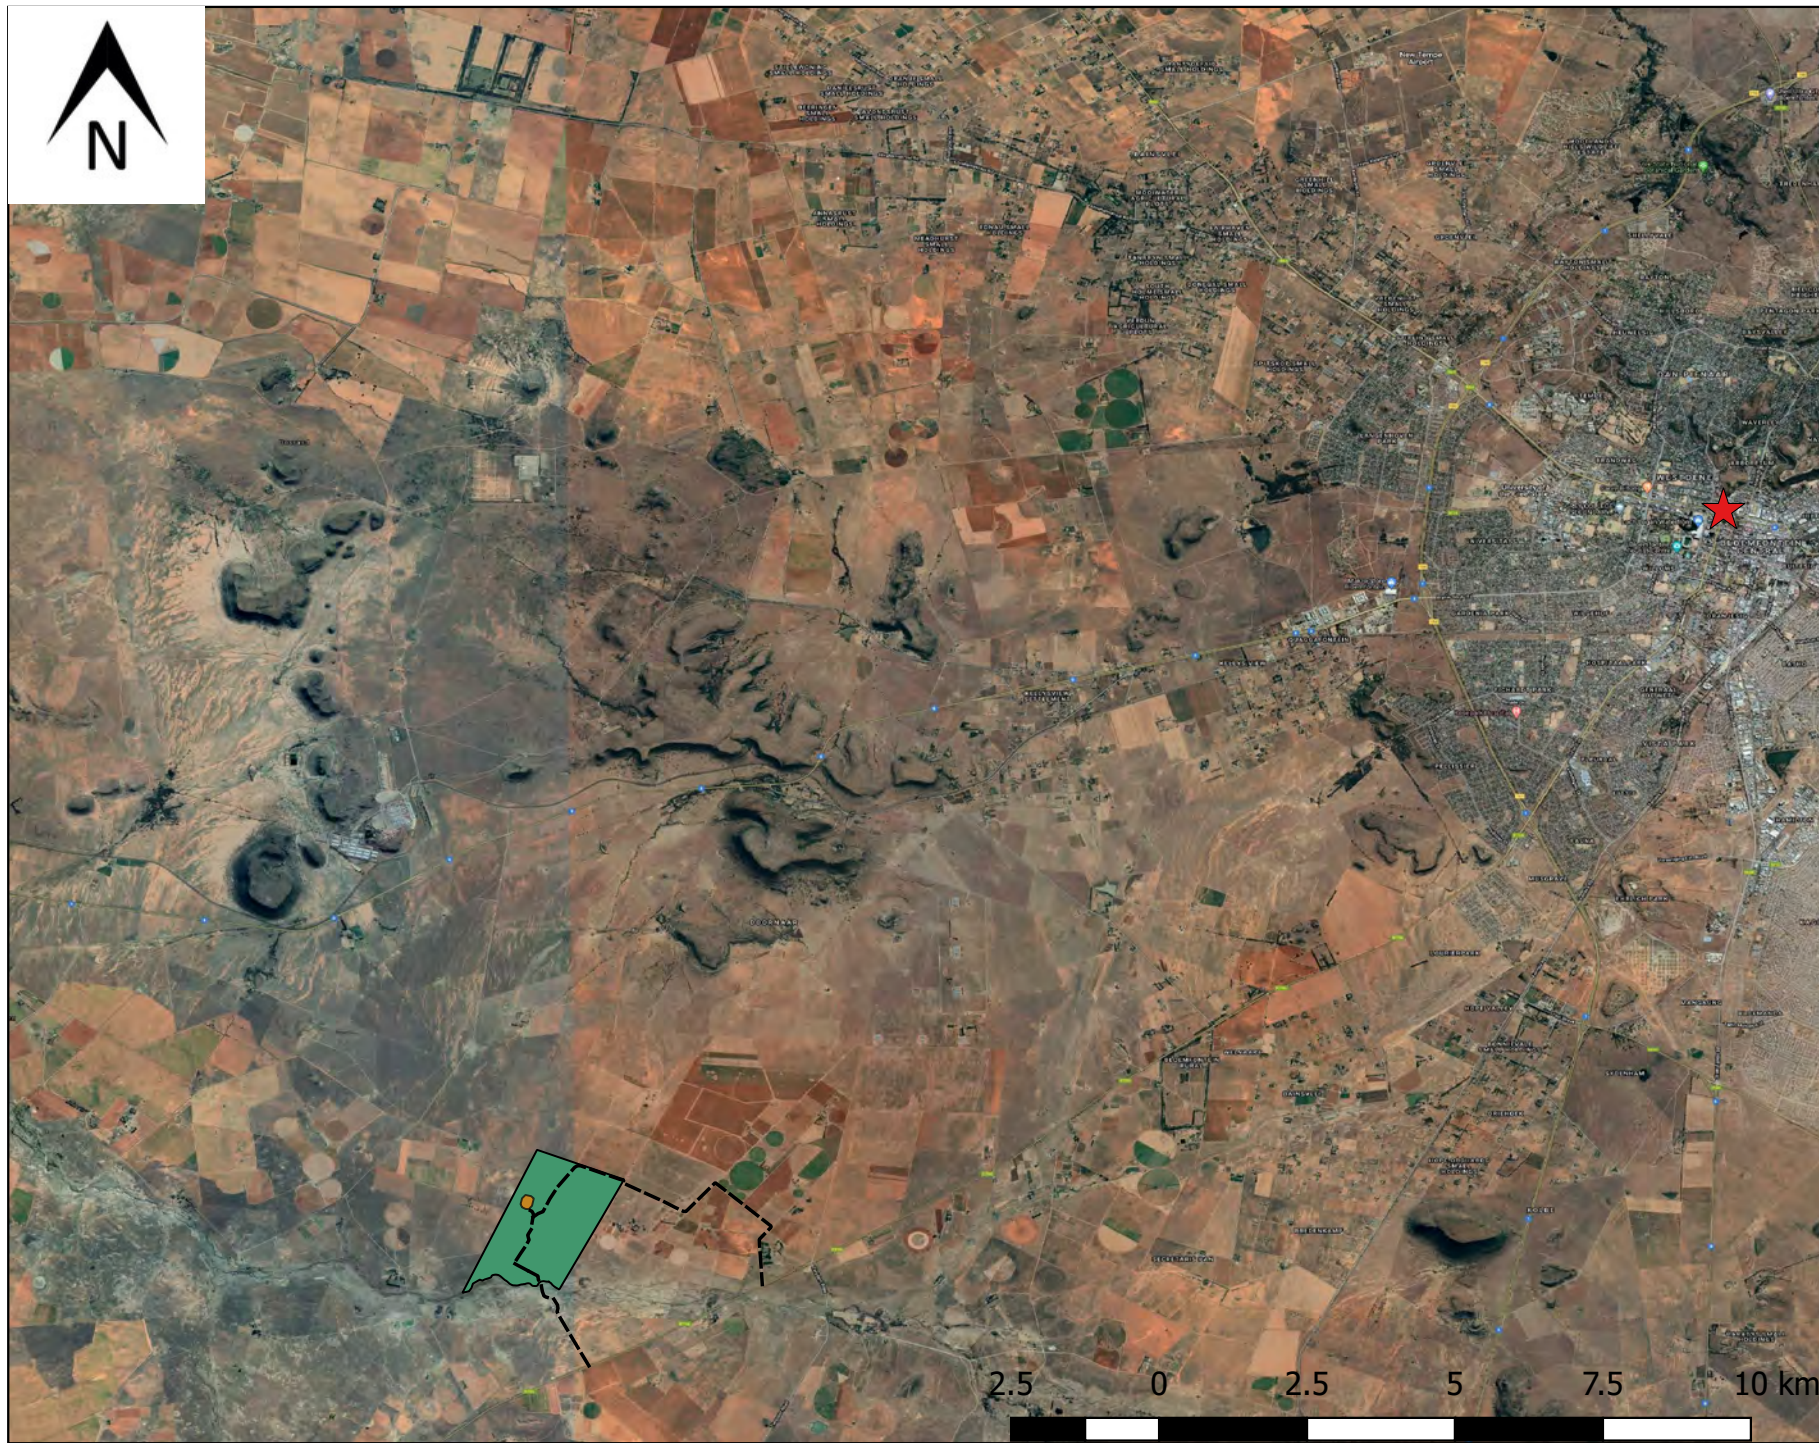
Locality Map for the proposed mining permit application on the farm De Hoop 320/0

- Access road
 - Orange square Quarry perimeter
 - Green square Farm De Hoop 320
 - Red star BFN
 - Black line R706
- Google Hybrid

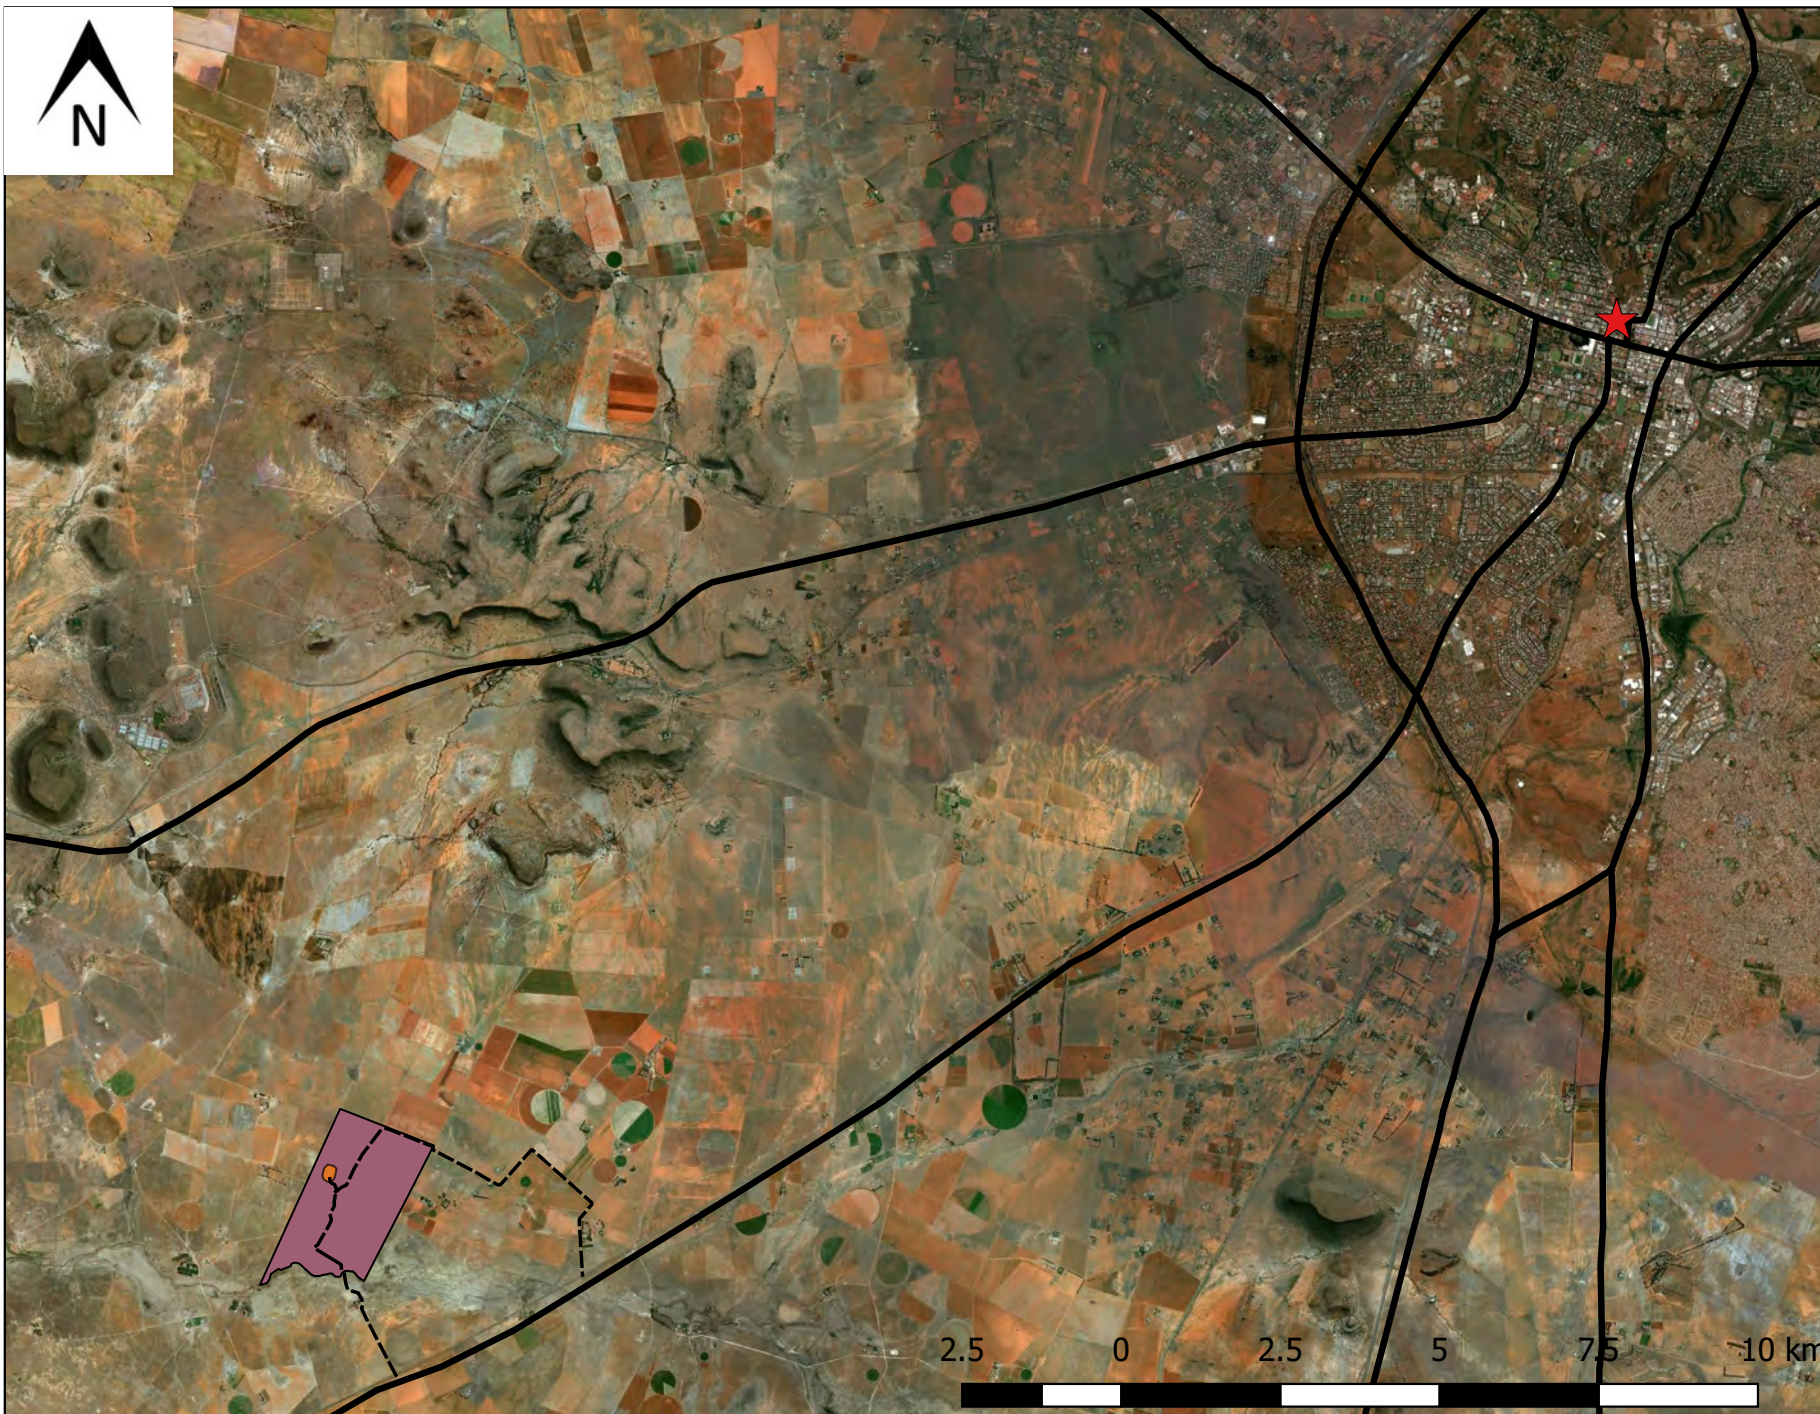
Locality Map for the proposed mining permit application on the farm De Hoop 320/0

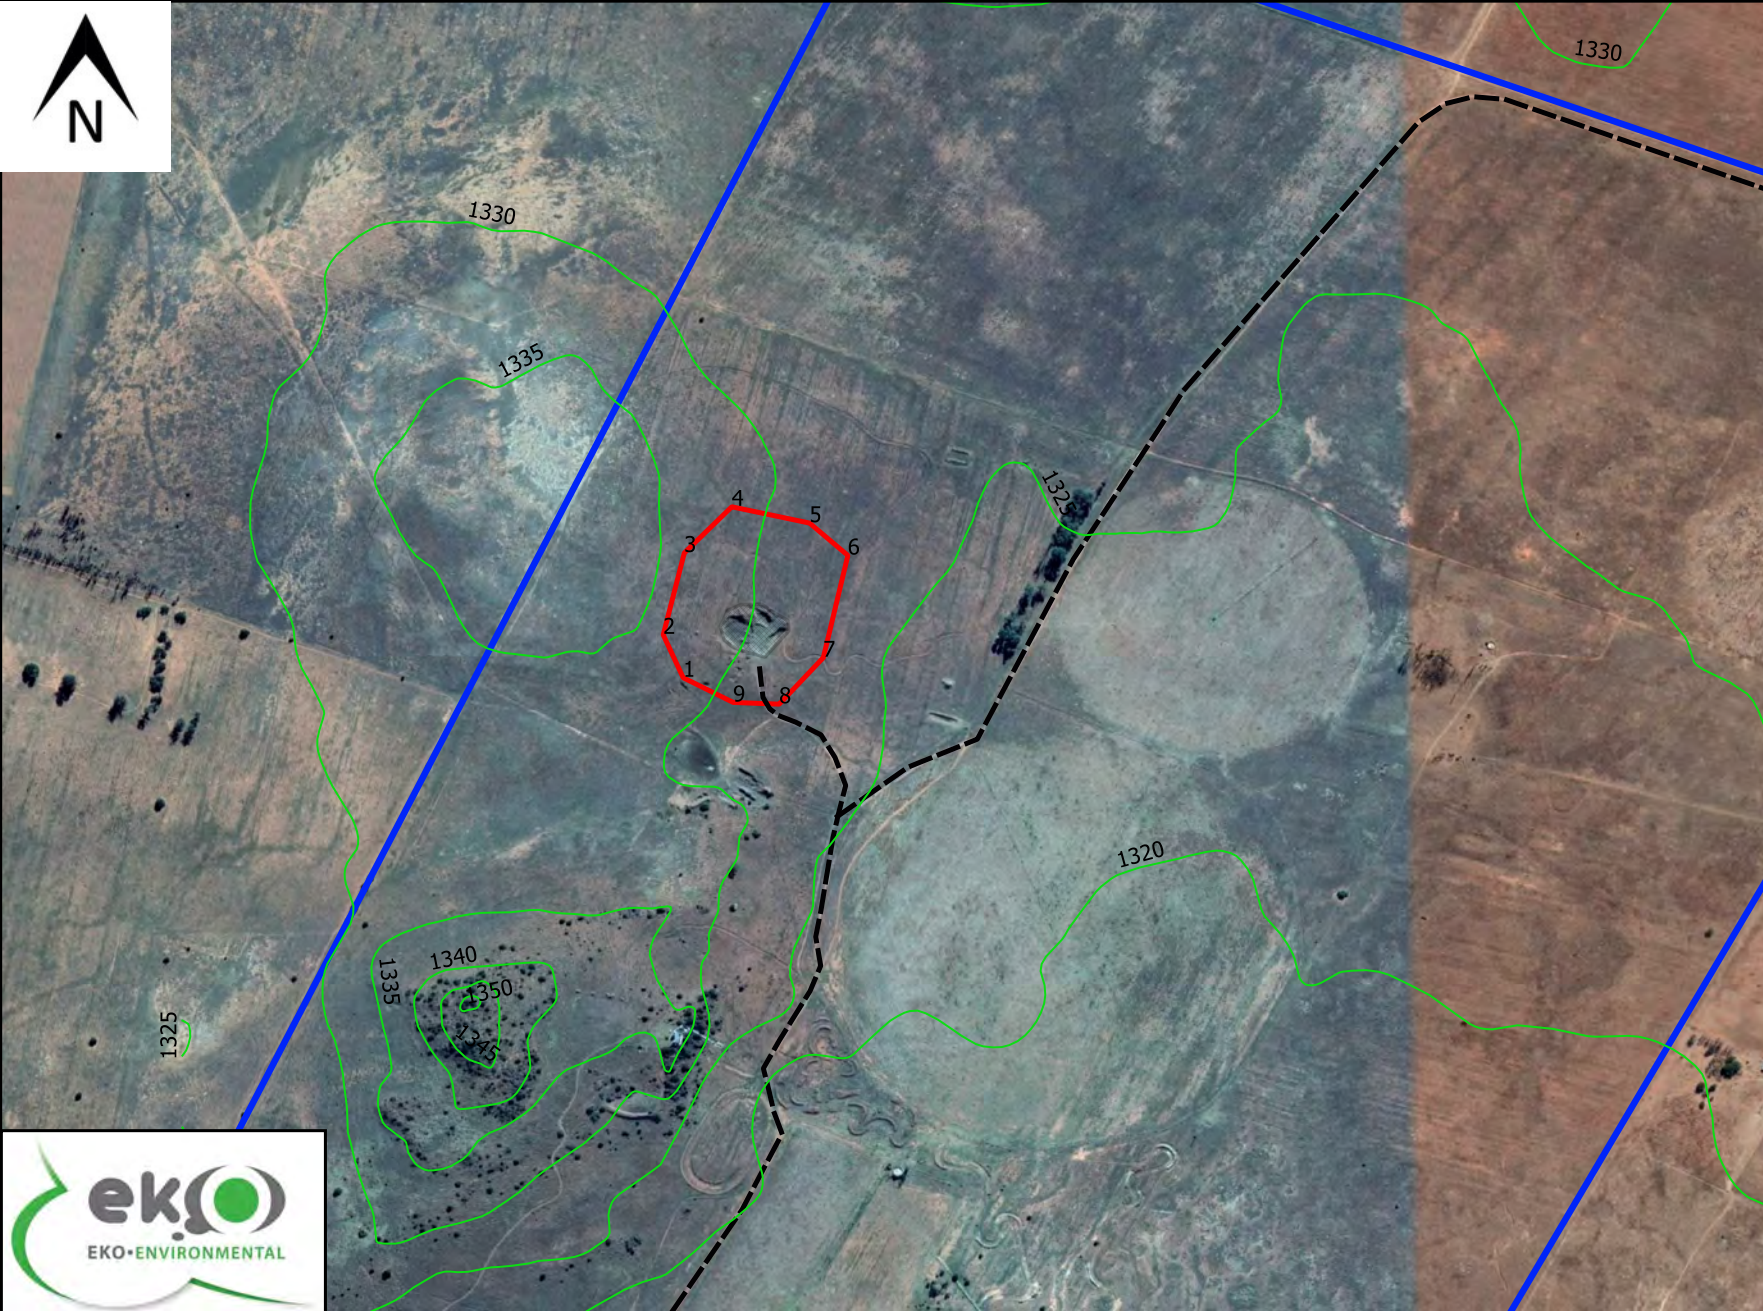
Site map in terms of Regulation 2(2) of the Mineral and Petroleum Resources Development Act, Act 28 of 2002 - Proposed mining area on remainder portion of Farm De Hoop 320, just south west of Bloemfontein, Free State

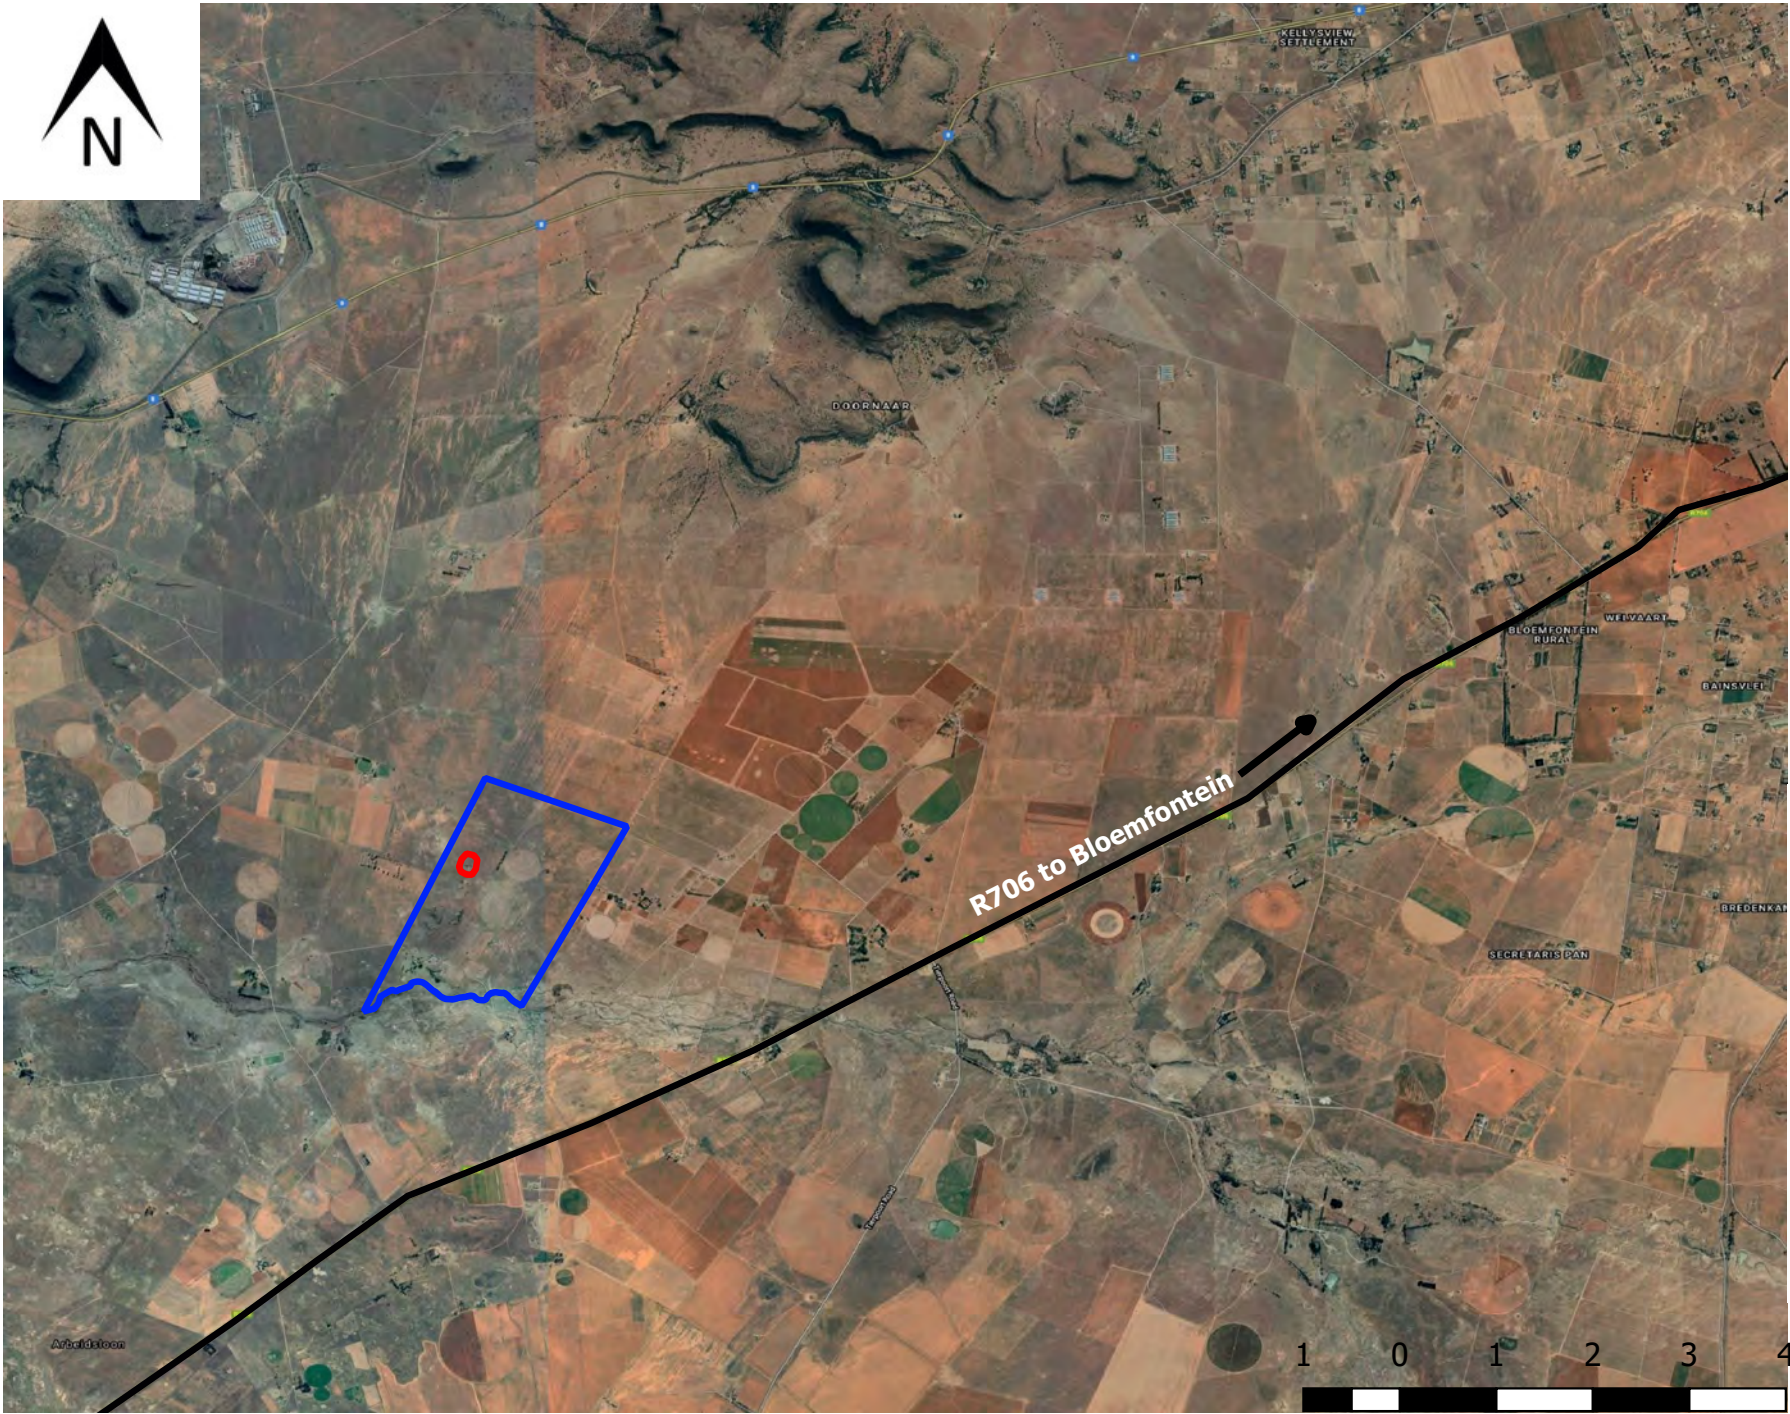
Locality Map for the proposed mining permit application on the farm De Hoop 320/0

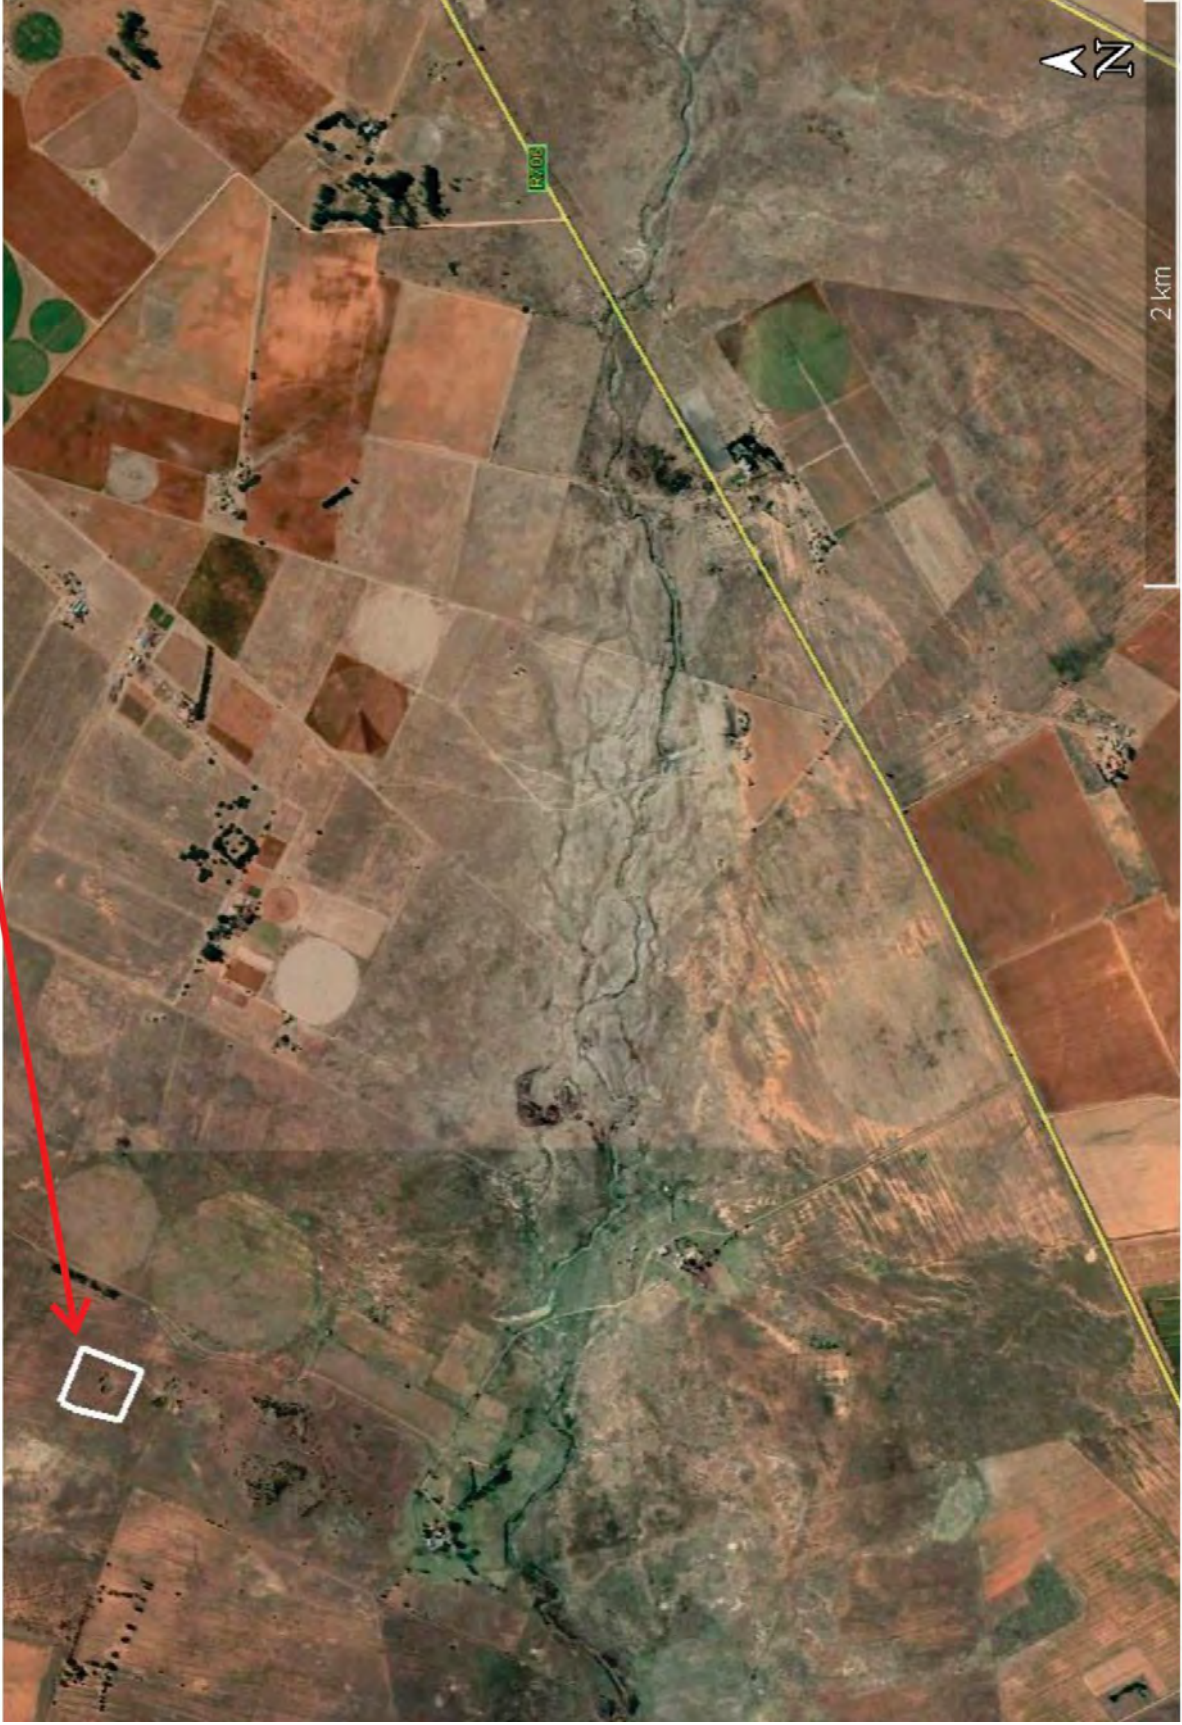
Figure 1. Aerial view the proposed new quarry on the remainder portion of the farm De Hoop 320 (source 1:50 000 scale topographical map 2926 AA Bloemfontein).

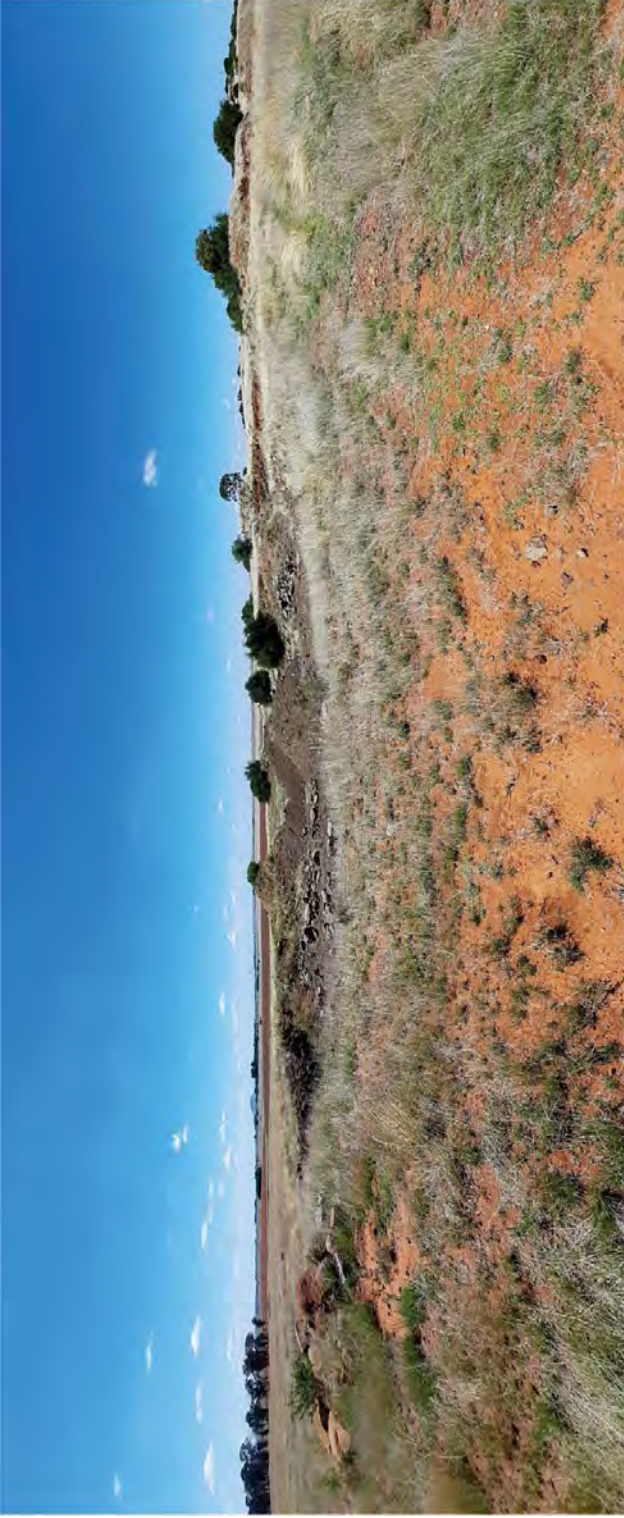
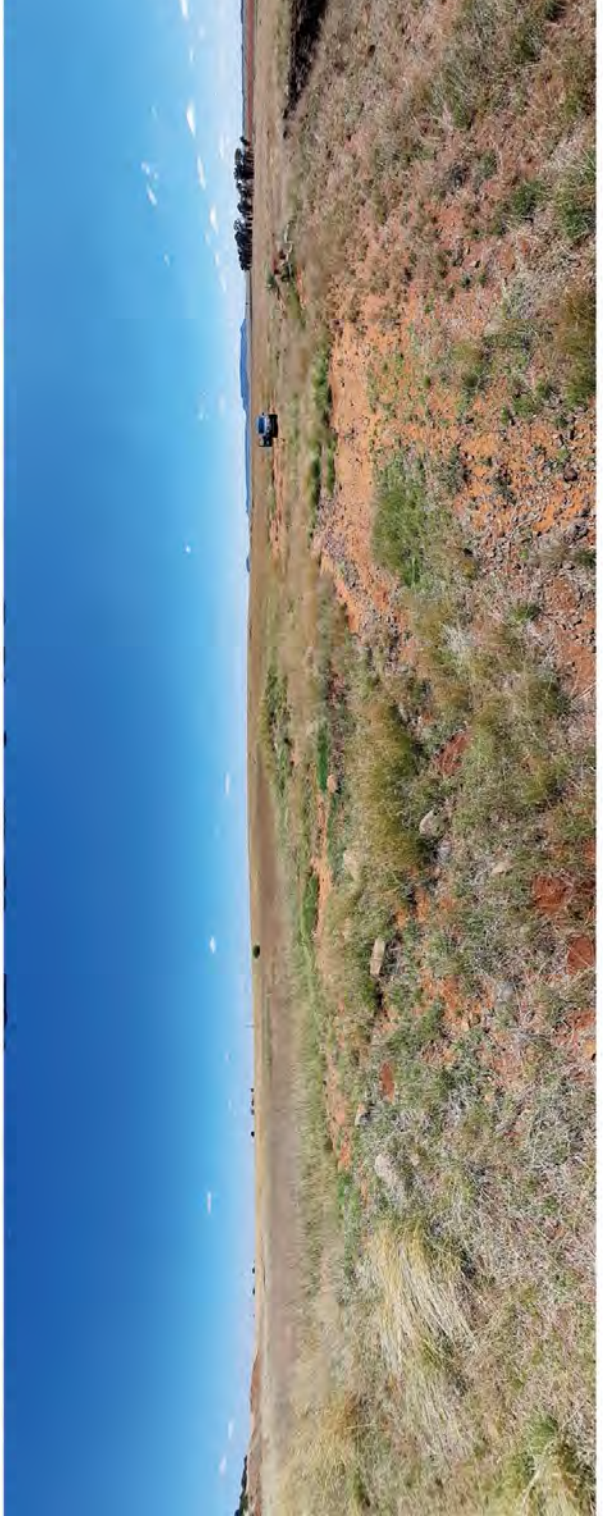
Figure 2. General view of the site looking at old borrow pit, direction north.

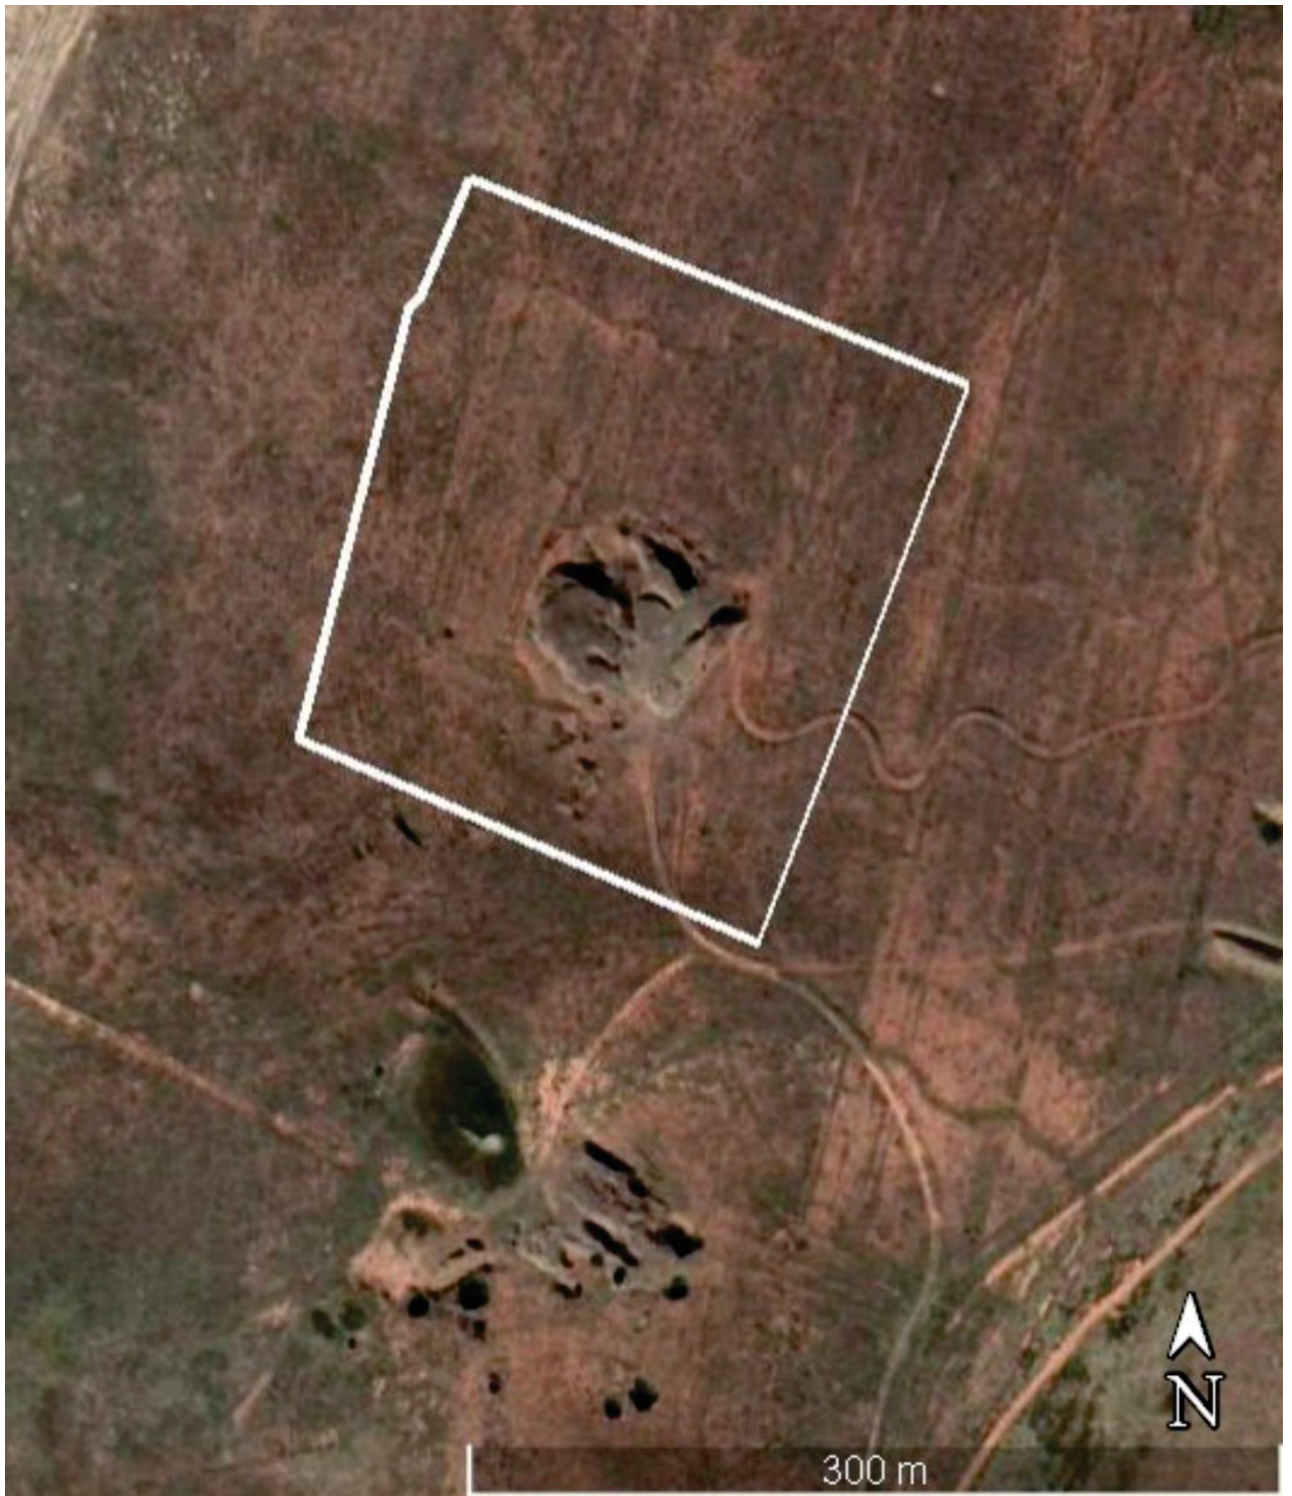
Figure 3. Aerial view of the study area.

The study area forms part of an old borrow pit located on the farm De Hoop 320 situated about 3 km north of the R706 road between Bloemfontein and Jagersfontein and about 25 km west south west of the Bloemfontein CBD (**Fig. 2 & 3**).

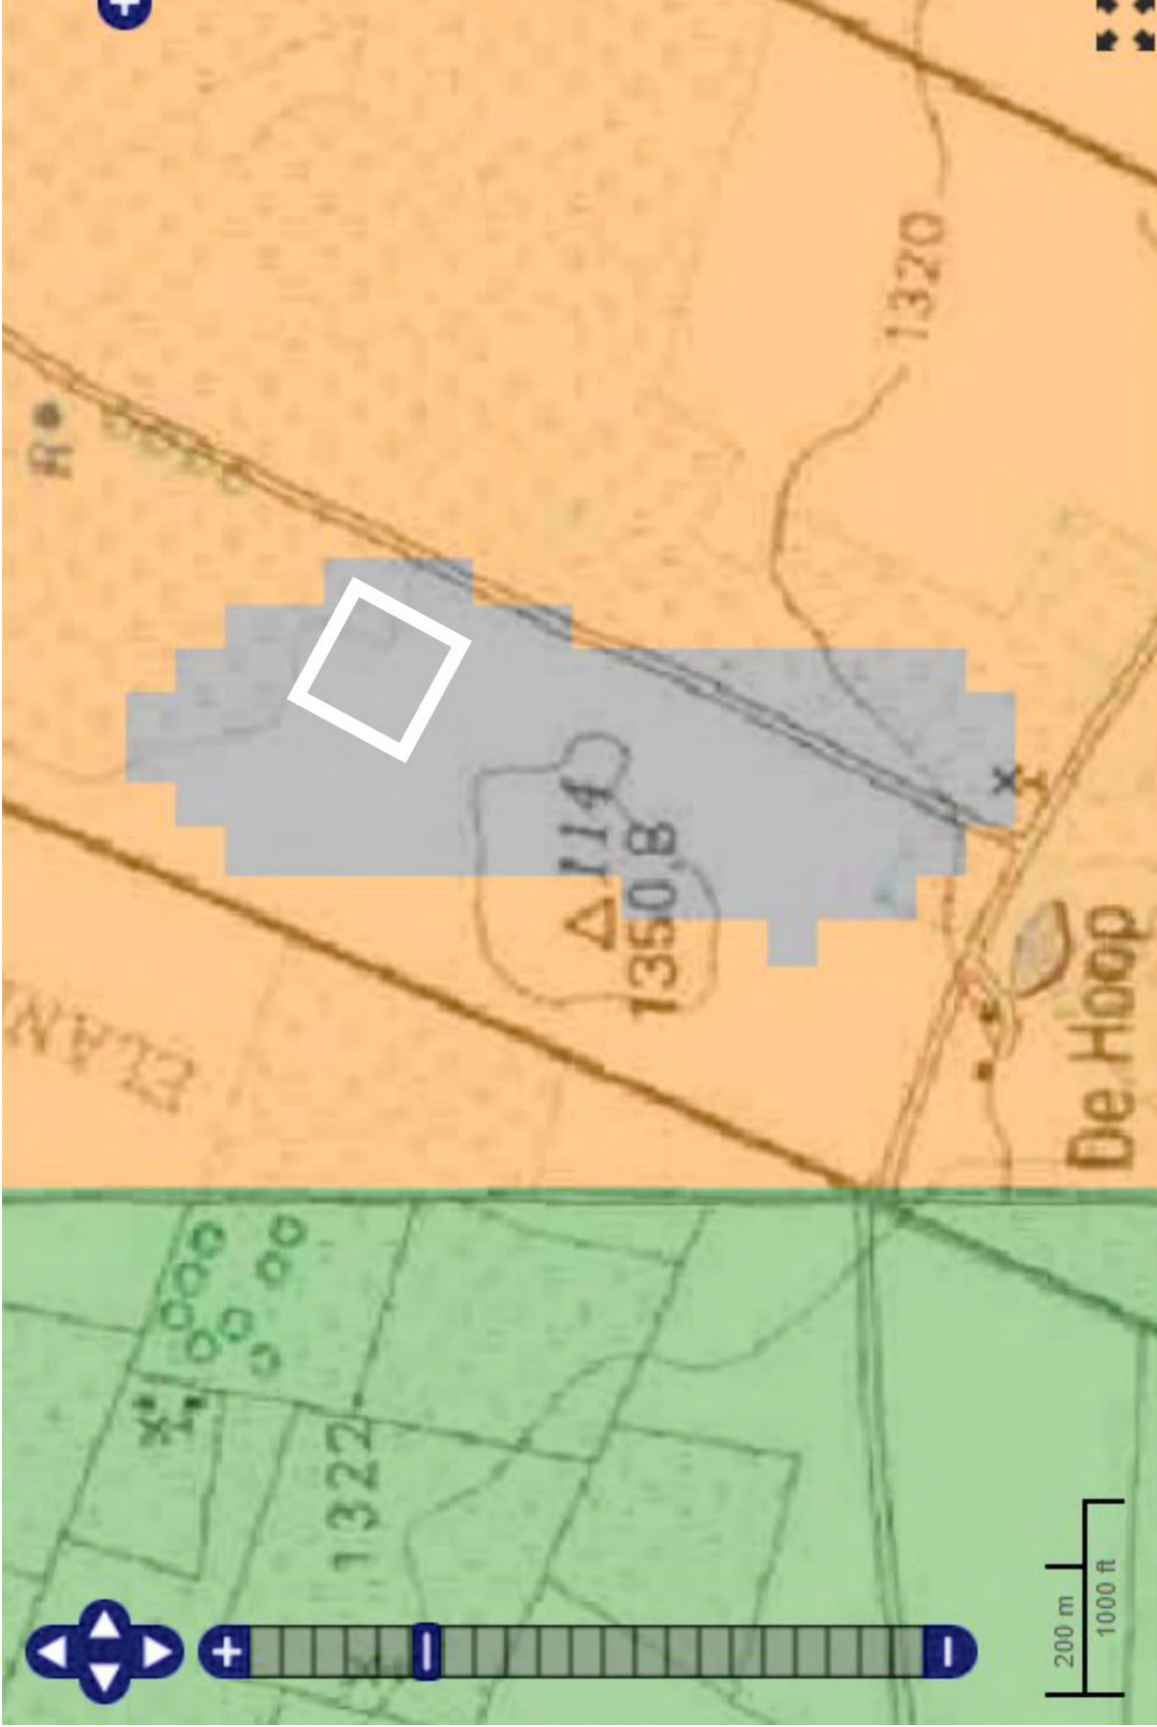
Figure 6. Position of the study area (white polygon) marked on the SAHRIS Palaeontological Sensitivity Map: Grey Zone = insignificant, no further palaeontological studies required.

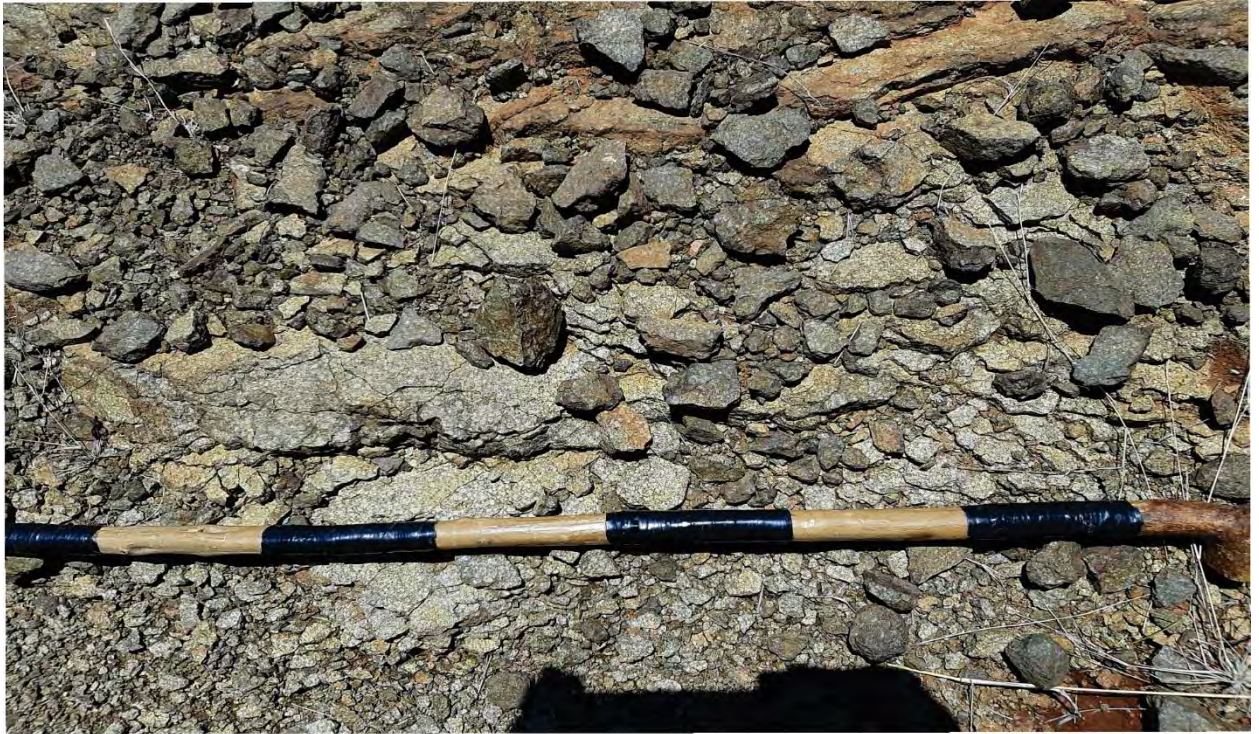
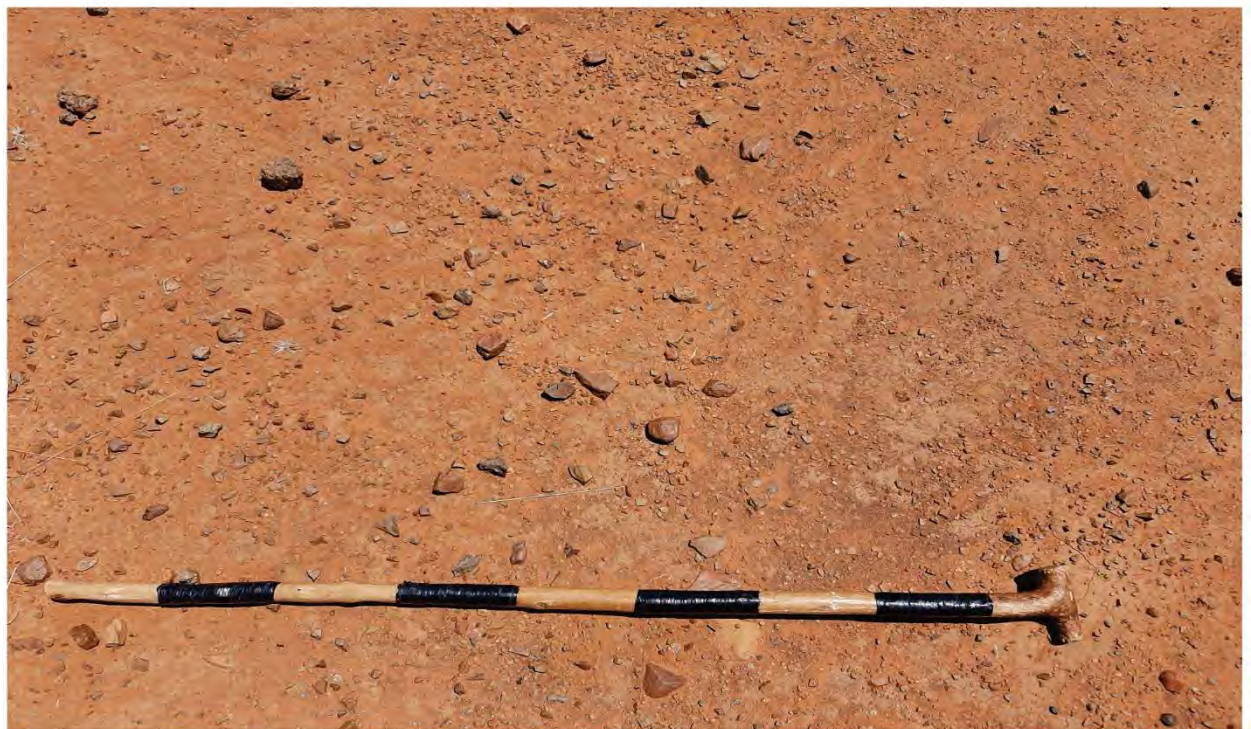
Figure 7. The entire study area is underlain by intrusive dolerite outcrop (above) that are capped in places by well-developed superficial deposits (below). (scale: 1 = 10 cm).

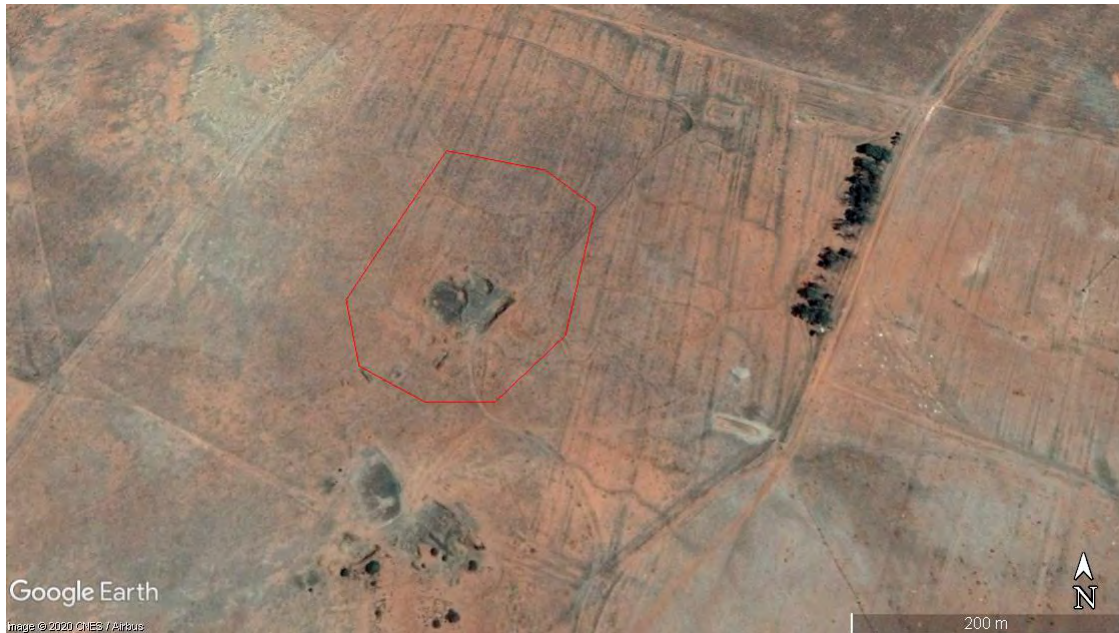
Figure 1: Aerial view of the proposed site (Google Earth 2019). Note the historical borrow pit on the site is clearly visible as well as plough furrows in the surrounding grassland which clearly indicates previous clearing of the natural vegetation.

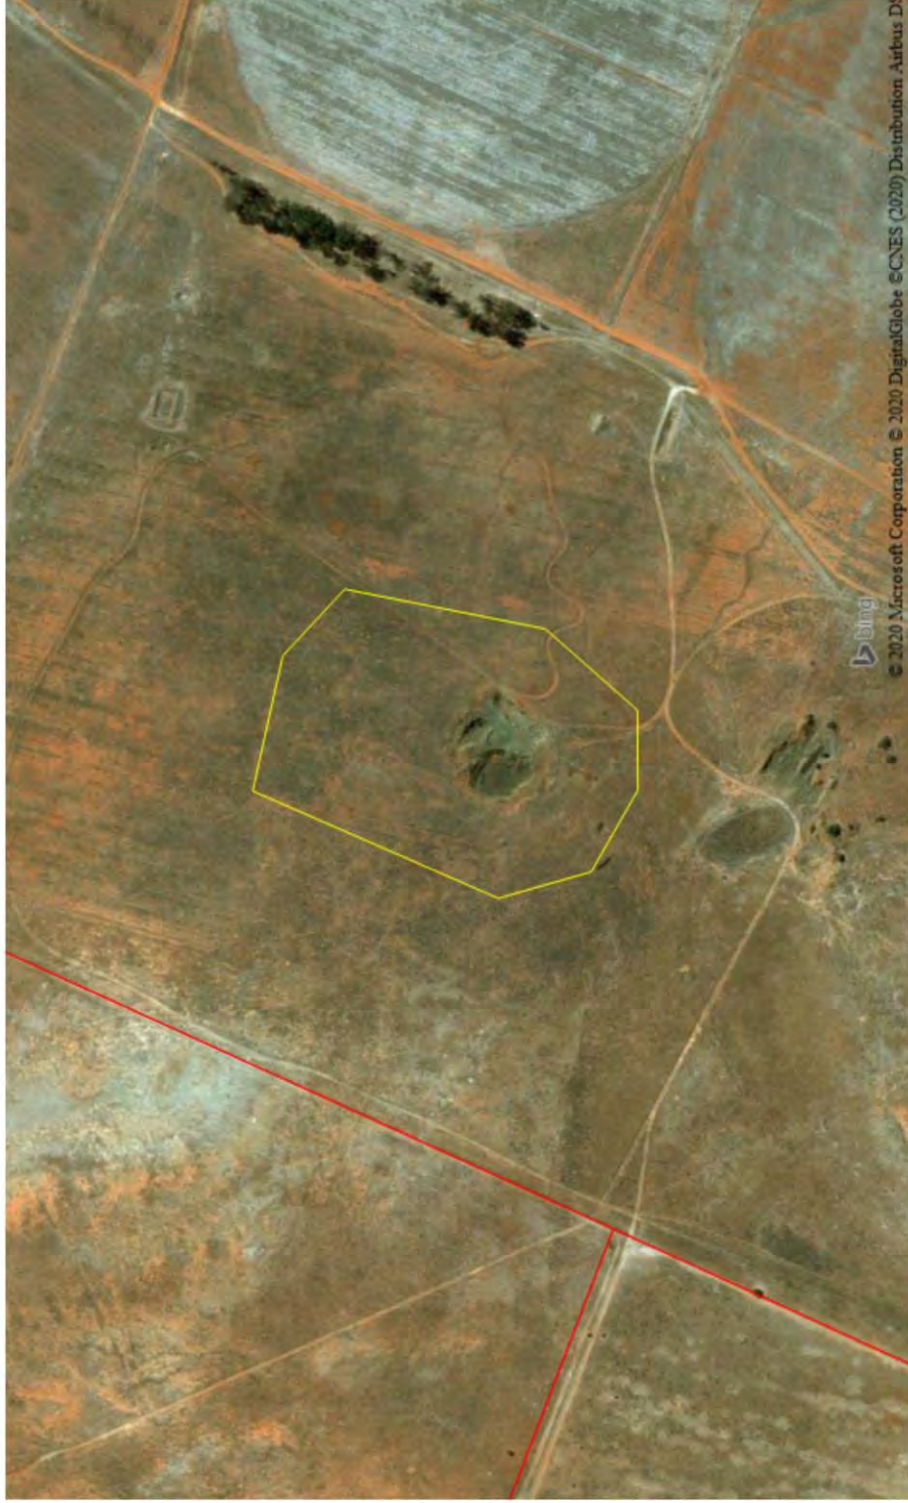
Map 1: Layout map of the proposed quarry on the Farm De Hoop 320 near Bloemfontein. The existing historical borrow pit is visible on the site. Note also faint plough furrows still visible on the site and surroundings.
