FINAL NEMA BAR AND EMPr:

IN SUPPORT OF A MINING PERMIT AND
ENVIRONMENTAL AUTHORISATION APPLICATION FOR
THE ESTABLISHMENT OF A QUARRY ON REMAINDER OF
FARM DE HOOP 320, BLOEMFONTEIN, FREE STATE

November 2020

WLS Trust

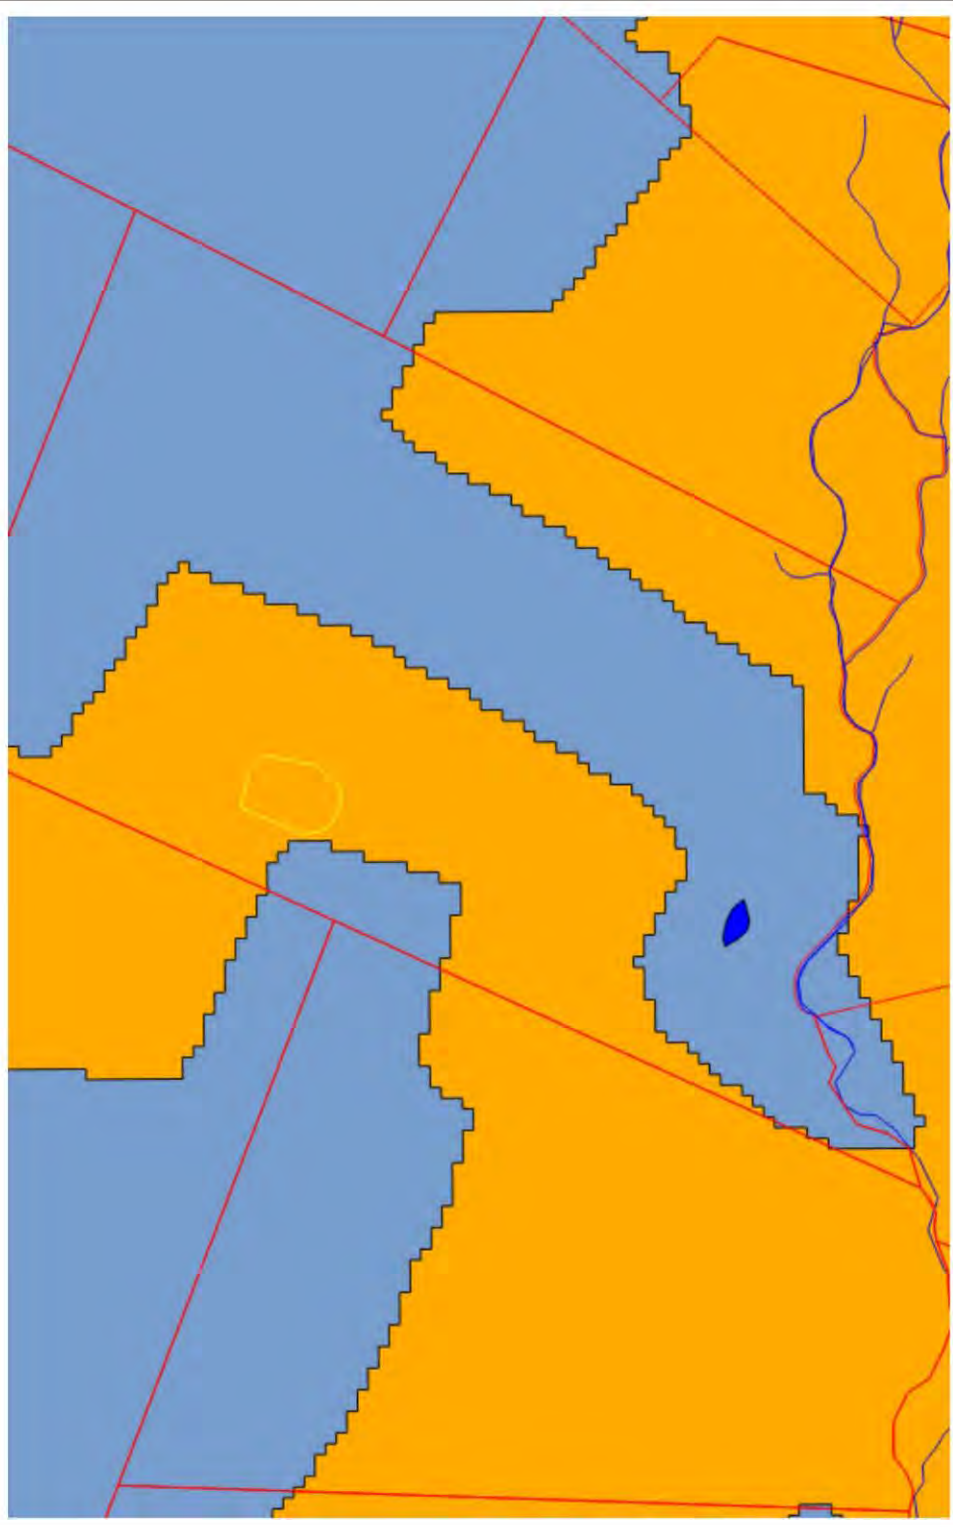
Map 2: General ecology map of the proposed quarry on the Farm De Hoop 320 near Bloemfontein. Note that the area consists of Bloemfontein Dry Grassland, a listed Threatened Ecosystem. Although this is also indicated for the site, the on-site survey as well as the Free State Biodiversity Management Plan confirms that the natural grassland has been largely transformed on the site. Note also the Kaalspruit, situated to the south of the site.

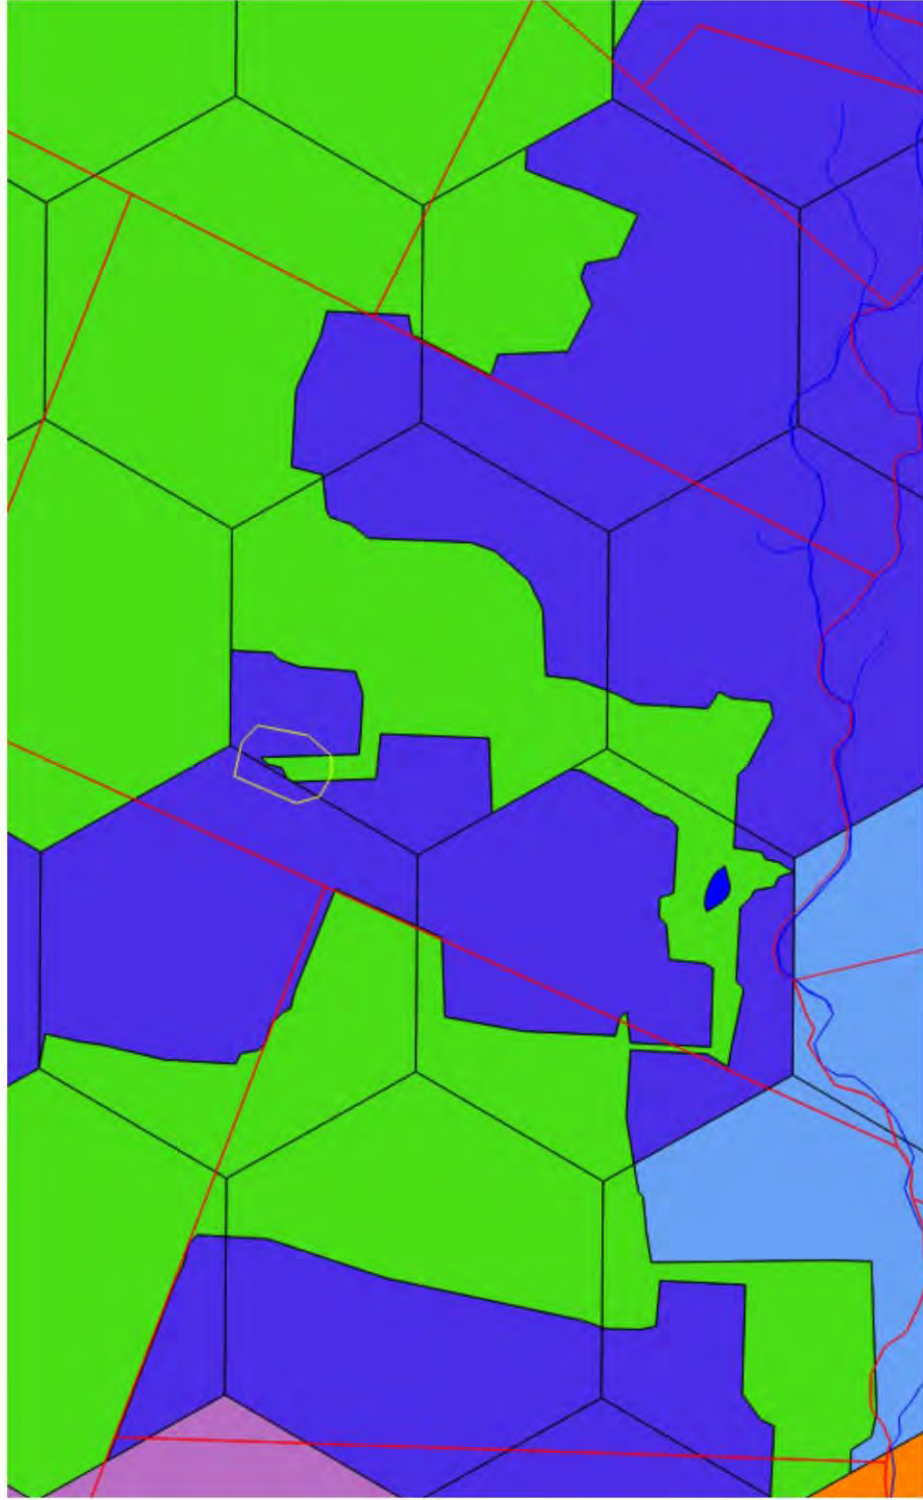
Map 3: Biodiversity plan map of the proposed quarry on the Farm De Hoop 320 near Bloemfontein. The site is situated within a Degraded and Other categories and confirms the largely transformed condition of the vegetation on the site.

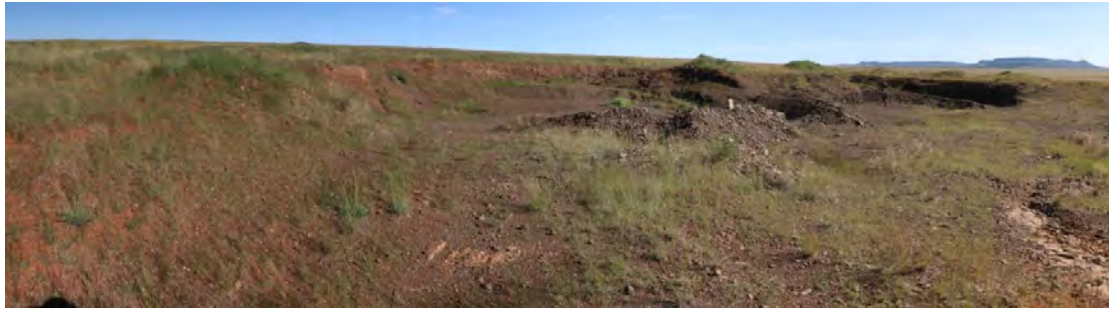
Figure 1: Panorama of the site showing the existing borrow pit excavation. Note transformation of the topography and vegetation with a very low percentage vegetation cover re-establishing.

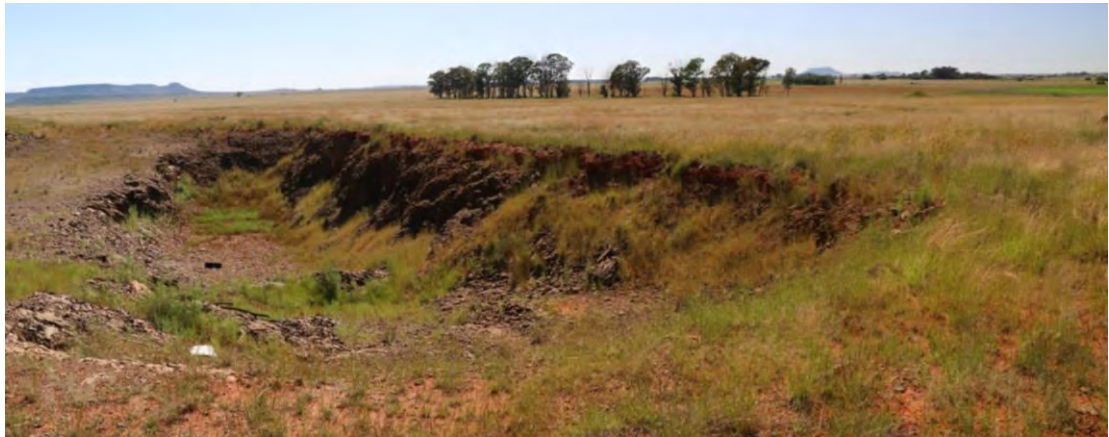
Figure 2: Panorama of the site showing the existing borrow pit excavation. Note that it remains free draining.

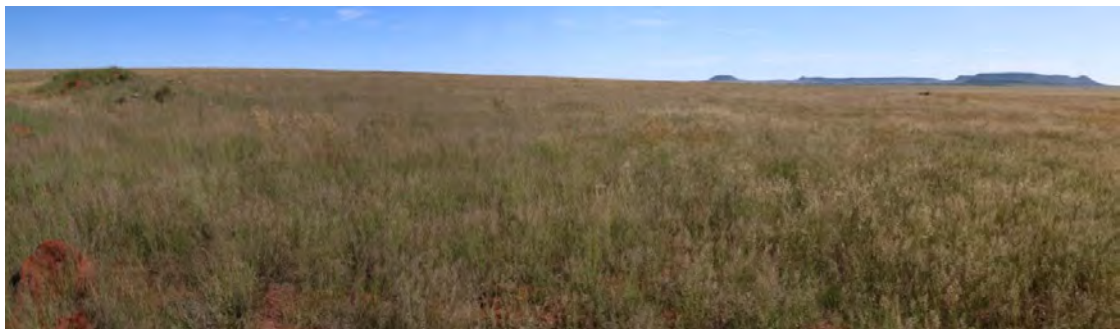
Figure 3: Panorama of the site around the existing borrow pit. A moderately dense grass layer is present. The species composition is clearly dominated by pioneer grasses.

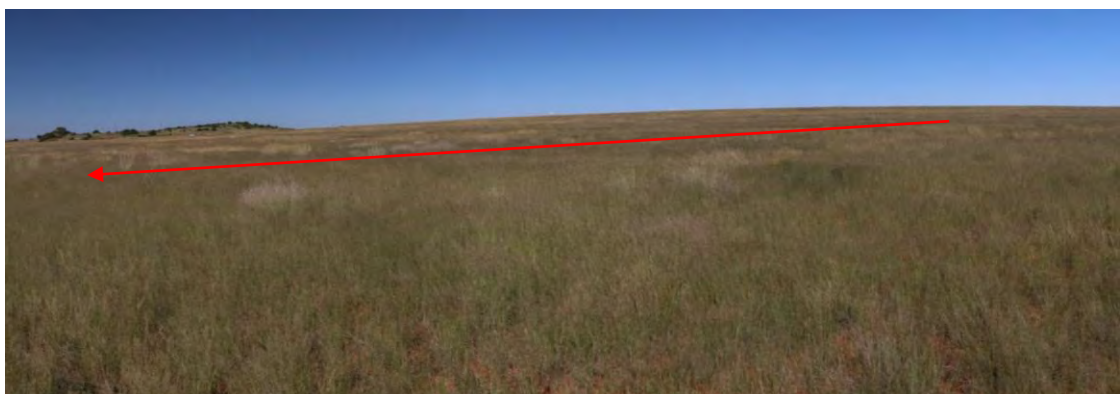
Figure 4: Panorama of the site showing the surrounding grassland. Again, note the dominance of pioneer grasses. The gentle slope of the site is also clearly visible (red arrow).

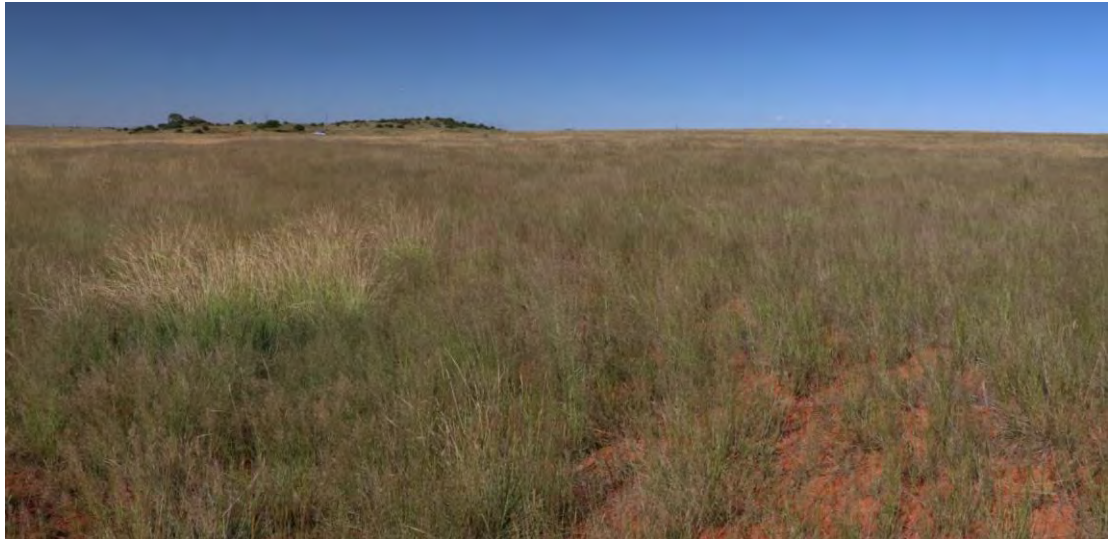
Figure 5: Another panorama of the site illustrating the pioneer grass layer dominating the area.

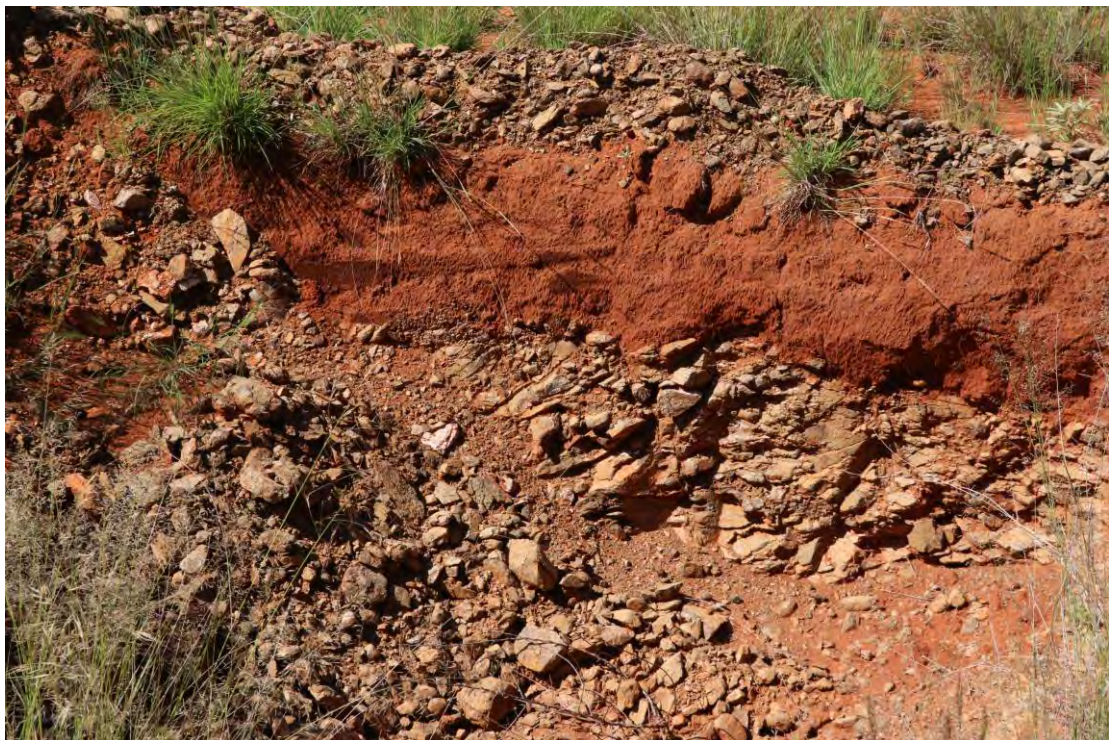
Figure 6: View of the soil profile at the site indicates a shallow topsoil layer, dominated by sandy-loam soils overlying weathered dolerite.
