GEOHYDROLOGICAL IMPACT ASSESSMENT FOR THE PROPOSED EXPANSION OF CHICKEN HOUSES FROM APPROXIMATELY 30 000 TO 60 000 CHICKENS, BULHOEK FARM, NEAR SWARTRUGGENS, NORTH WEST PROVINCE

Geohydrological Report

October 2021

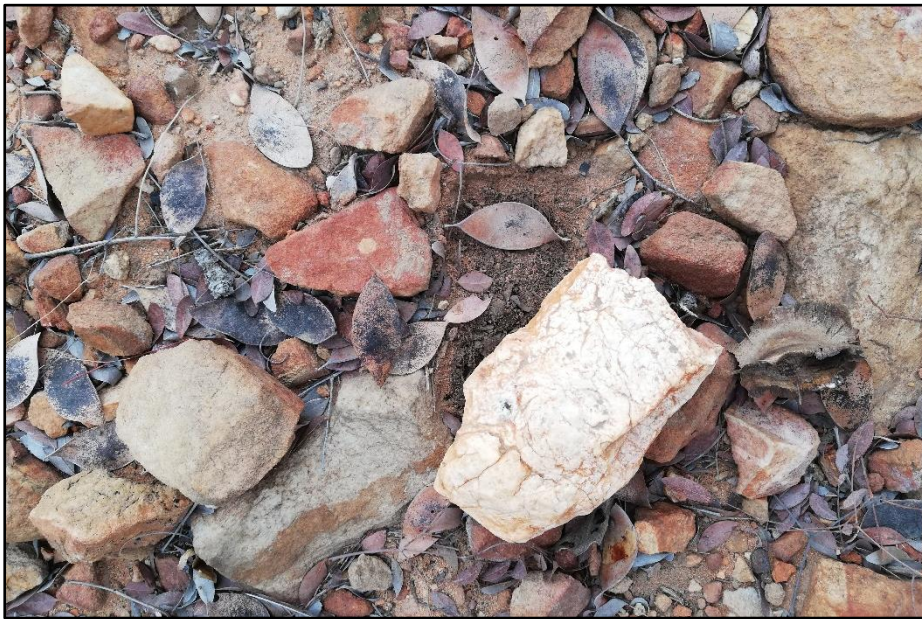
Figure 10. Quartzite and metamorphosed rocks on site.

Quartzite and metamorphosed rocks were observed in close proximity to the Witwatersrand Mountains on site as seen in Figure 10.

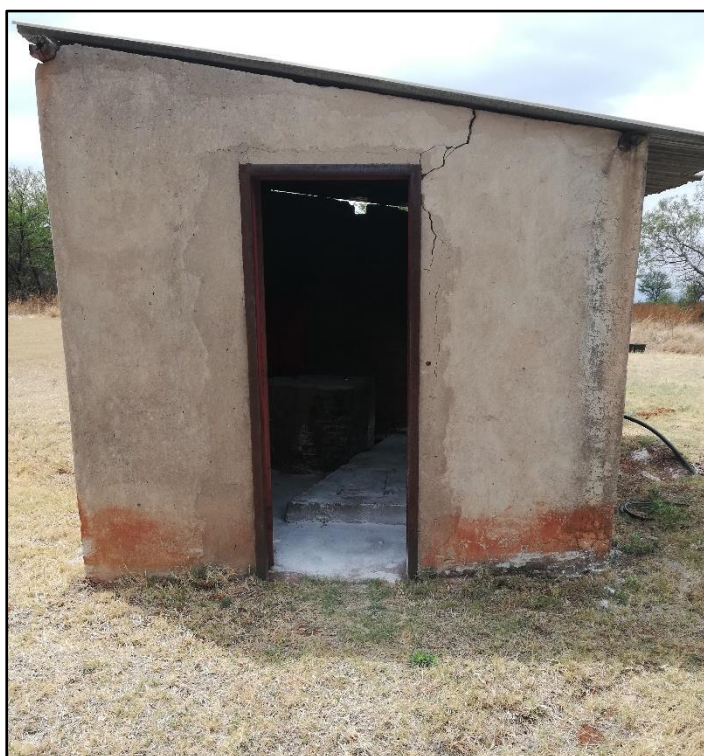
Figure 16. BULBH3 located within the pumping house.

The borehole is located in the Southern region of the Bulhoek Farm and is equipped with a 2.2KW 4SD69/14 Motor pump that has been installed at 50 meters deep. The borehole is situated inside a pumping house on site as seen in Figure 16. According to the Pump Test performed on 13 October 2021 by Tucana Solutions (Appendix B – Pump test BULBH03), the borehole delivers **73 440 litres per day**.

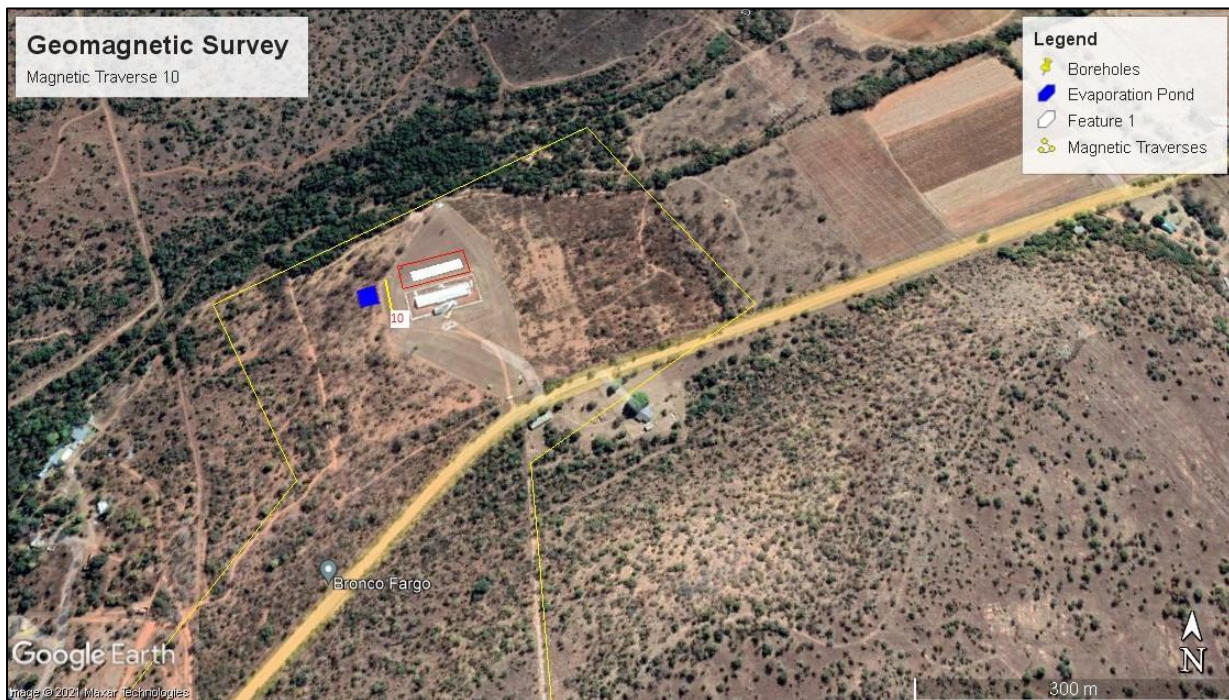
The magnetic field survey consisted of ten (10) traverses as indicated in Figure 25 & 26.

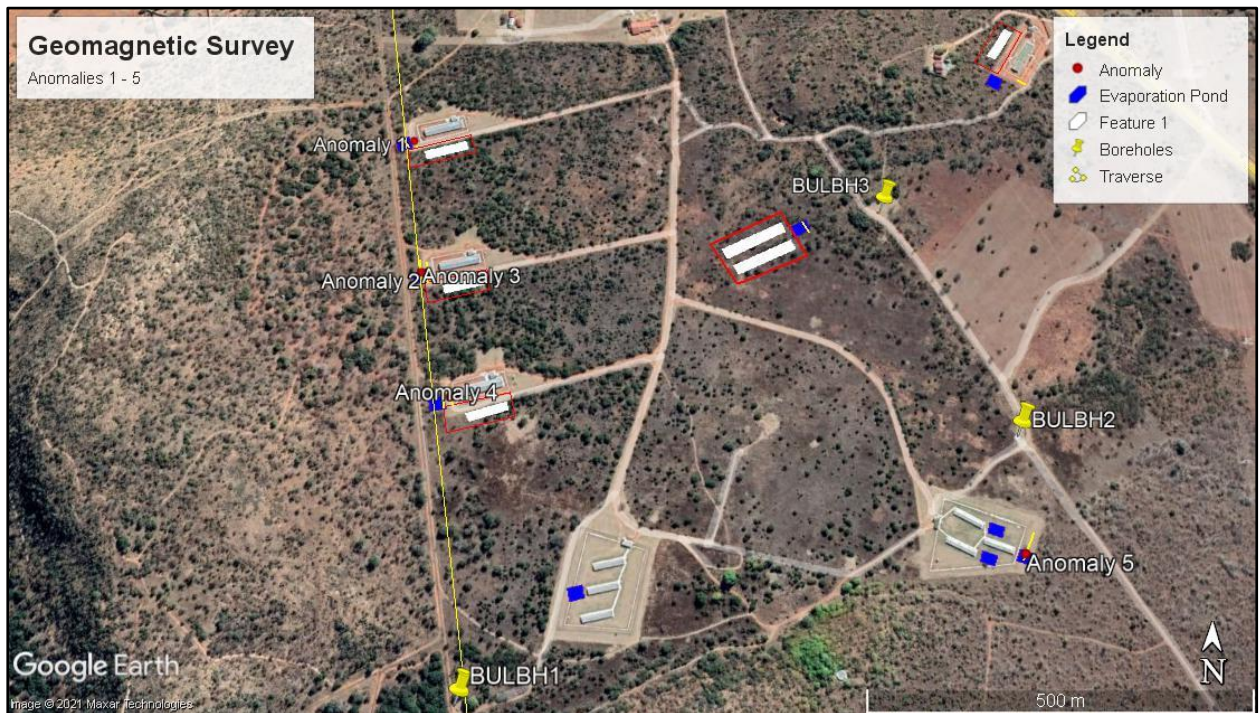
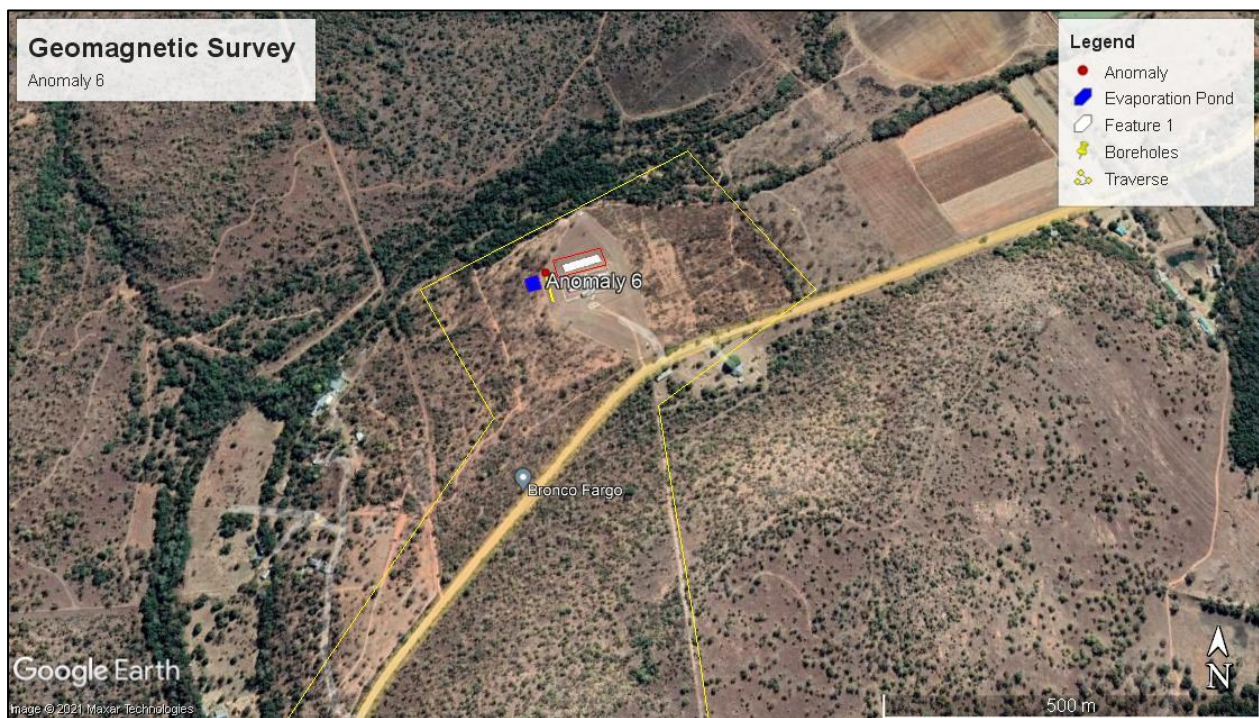
The anomalies will be discussed in the Figures below and the positions have been identified as seen in Figures 27 & 28.

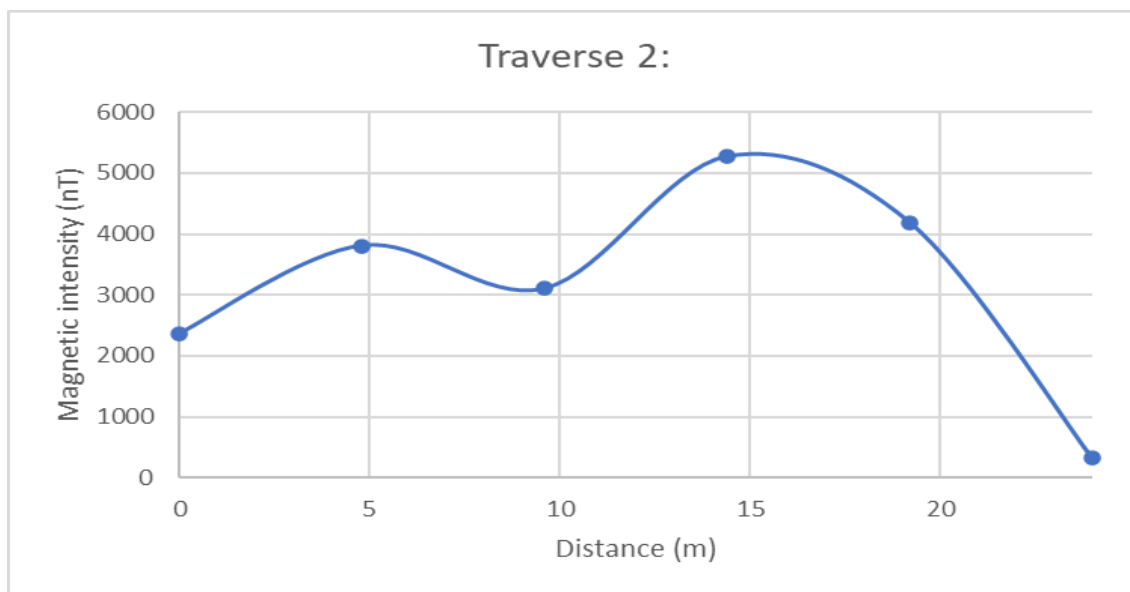
It can be concluded from Traverse 2 (Figure 30) that no significant anomalies were identified. Please note that this magnetic survey was done next to an existing chicken house with metal structures, electric fence and metal components which can be the reason for the magnetic noise in the background.

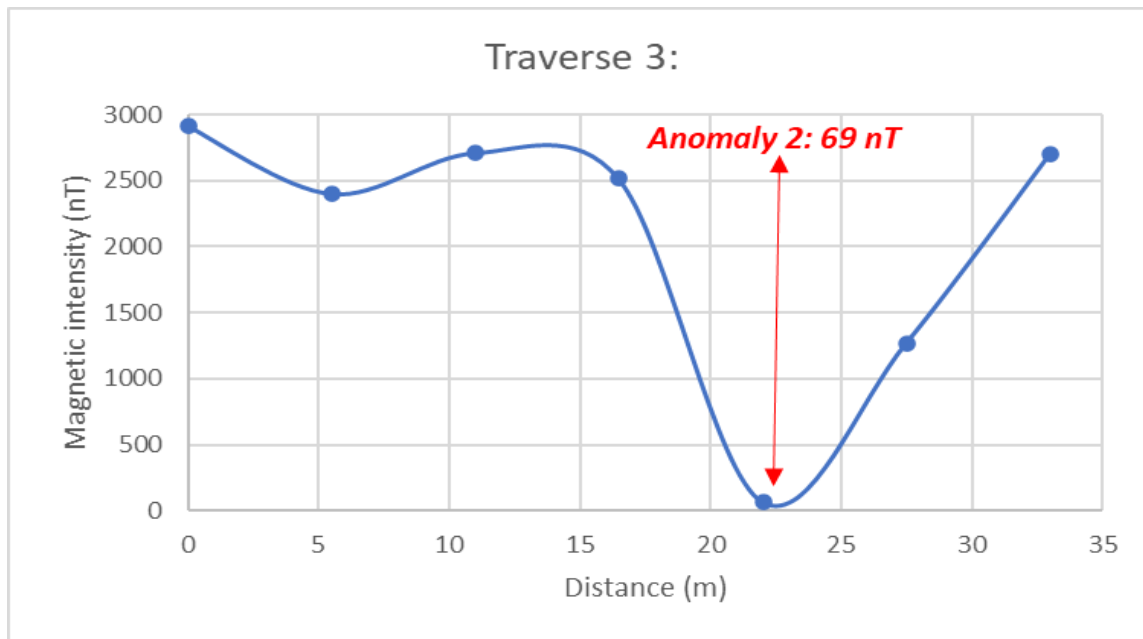
It can be concluded from Traverse 3 (Figure 31) that one (1) significant anomaly (Anomaly 2) was identified at 22 m with a magnetic intensity of 69 nT. The change in magnetic intensity can be indicative of an intrusive dolerite/ magnetic feature.

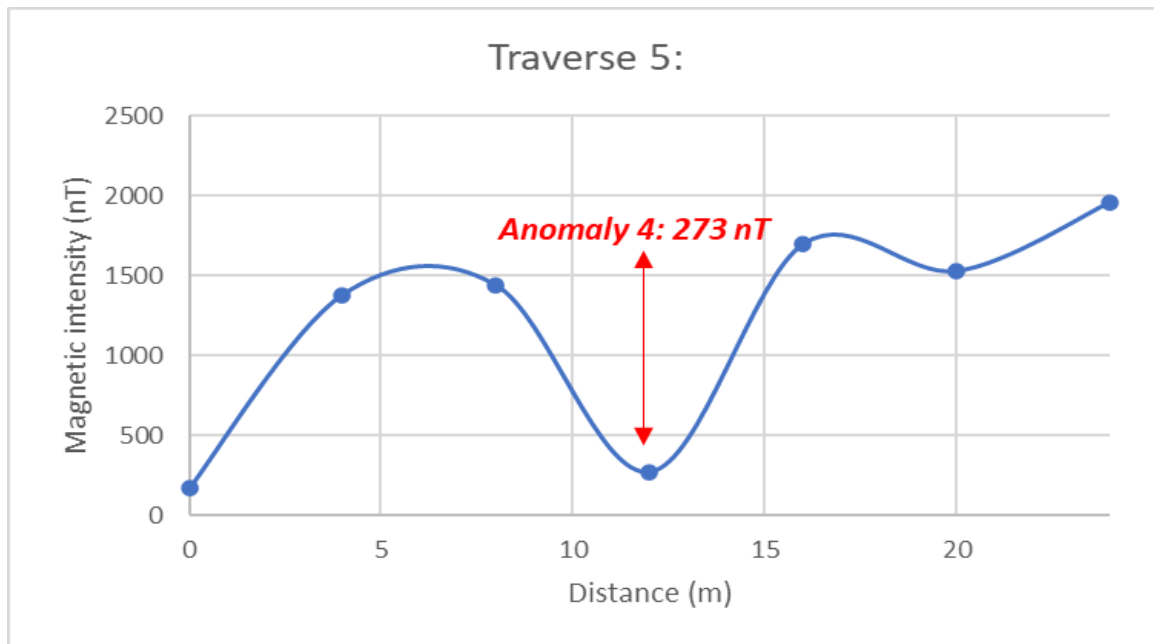
It can be concluded from Traverse 5 (Figure 33) that one (1) significant anomaly (Anomaly 4) was identified at 12 m. Anomaly 4 has a magnetic intensity of 273 nT and it is unlikely that this anomaly can be indicative of an intrusive dolerite/magnetic feature. Please note that this magnetic survey was done next to an existing chicken house with metal structures, electric fence and metal components which can be the reason for the magnetic noise in the background.

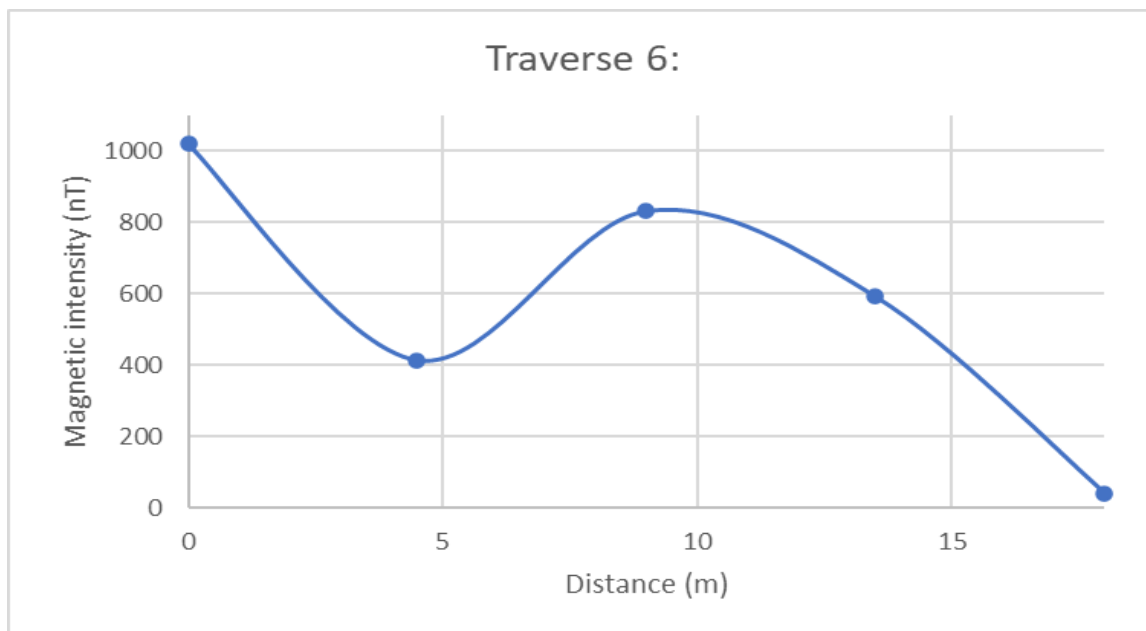
It can be concluded from Traverse 6 (Figure 34) that no significant anomalies were identified. Please note that this magnetic survey was done next to an existing chicken house with metal structures, electric fence and metal components which can be the reason for the magnetic noise in the background.

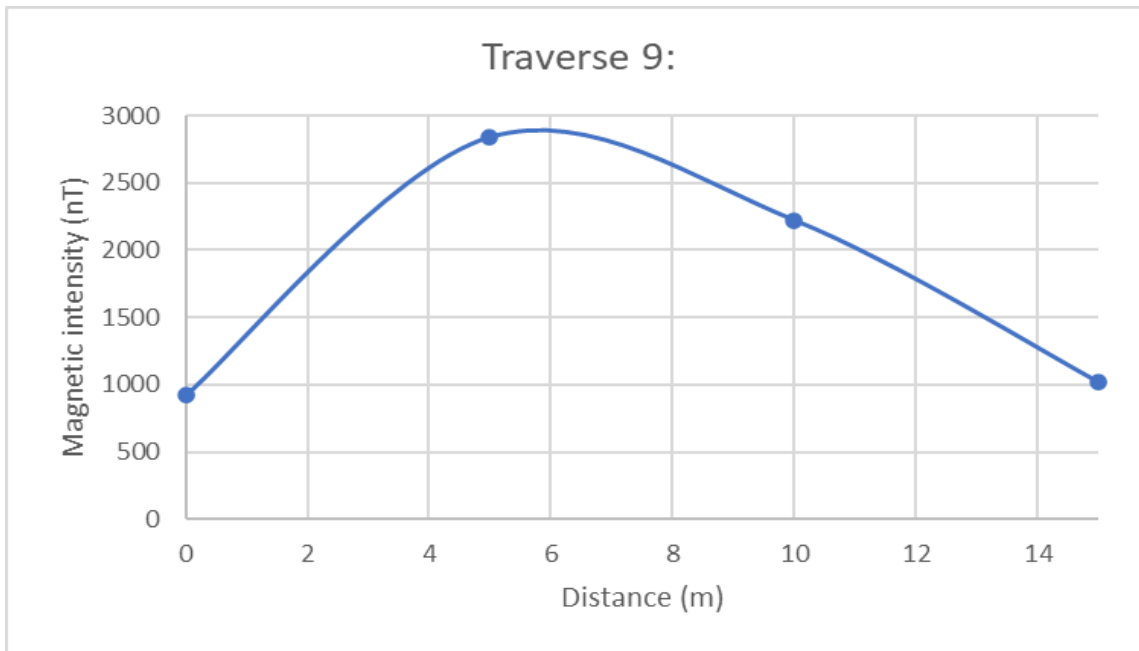
It can be concluded from Traverse 9 (Figure 37) that no significant anomalies were identified. Please note that this magnetic survey was done next to an existing chicken house with metal structures, electric fence and metal components which can be the reason for the magnetic noise in the background.

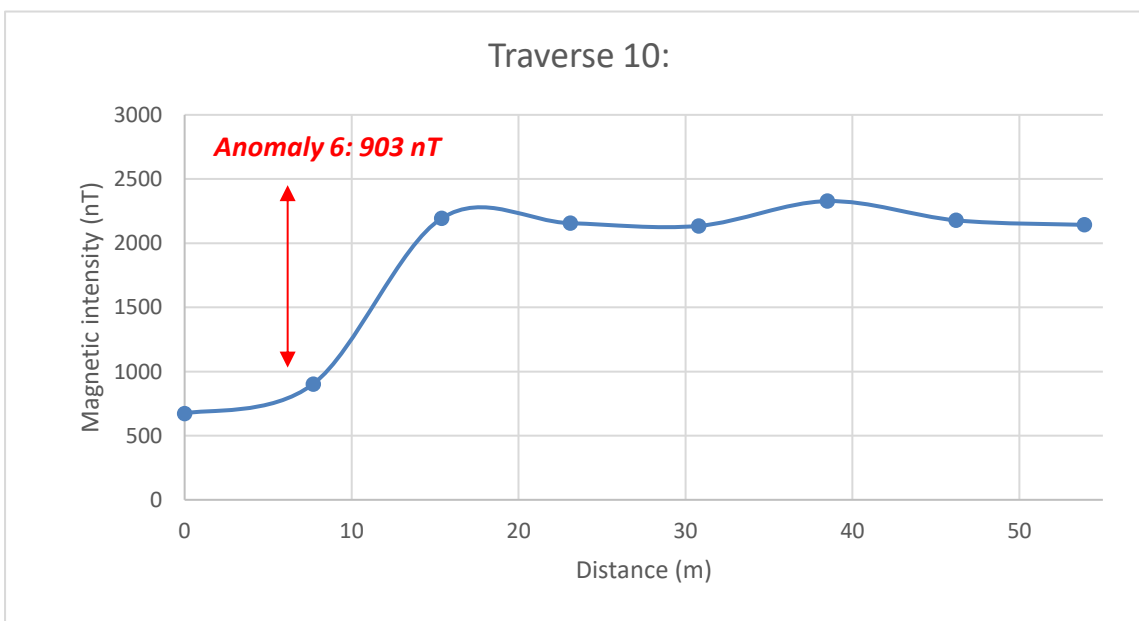
It can be concluded from Traverse 10 (Figure 38) that one (1) significant anomaly (Anomaly 6) was identified at 7.7 m. Anomaly 6 has a magnetic intensity of 903 nT and it is unlikely that this anomaly can be indicative of an intrusive dolerite/magnetic feature due to the close proximity that this magnetic traverse was done to the electric fence. Please note that this magnetic survey was done next to an existing chicken house with metal structures, electric fence and metal components which can be the reason for the magnetic noise in the background.

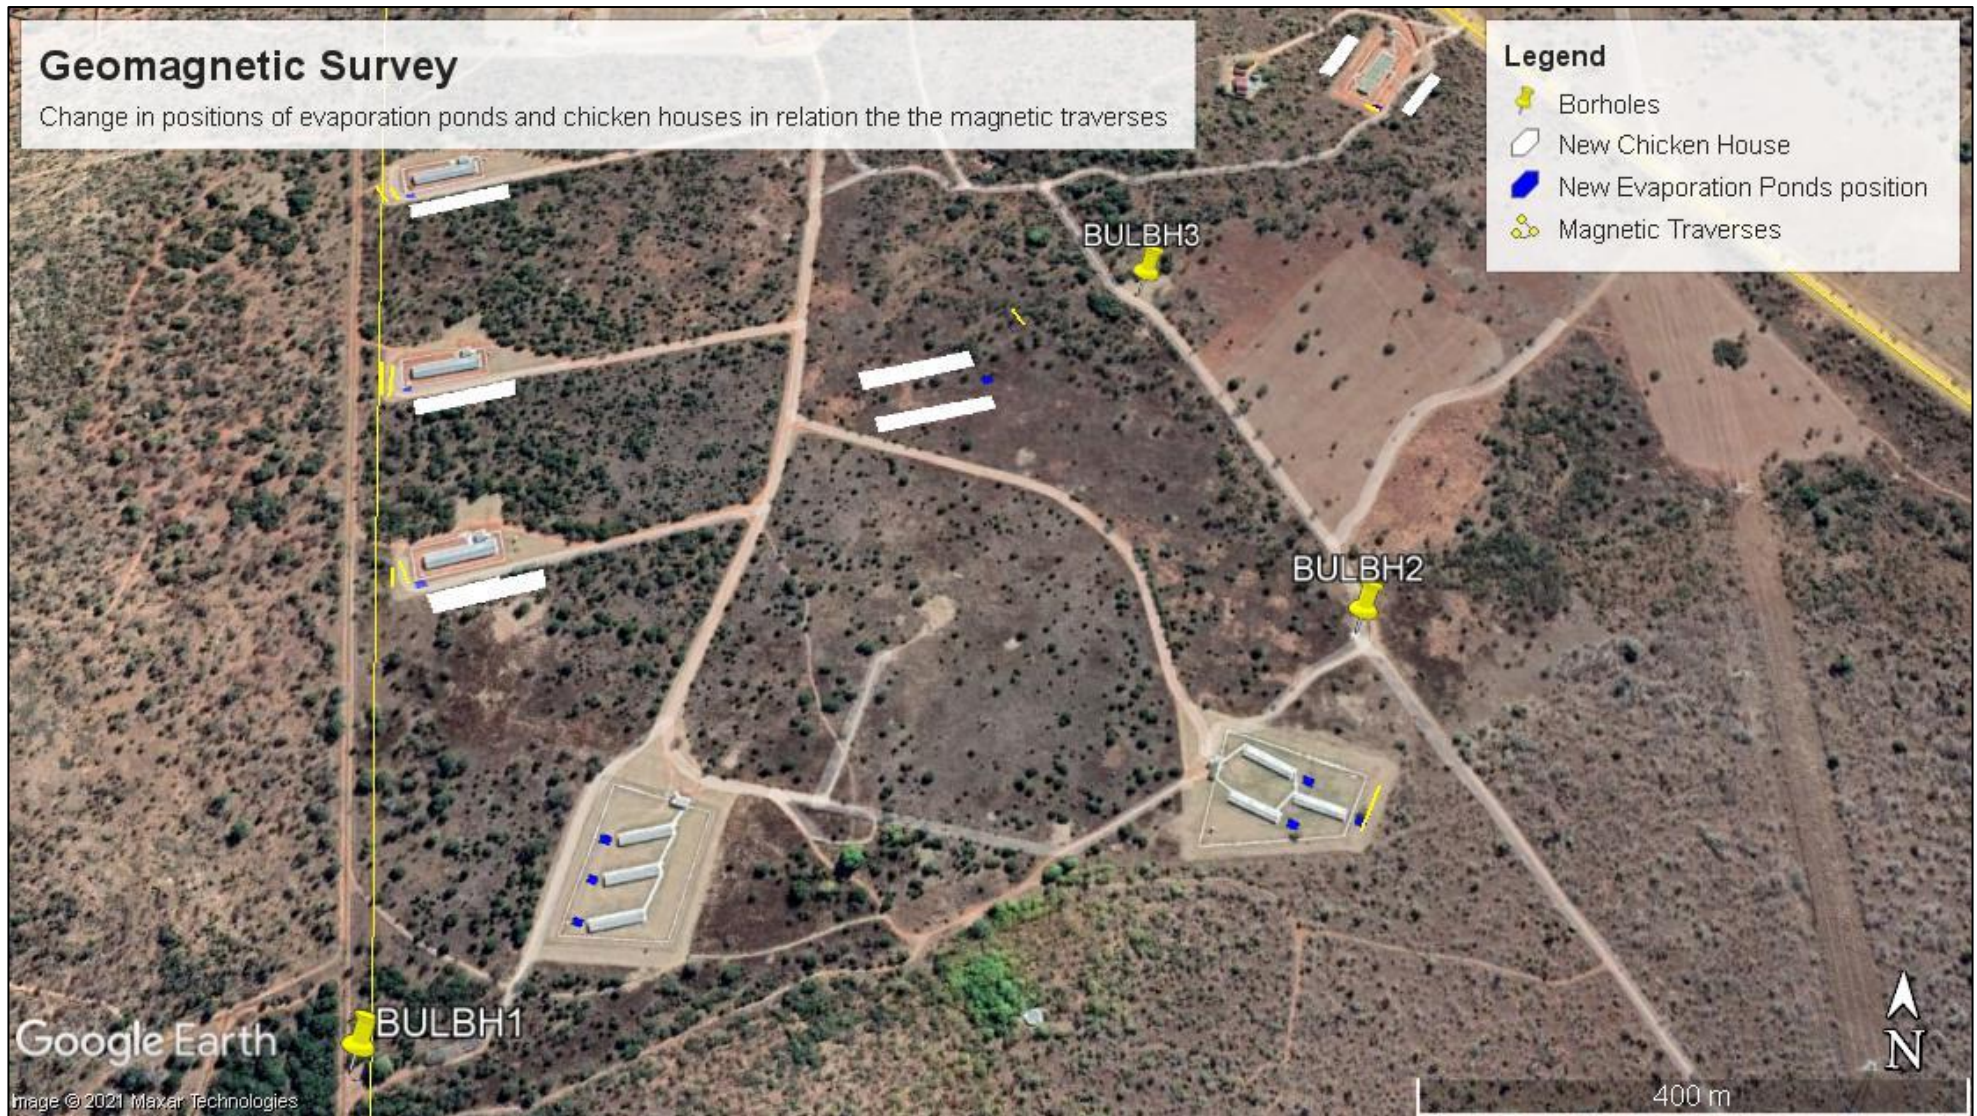
Figure 40. The new positions of the evaporation ponds, Southern side of the farm, Bulhoek Farm.

Kindly take note that the Geophysical Survey was performed at the previous evaporation ponds positions prior to the distribution of the revised layout map that indicate the new positions of the evaporation ponds as indicated by Figures 1, 40 & 41 . However, this does not change the fact that intrusive features are expected in the vicinity of the proposed development. Thus, the proposed recommendations as mentioned in Section 12 should still be implemented.

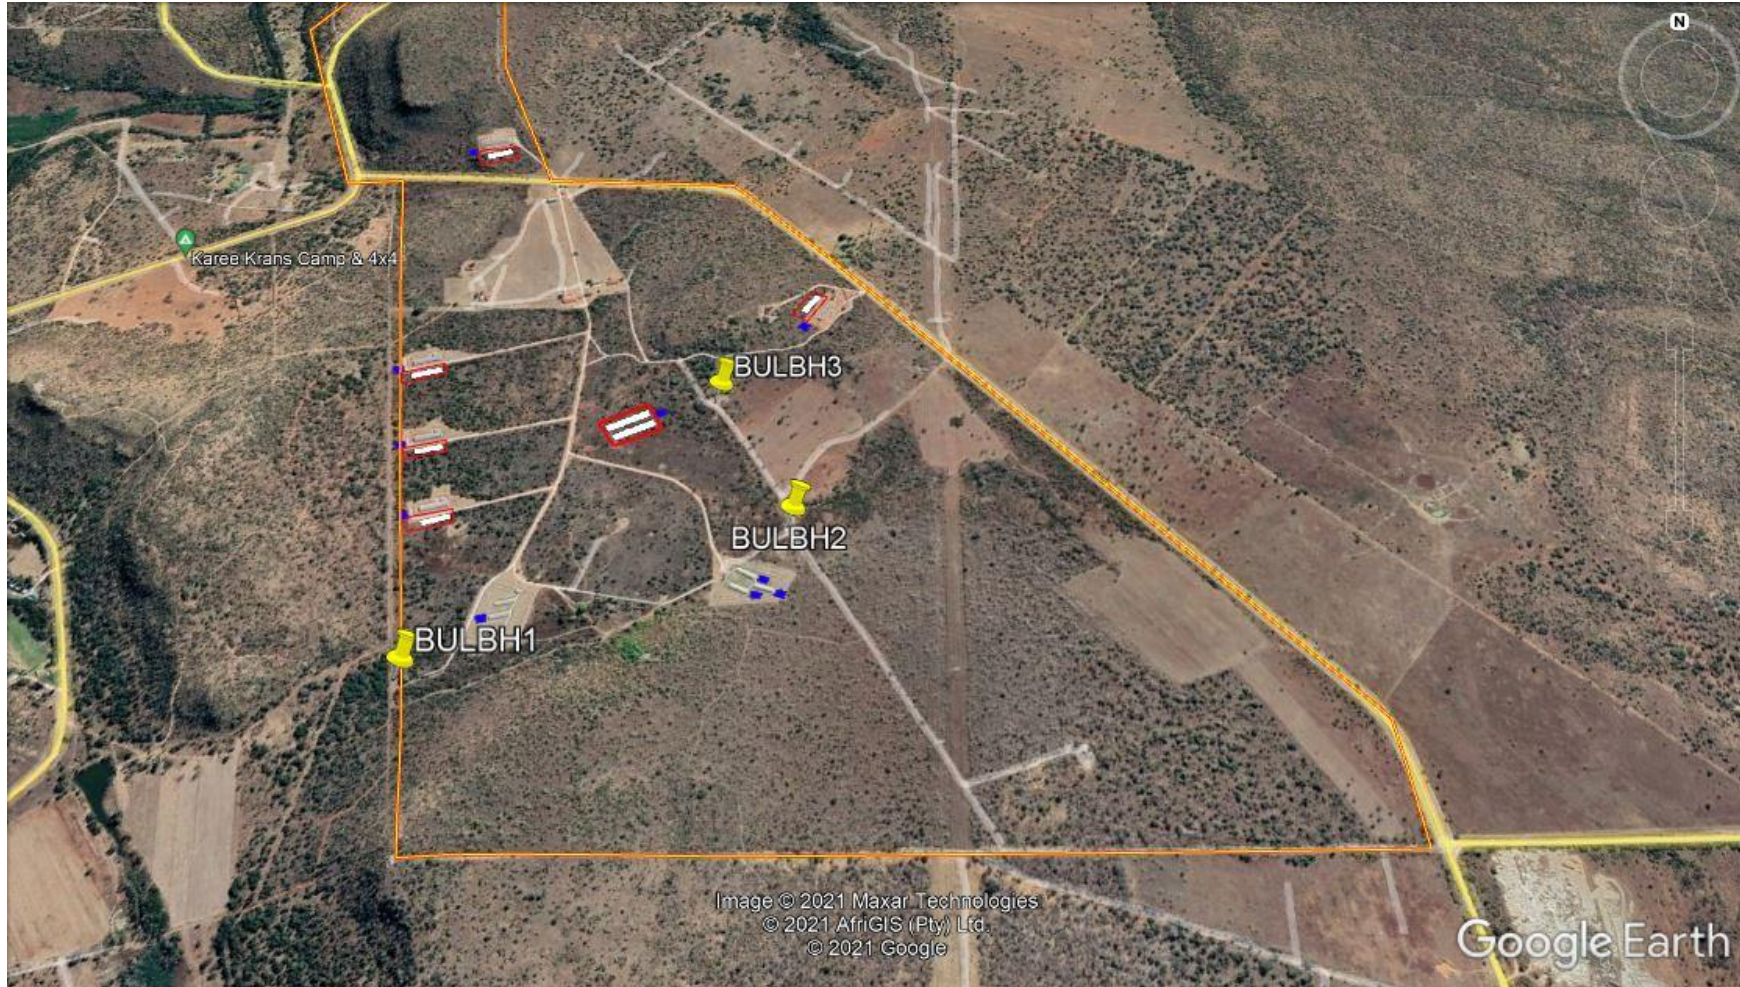
Figure 1: Google Earth map of the borehole sampling points at Bulhoek farm.

Google Earth maps were supplied by Rolene Lubbe (Enviroworks) and indicates the three borehole sampling points, at Bulhoek farm, Schweizer Reineke, North West. The water from the boreholes is transported to a reservoir where it is treated with chemicals before it is available as drinking water and usage in chicken broiler houses.

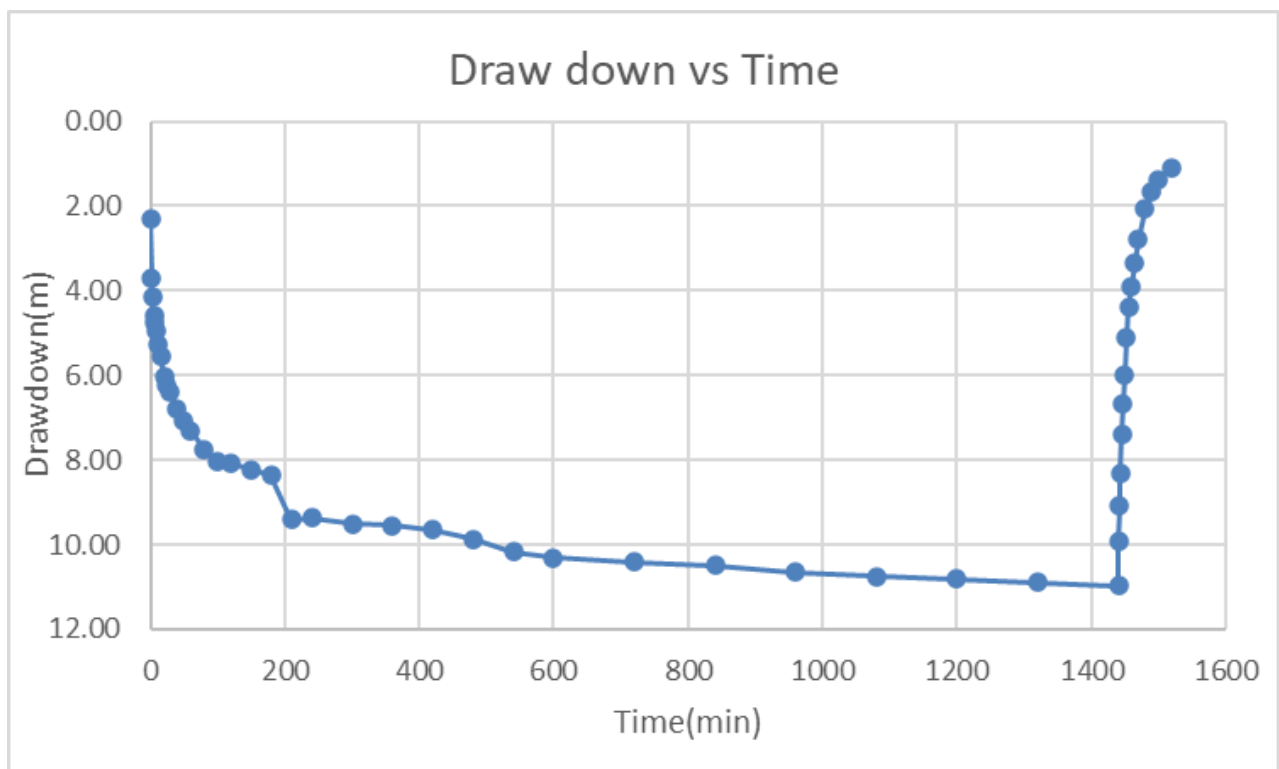
Figure 3: Draw down versus time (Pump & Recovery Data)- BULBH02

Abstraction rate: 0.5 l/s
