Alton Landfill Site Final Risk Assessment Report

September 2015

GCS Reference Number: 13-478

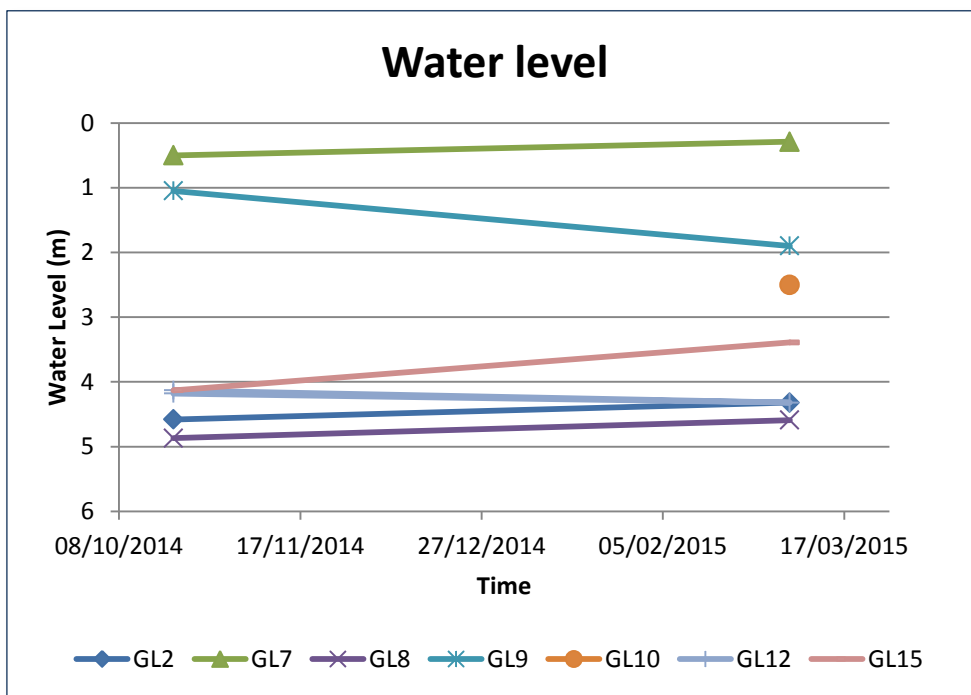
Figure 4-1: Water level trend graph (1)

A second round of water level measurements was conducted on the 5th of March 2015 by CSIR personnel to confirm the initial water levels measured during the site visit in October 2014. The results are tabulated and represented graphically as shown in Table 4-1, Figure 4-1 and Figure 4-2. No significant water level changes are observed, only slight variations which were less than a meter in some boreholes. It is highly recommended that groundwater levels within the site are measured in conjunction with monthly sampling. This will assist in understanding groundwater level fluctuations within the site.

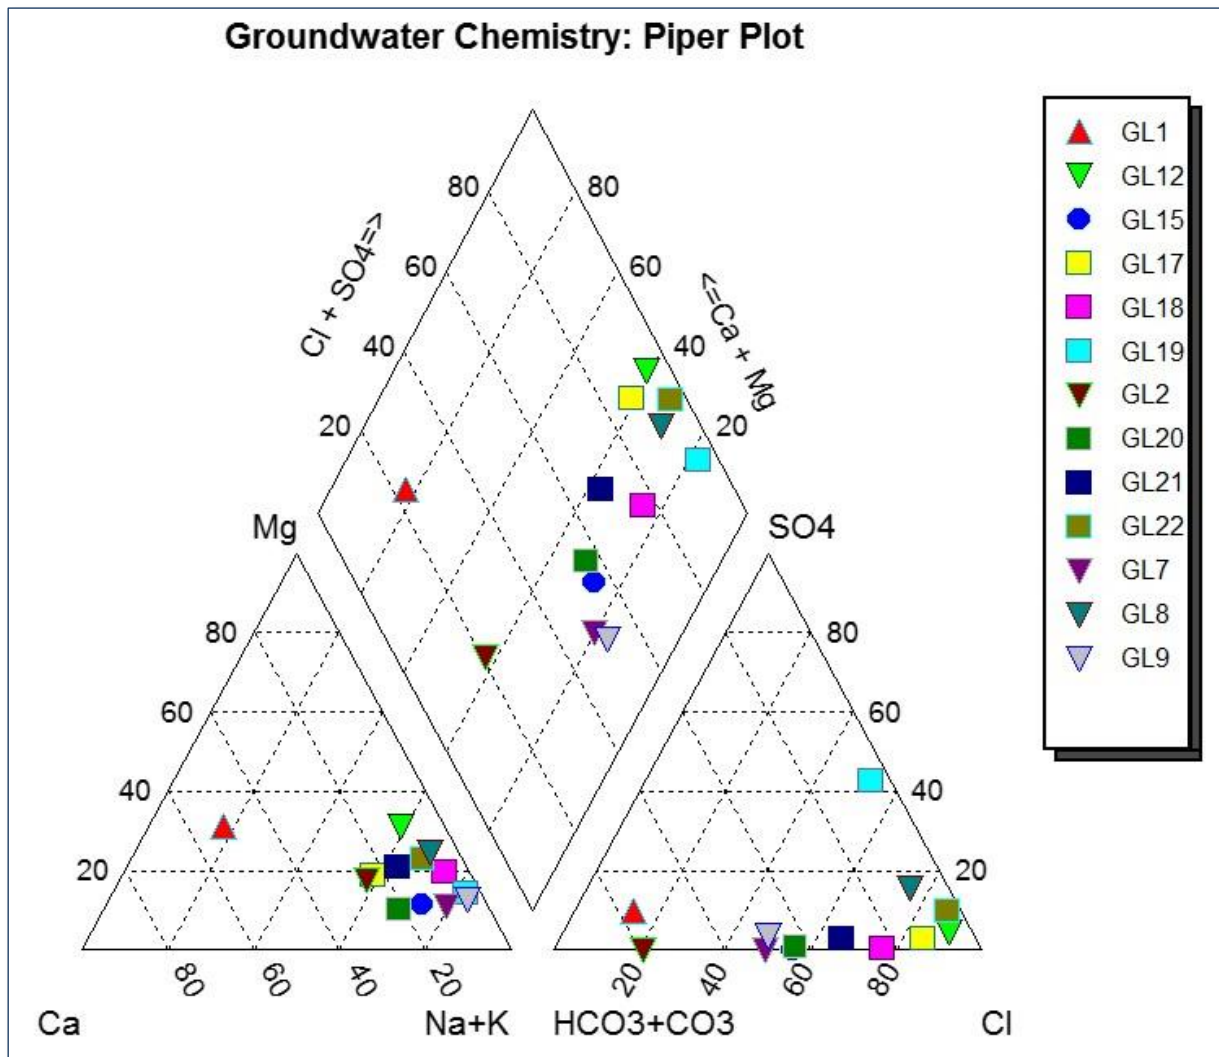
Figure 5-1: Piper plot of monitoring boreholes

The following can be stated from the piper plot produced for the site (refer to Figure 5-1):

- The data plots close to the saline apex indicating predominant saline water on site, explaining the high Na and Cl concentrations observed.
- Results for GL1 to the east of the site indicate natural water-rock interaction with hard water (high HCO₃, Ca and Mg) with respect to the other boreholes. This borehole also has the highest coliform count.
- Data for GL15, GL20, GL7, GL8 and GL2 indicates mixing of different waters, which explains irregular elevated constituents observed in the samples collected at these boreholes when compared to boreholes further away, to the south of the stream.

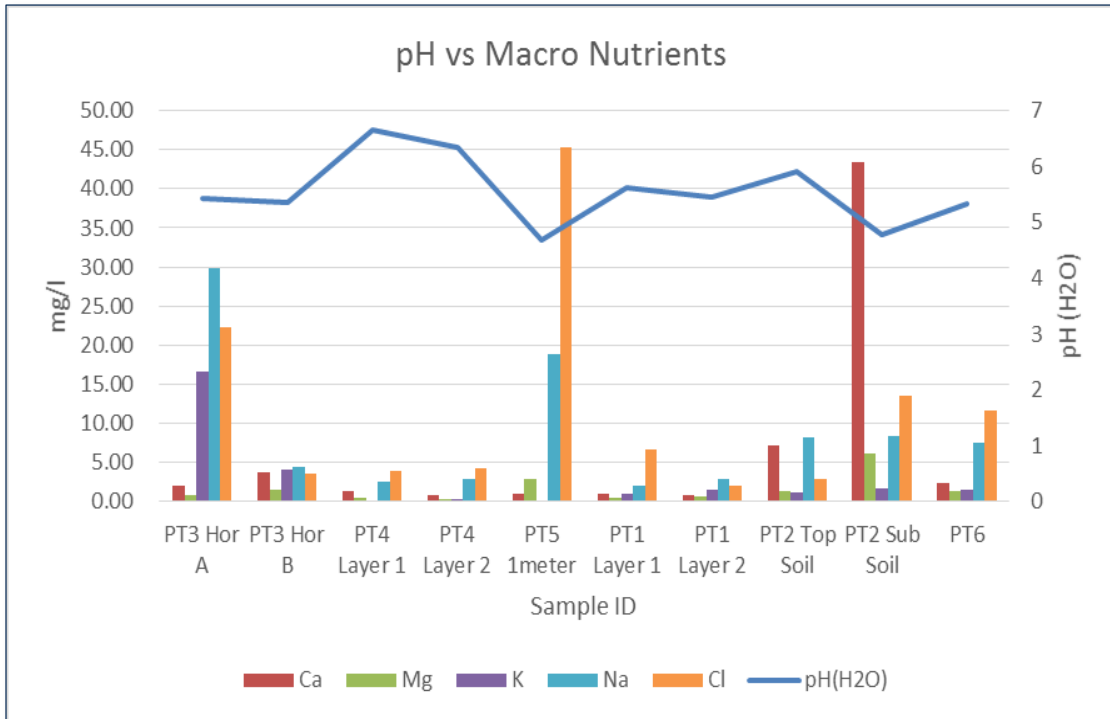
Figure 6-1: pH vs Macro Nutrients

- Outlined in Figure 6-1 are the macro nutrients (Ca, Mg, K, Na and Cl) vs. pH for the horizons sampled at each monitoring point. The results obtained indicate slightly acidic soil at PT₃, PT₄, PT₁, PT₂ and PT₆ (FSSA, 2007). Very acidic conditions are present at PT₅, and from the data obtained it can be clearly observed that pH decreases with depth at each sampling point where the B horizon was sampled.

- Macro elements (Ca, Mg, K, Na and Cl) are present in relatively low concentrations at all the sampling points. The highest macro elemental concentrations are observed at PT₃, PT₅, PT₂ and PT₆. The data suggests that nutrient concentrations within the A horizon is much higher than that of the B horizon. This indicates that leaching of nutrients from the A to B horizon is limited and that possible soil contamination will be localized to the topsoil or A horizon.

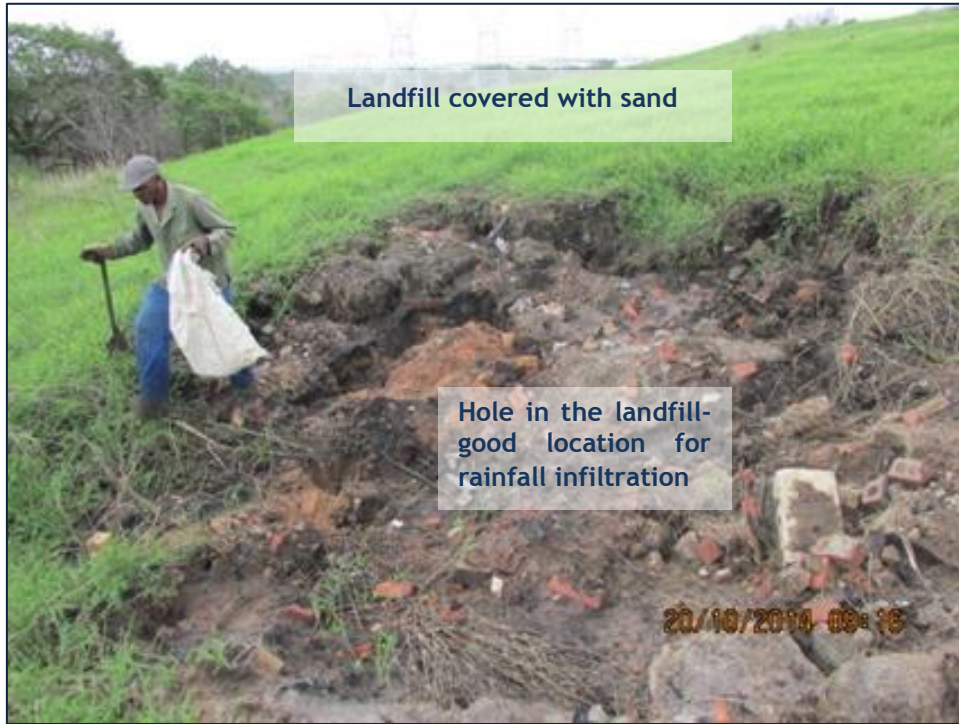
Figure 8-3: Photo showing a hole in the landfill and a man searching for steel

Furthermore, based on the field assessment, it was observed that the landfill is covered with a porous sandy/alluvial system. The surface was also identified as uneven and uncontrolled excavations by waste scavengers occurred. All these factors increase the risk of contamination by augmented recharge and porous flow. Figure 8-3 depicts an example of a typical scavenger digging. It can be seen from the photo that the landfill cover is not compacted and the soil cover has been compromised.

- **Landfill cover or landfill capping:** To minimise the infiltration of rain water into the landfill, the top surface of the landfill must be covered by an impermeable clay layer. The landfill must be fenced to prevent people from digging into the landfill for steel, as the holes left after digging provides infiltration points for rain water.

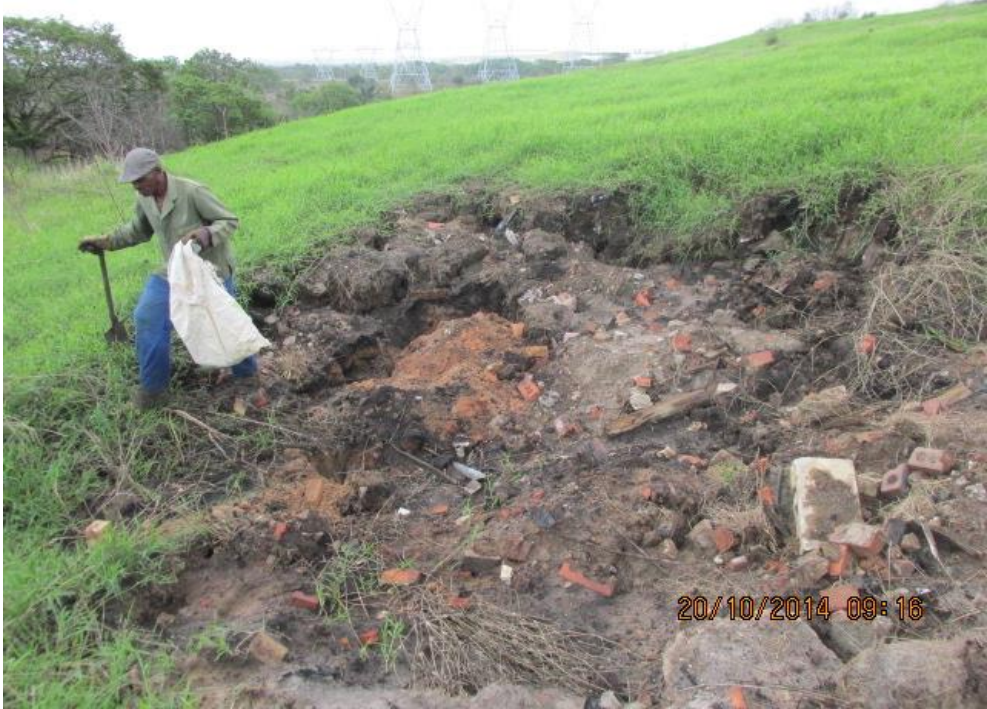
Client Name: CoU		Site Location: Alton landfill-Richards Bay	GCS Project No. 13-478
			CSIR Project No. CSIR\CAS\EMS\umhlathuze\Forensic Ecological Study
Photo No. 1	Date: 20/10/2014

Direction Photo Taken: S-N			
Description: This photo shows a hole in the landfill and a man who was searching for steel. There are a number of these holes in the landfill. Rain water is most likely to infiltrate into the landfill through these holes.			
Photo No. 2	Date: 21/10/2014

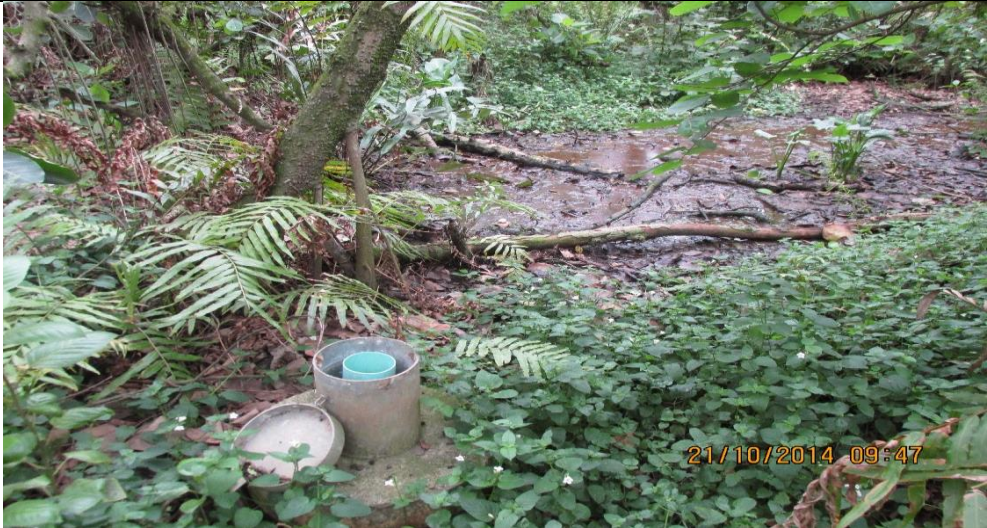
Direction Photo Taken: NW-SE			
Description: Monitoring borehole GL7 next to the stream that flows through the site.

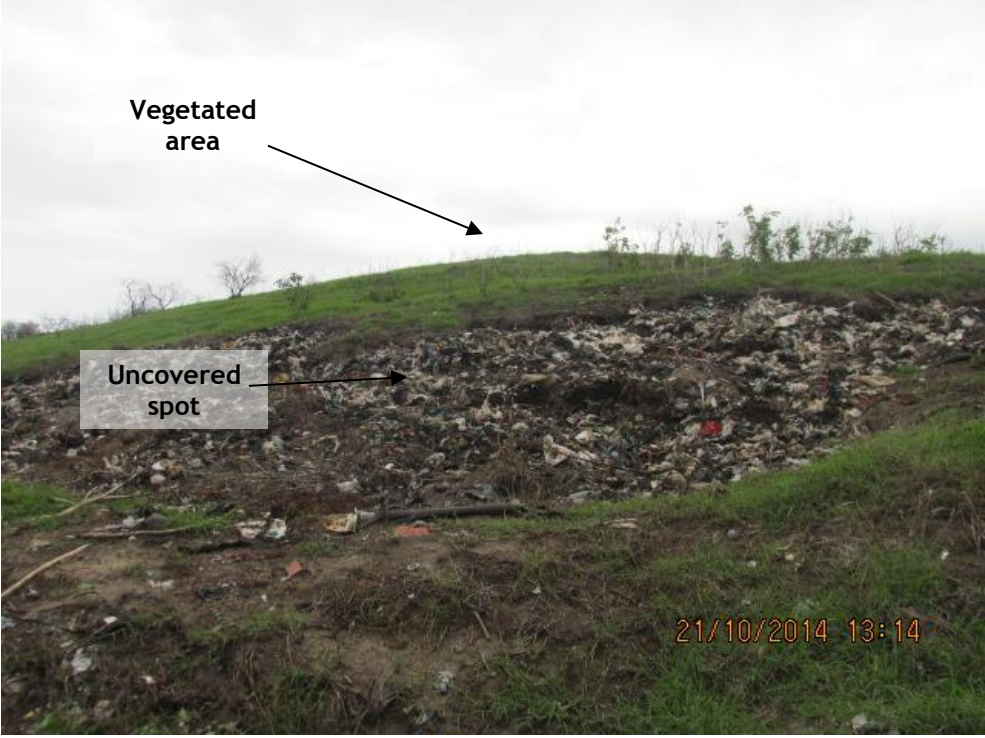
Description:
Uncovered areas within the landfill. The covered areas are vegetated with grass.

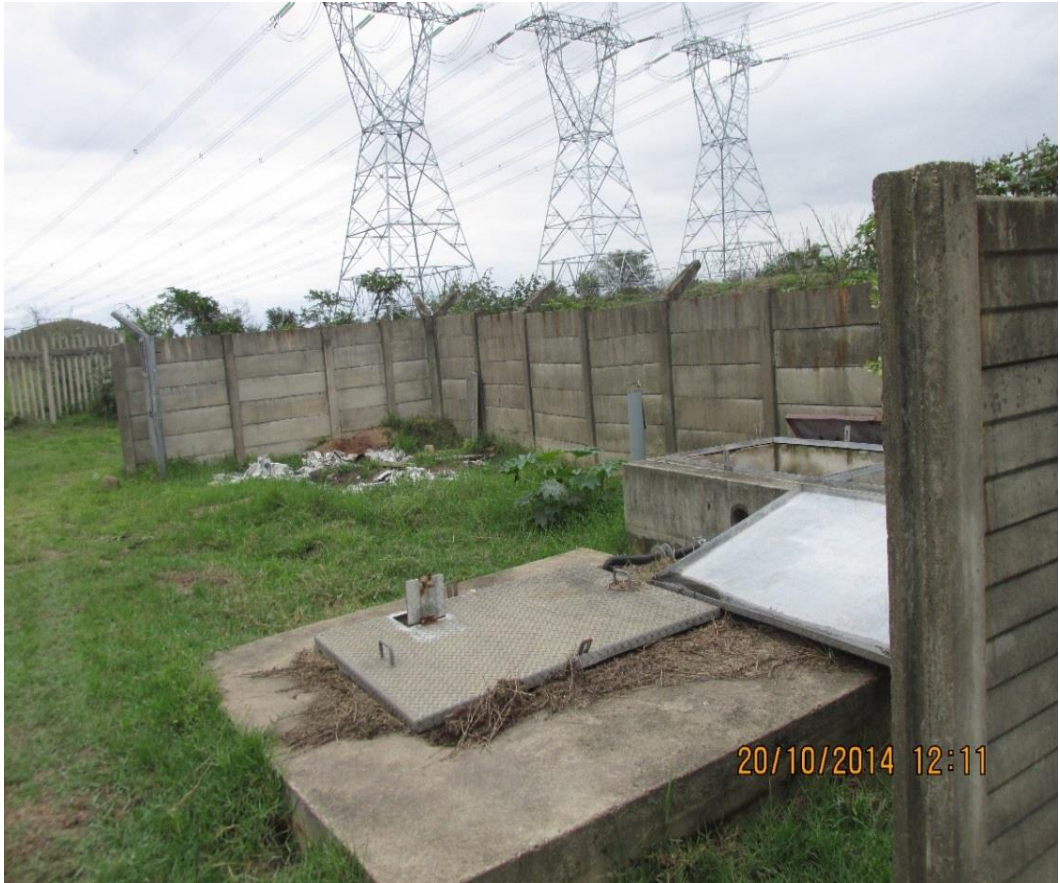
<p>Photo No. 4</p>	<p>Date: 20/10/2014</p>
<p>Direction Photo Taken: E-W</p>

The non-operational pump station, located next to borehole GL20 may potentially overflow with leachate from the landfill and contaminate the stream located down gradient, adjacent to borehole GL7.

Description: TP11.
Non-operational Pump station.
