PHASE 2 - PLANNING REPORT FINAL REHABILITATION PLAN

WAKKERSTROOM
V31A
W42C

REHABILITATION PLAN FOR WAKKERSTROOM, W42C, MPUMALANGA

MAIN REPORT

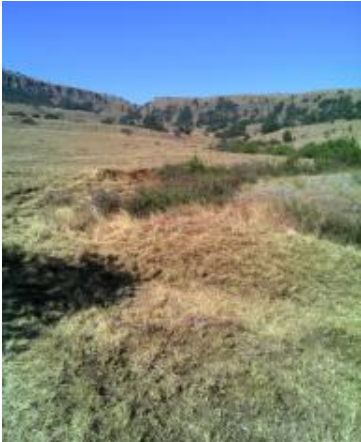
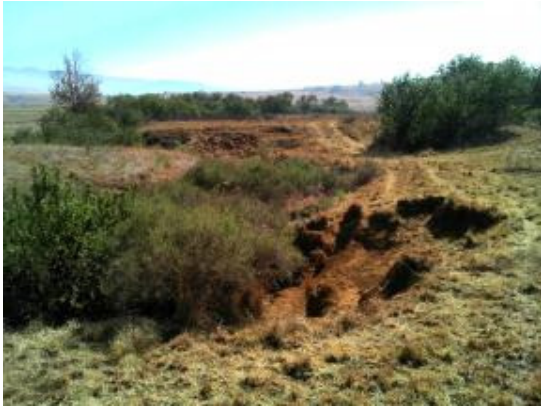
<p>Headcut erosion, main channel, looking south</p>	<p>Road through eastern channel, looking north</p>

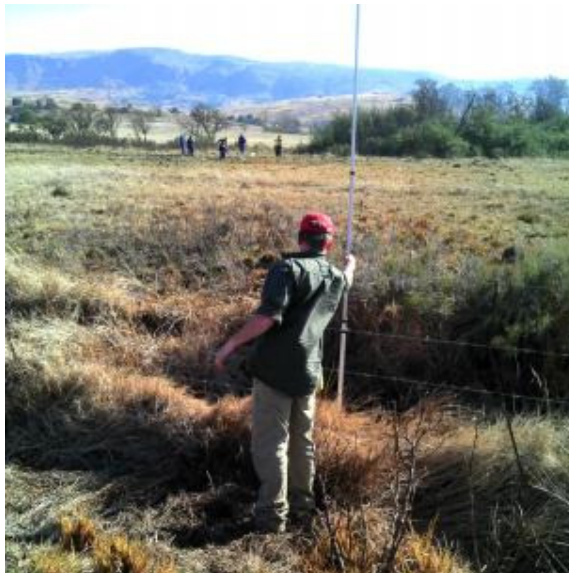
Figure 9: Earthen diversion berm, W42C-01-203-00 looking in a south-westerly direction

Designer	Trevor Pike
Design Date	July 2012
Intervention Description	Earthen Diversion Berm
Rehabilitation Objective	To divert flow from the channel onto the adjacent land thereby achieving diffuse flow over the eastern part of the wetland.
Latitude (D°M'S")	27°18'0.99"S
Longitude (D°M'S")	30°28'57.81"E
Engineering Drawings	W42C-01-203-00
Alternatives considered	Gabion and concrete diversion walls. Earth was considered a cost effective solution in the low energy environment

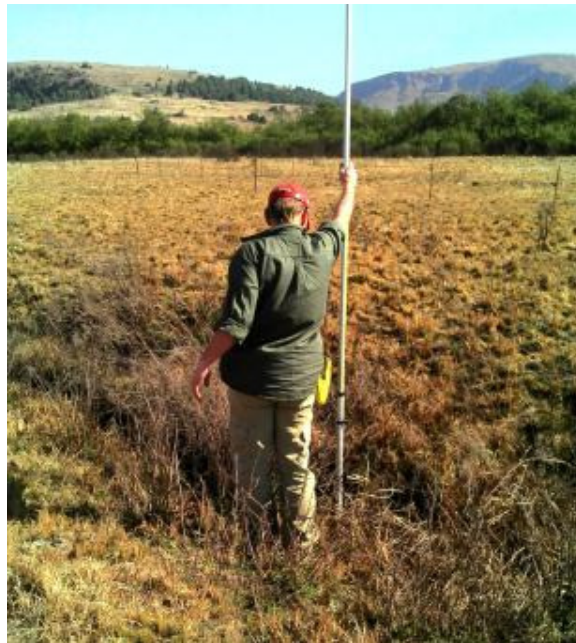
Figure 10: Earthen diversion berm, W42C-01-204-00 looking in a south-westerly direction

Designer	Trevor Pike
Design Date	July 2012
Intervention Description	Earthen Diversion Berm
Rehabilitation Objective	To divert flow from the channel onto the adjacent land thereby achieving diffuse flow over the eastern part of the wetland.
Latitude (D°M'S")	27°18'4.21"S
Longitude (D°M'S")	30°28'57.37"E
Engineering Drawings	W42C-01-204-00
Alternatives considered	Gabion and concrete diversion walls were considered. Berm was considered a cost effective solution in the low energy environment

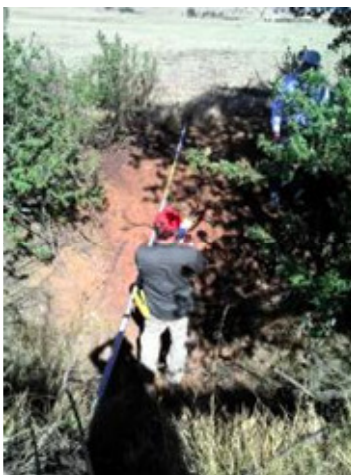
Figure 11: Reno mattress, WC42-01-205-00, looking in an easterly direction

Designer	Trevor Pike
Design Date	July 2012
Intervention Description	Reno mattress
Rehabilitation Objective	Channel protect and to set the base level of the eastern channel
Latitude (D°M'S")	27°18'14.36"S
Longitude (D°M'S")	30°28'54.48"E
Engineering Drawings	W42C-01-205-00
Alternatives considered	No alternatives considered. A Reno mattress was selected as it is adaptable to the profile of the channel.

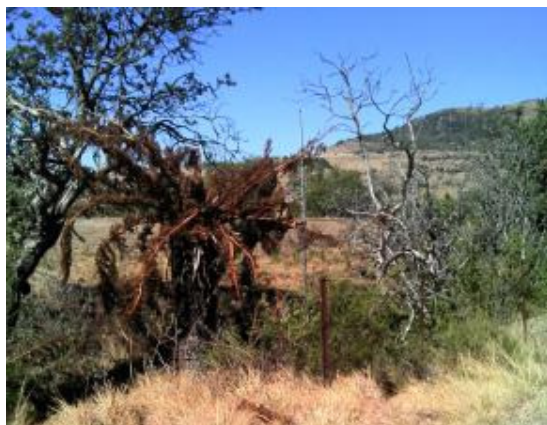
Figure 12: Gabion weir wall, W42C-01-206-00 looking in a south-easterly direction

Designer	Trevor Pike
Design Date	July 2012
Intervention Description	Gabion Weir and earthen berm
Rehabilitation Objective	To divert flow from the channel onto the adjacent land thereby achieving diffuse flow over the western part of the wetland. The weir is to encourage high flows to enter the eastern drain.
Latitude (D°M'S")	27°18'11.61"S
Longitude (D°M'S")	30°28'54.52"E
Engineering Drawings	W42C-01-206-00
Alternatives considered	A robust impermeable structure was required to withstand the force of the water from the catchment. Earthen material was therefore not considered

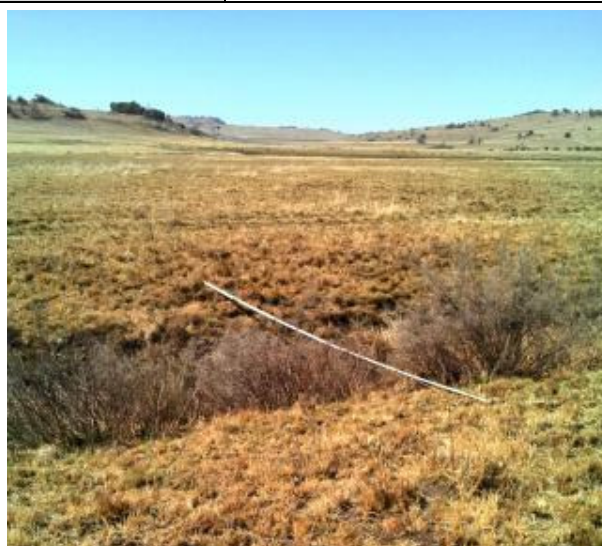
Figure 14: Gabion diversion wall, W42C-01-207-00, looking in a south-easterly direction

Designer	Trevor Pike
Design Date	July 2012
Intervention Description	Gabion Diversion Berm
Rehabilitation Objective	To divert flow from the channel onto the adjacent land thereby achieving diffuse flow over the eastern part of the wetland.
Latitude (D°M'S")	27°18'7.21"S
Longitude (D°M'S")	30°28'57.34"E
Engineering Drawings	W42C-01-207-00
Alternatives considered	Gabions were specified as a robust structure is required to handle higher energy in the system in the event of the upstream earthen diversion berm failing.

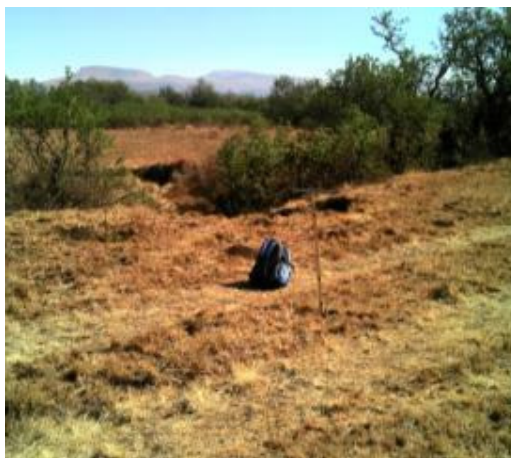
Figure 15: Earthen diversion berm, W42C-01-208-00 looking in a north-westerly direction

Designer	Trevor Pike
Design Date	July 2012
Intervention Description	Earthen Diversion Berm
Rehabilitation Objective	To divert flow from the channel onto the adjacent land thereby achieving diffuse flow over the eastern part of the wetland.
Latitude (D°M'S")	27°18'8.84"S
Longitude (D°M'S")	30°28'57.52"E
Engineering Drawings	W42C-01-208-00
Alternatives considered	Earth was specified as the bulk of the flows will be diverted by the upstream concrete diversion wall. An earthen diversion was considered a cost effective option

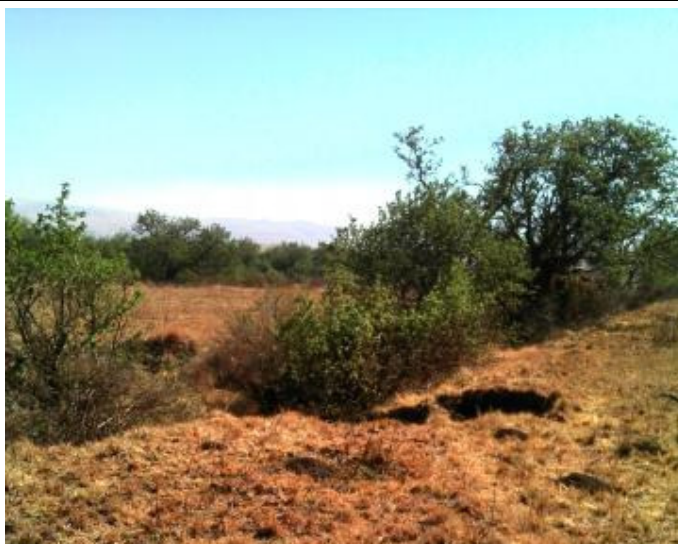
Figure 16: Concrete diversion wall, W42C-01-209-00 looking in a north-westerly direction

Designer	Trevor Pike
Design Date	July 2012
Intervention Description	Concrete Diversion Berm
Rehabilitation Objective	To divert flow from the channel onto the adjacent land thereby achieving diffuse flow over the eastern part of the wetland.
Latitude (D°M'S")	27°18'11.34"S
Longitude (D°M'S")	30°28'57.44"E
Engineering Drawings	W42C-01-209-00
Alternatives considered	The intervention will be receiving the full force of water in the drain and an earthen berm was therefore not considered.

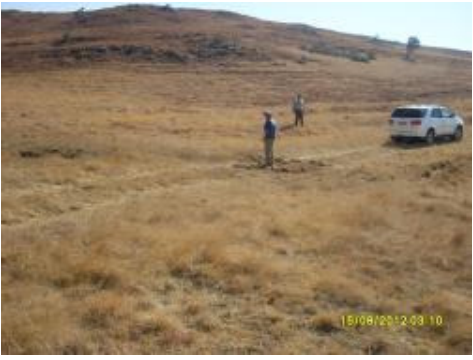
<p>Headcut erosion to be stabilised by gabion baskets looking in a north-westerly direction (Intervention W42-02-209-00)</p>	<p>Road to be stabilised by means of concrete strips. Looking in a northern direction(Intervention W42-02-209-00)</p>

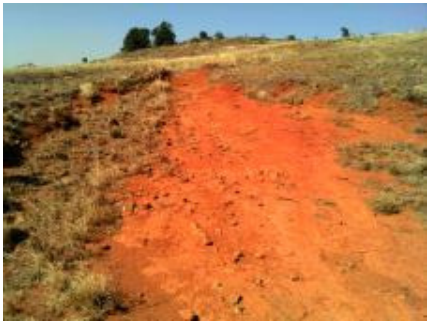
<p>Hillslope failure identified for contouring and rehabilitation looking in a south-westerly direction (Intervention W42C-02-2010-00)</p>	<p>Erosion next to road looking in a south-easterly direction to be stabilised by rockpacks (Intervention W42C-02-210-00)</p>

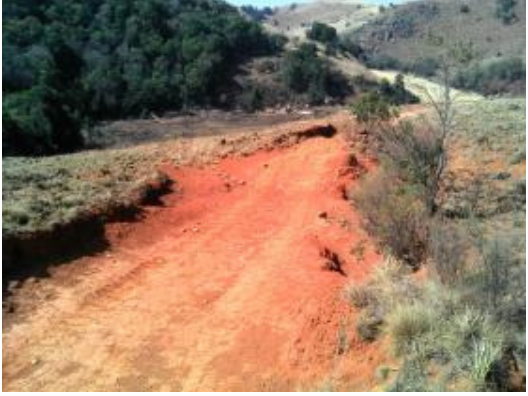
<p>Road to be protected by surface cross drains looking in a south-easterly direction (Intervention W42C-02-213-00, W42C-02-226-00 and W42C-02-227-00)</p>	<p>Seep area looking in a north-westerly direction (Intervention W42C-02-219-00)</p>

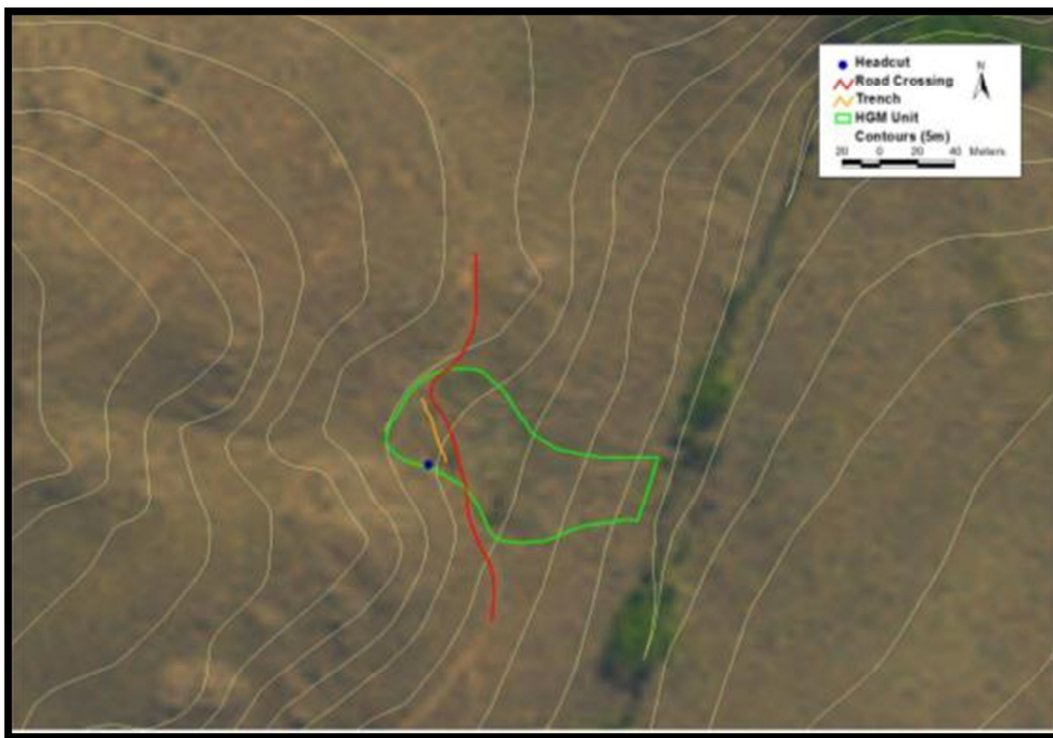
Figure 19: Wetland problems identified within wetland W42C-02

The upper portion of the wetland has been subjected to a number of impacts associated with the modification of the system's hydrology, which was likely to have been initiated to allow for the access across the wetland (see Figure 19 below). The problems identified within the wetland system can be addressed with the implementation of rehabilitation activities, which would include the deactivation of the headcut and trench, and the construction of concrete strips to stabilise the existing road/tracks.

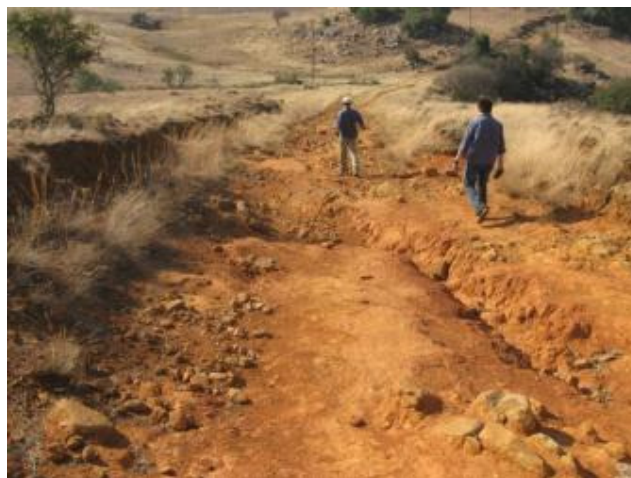
Figure 20: Old road requiring closure and rehabilitation (Intervention W42C-02-208-00)

Designer	Trevor Pike
Design Date	July 2012
Intervention Description	Rehabilitate old road with a series of gabion and earthen deflection structures, sloping of vertical banks and grass seeding
Rehabilitation Objective	Decommission old road
Latitude (D°M'S")	Linear feature
Longitude (D°M'S")	Linear feature
Engineering Drawings	W42C-02-208-00
Alternatives Considered	No alternatives were considered. Gabions were specified on the steeper areas in order to break the energy of the surface runoff. Earthen diversion berms were specified in the low energy environments. Gabions were better suited to the site conditions than concrete

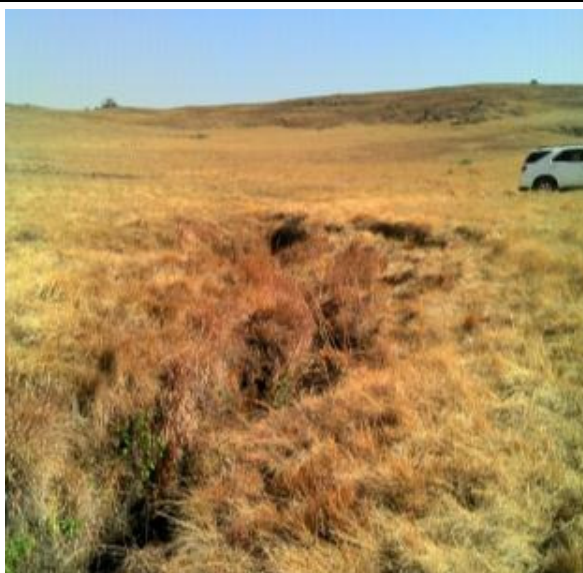
Figure 21: Road to be stabilised/protected by means of concrete strips and a gabion cut off wall (W42C-02-209-00) looking in south-westerly direction

Designer	Trevor Pike
Design Date	July 2012
Intervention Description	Gabions and concrete road strips
Rehabilitation Objective	Protect wet area from damage by vehicles
Latitude (D°M'S")	27°15'37.90"S
Longitude (D°M'S")	30°29'21.50"E
Engineering Drawings	W42C-02-209-00
Alternatives Considered	No alternatives considered. Gabions were specified for the cut off wall as they are permeable and would allow for the movement of subsurface flows. Gabions would not be suitable for protecting the vehicle tracks as they would require on-going maintenance and concrete was therefore the preferred option for the road strips

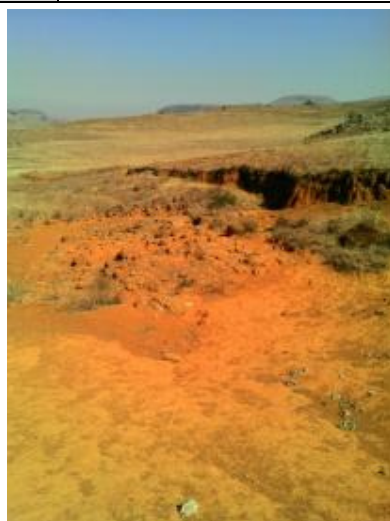
Figure 22: Hillslope failure/erosion to be contoured and revegetated (W42C-02-211-00) looking in a south-westerly direction

Designer	Trevor Pike
Design Date	September 2012
Intervention Description	Erosion rehabilitation
Rehabilitation Objective	Prevent further erosion, stabilise and revegetate slope
Latitude (D°M'S")	27°15'37.90"S
Longitude (D°M'S")	30°29'21.50"E
Engineering Drawings	N/A
Alternatives Considered	N/A

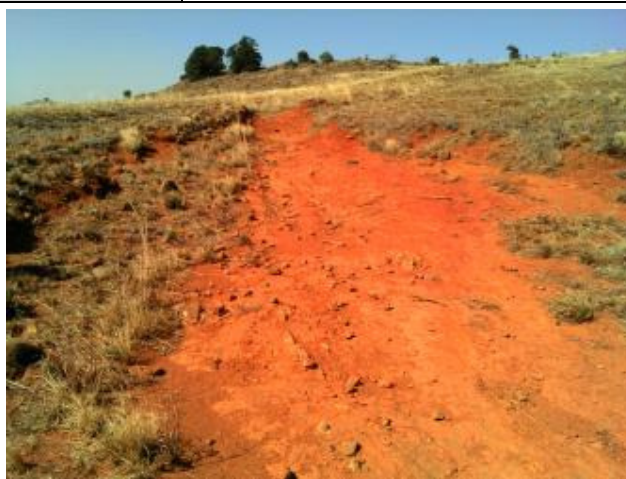
Figure 23: Erosion rehabilitation (intervention W42C-02-211-00) looking in a south-easterly direction

Designer	Trevor Pike
Design Date	July 2012
Intervention Description	Rockpacks
Rehabilitation Objective	Stabilise the erosion gully
Latitude (D°M'S")	27°14'58.74"S
Longitude (D°M'S")	30°29'42.61"E
Engineering Drawings	W42C-02-211-00
Alternatives Considered	No alternatives considered. Gabions were preferred due to the availability of rocks on site

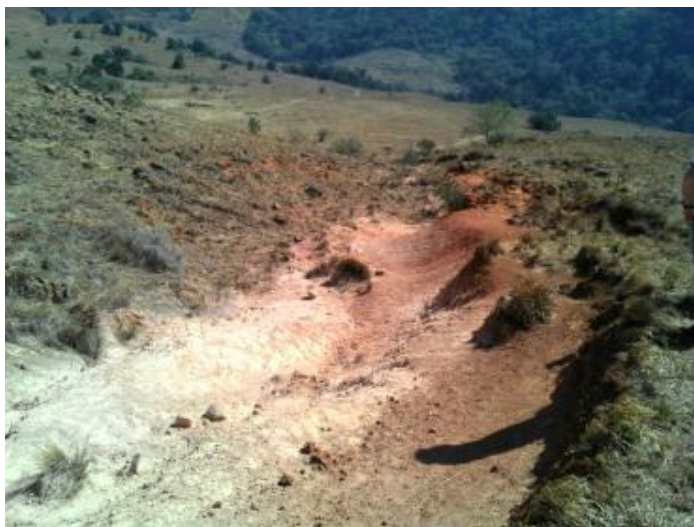
Figure 24: Erosion rehabilitation (intervention W42C-02-212-00) looking in a north-westerly direction

Designer	Trevor Pike
Design Date	July 2012
Intervention Description	Rockpacks
Rehabilitation Objective	Stabilise the erosion gully
Latitude (D°M'S")	27°14'58.74"S
Longitude (D°M'S")	30°29'42.61"E
Engineering Drawings	W42C-02-212-00
Alternatives Considered	No alternatives considered. Rockpacks were preferred due to the availability of rocks on site making them cost effective structures. Earthen berms were not considered due to the steep gradient of the site and high energy of the runoff

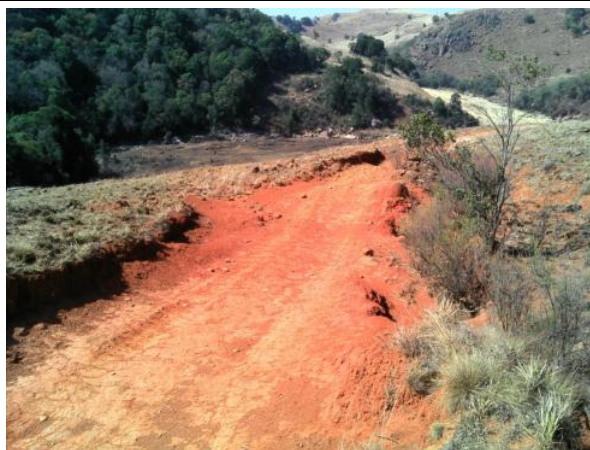
Figure 25: Road to be stabilised by surface cross drain (intervention W42C-02-213-00) looking in a south-easterly direction

Designer	Trevor Pike
Design Date	September 2012
Intervention Description	Surface cross drains
Rehabilitation Objective	Divert flows off the road to prevent erosion of the steep areas
Latitude (D°M'S")	Linear activity. Refer to layout plans
Longitude (D°M'S")	
Engineering Drawings	W42C-02-213-00
Alternatives Considered	<i>In situ</i> cross drains are a cost effective option of managing surface runoff. Hard structures (e.g. concrete berms) were therefore not considered

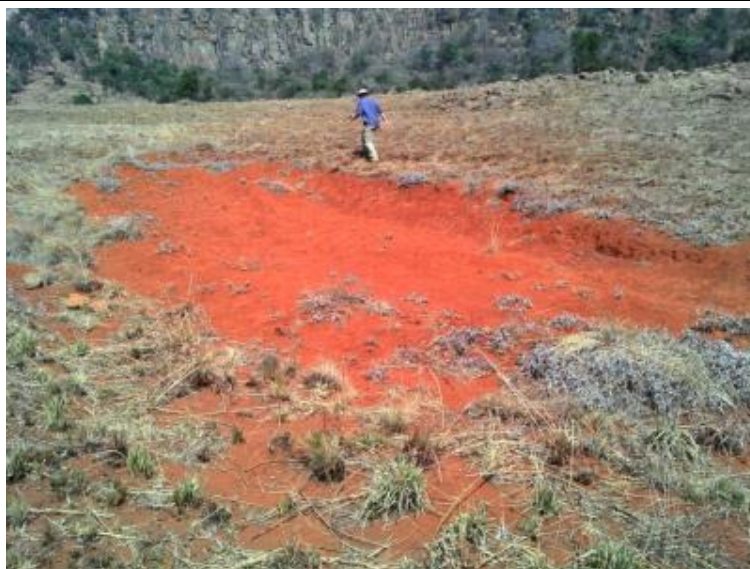
Figure 26: Hillside erosion rehabilitation (intervention W42C-02-215-00) looking in a north-westerly direction

Designer	Trevor Pike
Design Date	September 2012
Intervention Description	Hillside erosion rehabilitation
Rehabilitation Objective	Rehabilitation of hillside erosion by means of grass seeding and water diversion berms
Latitude (D°M'S")	27°14'49.46"S
Longitude (D°M'S")	30°29'27.59"E
Engineering Drawings	N/A
Alternatives Considered	Seeding was considered the most appropriate method to rehabilitate the area. Hard options were not considered as vegetative cover was required

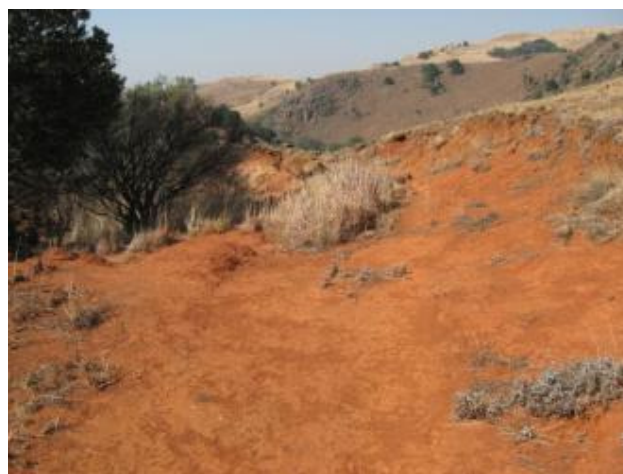
Figure 27: Gully to be rehabilitated (W42C-02-215-00) looking in a south-easterly direction

Designer	Trevor Pike
Design Date	September 2012
Intervention Description	Rock packs
Rehabilitation Objective	Stabilise erosion gully next to road
Latitude (D°M'S")	27°14'49.32"S
Longitude (D°M'S")	30°29'49.31"E
Engineering Drawings	W42C-02-215-00
Alternatives Considered	Rock packs were considered cost effective interventions as they would utilise available rock on site. Earthen berms were not considered due to the steep gradient of the gully

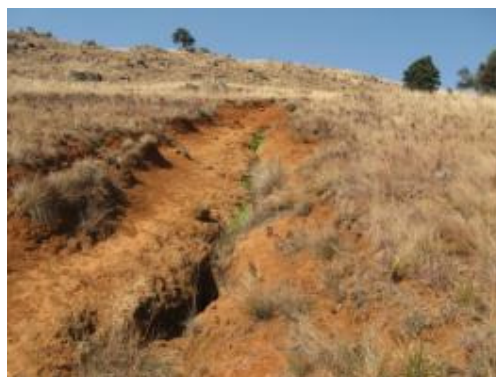
Figure 28: Deactivation of erosion gully next to road (W42C-02-216-00) looking south-southeast

Designer	Trevor Pike
Design Date	September 2012
Intervention Description	Gabions and earthen berms and rockfill of the flow path
Rehabilitation Objective	Deactivate erosion gully
Latitude (D°M'S")	27°15'2.92"S
Longitude (D°M'S")	30°30'29.85"E
Engineering Drawings	W42C-02-216-00
Alternatives Considered	Gabions were considered cost effective interventions on the steep areas as they would utilise available rock on site. Earthen berms were specified on the flatter areas. Concrete was not considered due to the associated costs

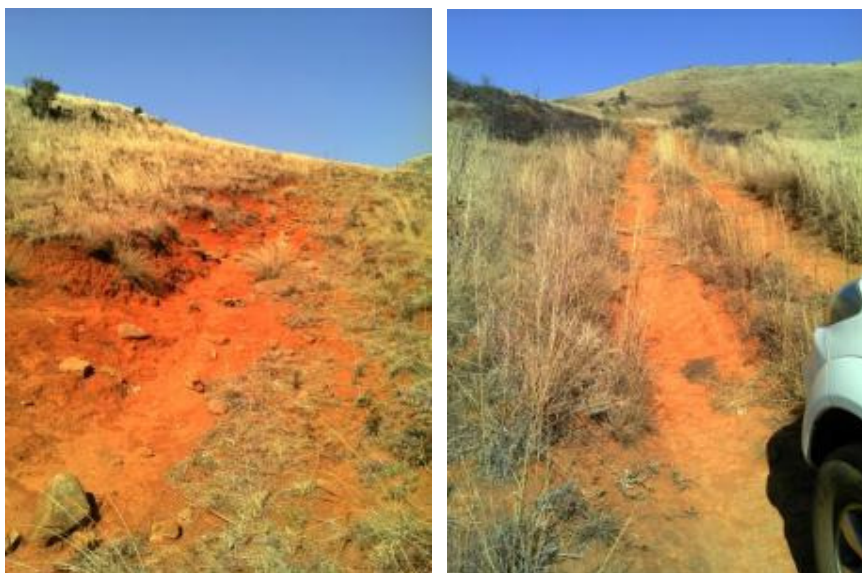
Figure 29: Deactivation of old road (left hand side photo) and protection of new road (right hand side photo) by means of gabion walls and earthen diversion berms (W42C-02-217-00)

Designer	Trevor Pike
Design Date	July 2012
Intervention Description	Gabions and earthen berms
Rehabilitation Objective	Deactivate old road and protect new road with surface cross drains
Latitude (D°M'S")	Linear feature
Longitude (D°M'S")	Linear feature
Engineering Drawings	W42C-02-217-00
Alternatives Considered	<p>Deactivation of old road: Gabions were considered cost effective interventions on the steep areas as they would utilise available rock on site. Earthen berms were specified on the flatter areas.</p> <p>Protection of new road: <i>In situ</i> cross drains are a cost effective option of managing surface runoff. Hard structures (e.g. concrete berms) were therefore not considered</p>

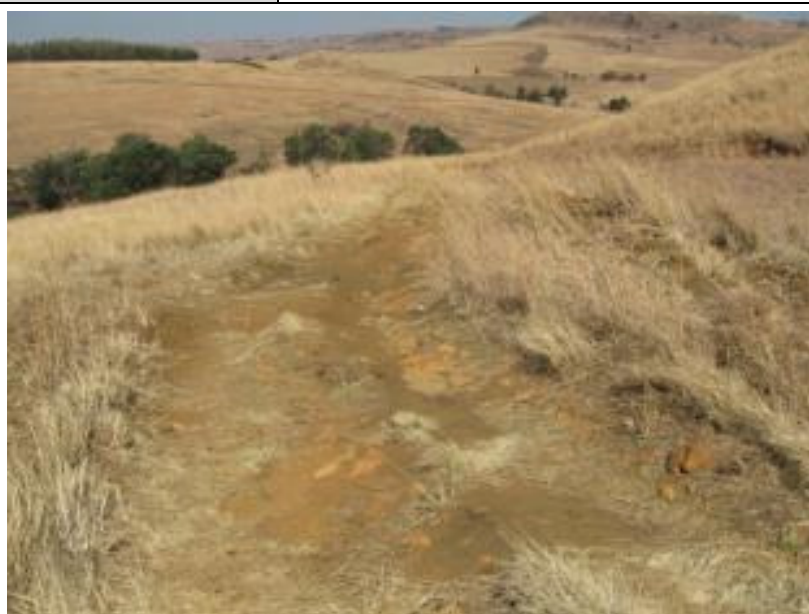
Figure 30: Section of road requiring concrete strips and adjacent trench (right side of road) to be backfilled (W42C-02-218-00), looking in a south-south-eastern direction

Designer	Trevor Pike
Design Date	July 2012
Intervention Description	Concrete road strips, backfilling of trench and fencing
Rehabilitation Objective	Protect seep and wetland area from damage by vehicles, promote diffuse flows cattle trampling
Latitude (D°M'S")	27°15'43.92"S
Longitude (D°M'S")	30°30'50.46"E
Engineering Drawings	W42C-02-218-00
Alternatives Considered	Concrete was considered a permanent and suitable material for the road strips. Gabions were not considered due to the associated maintenance requirements

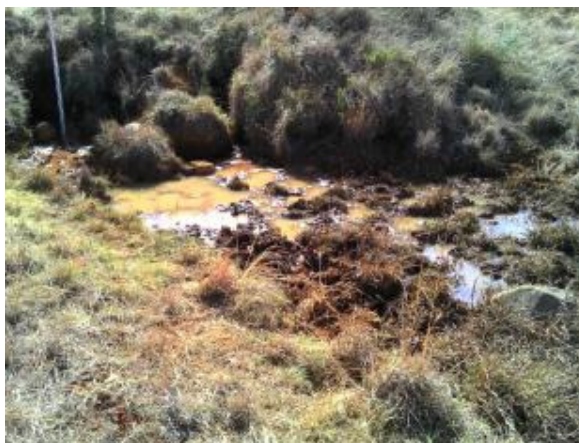
Figure 31: Headcut erosion stabilisation with concrete (intervention W42C-02-219-00) looking in a north-westerly direction

Designer	Trevor Pike
Design Date	September 2012
Intervention Description	Concrete Weir and stock watering trough
Rehabilitation Objective	Deactivate headcut erosion and protect seep area from damage by cattle
Latitude (D°M'S")	27°15'43.92"S
Longitude (D°M'S")	30°30'50.46"E
Engineering Drawings	W42C-02-219-00
Alternatives Considered	An impermeable structure was required and gabions were therefore not considered for stabilising the headcut

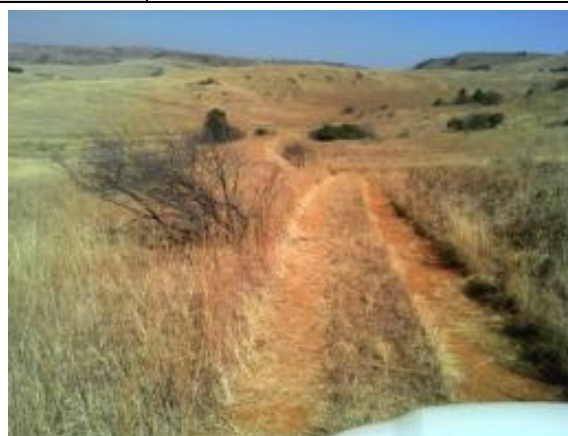
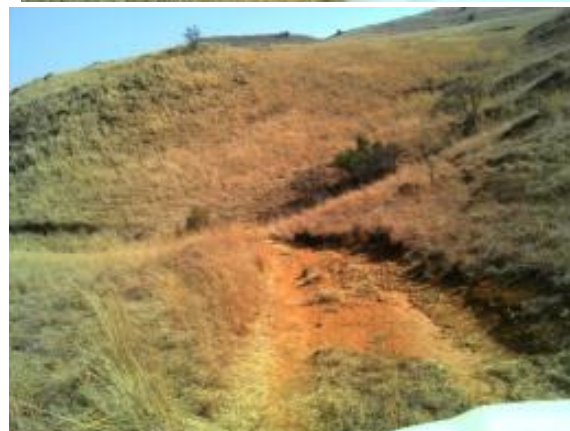
Figure 32: Surface cross drain (interventions W42C-02-221-00 to W42C-02-226-00) looking in a south and south-easterly direction

Designer	Trevor Pike
Design Date	September 2012
Intervention Description	Surface cross drains
Rehabilitation Objective	Divert flows off the road to prevent erosion of the steep areas
Latitude (D°M'S")	Linear activity. Refer to layout plans
Longitude (D°M'S")	
Engineering Drawings	W42C-02-221-00- W42C-02-226-00
Alternatives Considered	<i>In situ</i> cross drains are a cost effective option of managing surface runoff. Hard structures (e.g. concrete berms) were therefore not considered

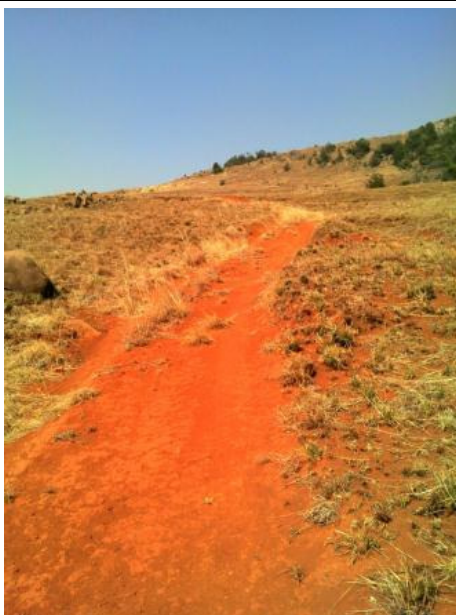
Figure 33: Surface cross drain (interventions W42C-02-227-00 and W42C-02-228-00) looking in a south and south-easterly direction

Designer	Trevor Pike
Design Date	September 2012
Intervention Description	Surface cross drains
Rehabilitation Objective	Divert flows off the road to prevent erosion of the steep areas
Latitude (D°M'S")	Linear activity. Refer to layout plans
Longitude (D°M'S")	
Engineering Drawings	W42C-02-226-00 & W42C-02-227-00
Alternatives Considered	<i>In situ</i> cross drains are a cost effective option of managing surface runoff. Hard structures (e.g. concrete berms) were therefore not considered

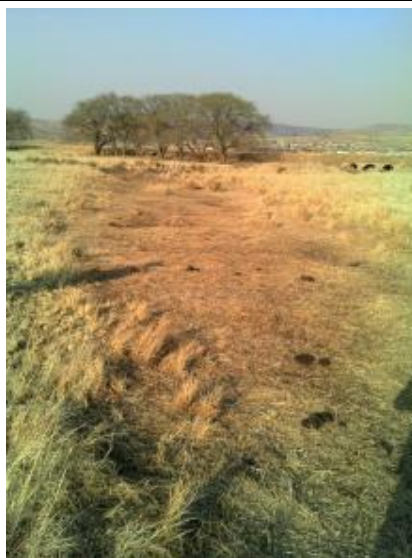
Figure 35: Channel to be excavated (V31A-01-201-01), looking in a north-easterly direction

Designer	Trevor Pike
Design Date	July 2012
Intervention Description	Earthworks/Excavation
Rehabilitation Objective	Deepen channel to achieve diffuse flow throughout the year
Latitude (D°M'S")	27°20'50.10"S
Longitude (D°M'S")	30° 8'57.59"E
Engineering Drawings	V31A-01-201-01
Alternatives Considered	N/A
