# FINAL BASIC ASSESSMENT REPORT FOR THE PROPOSED PIET RETIEF EXTENSION 22

On Portion 100 (A Portion of Portion) of the Farm Piet  
Retief Town and Townlands 149 HT; Mkhondo Local  
Municipality in Mpumalanga Province.

REF NR: 17/2/3 GS-239

JULY 2015

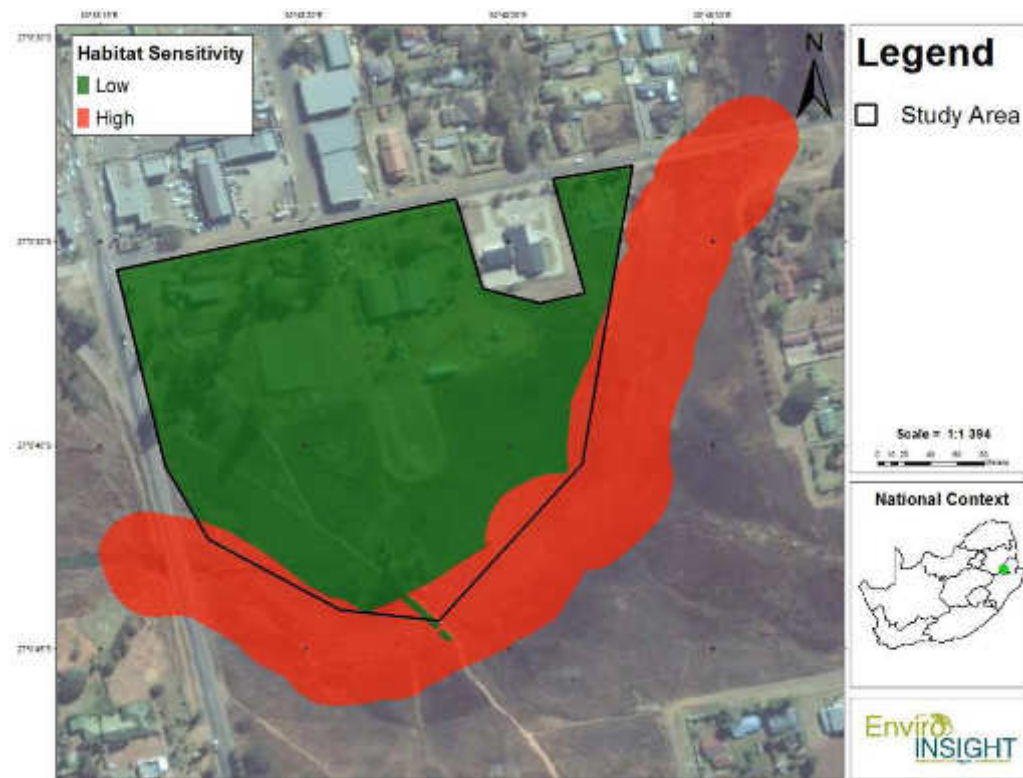
**Figure 9: Sensitivity Map**

The site is classified as being non-sensitive and it's not expected that any Red-Listed species will occur. It was recommended that the stream/ stream buffer habitat areas should be buffered in order to maintain corridor movement of birds and aquatic faunal species. Any alien or invasive plants should also be removed from the site.

- It is recommended that only indigenous flora be used for landscaping;
- An alien invasive eradication and monitoring programme should be implemented;
- Sediment barriers should be placed above and below the construction site in pairs of three to reduce sediment entering the system lower down in the catchment area; and
- The stormwater leaving the site downstream must be clean and of the same quality as in situ before it enters the construction site (upstream). Pre-construction measures must be in place to ensure that sedimentation is trapped.

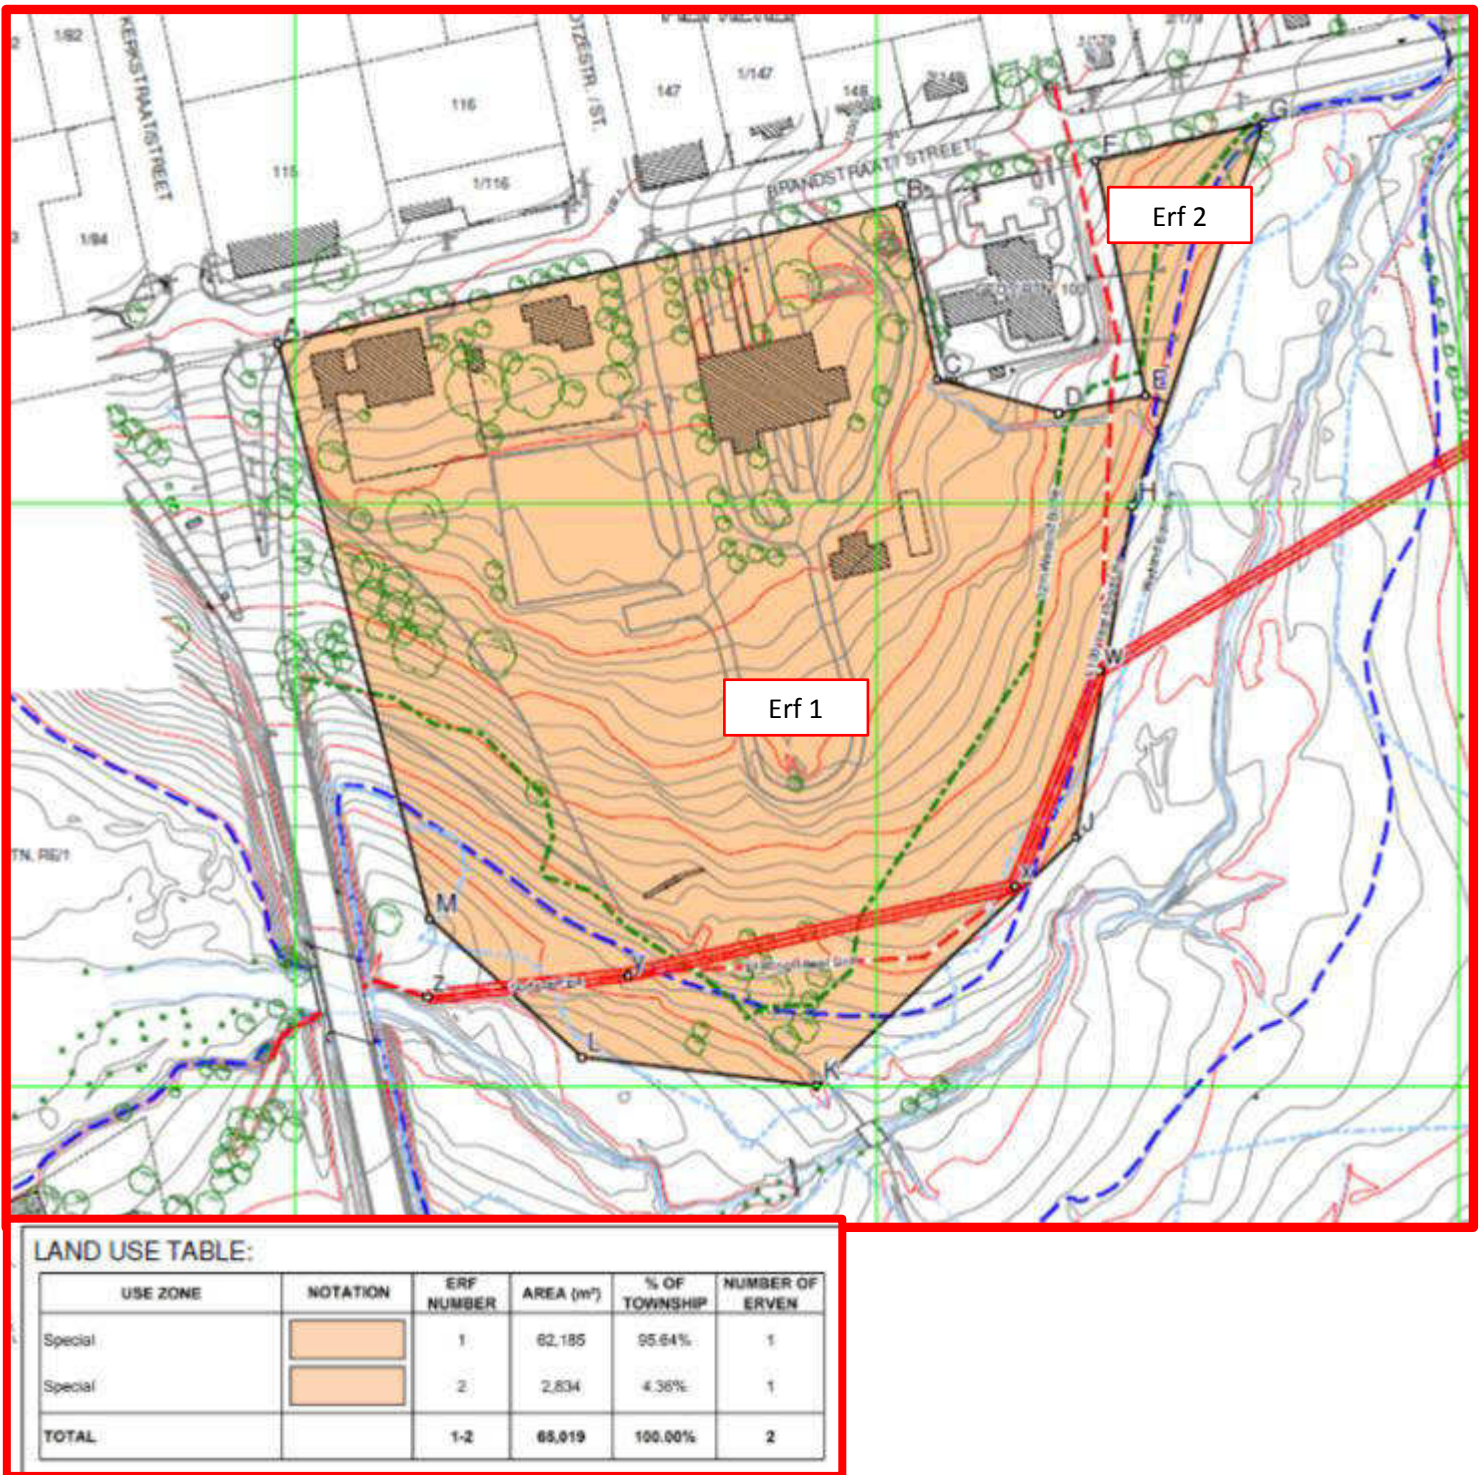
**Figure 17: Proposed Land-Use**

The proposed zoning for the mall development is "Special" for shops, businesses, offices, places of refreshment, dry cleaners, motor dealerships, vehicle sales mart, vehicle sales showroom, workshops, as well as related uses subservient thereto.

<b>FAR</b>	:	The floor area ratio shall not exceed 0.6.
<b>Coverage</b>	:	Not exceed 60%
<b>Parking</b>	:	Parking shall be in accordance with provision Clause 19, Table E of the Piet Retief Town-planning Scheme, 1980.

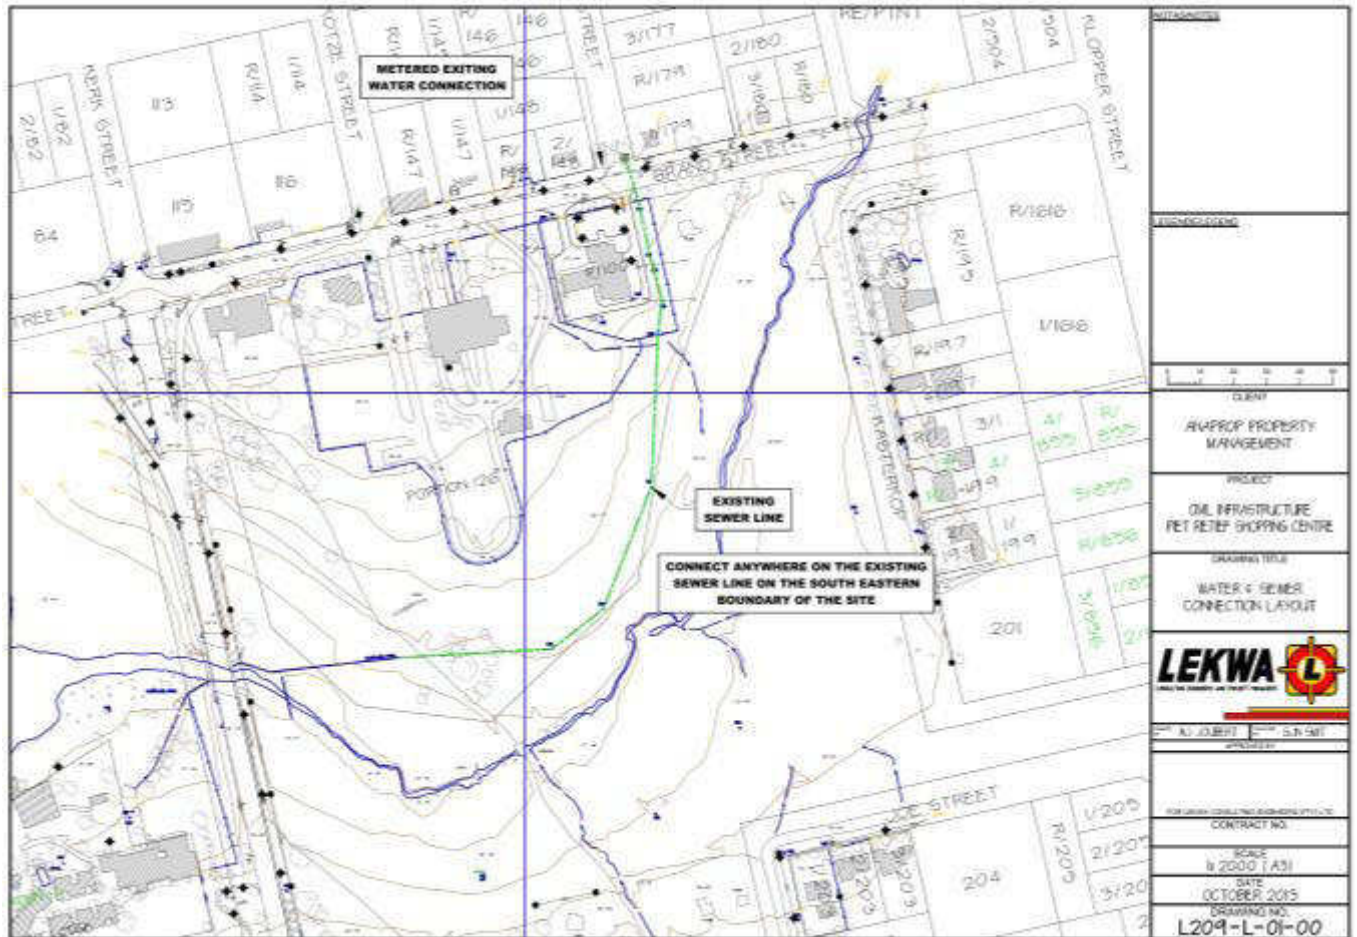
**Figure 20: Services Map (Water and Sewer)**

The proposed development site is currently zoned as municipal and the existing rights for the property allows for 75% coverage of Municipal purposes. As the property forms part of an existing township, the existing network would have been designed/sized for these existing rights. There is an existing water connection which is currently being used by the land occupiers. The services engineer informed that according to the "Red Book" (Guidelines for the provision of Engineering Services and Amenities in Residents Township Developments) the annual average water demand is the same for Government and Municipal areas and Offices and Shops. The current water network and connection has sufficient capacity for the proposed shopping mall in Piet Retief.

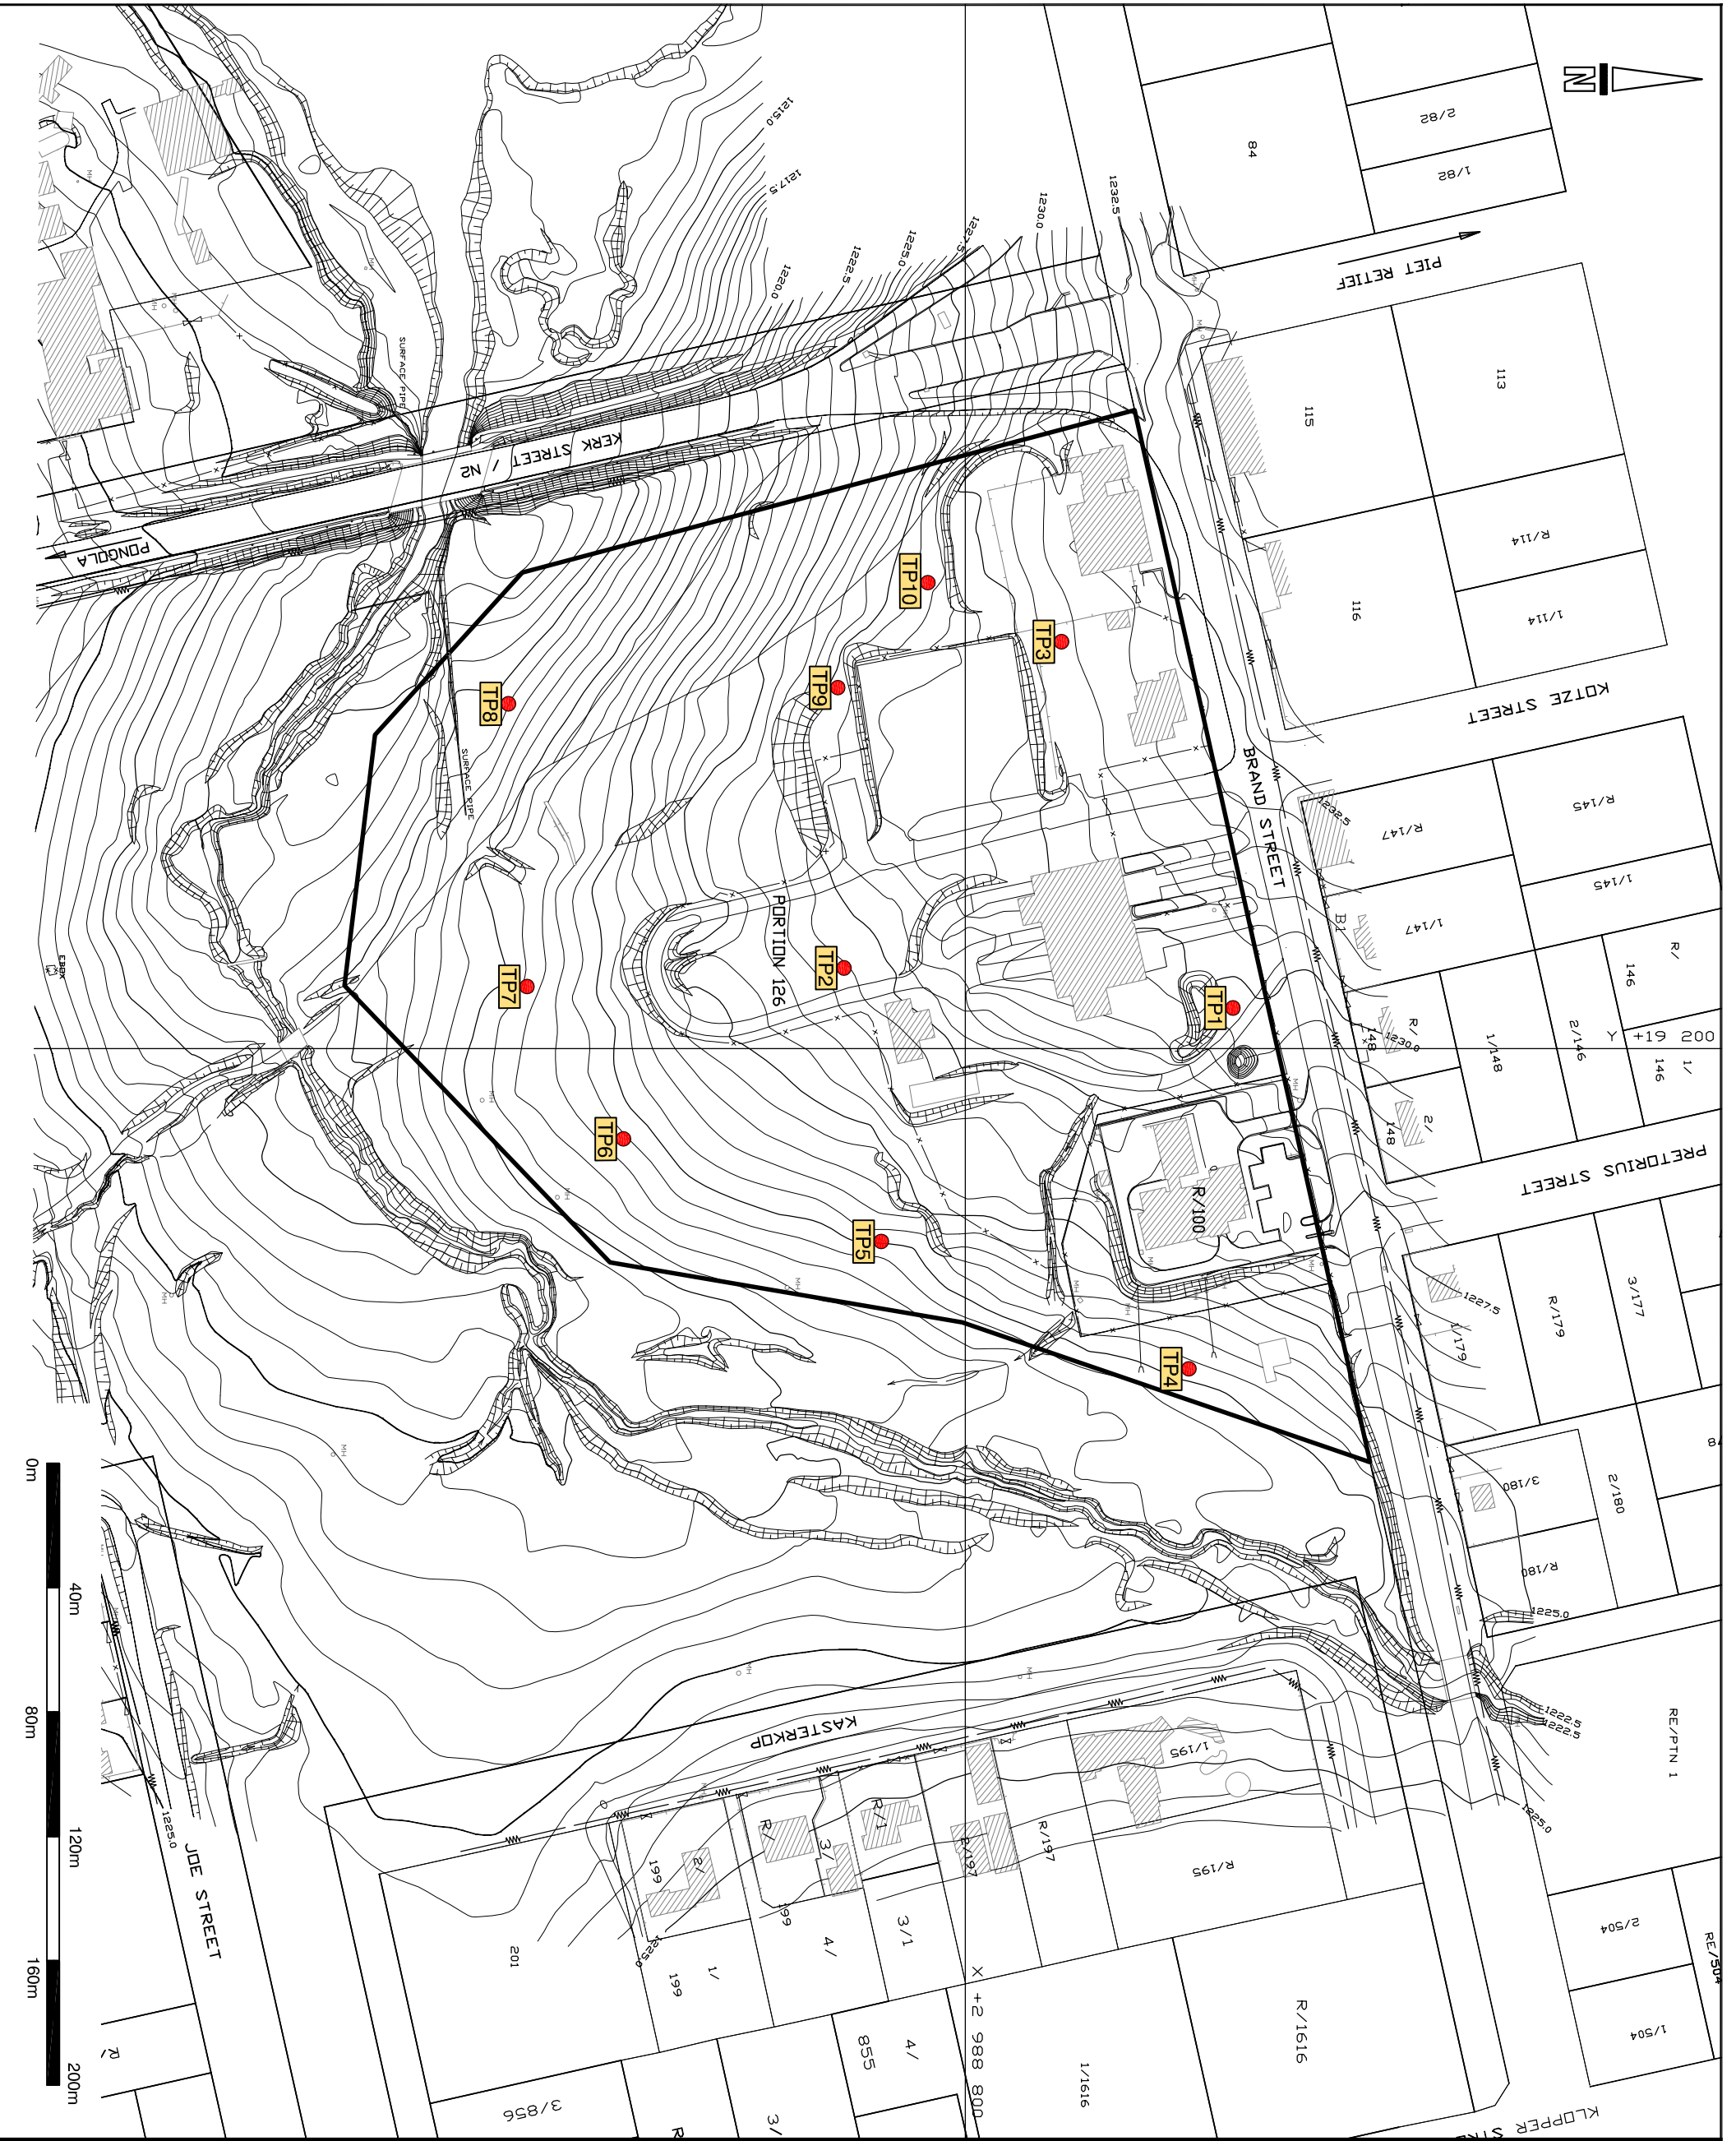
**FIGURE 2**

The positions of trial holes are depicted in Figure 2.

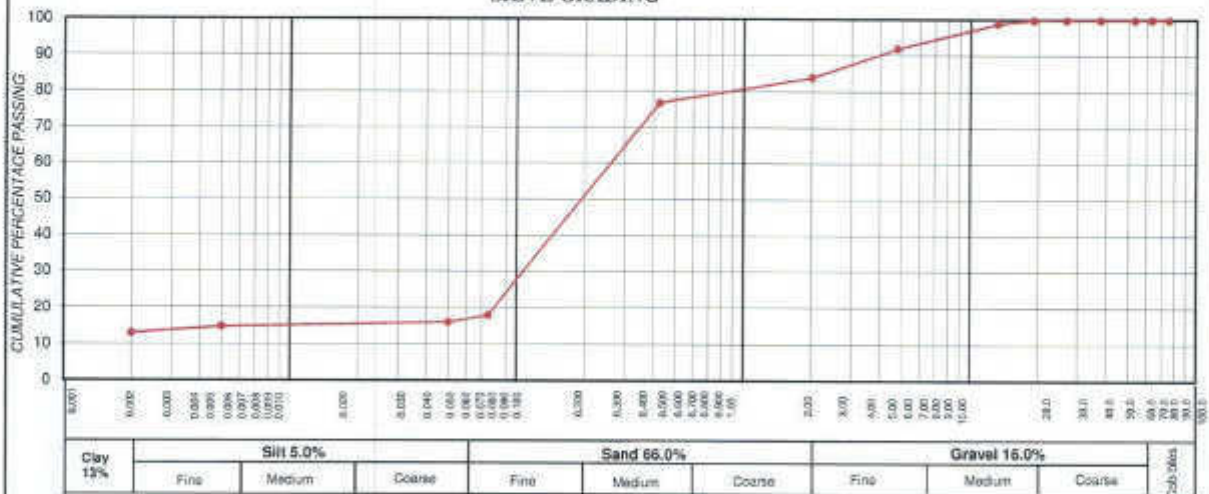
**SIEVE GRADING**

SIEVE SIZE ( BY LOG SCALE )

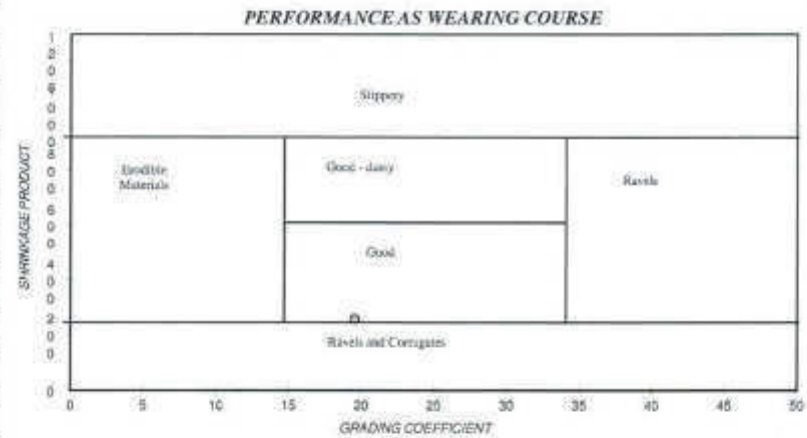
Soil Mortar Analysis % < 2.00mm	2.000 - 0.425	19.0
	0.425 - 0.250	10.0
	0.250 - 0.150	10.0
	0.150 - 0.075	13.0
	< 0.075	34.2
Effective size	0.005	
Uniformity Coefficient	22.8	
Curvature Coefficient	7.4	
Oversize Index	0.0	
Shrinkage Product	259.8	
Grading Coefficient	19.5	
Grading modulus	1.34	
Atterberg Limits	Liquid Limit	26
	Plasticity Index	10
	Linear Shrinkage	4.33
Unified Soil Classification	SC	
U.S. Highway Classification	A-2-4(0)	
pH - Value	N/A	
Conductivity mS/cm	N/A

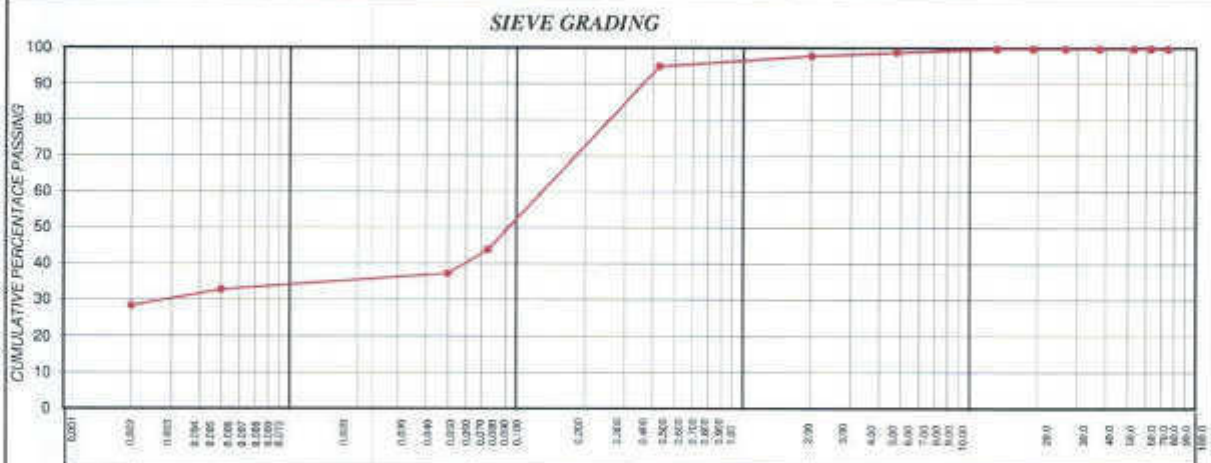
Clay 20%	Silt 15.4%			Sand 54.0%			Gravel 2.0%			Job Data
	Fine	Medium	Coarse	Fine	Medium	Coarse	Fine	Medium	Coarse

SIEVE SIZE ( BY LOG SCALE )

**FOUNDATION INDICATOR RESULTS**

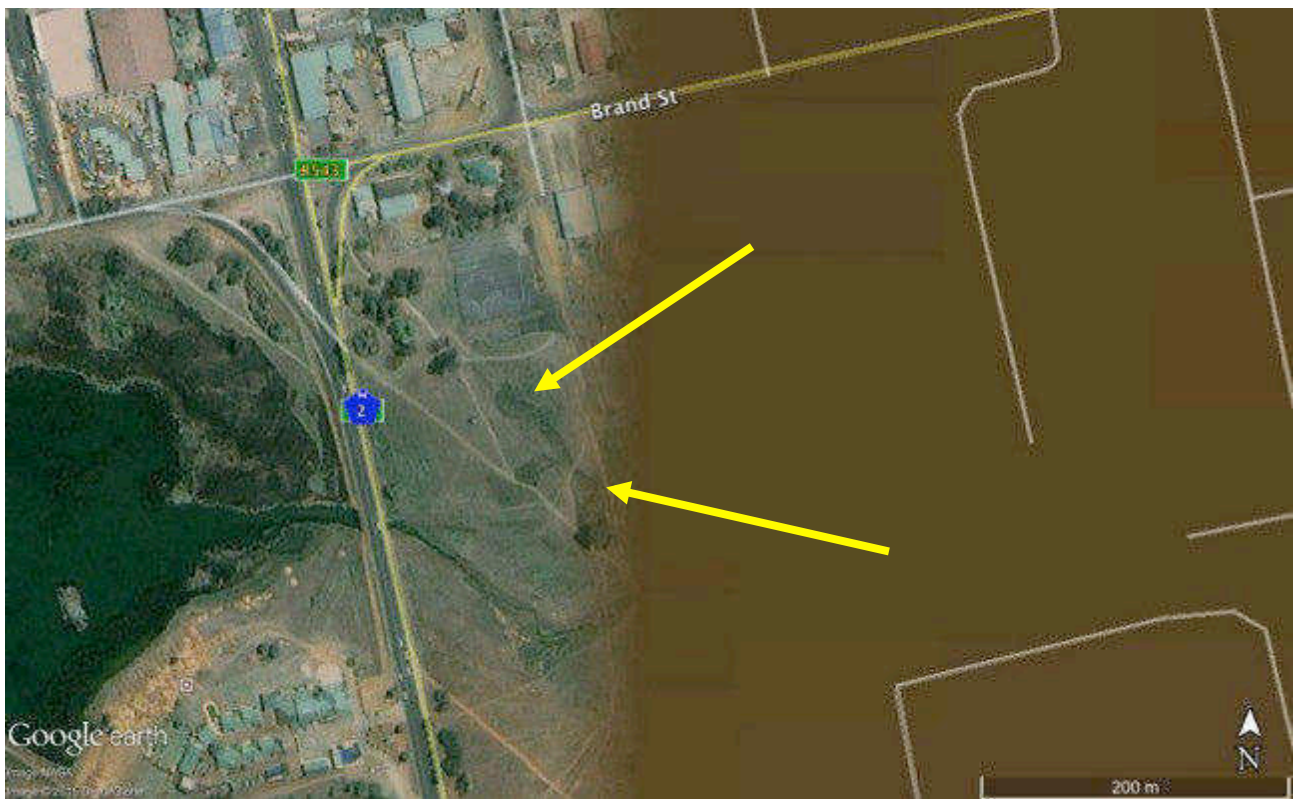
**Figure 12** Google Earth image (2003/10/02) indicating potential seepage areas (yellow arrows)

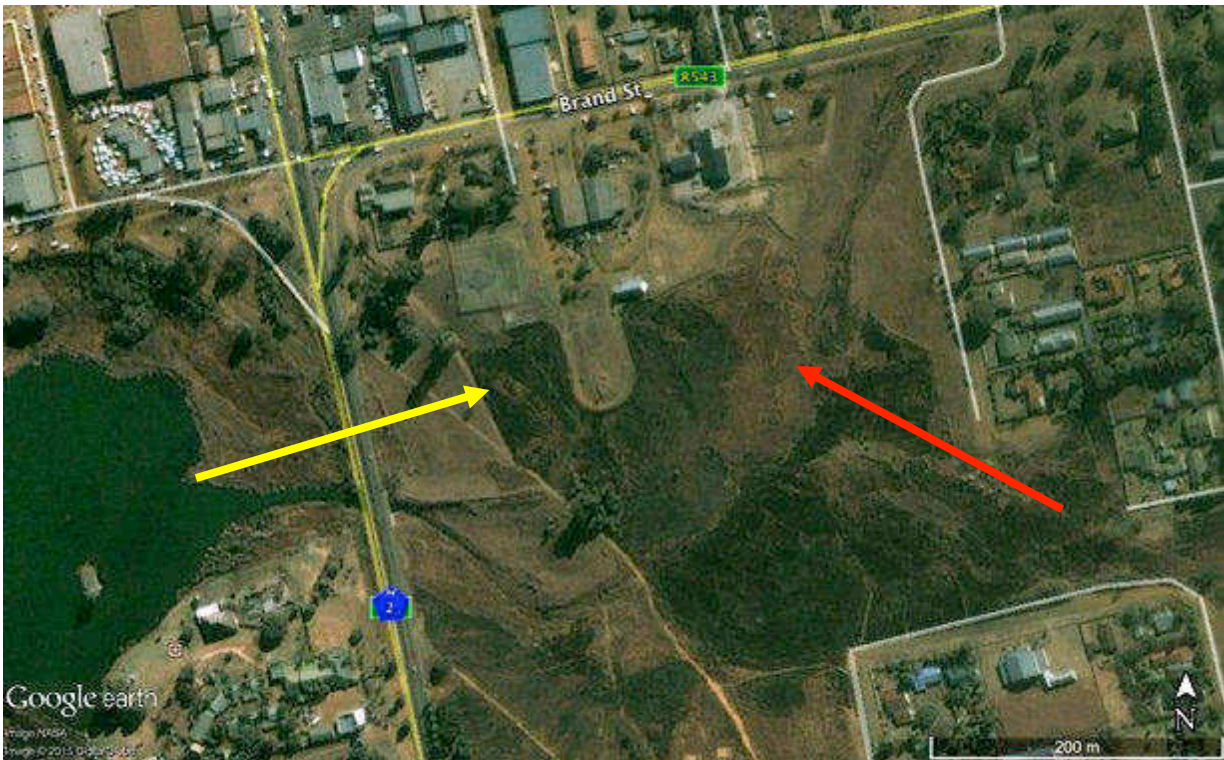
**Figure 13** Google Earth image (2010/06/18) with the potential seepage areas (yellow arrow) very evident as artificial modifiers and indicating a potential seepage wetland in the east (red arrow)

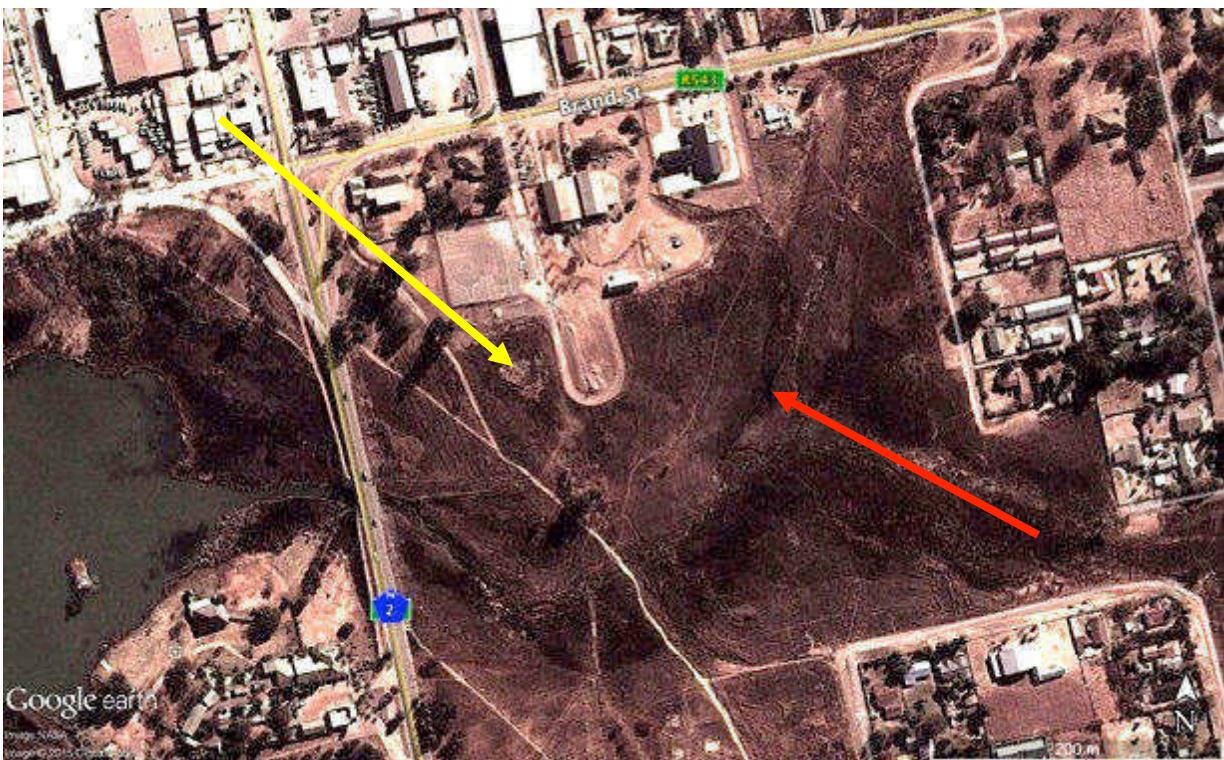
**Figure 14** Google Earth image (2011/07/20) with the potential seepage areas (yellow arrow) very evident as artificial modifiers and without signs of a potential seepage wetland in the east (red arrow)
