Aquatic Biodiversity Impact Assessment – Fountain Solar Photo- Voltaic (PV) Solar Energy Facility and associated Grid Connection Infrastructure

**Pixley ka Seme District Municipality,
Northern Cape Province**

Report Date: September 2022

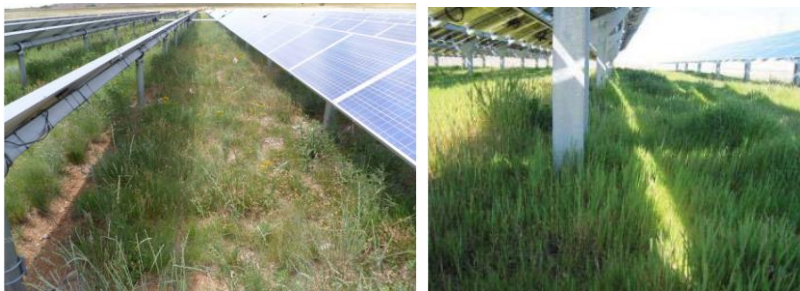
- Indigenous vegetation must be maintained under the solar panels to ensure biodiversity is maintained and to prevent soil erosion (Beatty *et al*, 2017; Sinha *et al*, 2018). This vegetation cover will maintain surface roughness which will assist in maintaining hydrological connectivity through infiltration and subsurface interflow. The photographs below are sourced from these documents;
