GEOTECHNICAL INVESTIGATION REPORT OF PORTION 1 OF THE FARM MADIERA 274-IQ, ROODEPOORT

**Prepared for: HUNTER THERON TOWN
PLANNERS**

Report No.: 1806

Date: March 2006

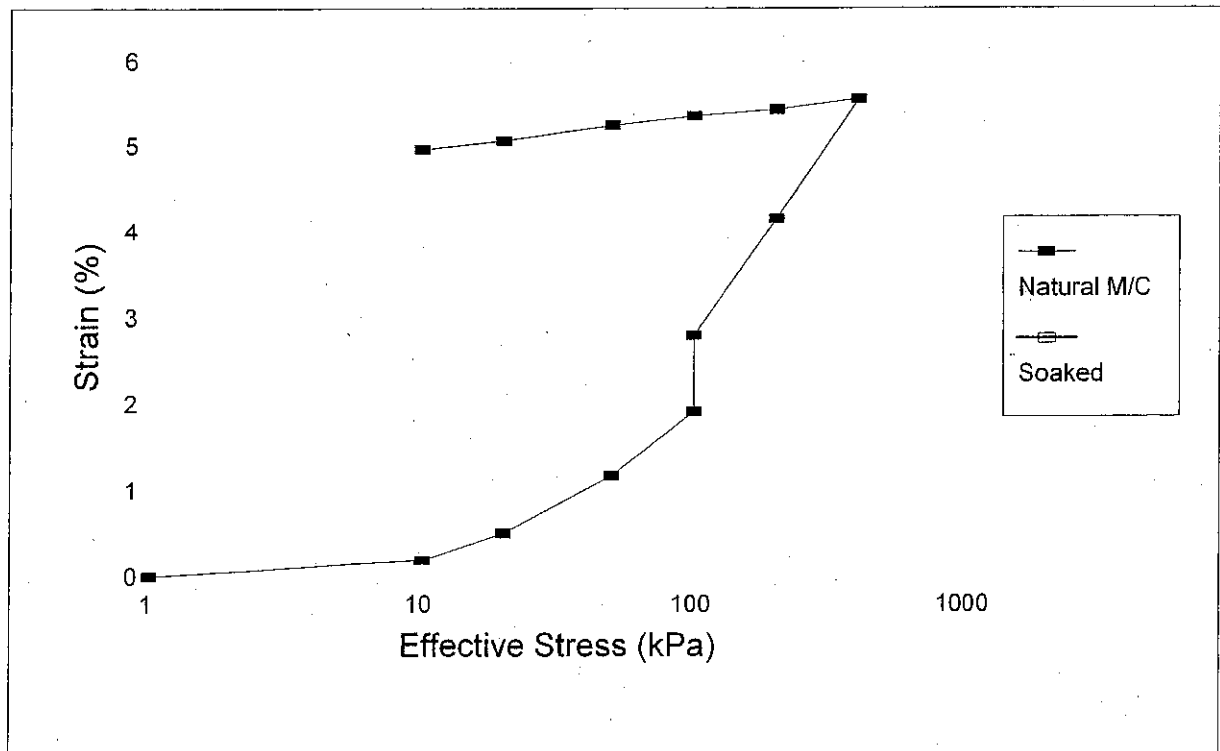
Test No: TP 6 @ 1.9-2.0m

STRAIN v EFFECTIVE STRESS

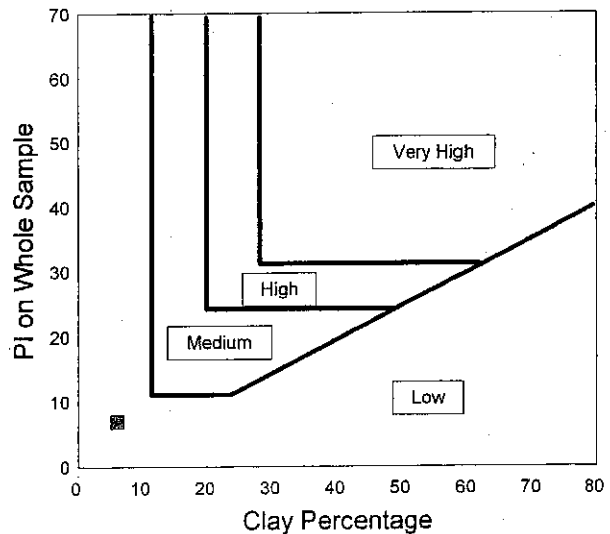
Sieve Size (mm)	Total Passing (%)
75.00	100.00
53.00	100.00
37.50	100.00
26.50	100.00
19.00	100.00
9.50	98.00
4.75	96.00
2.00	92.00
0.425	58.00

Liquid Limit	31
Plastic Limit	12
Plastic Index	19
Linear Shrinkage	6
Grading Modulus	0.98
PI on Whole Sample	7

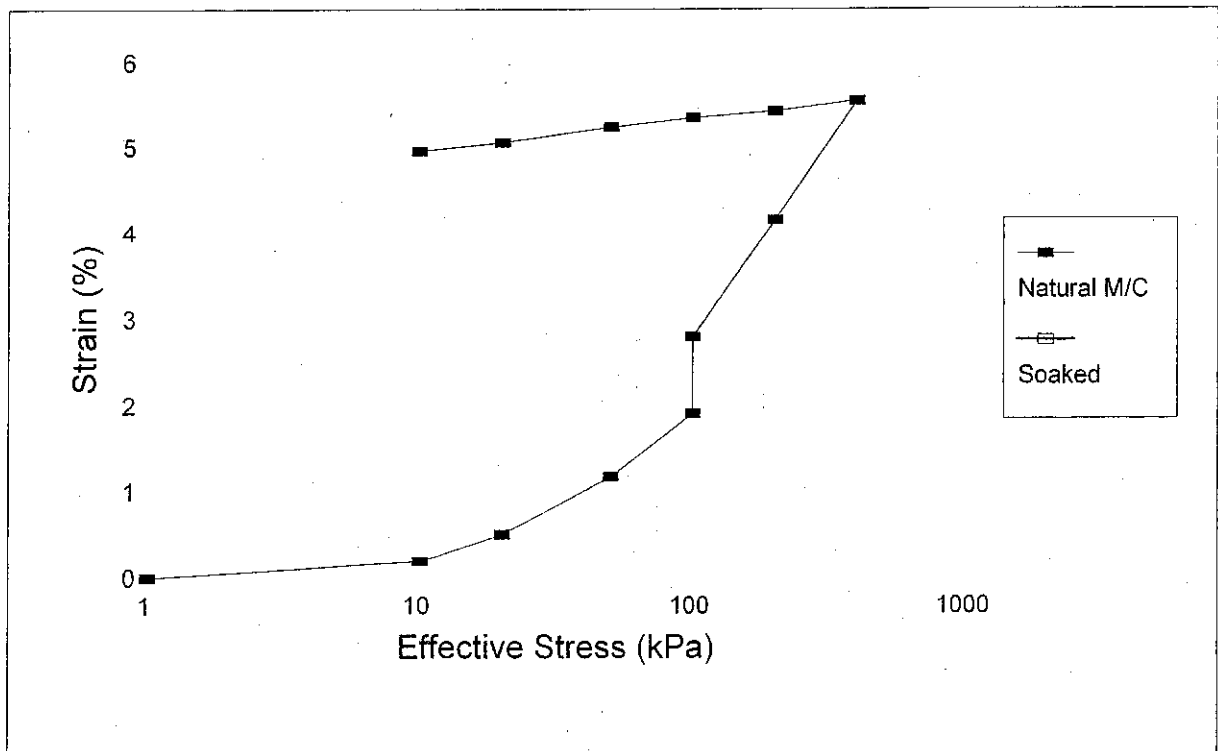
Test No: TP 6 @ 1.9-2.0m

STRAIN v EFFECTIVE STRESS
