**GOUTROU, HOPETOWN,
THEMBELIHLE LOCAL MUNICIPALITY**

**PHASE 1 ENGINEERING GEOLOGICAL INVESTIGATION
to DETERMINE the POTENTIAL for TOWNSHIP DEVELOPMENT
at GOUTROU EXTENSION, HOPETOWN,
THEMBELIHLE LOCAL MUNICIPALITY, NORTHERN CAPE PROVINCE.**

January 2020

Report number: GS202001G

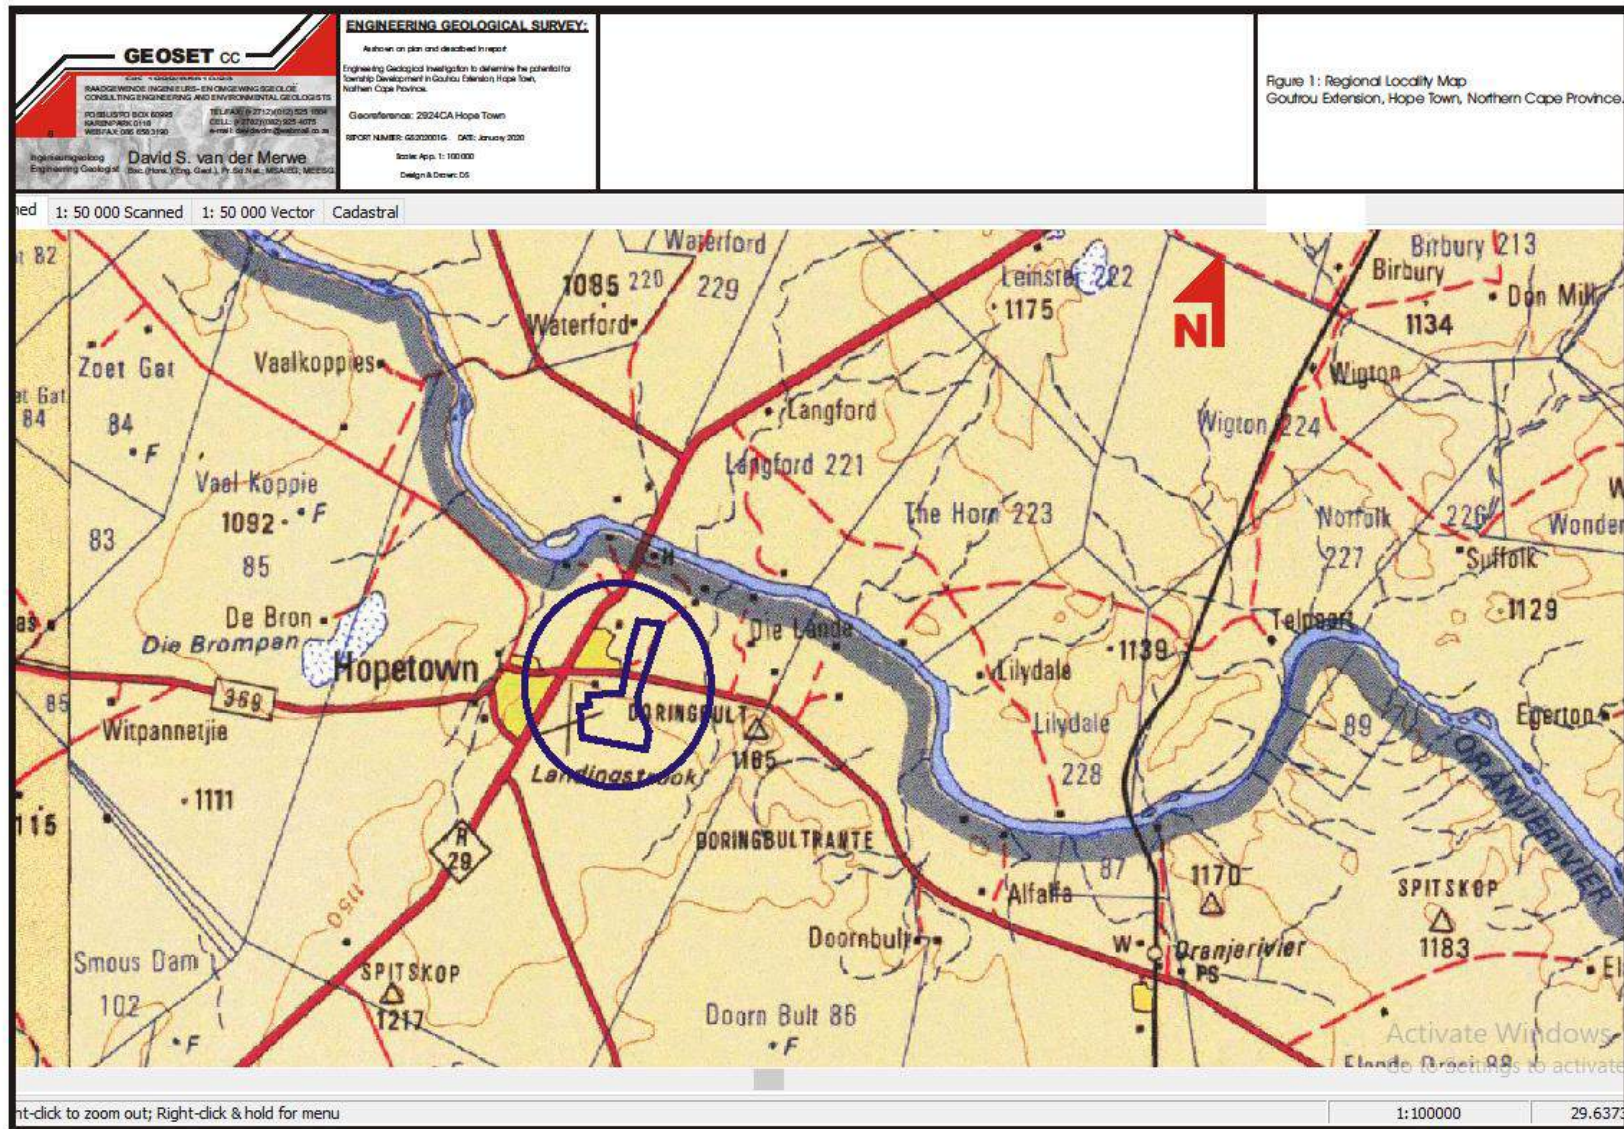
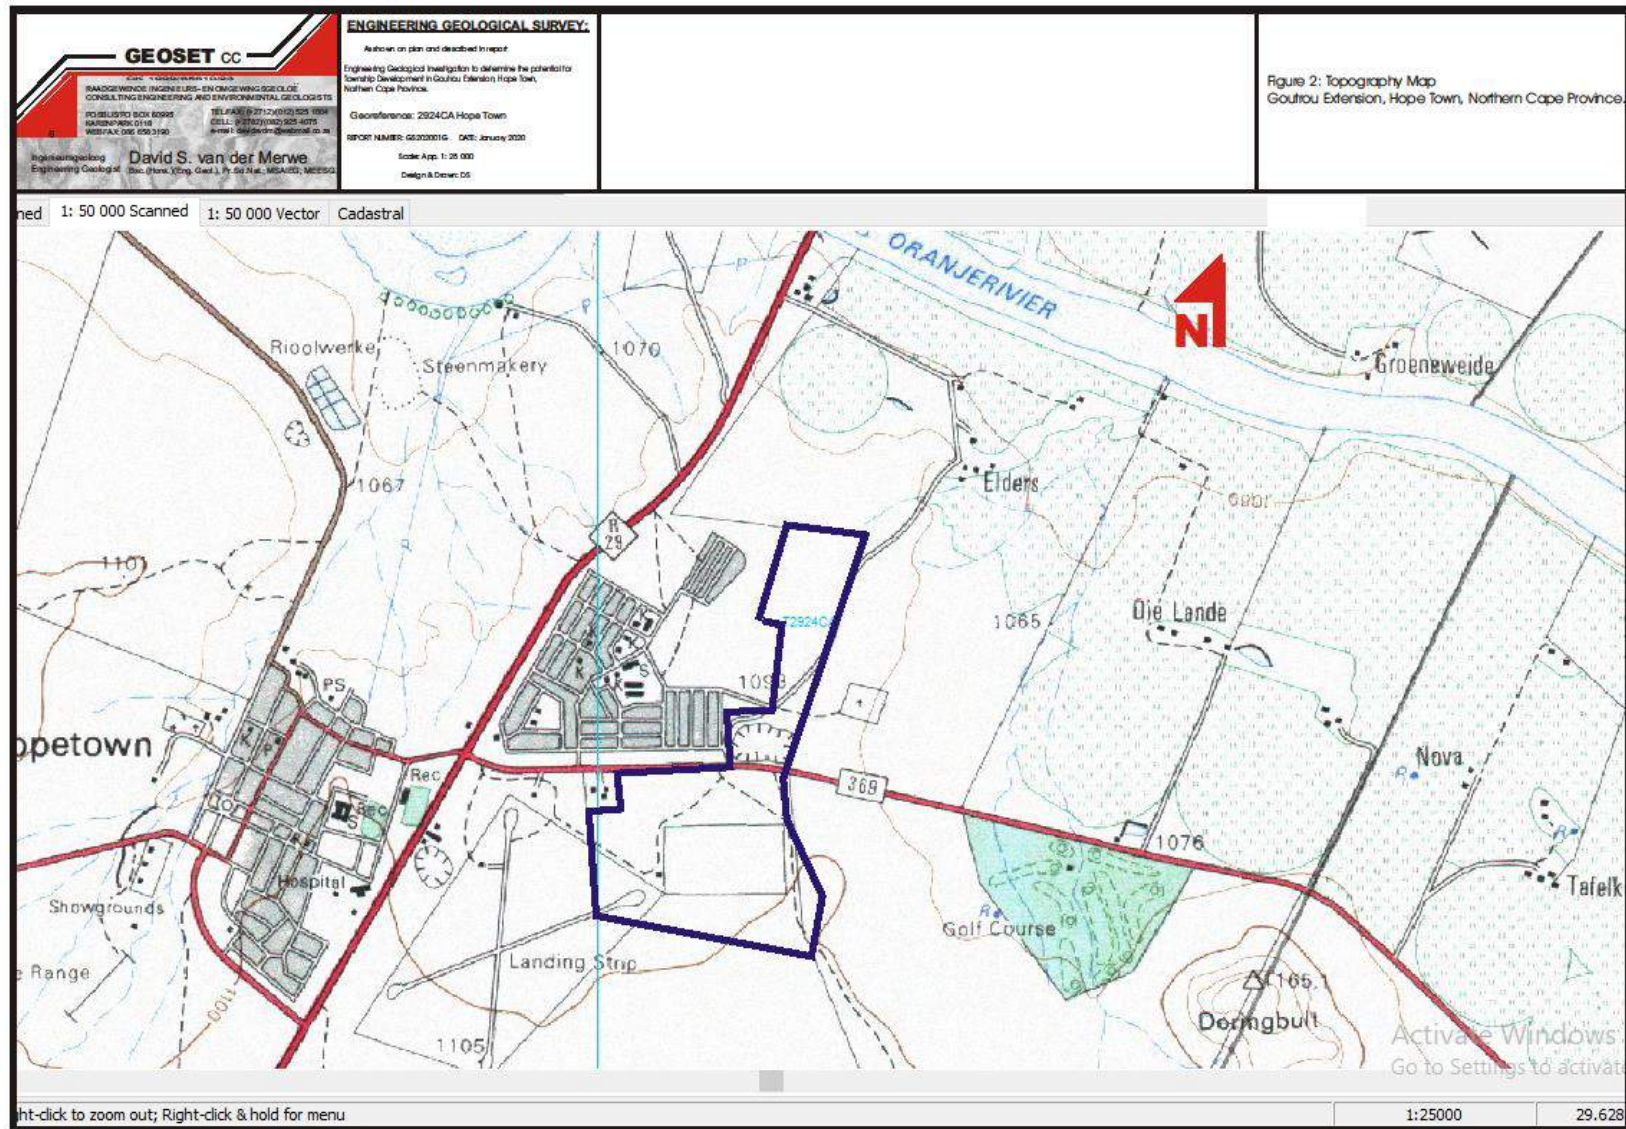
- Figure 1: Goutrou Extension, Hopetown, Thembelihle Local Municipality: Regional Locality Map.
- Figure 2: Goutrou Extension, Hopetown, Thembelihle Local Municipality: Topography Map.
- Figure 3: Goutrou Extension, Hopetown, Thembelihle Local Municipality: Geology Map.
- Figure 4: Goutrou Extension, Hopetown, Thembelihle Local Municipality: Engineering Geological Zone Map with Test Pit Positions on Google Image.

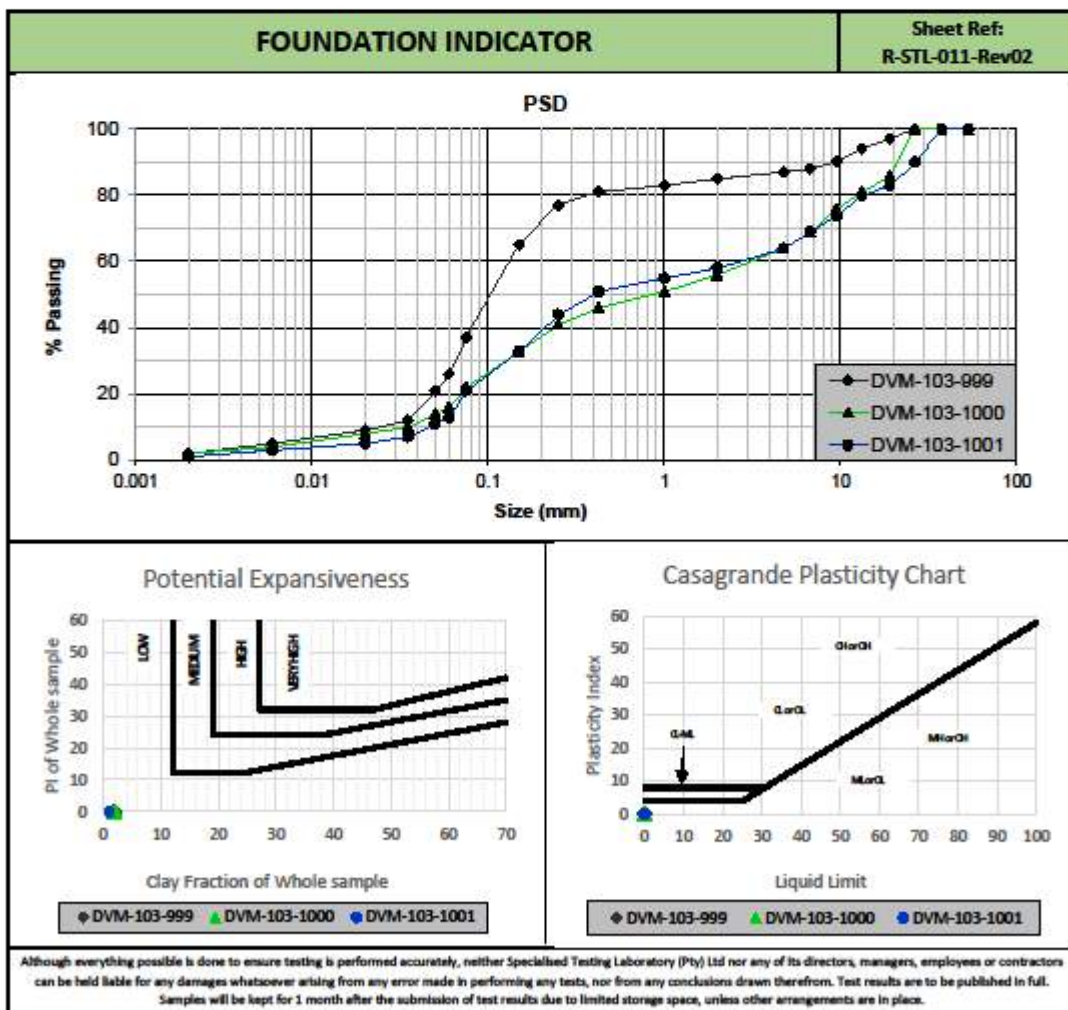
FOUNDATION INDICATOR				Sheet Ref: R-STL-011-Rev02			
Grading & Hydrometer Analysis (Particle Size (mm) & % Passing)				Atterberg Limits & Classification			
Sample	G1	G1	G12	Sample	G1	G1	G12
Depth (m)	0.1	0.5	0.4	Depth (m)	0.1	0.5	0.4
Lab No	DVM-103-999	DVM-103-1000	DVM-103-1001	Lab No	DVM-103-999	DVM-103-1000	DVM-103-1001

0.050	21	14	11	Moisture Content (%)	N / T	N / T	N / T
0.035	12	10	7	Relative Density (SG)*	2.65	2.65	2.65
0.020	9	8	5				
0.006	5	4	3	Unified (ASTM D2487)	SM	SM	SM

0.002	2	2	1	AASHTO (M145-91)	A - 4	A - 1 - b	A - 2 - 4
Remarks: *: Assumed N / T: Not Tested							
<p>Although everything possible is done to ensure testing is performed accurately, neither Specialised Testing Laboratory (Pty) Ltd nor any of its directors, managers, employees or contractors can be held liable for any damages whatsoever arising from any error made in performing any tests, nor from any conclusions drawn therefrom. Test results are to be published in full. Samples will be kept for 1 month after the submission of test results due to limited storage space, unless other arrangements are in place.</p>

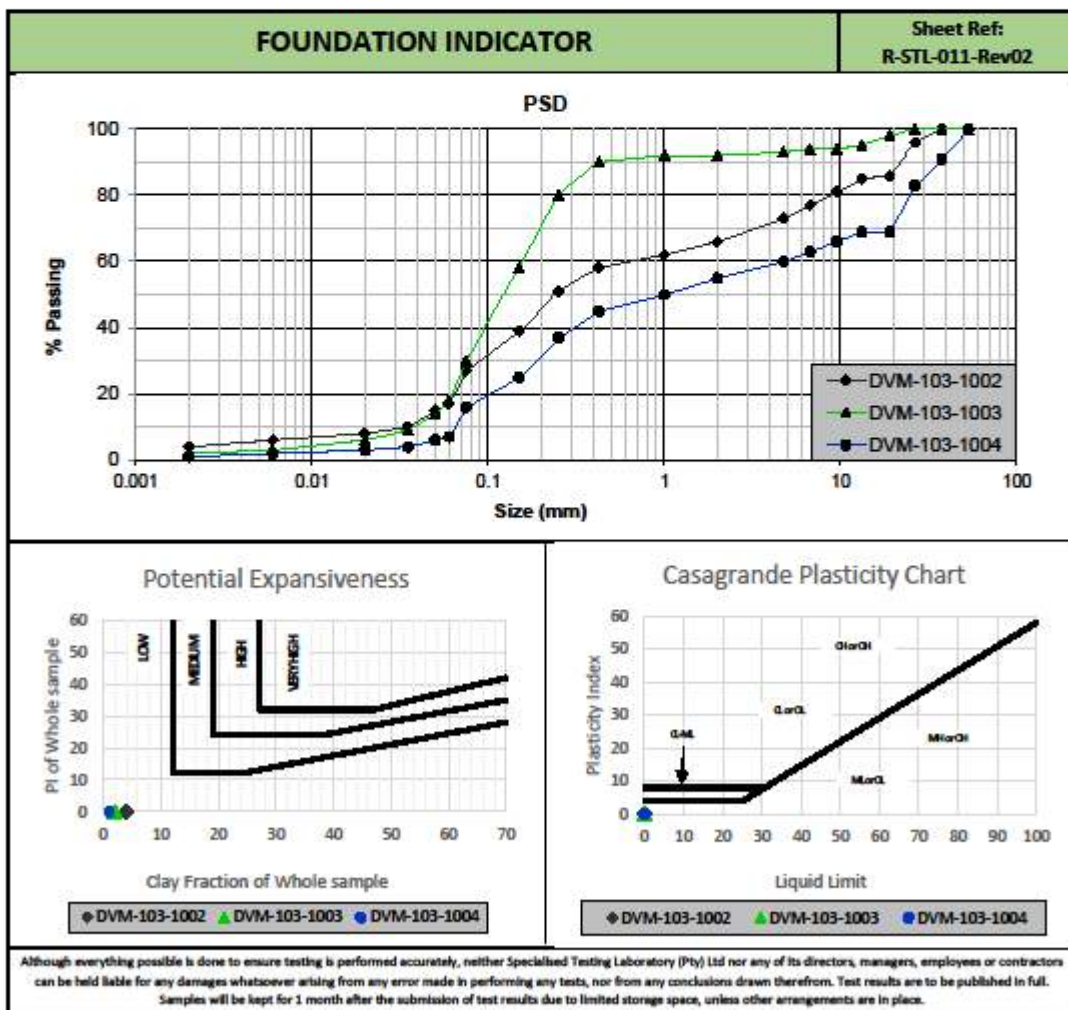
FOUNDATION INDICATOR				Sheet Ref: R-STL-011-Rev02			
Grading & Hydrometer Analysis (Particle Size (mm) & % Passing)				Atterberg Limits & Classification			
Sample	G22	G30	G30	Sample	G22	G30	G30
Depth (m)	0.4	0.2	0.5	Depth (m)	0.4	0.2	0.5
Lab No	DVM-103-1002	DVM-103-1003	DVM-103-1004	Lab No	DVM-103-1002	DVM-103-1003	DVM-103-1004

53.0	100	100	100	Liquid Limit (%)	-	-	-
37.5	100	100	91	Plastic Limit (%)	-	-	-
26.5	96	100	83	Plasticity Index (%)	SP	NP	NP
19.0	86	98	69	Linear Shrinkage (%)	0.5	0.0	0.0

0.050	15	14	6	Moisture Content (%)	N / T	N / T	N / T
0.035	10	9	4	Relative Density (SG)*	2.65	2.65	2.65
0.020	8	6	3				
0.006	6	3	2	Unified (ASTM D2487)	SM	SM	SM

0.002	4	2	1	AASHTO (M145-91)	A - 2 - 4	A - 2 - 4	A - 1 - b
Remarks: *: Assumed							
N / T: Not Tested							
<p>Although everything possible is done to ensure testing is performed accurately, neither Specialised Testing Laboratory (Pty) Ltd nor any of its directors, managers, employees or contractors can be held liable for any damages whatsoever arising from any error made in performing any tests, nor from any conclusions drawn therefrom. Test results are to be published in full.</p> <p>Samples will be kept for 1 month after the submission of test results due to limited storage space, unless other arrangements are in place.</p>

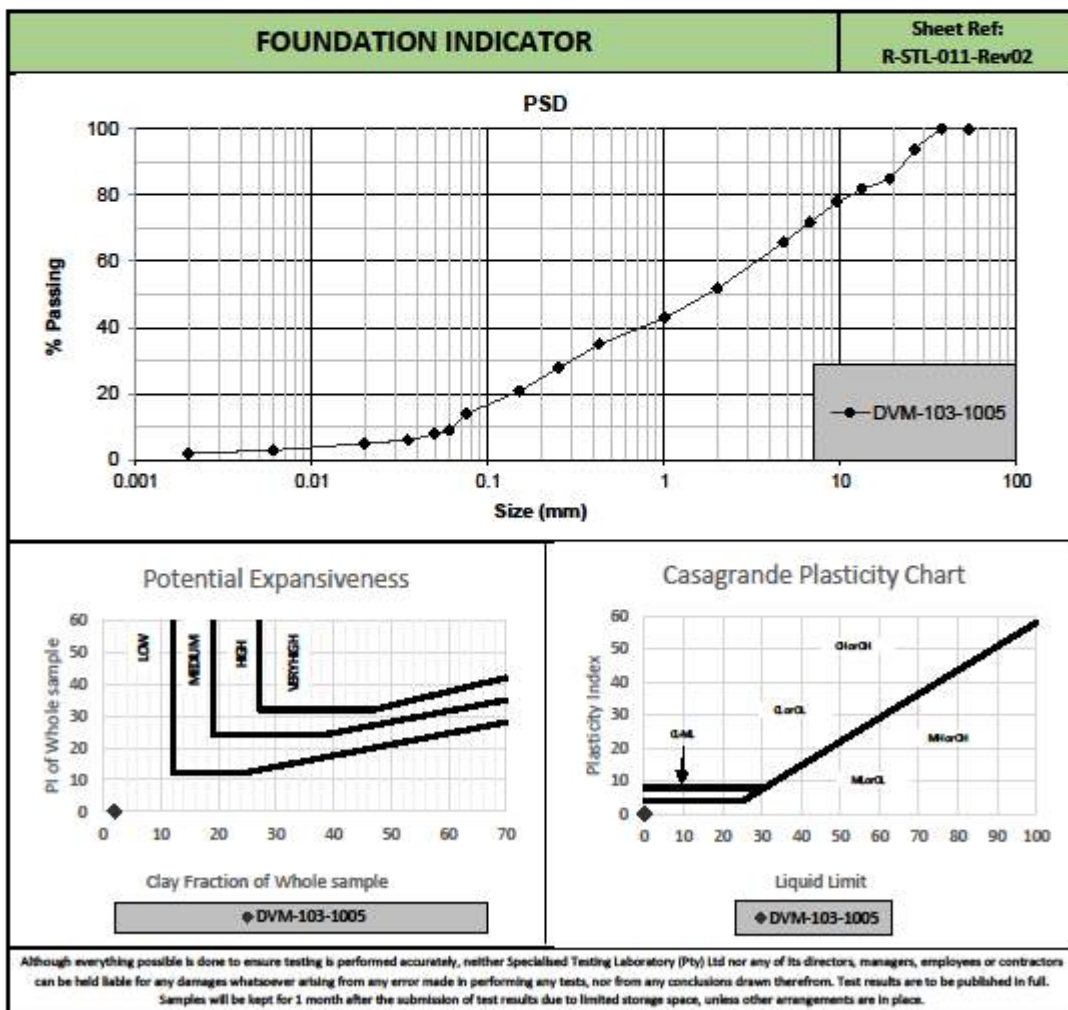
FOUNDATION INDICATOR				Sheet Ref: R-STL-011-Rev02			
Grading & Hydrometer Analysis (Particle Size (mm) & % Passing)				Atterberg Limits & Classification			
Sample	G36			Sample	G36		
Depth (m)	0.5			Depth (m)	0.5		
Lab No	DVM-103-1005			Lab No	DVM-103-1005

53.0	100			Liquid Limit (%)	-		
37.5	100			Plastic Limit (%)	-		
26.5	94			Plasticity Index (%)	SP		
19.0	85			Linear Shrinkage (%)	0.5		
13.2	82			PI of whole sample	-

0.075	14						
0.060	9			Grading Modulus	1.99		
0.050	8			Moisture Content (%)	N / T		
0.035	6			Relative Density (SG)*	2.65		
0.020	5						
0.006	3			Unified (ASTM D2487)	SM

0.002	2			AASHTO (M145-91)	A - 1 - b		
Remarks: *: Assumed N / T: Not Tested							
Although everything possible is done to ensure testing is performed accurately, neither Specialised Testing Laboratory (Pty) Ltd nor any of its directors, managers, employees or contractors can be held liable for any damages whatsoever arising from any error made in performing any tests, nor from any conclusions drawn therefrom. Test results are to be published in full. Samples will be kept for 1 month after the submission of test results due to limited storage space, unless other arrangements are in place.
