IPELEGENG EXTENSION 12, SCHWEIZER RENEKE

**PHASE 1 ENGINEERING GEOLOGICAL INVESTIGATION
to DETERMINE the POTENTIAL for TOWNSHIP DEVELOPMENT
FOR
IPELEGENG EXTENSION 12, SCHWEIZER RENEKE, NORTHWEST PROVINCE.**

Report number: GS202008S

REPORT ON THE PHASE 1 ENGINEERING GEOLOGICAL INVESTIGATION CONDUCTED FOR IPELEGENG EXTENSION 12, SCHWEIZER RENEKE, NORTHWEST PROVINCE.

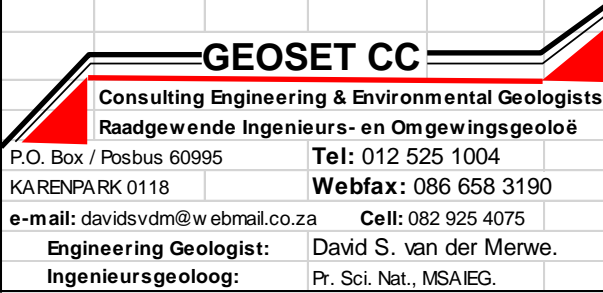
Soil Profile Nr: S26

0.1			
0.2			
0.3			
0.4		●	Dry, dark red, stiff, shattered, sandy clay. Hillw ash.
0.5		S26-0,4	
0.6			
0.7			
0.8			
0.9			
1.0			
Notes:			
1. Refusal on dry clay.

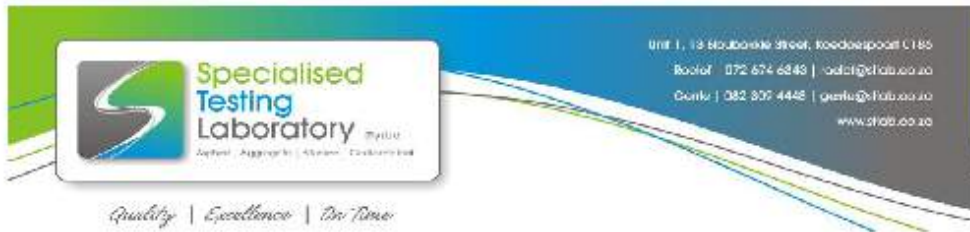
FOUNDATION INDICATOR				Sheet Ref: R-STL-011-Rev02			
Grading & Hydrometer Analysis (Particle Size (mm) & % Passing)				Atterberg Limits & Classification			
Sample	S1	S2	S3	Sample	S1	S2	S3
Depth (m)	0.8	0.6	0.5	Depth (m)	0.8	0.6	0.5
Lab No	DVM-114-1074	DVM-114-1075	DVM-114-1076	Lab No	DVM-114-1074	DVM-114-1075	DVM-114-1076

0.050	13	15	31	Moisture Content (%)	N / T	N / T	N / T
0.035	9	9	27	Relative Density (SG)*	2.65	2.65	2.65
0.020	8	8	26				
0.006	6	6	21	Unified (ASTM D2487)	SM	SM	SC

0.002	5	5	17	AASHTO (M145-91)	A - 2 - 4	A - 2 - 4	A - 6
Remarks: *: Assumed N / T: Not Tested							
<small>Although everything possible is done to ensure testing is performed accurately, neither Specialised Testing Laboratory (Pty) Ltd nor any of its directors, managers, employees or contractors can be held liable for any damages whatsoever arising from any error made in performing any tests, nor from any conclusions drawn therefrom. Test results are to be published in full. Samples will be kept for 1 month after the submission of test results due to limited storage space, unless other arrangements are in place.</small>

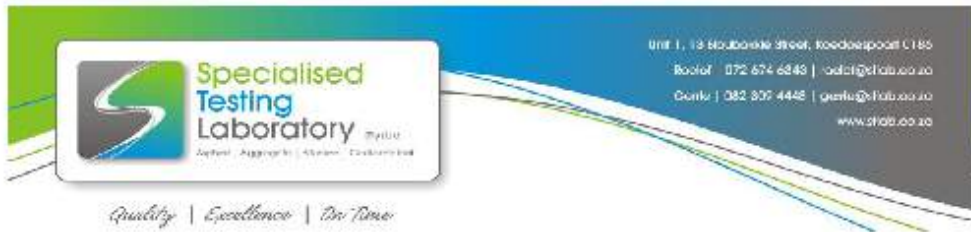
FOUNDATION INDICATOR				Sheet Ref: R-STL-011-Rev02			
Grading & Hydrometer Analysis (Particle Size (mm) & % Passing)				Atterberg Limits & Classification			
Sample	S4	S5	S7	Sample	S4	S5	S7
Depth (m)	0.8	0.7	0.7	Depth (m)	0.8	0.7	0.7
Lab No	DVM-114-1077	DVM-114-1078	DVM-114-1079	Lab No	DVM-114-1077	DVM-114-1078	DVM-114-1079

0.050	42	26	30	Moisture Content (%)	N / T	N / T	N / T
0.035	38	22	26	Relative Density (SG)*	2.65	2.65	2.65
0.020	36	18	24				
0.006	34	11	22	Unified (ASTM D2487)	CL	SC	SC

0.002	33	9	20	AASHTO (M145-91)	A - 7 - 6	A - 7 - 6	A - 6
Remarks: *: Assumed N / T: Not Tested							
<small>Although everything possible is done to ensure testing is performed accurately, neither Specialised Testing Laboratory (Pty) Ltd nor any of its directors, managers, employees or contractors can be held liable for any damages whatsoever arising from any error made in performing any tests, nor from any conclusions drawn therefrom. Test results are to be published in full. Samples will be kept for 1 month after the submission of test results due to limited storage space, unless other arrangements are in place.</small>
