Desktop Geotechnical Specialist Study for the:

DEA Reference:	2020-09-0030
Report Prepared by:	GaGE Consulting (Pty) Ltd
Issue Date:	6 November 2020
Version No.:	F0
GaGE Ref No.:	KSV20700/G0262

Mierdam Photo Voltaic (PV) Solar Energy Facility Battery Energy Storage System (BESS)

Desktop Geotechnical Specialist Study

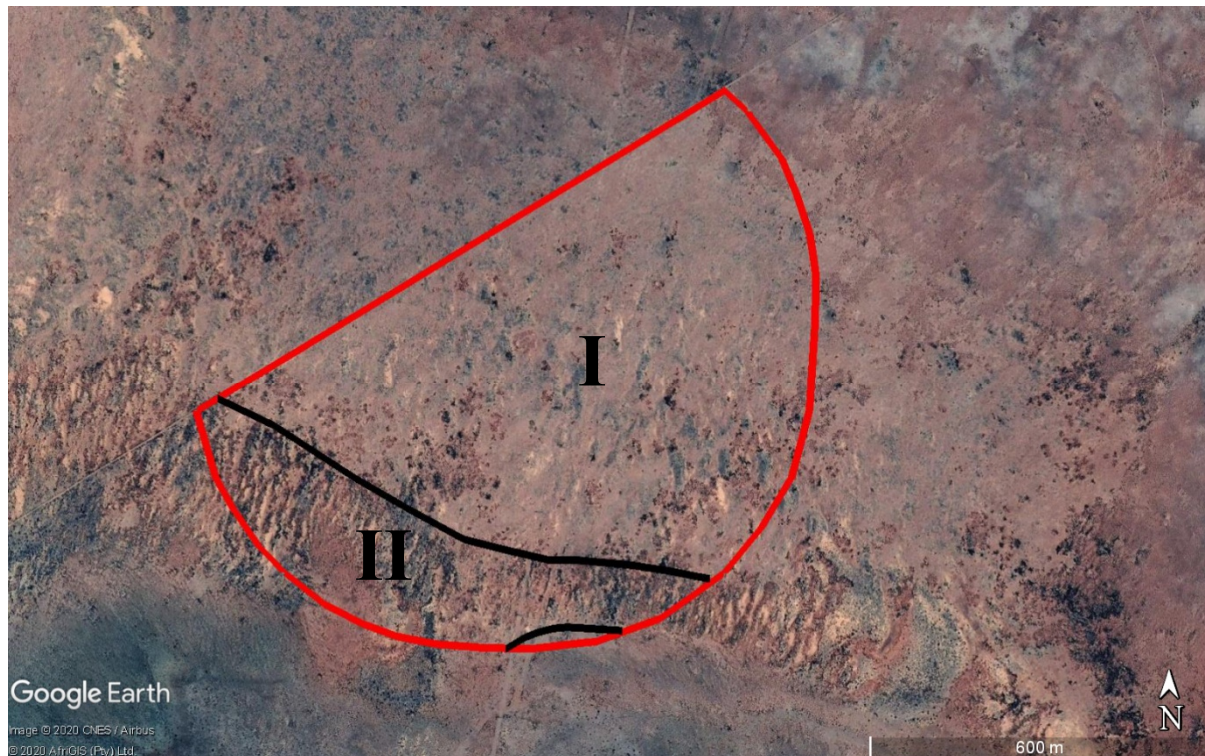
Figure 5-2 Inferred Ground Units

Based on the desktop study, the proposed BESS assessment area may be divided into two Ground Units where similar geotechnical conditions are anticipated. These correspond to areas underlain by rock units of the Dwyka Group and those

underlain by alluvial deposits. The boundary of the two zones is approximate only and will need to be confirmed on site through intrusive investigations.

Both ground units are considered suitable for the development of the BESS infrastructure, from a geotechnical viewpoint, provided that standard engineering design and construction measures are implemented to mitigate the identified geotechnical constraints. While Zone I is considered marginally more suitable for development from a geotechnical perspective, other factors are likely to be more critical in determining the final BESS layout.
