**PROPOSED CONSTRUCTION AND OPERATION OF THE BATTERY ENERGY STORAGE SYSTEM (BESS) AND ASSOCIATED INFRASTRUCTURE FOR THE AUTHORISED PLATSJAMBOK WEST SOLAR PHOTOVOLTAIC (PV) ENERGY FACILITY, LOCATED NEAR THE TOWN OF PRIESKA, IN THE SIYATHEMBA LOCAL MUNICIPALITY, PIXLEY KA SEME DISTRICT IN THE NORTHERN CAPE PROVINCE OF SOUTH AFRICA**

<b>DEA Reference:</b>	2020-09-0032
<b>Report Prepared by:</b>	GaGE Consulting (Pty) Ltd
<b>Issue Date:</b>	6 November 2020
<b>Version No.:</b>	F0
<b>GaGE Ref No.:</b>	KSV20700/G0264

Desktop Geotechnical Specialist Study

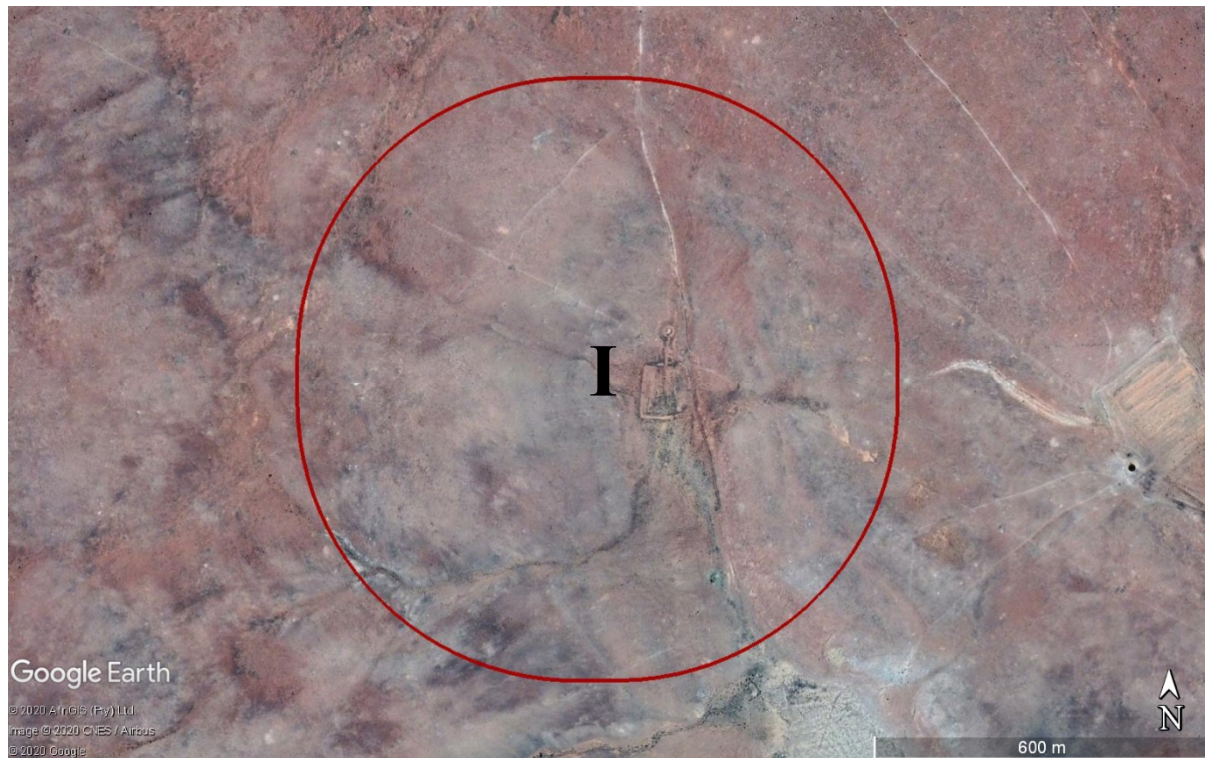
Based on the desktop study, the proposed BESS assessment area may be assigned a single Ground Unit. Broadly similar conditions are anticipated across the site, although local variation in the bedrock lithology, soil cover, material hardness and degree of calcrete formation are anticipated (as detailed above).

**Figure 5-2 Inferred Ground Units**

The assessment area is considered suitable for the development of the BESS infrastructure, from a geotechnical viewpoint, provided that standard engineering design and construction measures are implemented to mitigate the identified geotechnical constraints. It is recommended that the steeper section of the site are avoided when determining the layout of the BESS infrastructure.
