# Hydrogeological Investigation - Proposed Emdemi Public Transport Facility

Report

14 December 2021

GCS Project Number: 19-1075

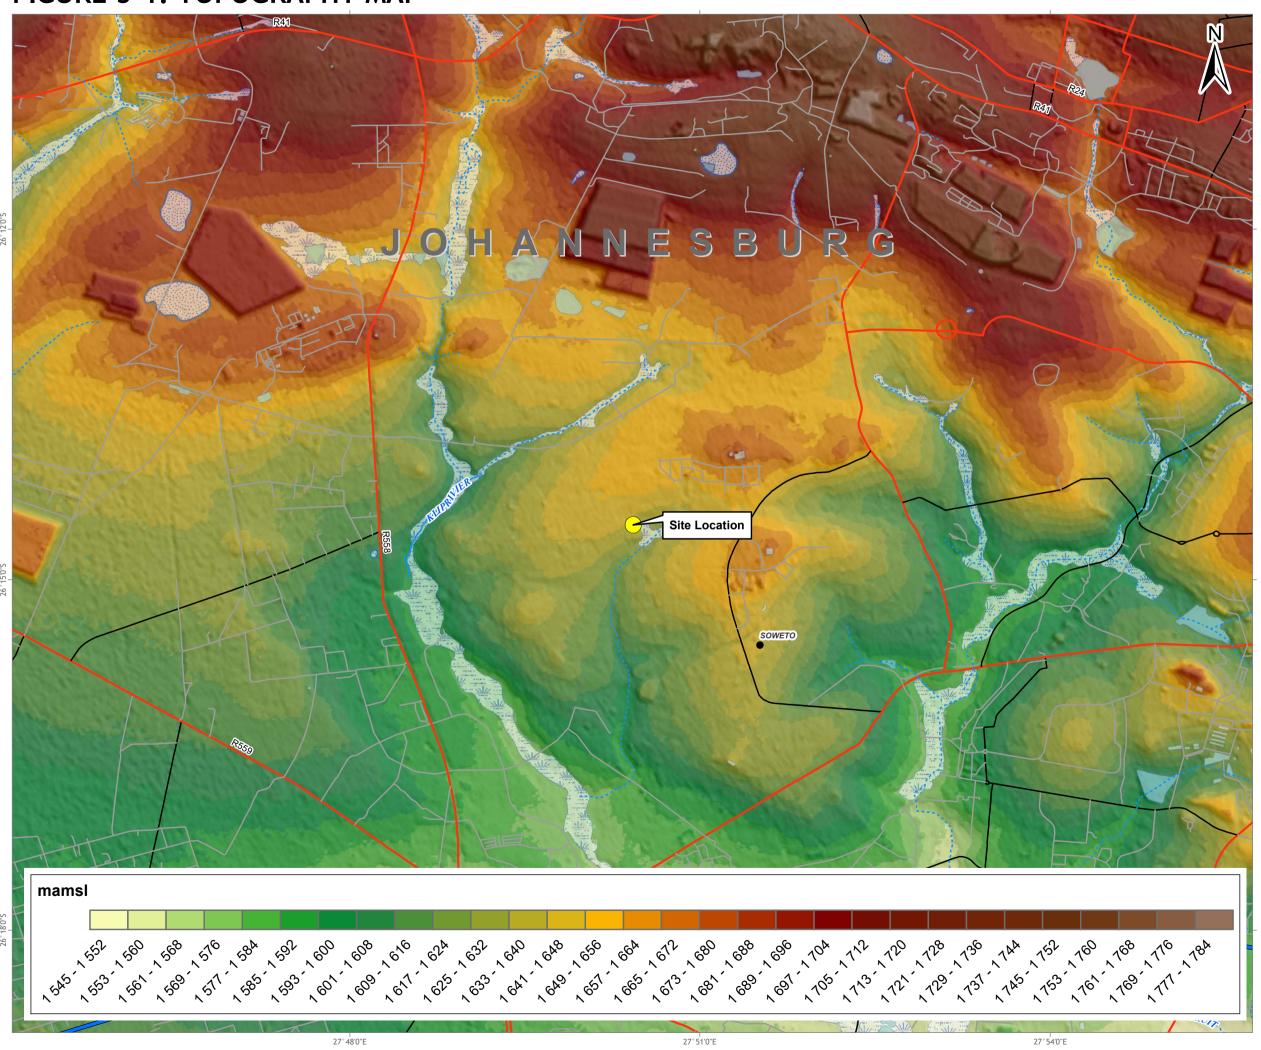
# **FIGURE 5-1: TOPOGRAPHY MAP**

The site is located at an elevation of approximately 1,634 mamsl (meters above mean sea level) according to the 1:50 000 topographical map (2627BB). The topography at and near the site slopes gently in a south-easterly direction. Regionally however the site slopes towards the south-south-west. The groundwater flow was expected to emulate the regional topography in a south-south-westerly direction. The results of the hydrogeological investigation confirm that locally groundwater flow is towards the south-south westerly direction.

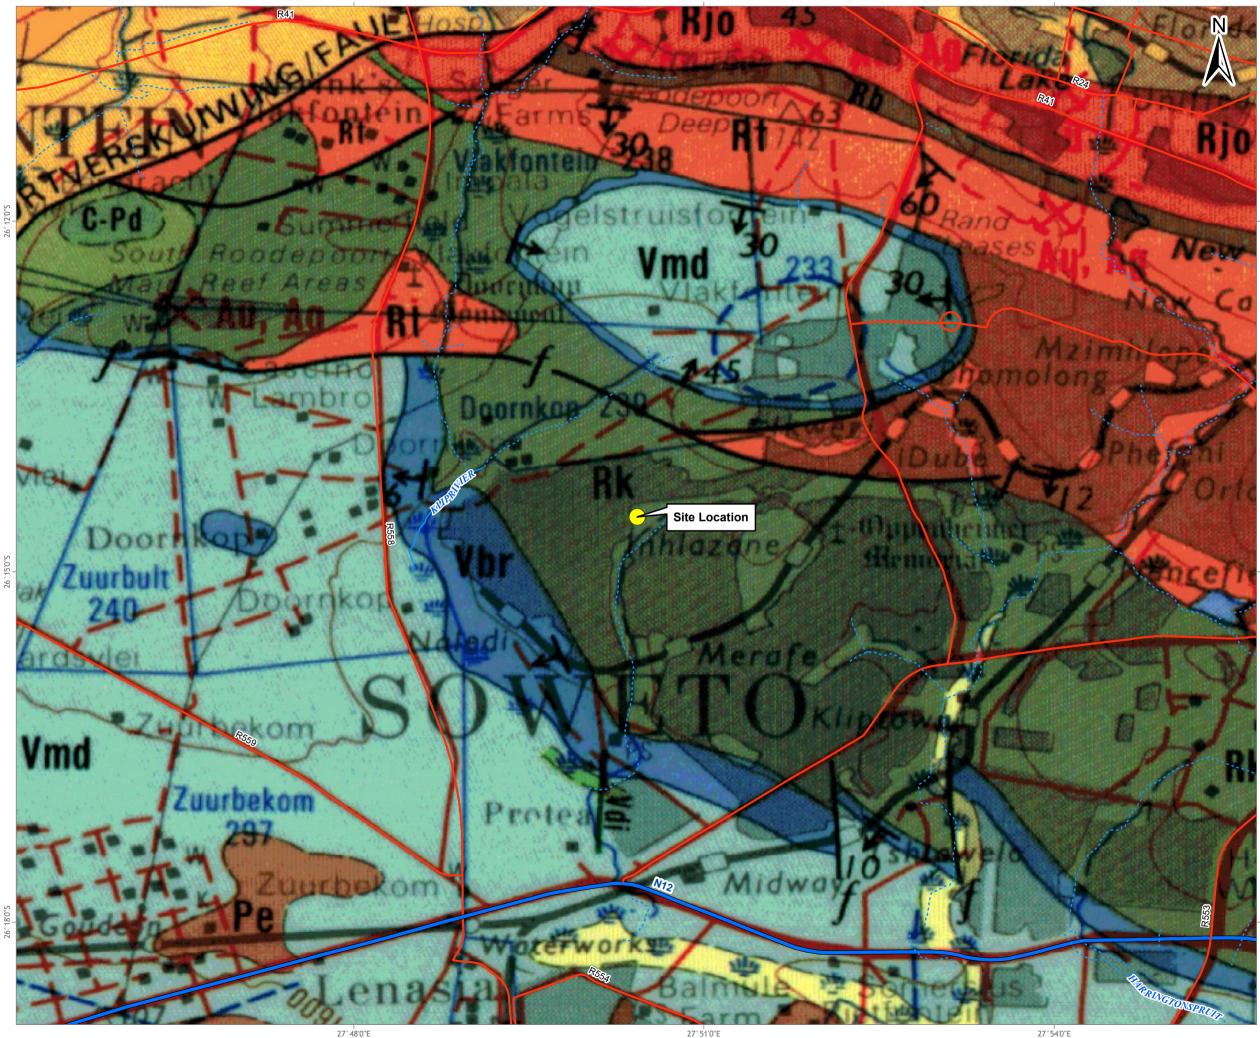
# FIGURE 5-2: GEOLOGY MAP

According to the 1:250 000, Geological Series map of South Africa, (Sheet 2626, West Rand) the site is underlain by basaltic lava, agglomerate and tuff of the Klipsrivier Group from the Randian age (refer to Figure 5-2). The general conditions encountered during augering consisted of reddish and light brown shades of silty sand and clay with rock inclusions.

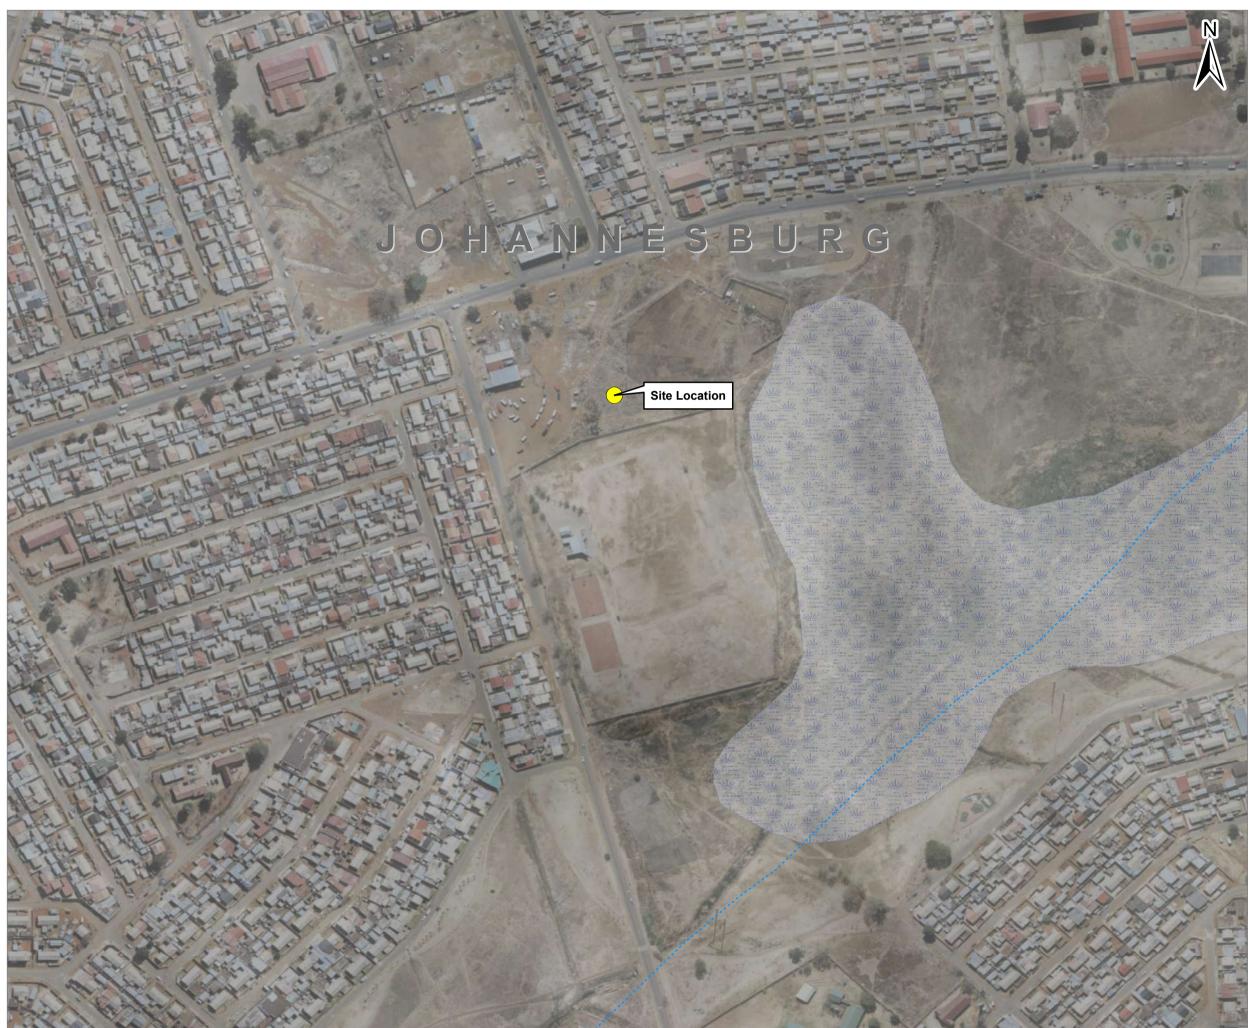
# FIGURE 5-3: AERIAL MAP

The site is located at Ntshunyana street (Refer to Figure 5-3), Zola Extension 3, Soweto in Gauteng Province which falls under the jurisdiction of the City of Johannesburg Municipality.

A neighbouring land survey was conducted for the site in order to prepare a list of adjacent land use as detailed in Table 4-1. An aerial photograph depicting the general surrounding land use properties is presented in Figure 5-3.

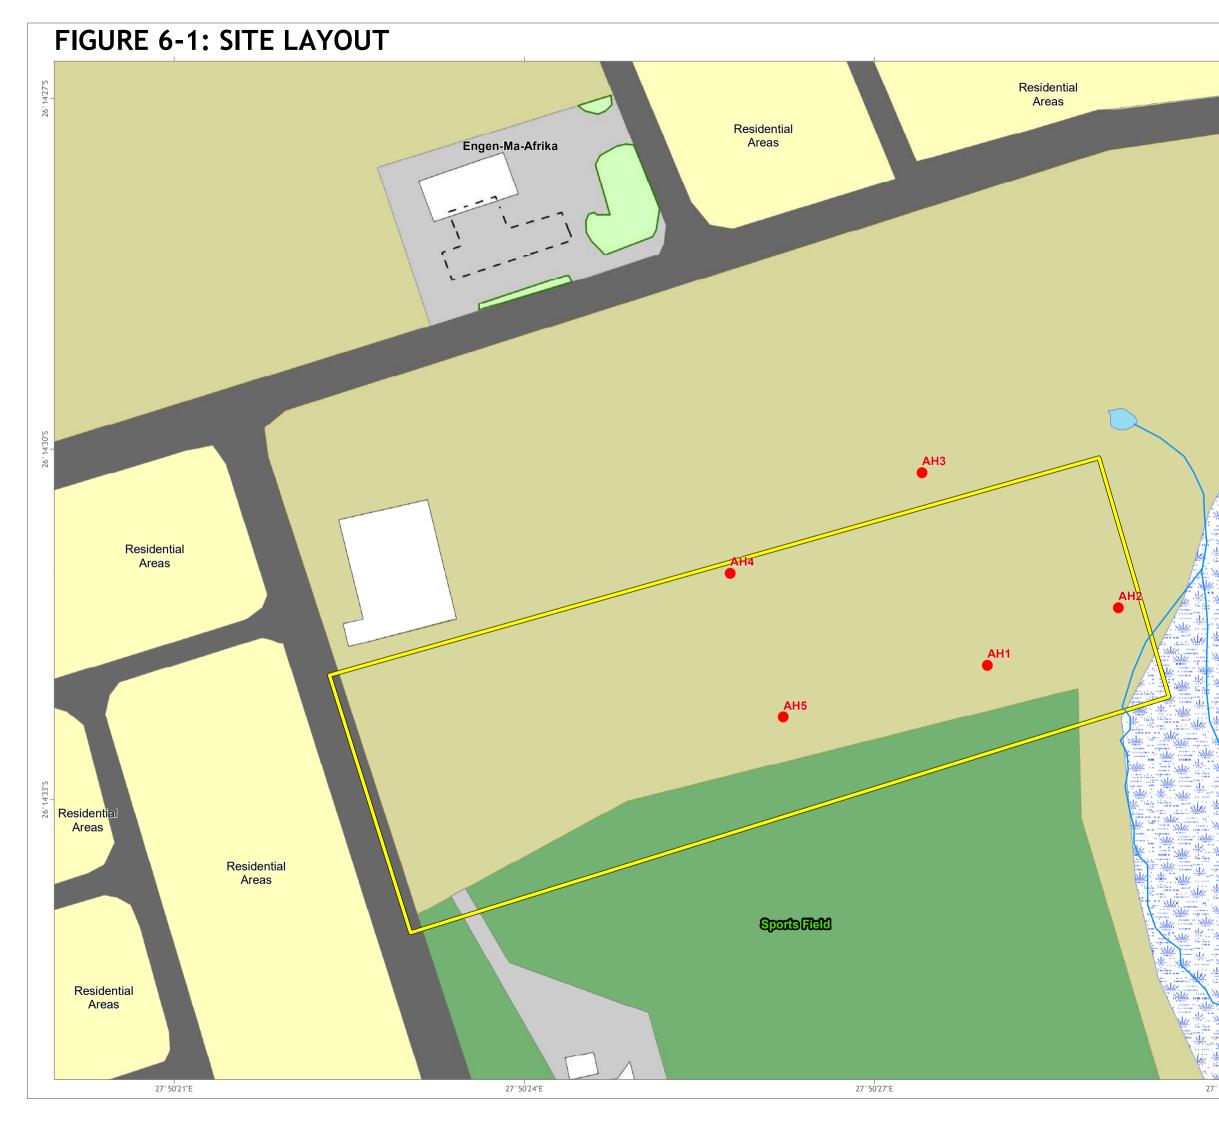
The measured VOC readings in all auger holes ranged between 0.0 and 86.3 ppm. Slight hydrocarbon odours and slightly elevated VOC readings were recorded from the soil arisings of auger hole AH5 from 3.8 to 4.2 m bgl.

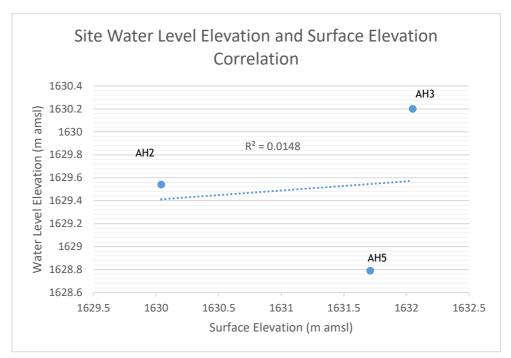
Figure 6-2: Water level correlation with surface elevation

The groundwater hydraulic gradient on-site was calculated to be 0.19 in a south-southwesterly direction. The calculated gradient assumes that the subsurface conditions are homogeneous throughout the site. A weak ( $R^2$ = 0.0148) degree of correlation exists between groundwater level elevation and surface elevation at the site as is illustrated in Figure 6-2, indicating that the groundwater flow direction deviates from the site surface topography at a local scale.

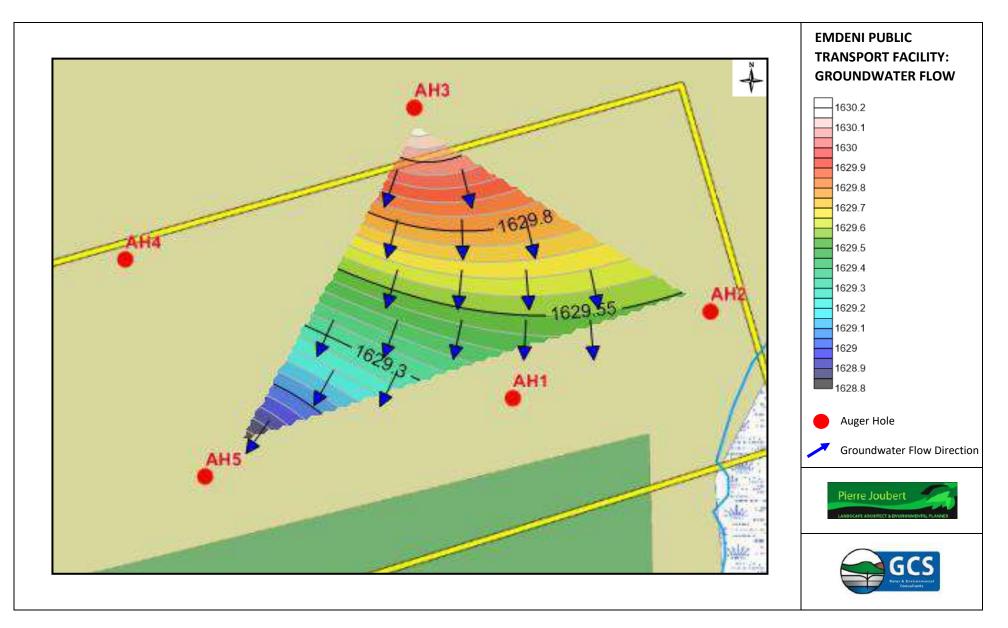
Figure 6-2: Groundwater flow direction contours

Furthermore, it would appear that groundwater flow at the site emulates the regional topography (sloping towards the south-south-west). It should be noted that the wetland also drains in a south-south-west direction as observed from the wetland outlet located further down-gradient of the site.

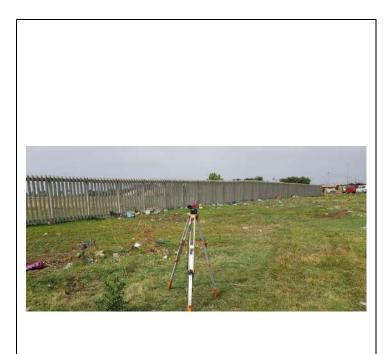
#### Photo No. 9

Description: View of the dumpy level used for surveying.

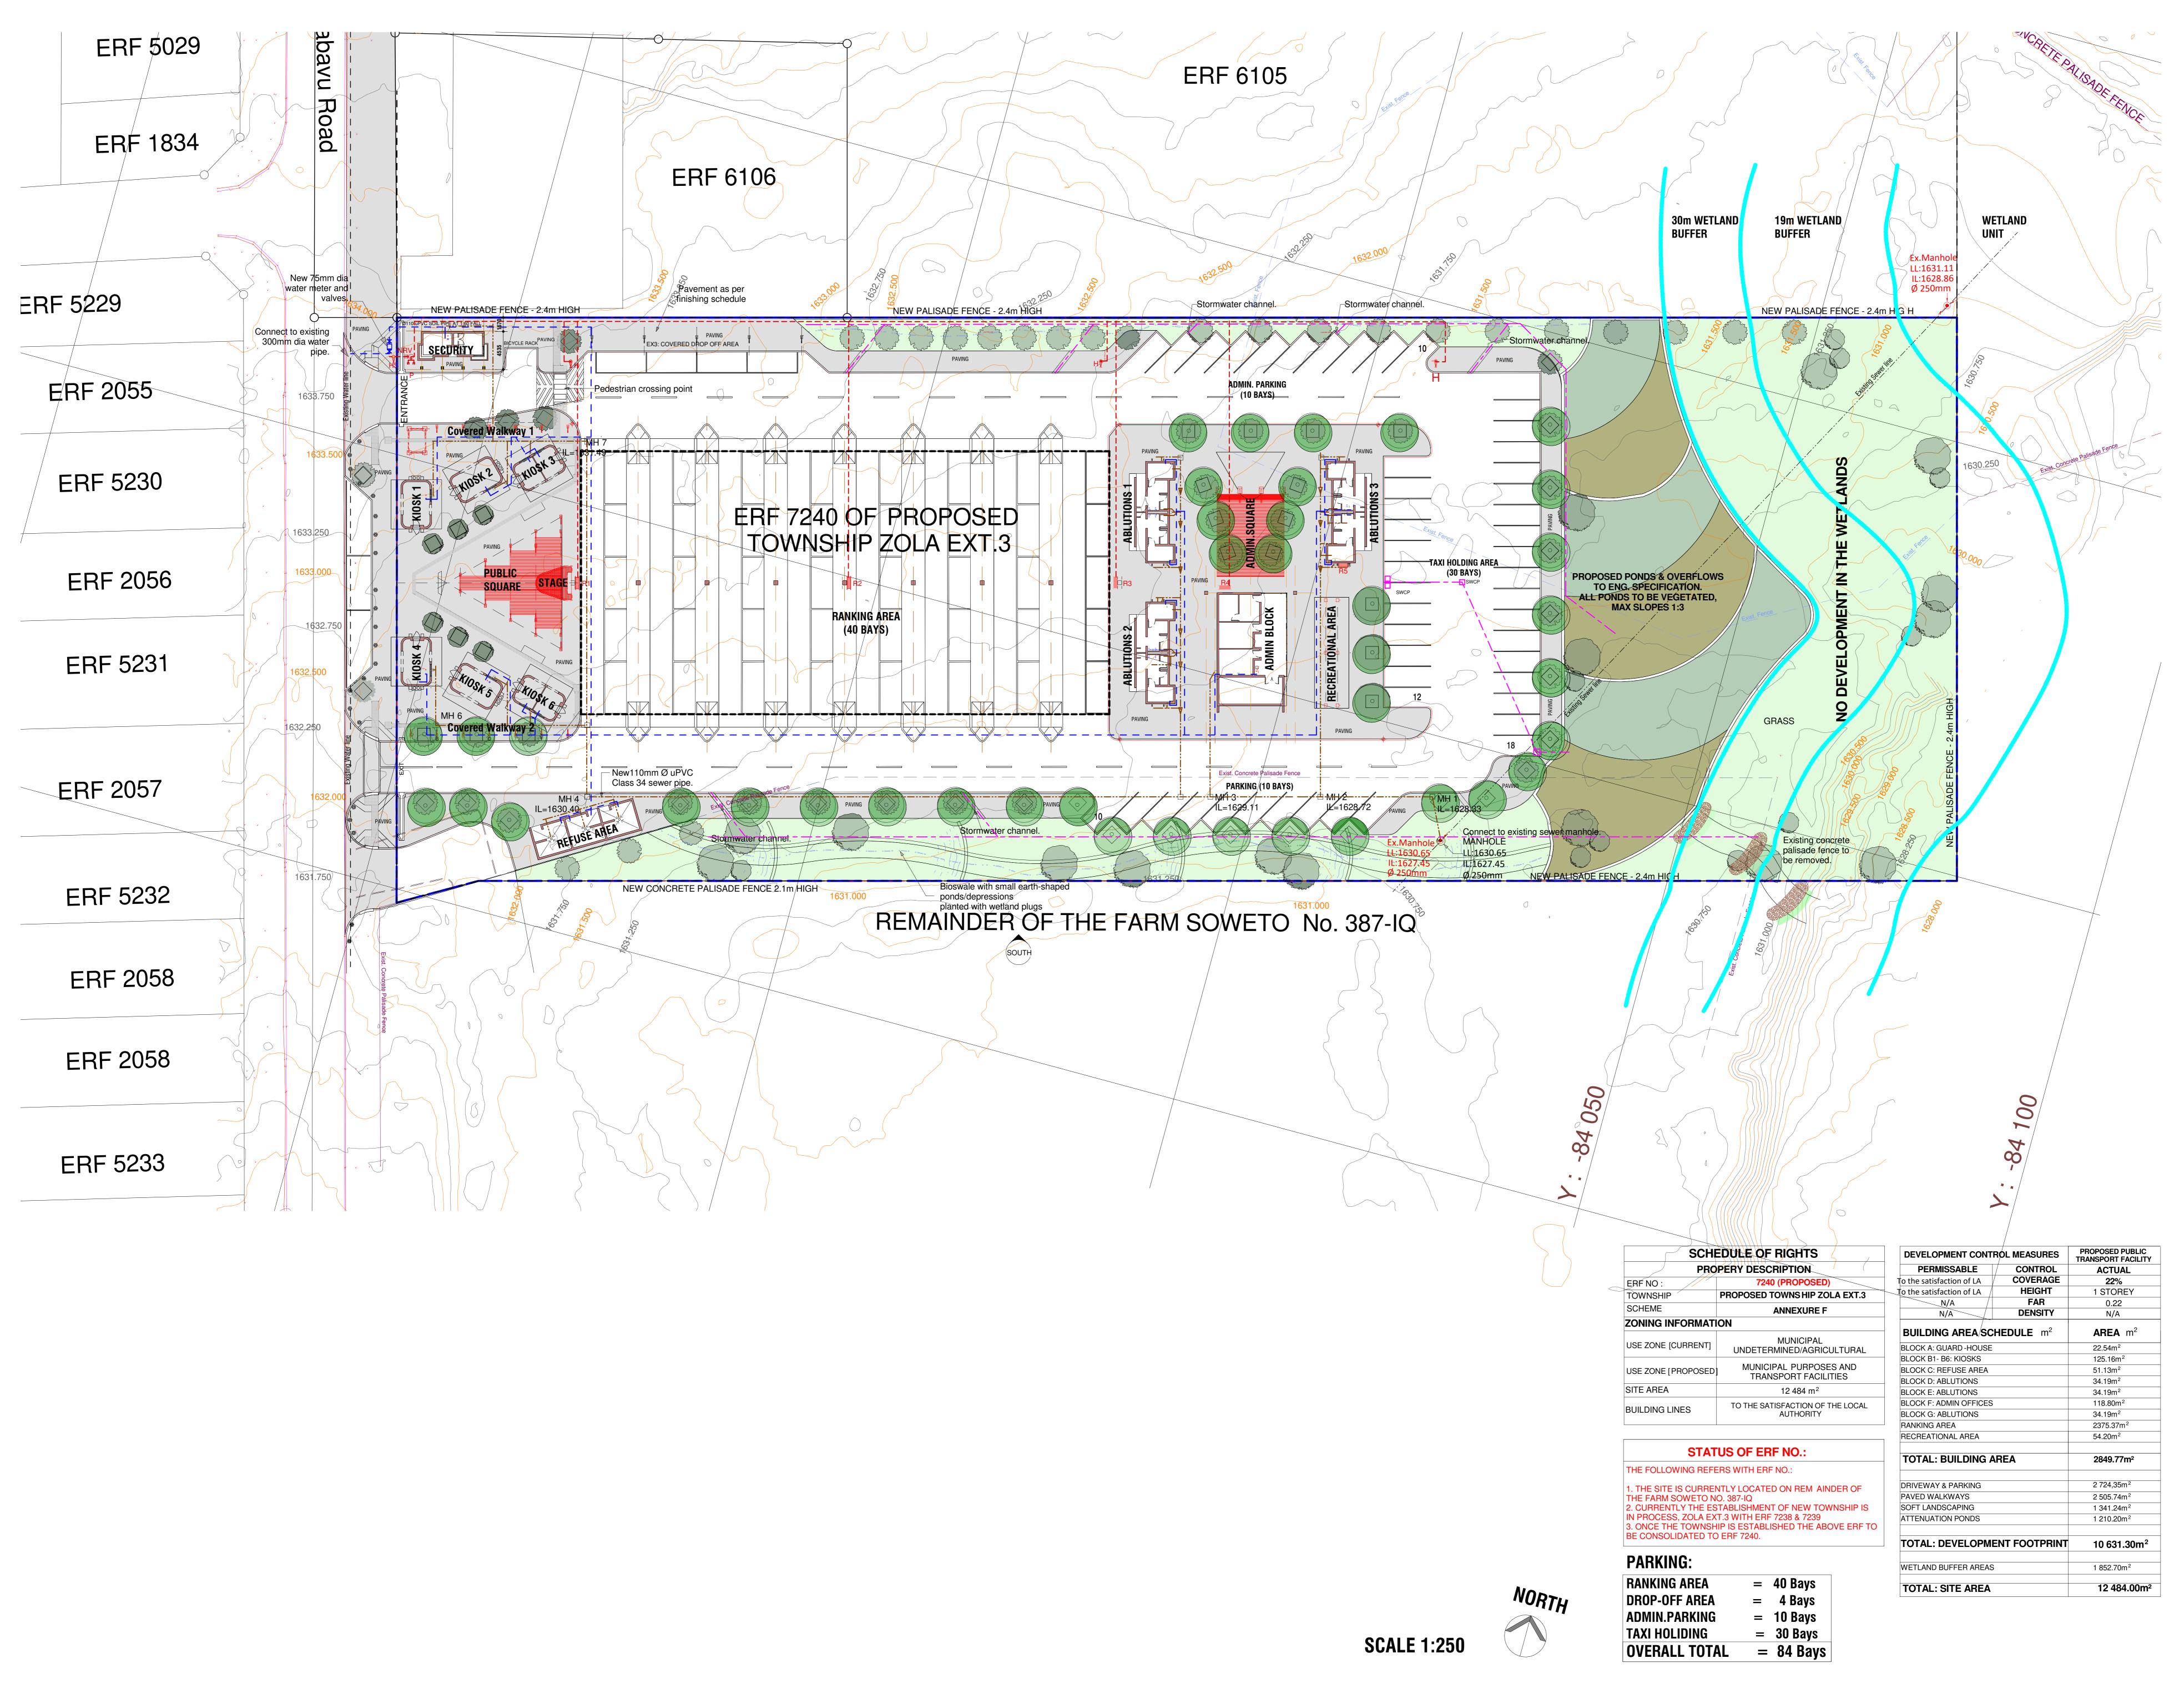
DRAWING TITLE
PROPOSED PREFERED LAYOUT
PLAN

- Taxi holding bays;
- Ranking bays;
- Admin parking bays;
- Drop off bays;
- Trading kiosks;
- Ablution blocks;
- Security office;
- Administration block; and
- A series of retention ponds, attenuation dams and bioswales.
