BRYPAAL SOLAR POWER (PV) PROJECT NOVEMBER 2017

Geological Report

Project Name	EIA for the proposed development of a 100 MW PV Solar Facility on the farm Brypaal, Northern Cape Province.		
Report Title Geological Report			
DEA Reference	14/12/16/3/3/2/1019		
Report Status	Final

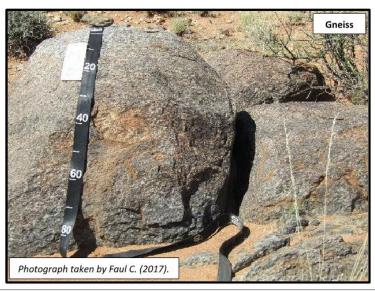
Figure 10 (continued): Geological identification and description.

Mapping	Coordinates		Geological Identification	Properties	
Unit	Latitude	Longitude		Topences	
C7	29°12'50,9″ S	20°21'48,1" E	Metaquartzite outcrop (MQ5 in Figure 2). No properties recorded.		
0	29°12′51,6″ S	20°21′43,9″ E	Metaquartzite outcrop (MQ6 in Figure 2).	5 in No properties recorded.	
	29°12′20.2″ S	20°22'37.2" E	No visible outcrops.	Small fragments of hydrothermal quarts and plagioclase present on the surface. Mixture of aeolian and fluvial sedimentary deposits.	
C14	29°12′20.1″ S	20°22′37.3″ E	Calcrete outcrop (C24 in Figure 2).	Total outcrop is approximately 4 m by 4 m in diameter.	
	29°12′20.5″ S	20°22′37.2″ E	Gneiss outcrop (G14 in Figure 2).	Total outcrop is approximately 4 m by 4 m in diameter. No strike or dip visible.

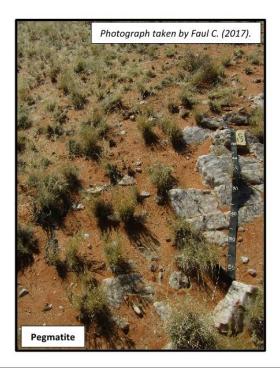
Figure 10 (continued): Geological identification and description.

Mapping	Coordinates		Geological	Properties	
Unit	Latitude	Longitude	Identification	riopentes	
D17	29°12′06.2″ S	20°23′18.1″ E	Metaquartzite outcrop (MQ15 in Figure 2).	The length of the outcrop is approximately 23 m in a E (74°) to a W (254° direction. The width is 17 m perpendicular to the length. The strike was r as 112°, with a 60° dip to the north.	
	29°12'04,8" S	20°23′16,6″ E	Gneiss outcrop (G15 in Figure 2).	No properties recorded.	
D10	29°12′05.0″ S	20°22'07.5" E	No visible outcrops.	Mixture of aeolian and fluvial sedimentary deposits.	
D19	29°12′05.2″ S	20°22′07.7″ E	Calcrete outcrop (C25 in Figure 2).	The length of the outcrop is approximately 10 m in a S (170°) to a N (340°) direction. The width is 5 m perpendicular to the length.

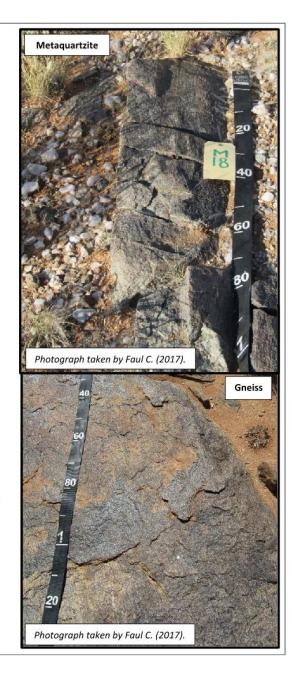
Figure 10 (continued): Geological identification and description.

Mapping	Coord	inates	Geological Identification	Properties	
Unit	Latitude	Longitude	Geological identification		
	29°11'45.9" S	20°23′23.5″ E	Calcrete outcrop (C19 & C20 in Figure 2).	No properties recorded.	
E3	29°11′47.1″ S 20°23′21.4″ E		Pegmatite outcrop (P6 & P7 in Figure 2).	No properties recorded.	
	29°11′41.9″ S	20°23′26.5″ E	Pegmatite outcrop (P8 in Figure 2).	No properties recorded.	
E5	29°12′34.5″ S	20°21′42.2″ E	No visible outcrops.	Calcrete boulders present on surface, as well as smaller fragments of hydrothermal quartz and plagioclase.	
E6	29°12′52.8″ S	20°21′48.0″ E	Pegmatite outcrop (P2 in Figure 2).	No properties recorded.	
E7	29°11′33.8″ S	20°22′18.4″ E	No visible outcrops.	Mixture of aeolian and fluvial sedimentary deposits.	
	29°11′33.7″ S	20°22′20.1″ E	Calcrete outcrop (C26 & C28 in Figure 2).	Total outcrop is approximately 5 m by 5 m in diameter.

Mapping Unit	Coordinates		Geological	Properties	
	Latitude	Longitude	Identification	ropentes	
	29°11'34.3″ S	20°22'21.2" E	Gneiss outcrop (G3 in Figure 2).	The length of the outcrop is approximately 40 m in a N (10°) to a S (190°) direction. The width is 20 m perpendicular to the length.	
E7	29°11′34.3″ S	20°22′21.2″ E	Calcrete outcrop (C27 in Figure 2).	The length of the outcrop is approximately 17 m in a SSE (150°) to a NNW (330°) direction. The width is 5 m perpendicular to the length.	
	29°11′33.4″ S	20°22′18.4″ E	Calcrete outcrop (C39 in Figure 2).	No properties recorded.	
E9 29°11′55.3″ S		20°22'06.0" E	No visible outcrops.	Calcrete boulders present on surface, as well as smaller fragments of hydrothermal quartz and plagioclase.
