**PAN AFRICAN RESOURCES PLC: BARBERTON MINES (PTY) LTD**  
**FAIRVIEW MINE**  
**PROPOSED FAIRVIEW TSF AND RECLAMATION OF HISTORIC DUMPS**  
**REFERENCE NUMBER MP30/5/1/2/2/191MR**

Plan 1: Project activities in relation to the WHS, Geotrail and BNR

**Figure 1: Location of Barberton in the Mpumalanga Province.**

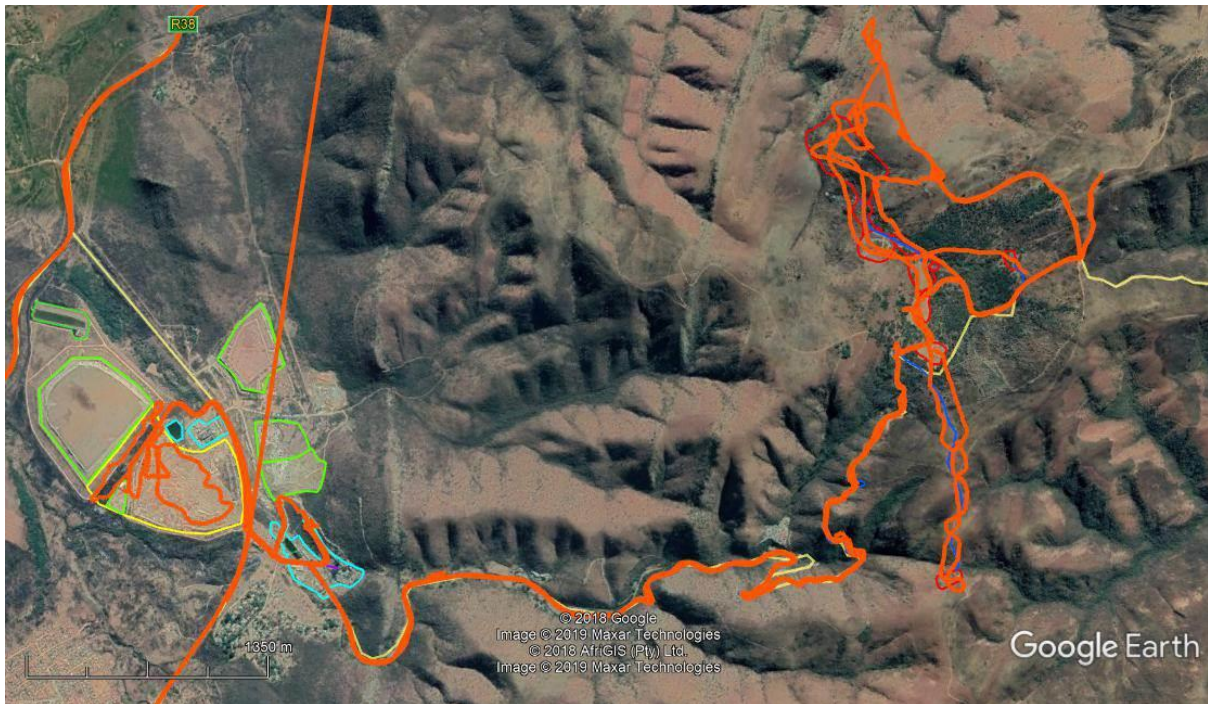
**Figure 5: GPS track of the surveyed area. North reference is to the top.**

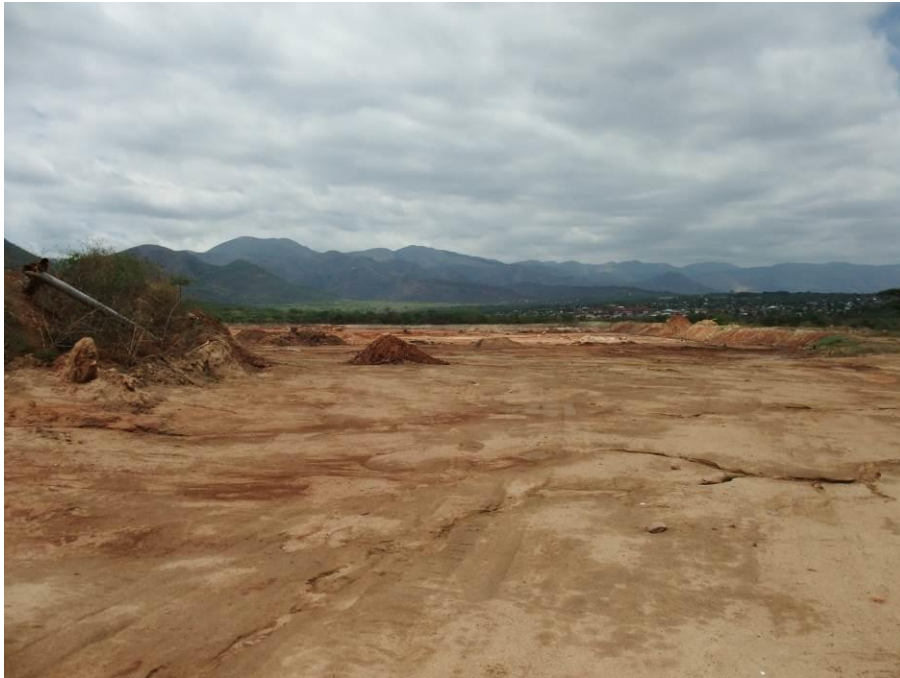
The surveyed area can be divided into three. Firstly, there is the proposed tailings dam area, which is entirely disturbed. It consists of an existing TSF, which is being reclaimed (Figure 6) and a small stretch with natural vegetation where disturbance is also visible. In this section the vegetation is reasonably dense in certain sections, but with open patches in between (Figure 7). The topography here is reasonably flat.

**Figure 6: General view of TSF being reclaimed.**

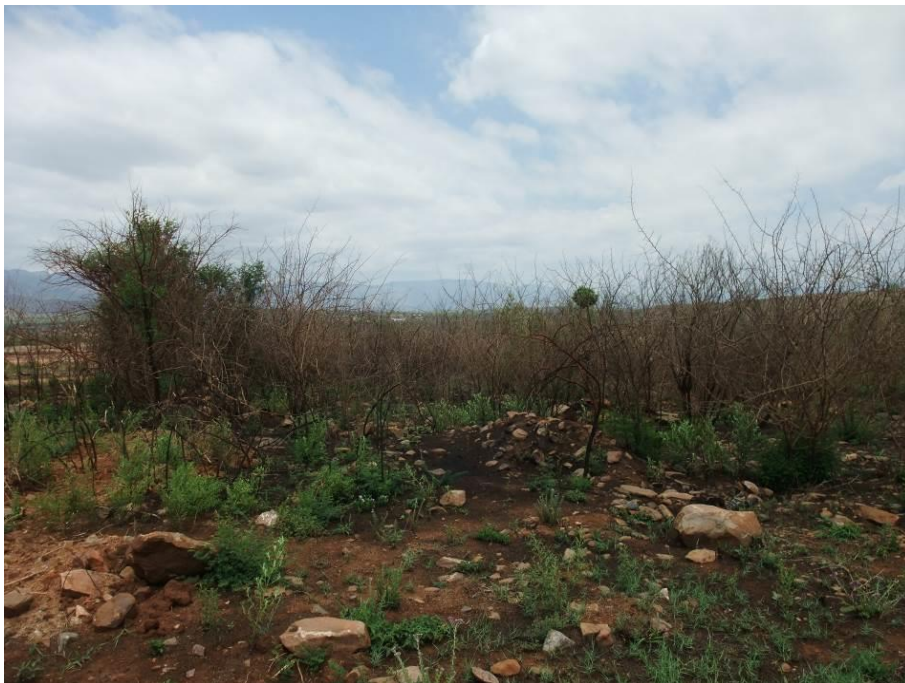
**Figure 7: General view at the area where the TSF is proposed.**

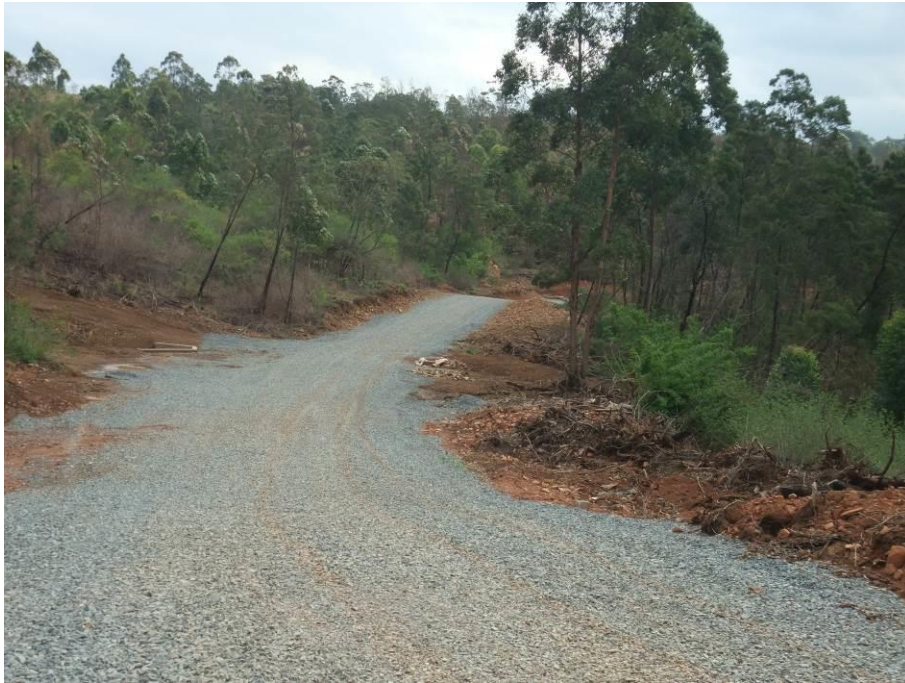
The second area is the road leading up to the third. This is an existing road, which will merely be upgraded. It runs along the very steep sides of the mountain and is entirely disturbed, since it is an existing road (Figure 8-9). The topography here is steep.

**Figure 8: Section of road that will be upgraded.**

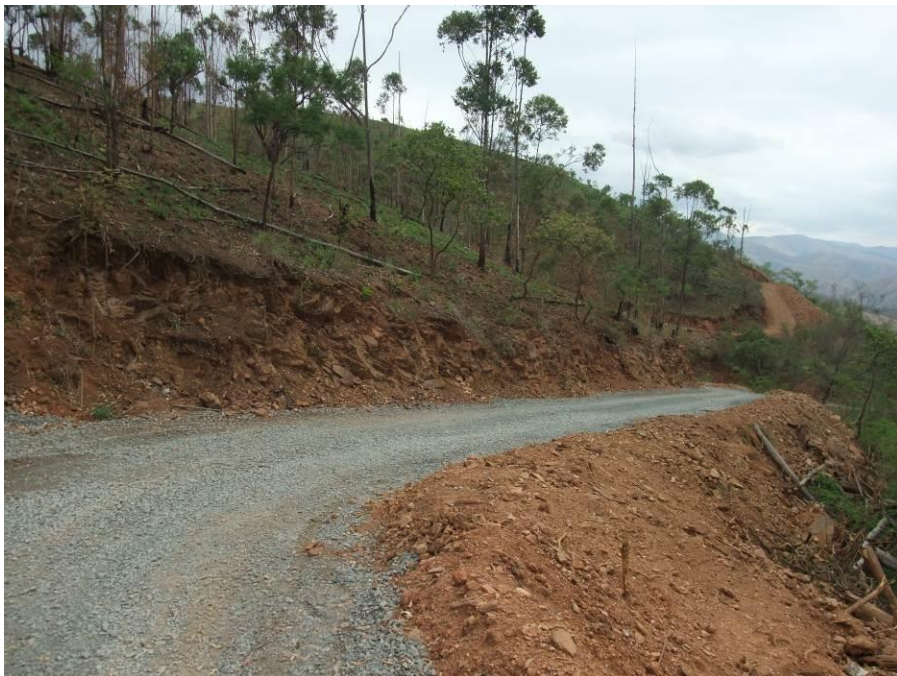
**Figure 9: Another section of the road to be upgraded.**

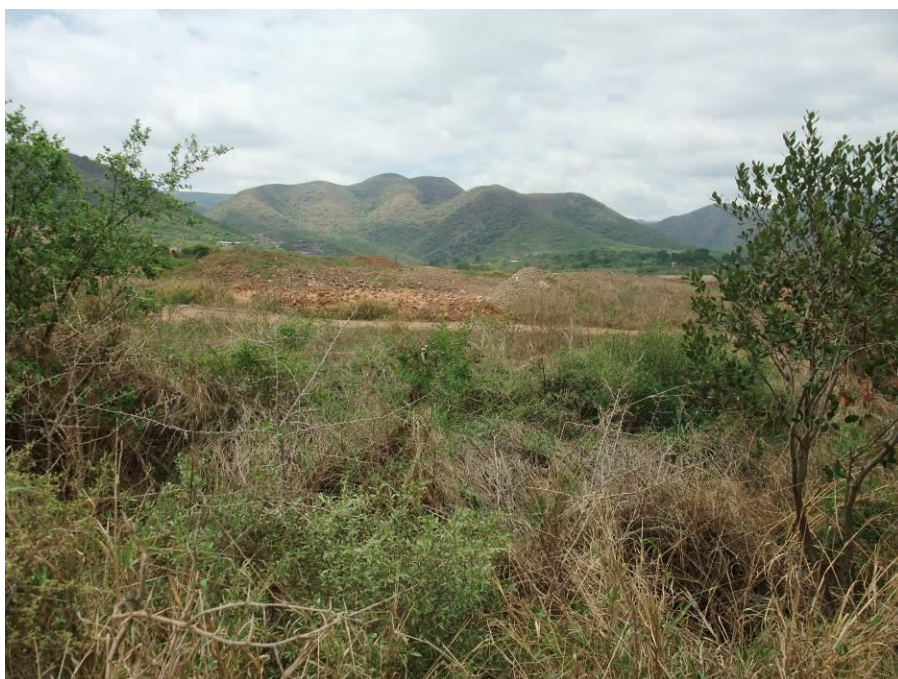
The third is the different areas that will be reclaimed for mining purposes. These are either within the valleys or against the very steep slopes of the mountains (Figure 10) As these are were formerly mined it also is disturbed areas. Vegetation cover is low against the slopes (Figure 11), but denser within the valleys. Disturbance mainly consist of roads, former mining excavations (Figure 12) and building ruins. The topography of the area is steep, falling rapidly towards the valleys where water courses are located.

**Figure 10: General view of the environment with high mountains.**

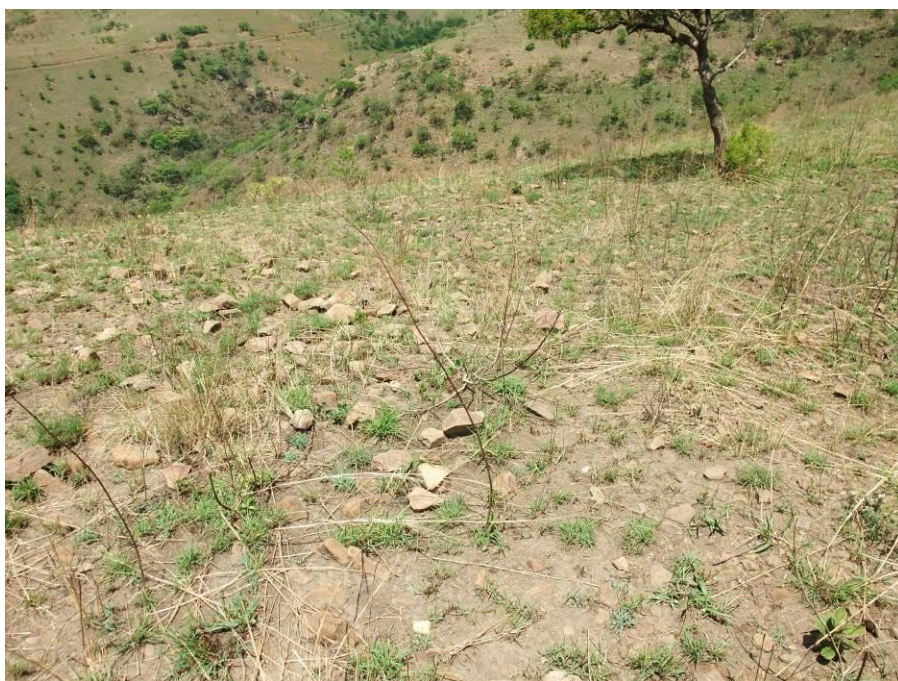
**Figure 11: View of vegetation in the mountainous area.**

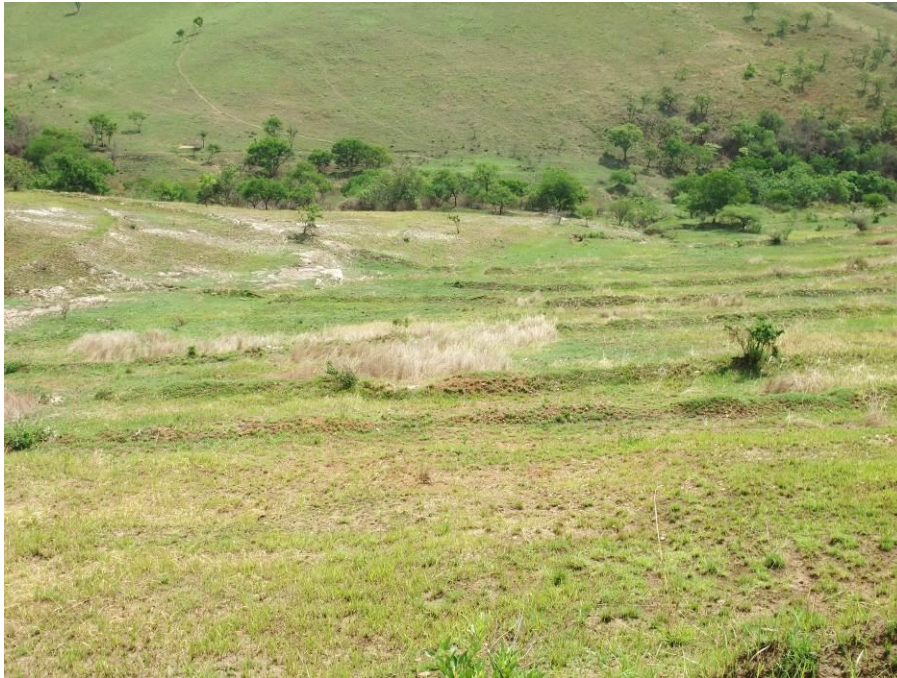
**Figure 12: View of old mining excavation in the surveyed area.**

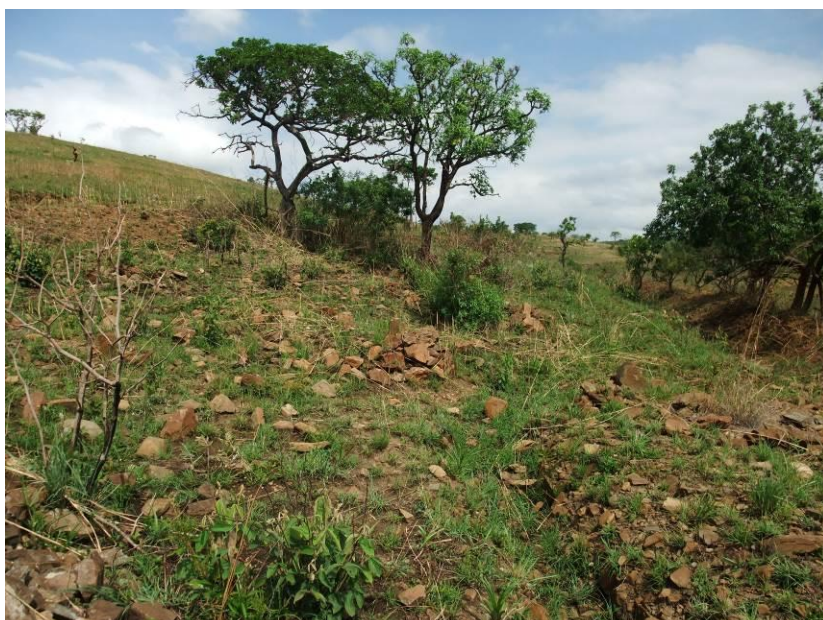
This is a site containing at least 17 graves (Figure 16). These are all stone packed without any information although they all have stone headstones. It probably is the graves of mine workers.

31°06'12.09"E – this lies approximately 10 m from one of the proposed reclamation mining areas.

**Figure 16: The graves at site no. 1.**

Two possibilities exist. The first option would be to fence the graves in and have a management plan drafted for the sustainable preservation thereof. This should be written by a heritage expert. This usually is done when the graves are in no danger of being damaged, but where there will be a secondary impact due to the activities of the mine.

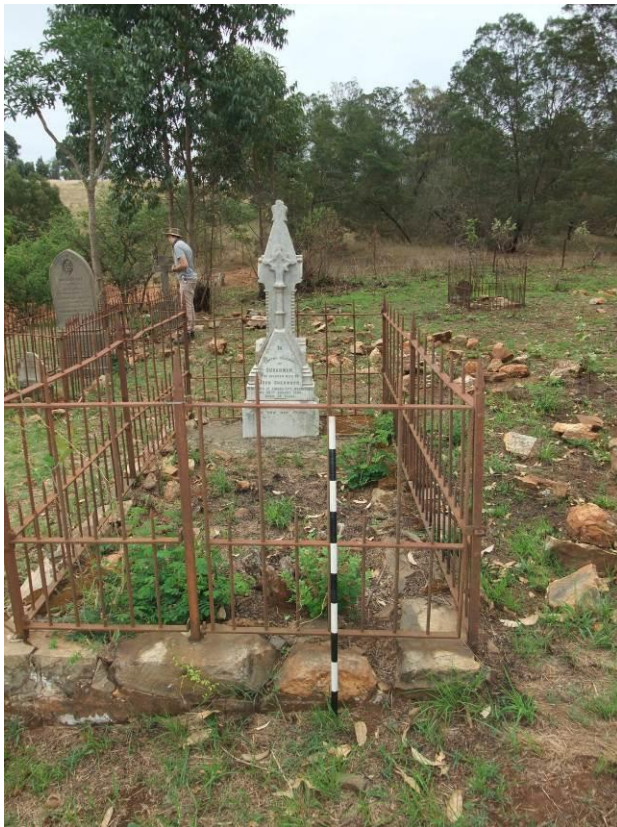
This is a site containing at least 18 graves (Figure 17). Some graves are stone packed, and some have cement dressing. The graves mostly have headstones, but in some cases the information is illegible. Headstones are made of stone, granite, marble and slate. One of the headstones is a commemorative stone in memory of three people who died when the Drummond Castle sank in 1896.

31°06'18.73"E – this lies next to the road to be upgraded.

**Figure 17: The graves at site no. 6.**

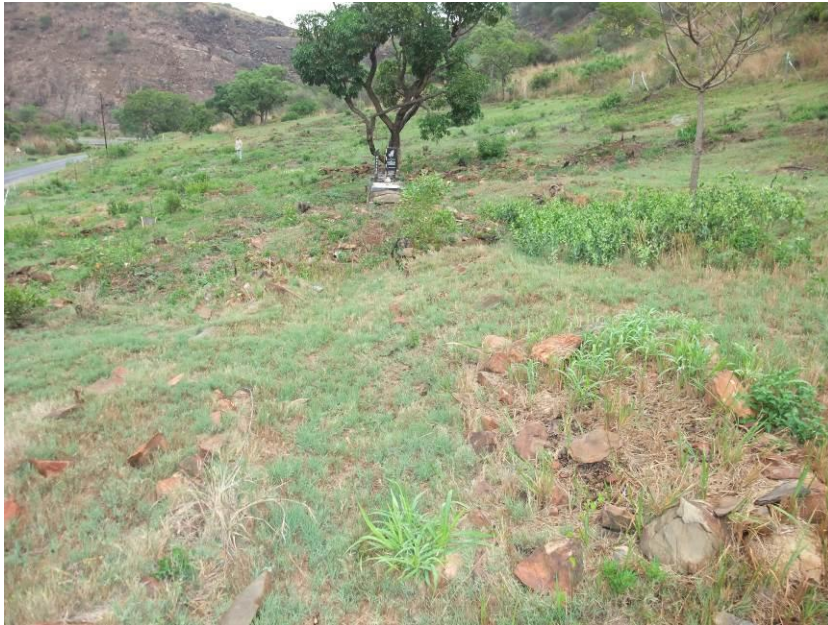
31°04'53.54"E – it lies right next to the tarred section of road, which will therefore not be upgraded.

**Figure 18: The graves at site no. 8.**

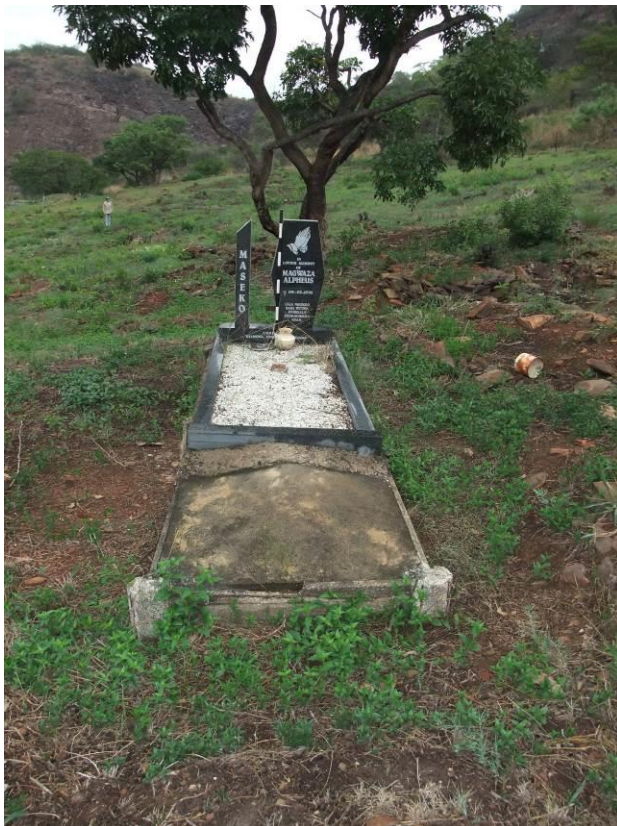
**Figure 19: The only marked grave at site no. 8.**

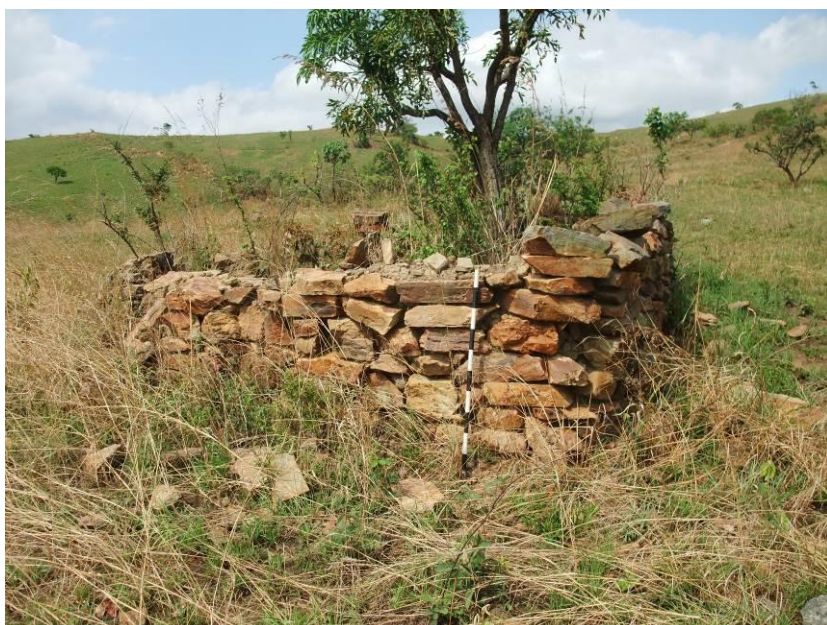
This is the ruin of a rectangular stone building with walls of 4 m long and approximately 1 m high (Figure 20). It has an entrance on the western side. It could be an old house used by a miner during the very first mining era on site.

31°06'15.30"E – this is about 20 m outside of one of the reclamation mining areas.

**Figure 20: Ruin of stone building.**

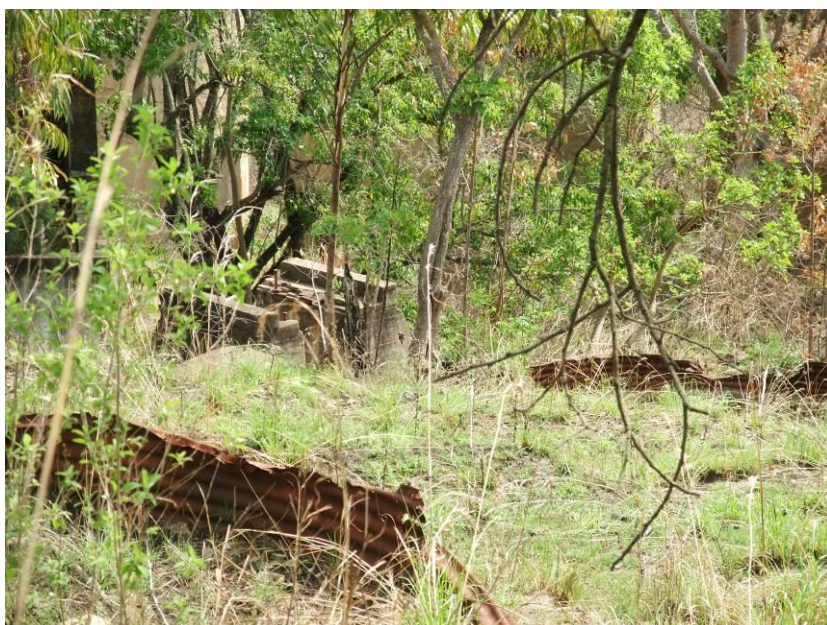
This is the remains of an old mine shaft and probably related to the earlier mining at Fairview during the 1950's-1970s (Figure 21). It consists of the ruins of various buildings, but the vegetation in the area is very dense making further identification difficult.

**Figure 21: Some of the buildings and structures at site no. 3.**

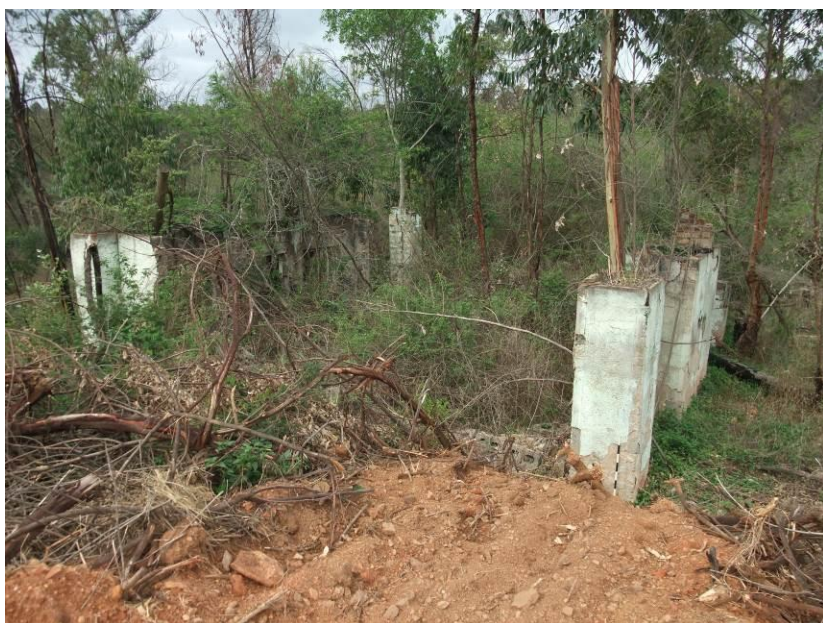
This is the ruin of a house with sides of approximately 12 x 12 m and at least five rooms (Figure 22). It is built from brick and concrete. It probably was used as accommodation during the mining period of the 1950's -1970's.

31°06'32.06"E – it is next to the road that will be upgraded.

**Figure 22: House ruin – site no. 4.**

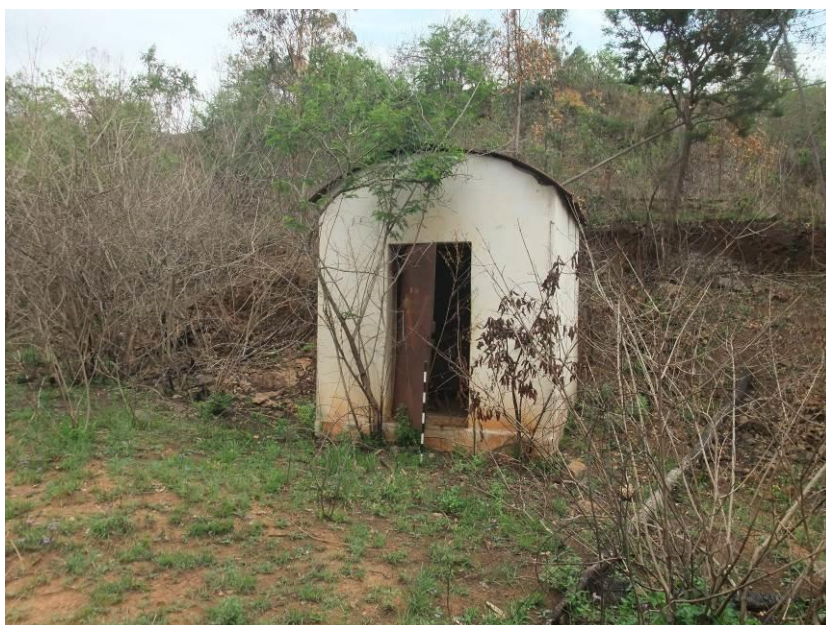
The site consists of a small building of about 3 x 2 m with concrete build walls and a corrugated iron roof (Figure 23). It also is likely associated with site no. 3 and may have been the magazines room for the mine/ one of the past mining operations.

**Figure 23: Possible magazines room.**

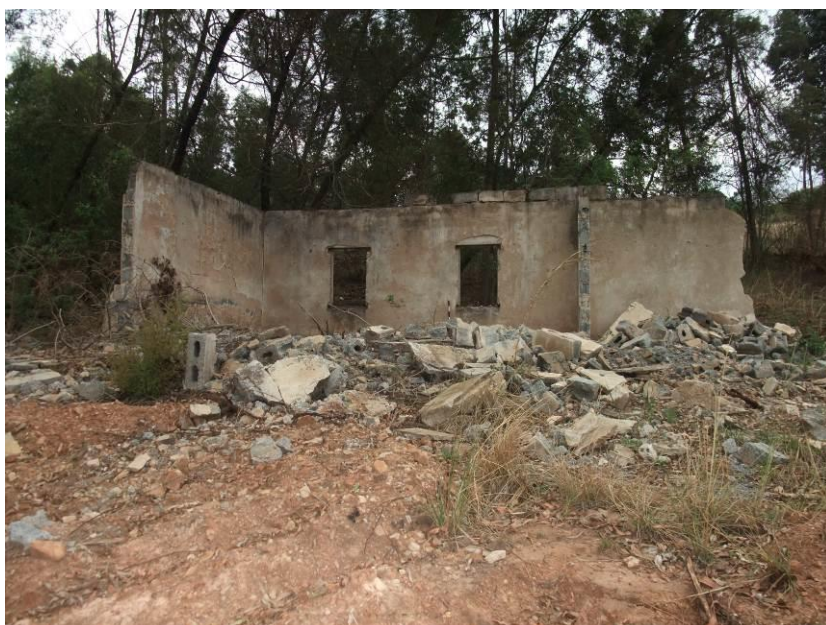
This is the ruin of a house with sides of approximately 10 x 6 m and at least two rooms (Figure 24). It is built from brick and concrete. It probably was used as accommodation during the mining period of the 1950's -1970's.

31°06'20.27"E – it is next to the road that will be upgraded.

**Figure 24: House ruin – site no. 6.**

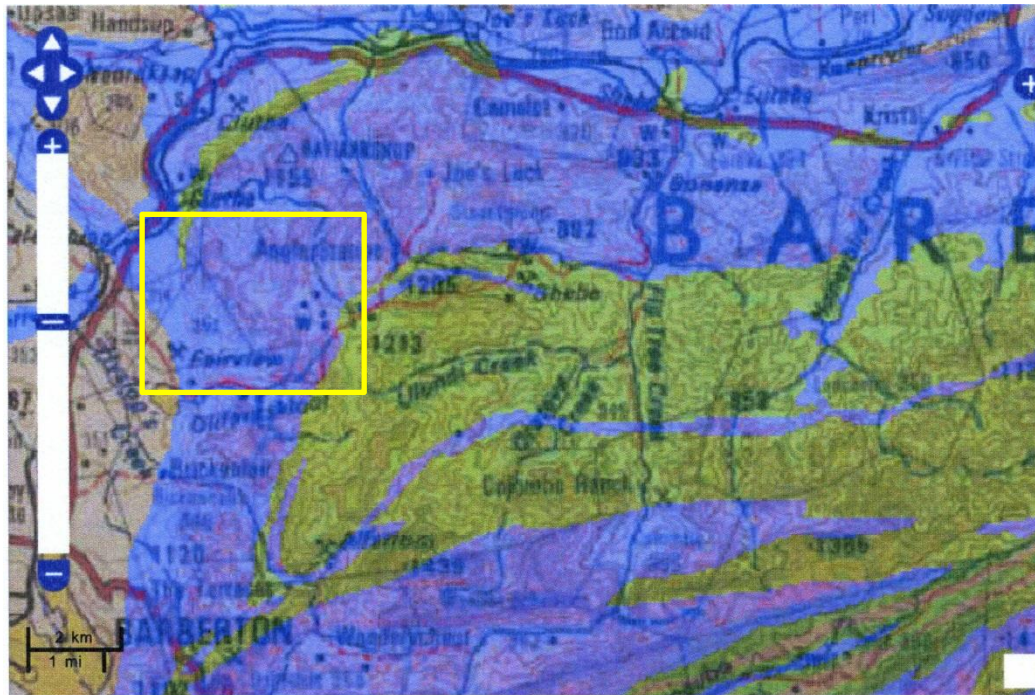
Figure 5: SAHRIS palaeosensitivity map of the region around Fairview Mining area (yellow rectangle) and Sheba Gold Mine (arrowed). The project site is in the blue area with sections on the east (unaffected by the proposed Project) in the green area. Colours indicate the following degrees of sensitivity: red = very highly sensitive; orange/yellow = high; green = moderate; blue = low; grey = insignificant/zero.

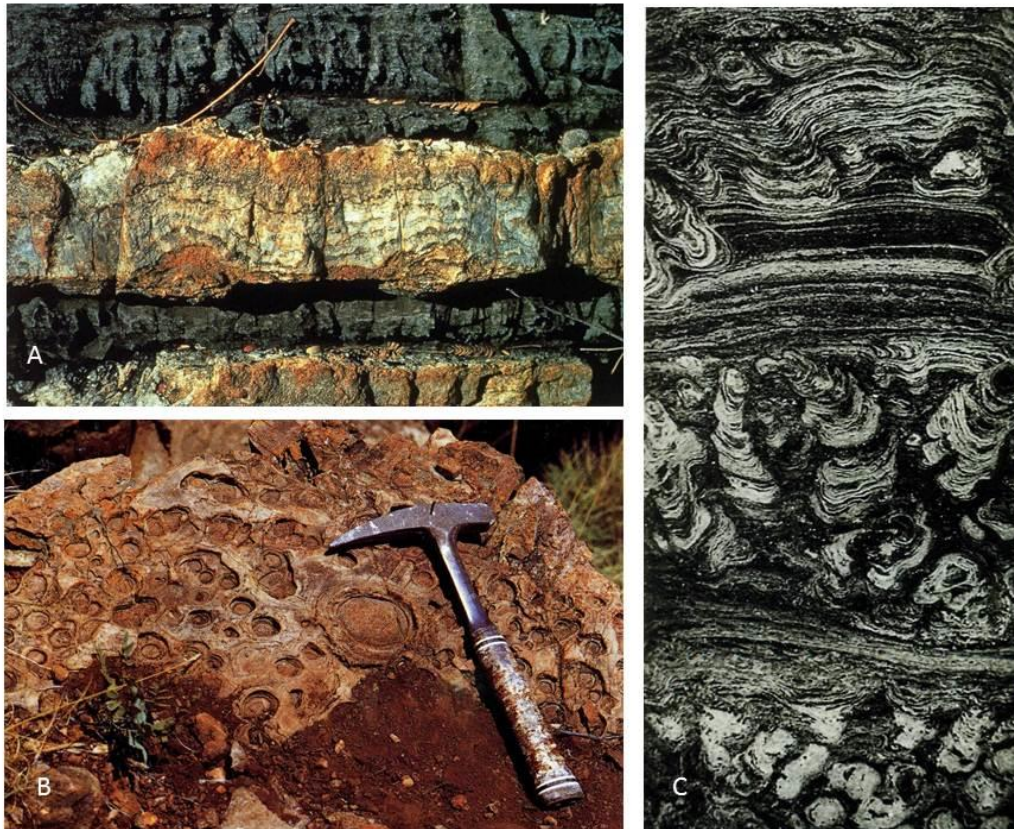
Figure 4: Examples of stromatolites as seen in the field; A and C are vertical cuts and B is the surface view.
