NKETOANA LOCAL
MUNICIPALITY

PROPOSED TOWNSHIP ESTABLISHMENT ON FARM MORGEN 542, REITZ

GEOTECHNICAL ENGINEERING REPORT

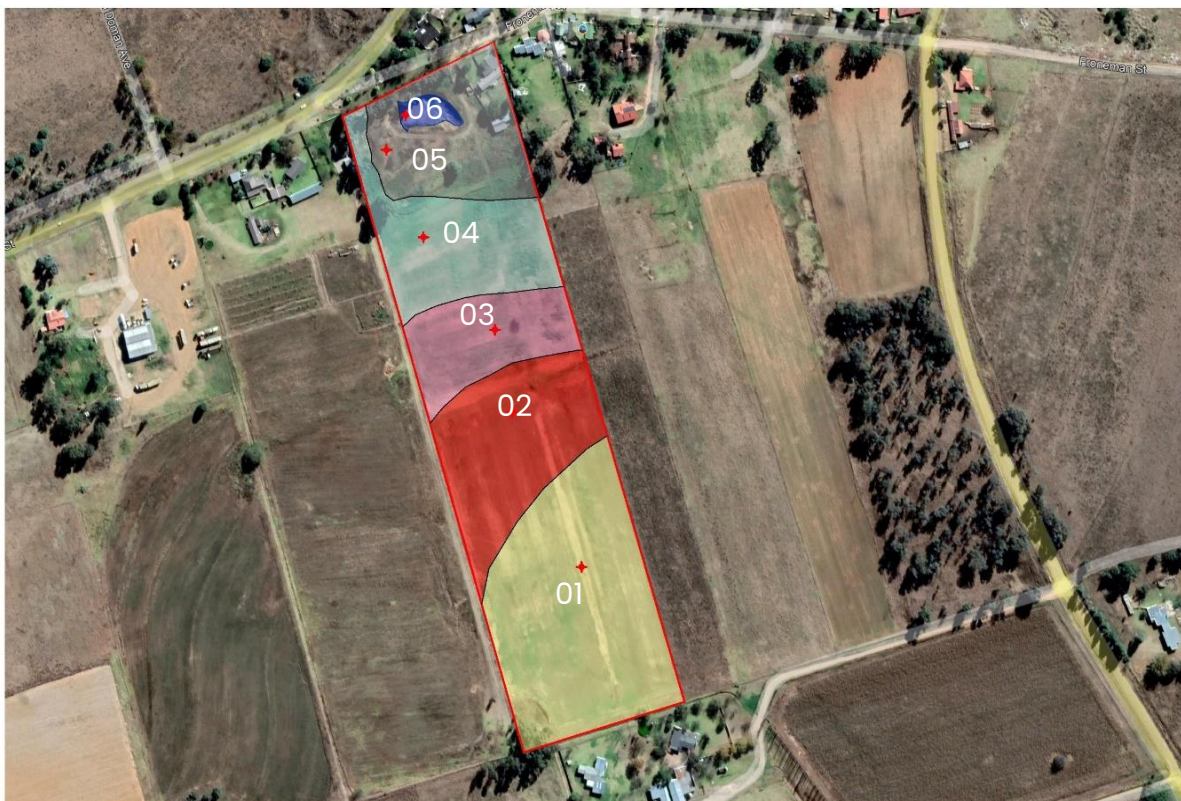
Figure 06: Soil Sensitivity Map for Morgen 542

The soil sensitivity was determined and mapped by logical comparison of the different soil factors as summarised in Table 1. The soil sensitivity map is illustrated in Figure 06. The soil properties of the various map units in figure 06 is summarised in Table 2.

Soil Formula Legend as Described in Table 1 above:			
01	Trtmh2d3Oa (W1)	04	Trtmh3d3Sw (W1)
02	Trtmh2d3Oa (W1)	05	Trtmh3d3Sw (W1)
03	Trtmh3d3Oa (W1)	06	Jdmh1d2Ms (W2)

Map No.	Formula	Soil Properties
01	Trtmh2d3Oa (W1)	Deep Oakleaf soil form on Tarkastad formation with Neocutanic Horizon B1, Weak to moderate structure, from saprolite
02	Trtmh2d3Oa (W1)	Deep Oakleaf soil form on Tarkastad formation with Neocutanic Horizon B1, Weak to moderate structure, from saprolite
03	Trtmh3d3Oa (W1)	Deep Oakleaf soil form on Tarkastad formation with Neocutanic Horizon B1, Weak to moderate structure, from saprolite
04	Trtmh3d3Sw (W1)	Sweetwater soil form on Tarkastad formation with Neocutanic Horizon B1, Weak to moderate structure, poor horizon differentiation
05	Trtmh3d3Sw (W1)	Sweetwater soil form on Tarkastad formation with Neocutanic Horizon B1, Weak to moderate structure, poor horizon differentiation
06	Jdmh1d2Ms (W2)	Shallow Mispah soils on dolerite outcrop with gentle slope

Figure 06	Soil Classification & Description	Geotechnical Constraints
01	Deep Oakleaf soil on Tarkastad Formation on gentle slope	a) Less active soil- Expansive properties in BI-horizon b) Slope- Between 2-4%
02	Deep Oakleaf soil on Tarkastad Formation on gentle slope	a) Less active soil - Expansive properties in BI-horizon b) Slope- Between 2-4%
03	Deep Oakleaf soil on Tarkastad Formation on gentle slope	a) Less active soil - Expansive properties in BI-horizon b) Slope- Between 4-8%
04	Deep Sweetwater soil on Tarkastad Formation on gentle slope	c) Less active soil - Expansive properties in BI-horizon a) Slope- Between 4-8%
05	Deep Sweetwater soil on Tarkastad formation on steep slope	d) Less active soil - Expansive properties in BI-horizon a) Slope- Between 4-8%
06	Shallow Mispah soil on Dolerite stone with shallow slope	a) Excavation up to 1.3m- Saprolite is <1300mm deep (Active) b) Slope- Between 0-2% gradient

Figure 06	Stable	Expandability	Collapsibility	Compressibility
01		H1	C1	S1
02		H	C1	S1
03		H1	C1	S1
04		H	C1	S1
05		H1	C1	S1
06	R	H

Figure 06	Site Classification	Recommended construction method (HNBC, 1999)
01	H1, C1, S1	Modified normal / compaction of in situ soil below individual footing / deep strip foundation / soil raft
02	H, C1, S1	Modified normal / compaction of in situ soil below individual footing / deep strip foundation / soil raft
03	H1, C1, S1	Modified normal / compaction of in situ soil below individual footing / deep strip foundation / soil raft
04	H, C1, S1	Modified normal / compaction of in situ soil below individual footing / deep strip foundation / soil raft
05	H1, C1, S1	Modified normal / compaction of in situ soil below individual footing / deep strip foundation / soil raft
06	R, H	Normal construction

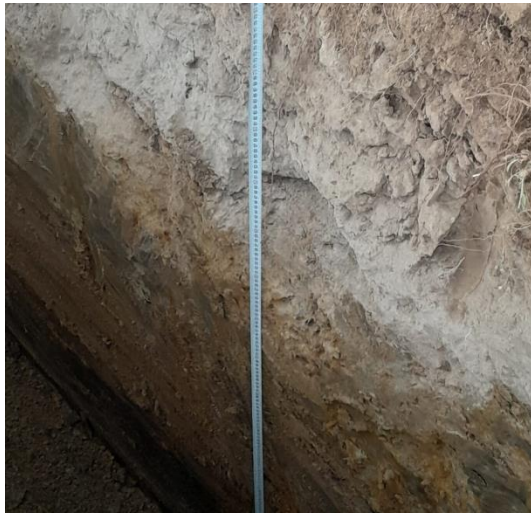
Test Pit 01

Pit no.	Horizons	Type of Horizon	Depth	Estimated Clay	
				Content	GPS Co-ordinates
01	A Horizon	Orthic	0-220mm	15	27°48'52"S
	B1 Horizon	Neocutanic	220-660mm	25	28°25'37.2"E
	B2 Horizon	Unspecified	660-2400mm	35	
	C Horizon	Hardrock	2400mm+		
Soil form		Oakleaf

UNIFIED/ TRB CLASS	SAMPLE NO.	LEGEND	DEPTH (m)	DESCRIPTION	POTENTIAL EXPANSIVENESS
			0.00	Moist, Brown, Dense, Fine-grained Sand, with Roots ORTHIC	(Low)
			0.22	Moist, Light Grey, Dense, Fine-grained Sand NEOCUTANIC	(Low)
			0.66	Moist, Orange_Grey, Dense, Fine-grained Mudstone UNSPECIFIED	(Low)
			1m		
			2m		
			2.40	Sandstone HARDROCK	
			3m		
			4m		
				NOTES: 1. Excavations done by Tractor-Loader Backhoe Machine. 2. No Ground water encountered below NGL. 3. No Pebble Marker encountered. 4. No Pedogenic material encountered.

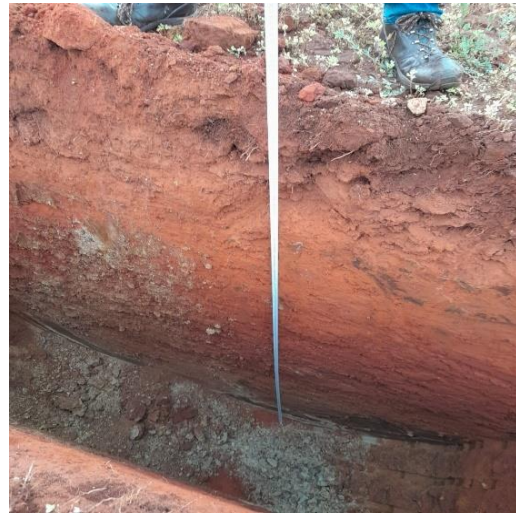
Test Pit 02

Pit no.	Horizons	Type of Horizon	Depth	Estimated Clay	
				Content	GPS Co-ordinates
02	A Horizon	Orthic	0-150mm	15	27°48'47.7"S
	B1 Horizon	Neocutanic	150-650mm	25	28°25'35"E
	B2 Horizon	Unspecified	650-2500mm	35	
	C Horizon	Hardrock	2500mm+		
Soil form		Oakleaf

UNIFIED/ TRB CLASS	SAMPLE NO.	LEGEND	DEPTH (m)	DESCRIPTION	POTENTIAL EXPANSIVENESS
			0.00	Moist, Brown, Dense, Fine-grained Sand, with Roots ORTHIC	(Low)
			0.15	Moist, Light Grey, Dense, Fine-grained Sand NEOCUTANIC	(Low)
			0.65	Moist, Orange_Black, Dense, Fine-grained Shale Mudstone UNSPECIFIED	(Low)
			2.50	Sandstone HARDROCK	
			4m		
				NOTES: 1. Excavations done by Tractor-Loader Backerhoe Machine. 2. No Ground water encountered below NGL. 3. No Pebble Marker encountered. 4. No Pedogenic material encountered.

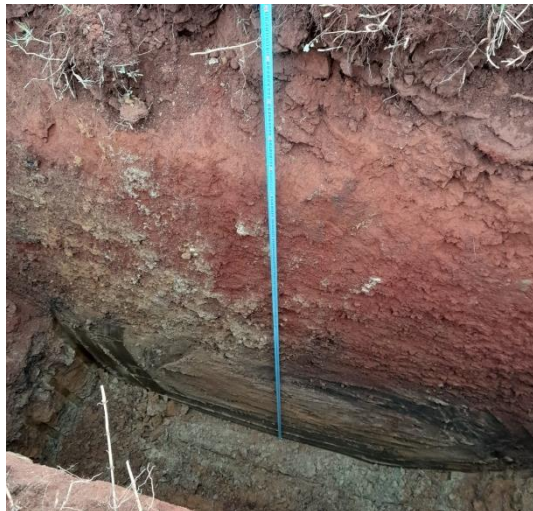
Test Pit 03

Pit no.	Horizons	Type of Horizon	Depth	Estimated Clay	
				Content	GPS Co-ordinates
03	A Horizon	Orthic	0-280mm	15	27°48'45.4"S
	B1 Horizon	Neocutanic	280-1200mm	25	28°25'34.4"E
	B2 Horizon	Unspecified	1200-2800mm	35	
	C Horizon	Hardrock	2800mm+		
Soil form		Oakleaf

UNIFIED/ TRB CLASS	SAMPLE NO.	LEGEND	DEPTH (m)	DESCRIPTION	POTENTIAL EXPANSIVENESS
			0.00	Moist, Dark Brown, Dense, Fine-grained Sand, with roots ORTHIC	(Low)
			0.28	Moist, Reddish Brown, Dense, Fine-grained Sand NEOCUTANIC	(Low)
			1.20	Moist, Reddish Brown-Grey, Dense, Clayey Sand UNSPECIFIED	(Low)
			2.80	Light-Brown, Dense, Clayey Sand UNSPECIFIED	(Low)
			3.40	Sandstone HARDROCK	
				NOTES: 1. Excavations done by Tractor-Loader Backhoe Machine. 2. No Ground water encountered below NGL. 3. No Pebble Marker encountered. 4. No Pedogenic material encountered.

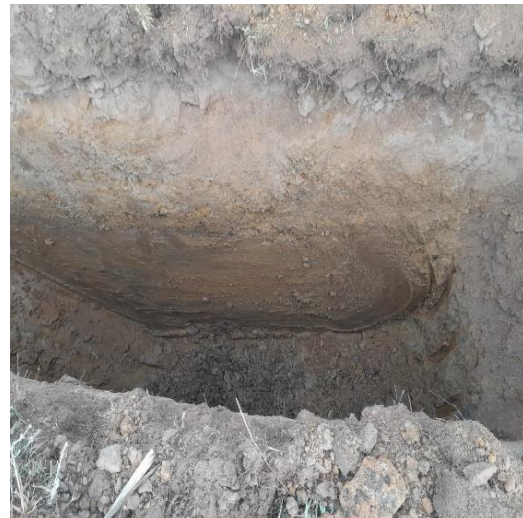
Test Pit 04

Pit no.	Horizons	Type of Horizon	Depth	Estimated Clay	
				Content	GPS Co-ordinates
04	A Horizon	Humic	0-200mm	15	27°48'42.8"S
	B1 Horizon	Neocutanic	200-2100mm	25	27°48'32.1"E
	B2 Horizon	Neocutanic	2100-3000mm	35	
	C Horizon	Hardrock	3000mm+		
Soil form		Sweetwater

UNIFIED/ TRB CLASS	SAMPLE NO.	LEGEND	DEPTH (m)	DESCRIPTION	POTENTIAL EXPANSIVENESS
			0.00	Moist, Dark Brown, Dense, Fine-grained Sand, with roots HUMIC	(Low)
			0.20	Moist, Reddish Brown, Dense, Fine-grained Sand NEOCUTANIC	(Low)
			2.10	Moist, Light Grey, Shale NEOCUTANIC	(Low)
			3.00	Sandstone HARDROCK	
<p>NOTES:</p> <ol style="list-style-type: none"> Excavations done by Tractor-Loader Backhoe Machine. No Ground water encountered below NGL. No Pebble Marker encountered. No Pedogenic material encountered.

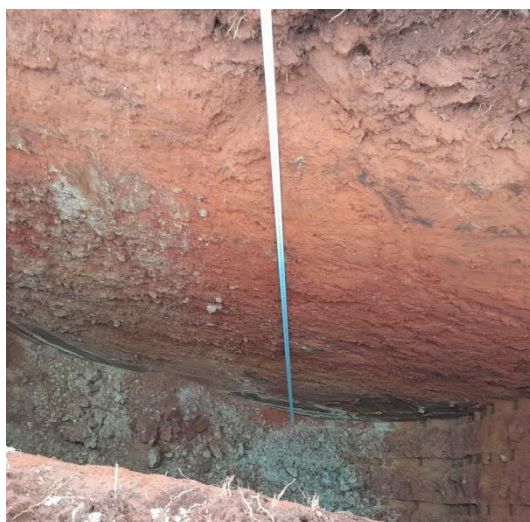
Test Pit 05

Pit no.	Horizons	Type of Horizon	Depth	Estimated Clay	GPS Co-ordinates
				Content	
05	A Horizon	Humic	0-180mm	15	27°48'40.4"S
	B1 Horizon	Neocuratic	180-1880mm	25	28°25'31.0"E
	B2 Horizon	Neocuratic	1880-2600mm	35	
	C Horizon	Hardrock	2600mm+		
Soil form		Sweetwater

UNIFIED/ TRB CLASS	SAMPLE NO.	LEGEND	DEPTH (m)	DESCRIPTION	POTENTIAL EXPANSIVENESS
			0.00	Moist, Dark Brown, Dense, Fine-grained HUMIC Sand, with roots	(Low)
			0.18	NEOCUTANIC	
			1m	Moist, Reddish Brown, Dense, Fine-grained Sand	(Low)
			1.88 2m	NEOCUTANIC Moist, Light Brown, Fine-grained Sandstone	(Low)
			2.60	HARDROCK Sandstone	
			3m		
			4m		
				NOTES: 1. Excavations done by Tractor-Loader Backhoe Machine. 2. No Ground water encountered below NGL. 3. No Pebble Marker encountered. 4. No Pedogenic material encountered.

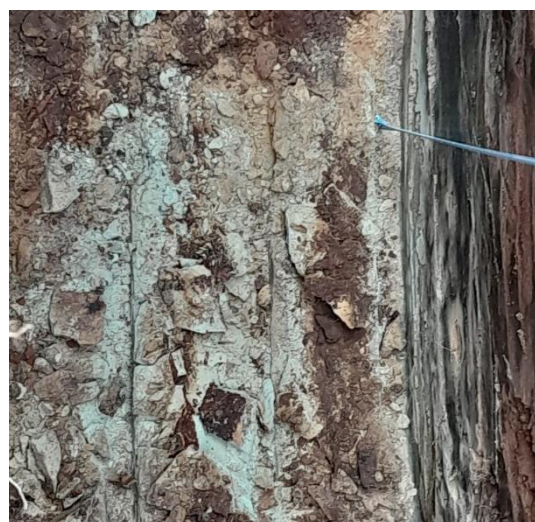
Test Pit 06

Pit no.	Horizons	Type of Horizon	Depth	Estimated Clay	GPS Co-ordinates
				Content	
06	A Horizon	Orthic	0-1300mm	35	27°48'39.3"S
	B1 Horizon	Hardrock	1300mm+	25	28°25'31.6"E
Soil form		Mispah

UNIFIED/ TRB CLASS	SAMPLE NO.	LEGEND	DEPTH (m)	DESCRIPTION	POTENTIAL EXPANSIVENESS
			0.00 1m	Moist, Dark Yellow, Soft Rock ORTHIC	(High)
			1.30 2m 3m 4m	Dolerite Rock HARDROCK	
				NOTES: 1. Excavations done by Tractor-Loader Backhoe Machine. 2. No Ground water encountered below NGL. 3. No Pebble Marker encountered. 4. No Pedogenic material encountered.

It was deduced that the liquid water that was encountered at test pit 06 during the inspection that was conducted was due to rainfall or other forms of precipitation and was not due to seepage and/ or infiltration.
