***Report to eThekweni Municipality Water and Sanitation
Unit on the Results of a Shallow Geotechnical
Investigation for the Proposed Sewer Reticulation
Pipelines within Wards 38, 41 and 45 of the Kwa
Mancinza Area, Ntuzuma B, Northern Operational Area
of eThekweni Municipality, KwaZulu-Natal***

Reference: 233-19.R01 Revision 0

Dated: 21 October 2019

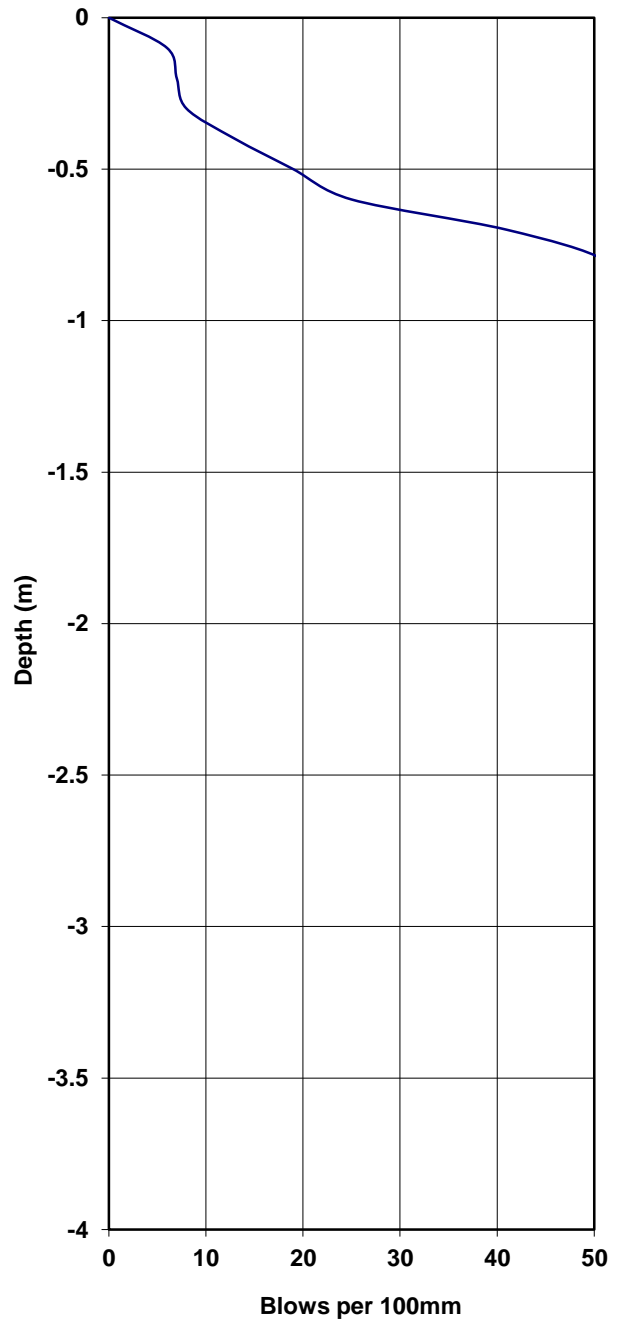
Depth (m)	Blows/100mm	Inferred Consistency	Shear Strength	CBR %
0				
0.1	6	Firm	50 kPa	10
0.2	7	Firm	60 kPa	12
0.3	8	Firm	65 kPa	14
0.4	13	Stiff	110 kPa	23
0.5	19	Very Stiff	>150 kPa	35
0.6	25	Very Stiff	>150 kPa	49
0.7	41	Very Stiff	>150 kPa	>55
	Refusal

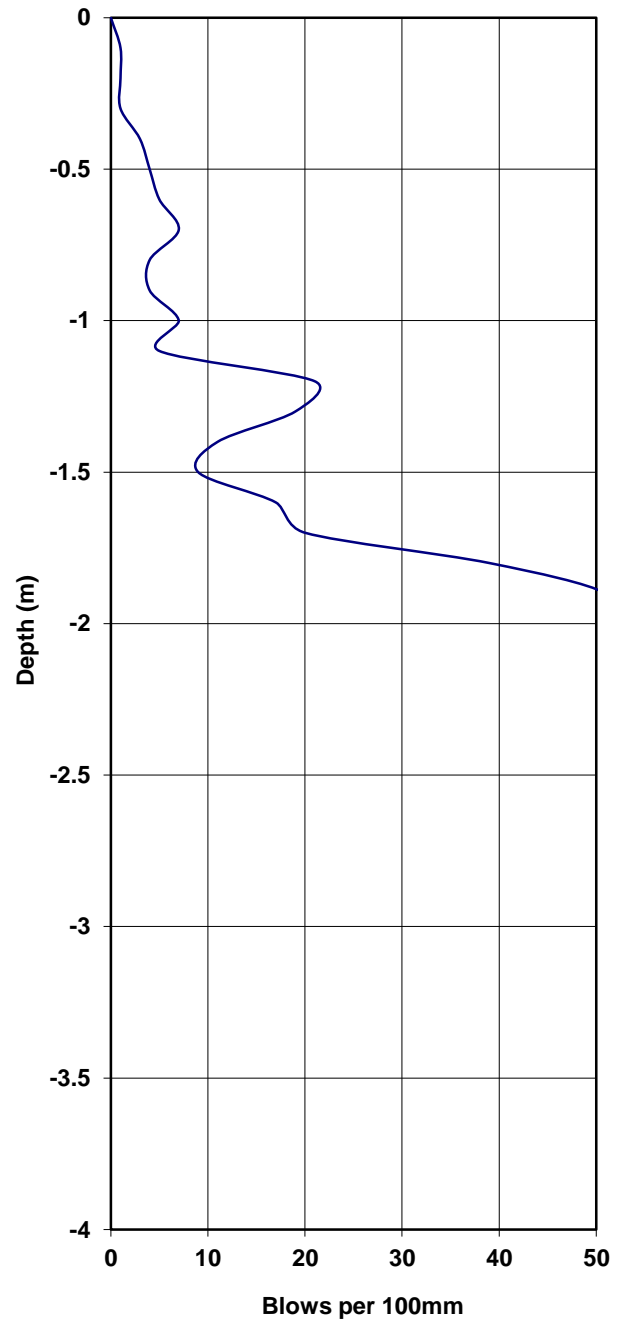
Depth (m)	Blows/100mm	Inferred Consistency	Shear Strength	CBR %
0				
0.1	1	Very Soft	<20 kPa	2
0.2	1	Very Soft	<20 kPa	2
0.3	1	Very Soft	<20 kPa	2
0.4	3	Soft	25 kPa	5
0.5	4	Soft	35 kPa	7
0.6	5	Firm	40 kPa	8
0.7	7	Firm	60 kPa	12
0.8	4	Soft	35 kPa	7
0.9	4	Soft	35 kPa	7
1	7	Firm	60 kPa	12
1.1	5	Firm	40 kPa	8
1.2	21	Very Stiff	>150 kPa	40
1.3	19	Very Stiff	>150 kPa	35
1.4	11	Stiff	90 kPa	19
1.5	9	Stiff	75 kPa	15
1.6	17	Stiff	140 kPa	31
1.7	20	Very Stiff	>150 kPa	37
1.8	39	Very Stiff	>150 kPa	>55
	Refusal

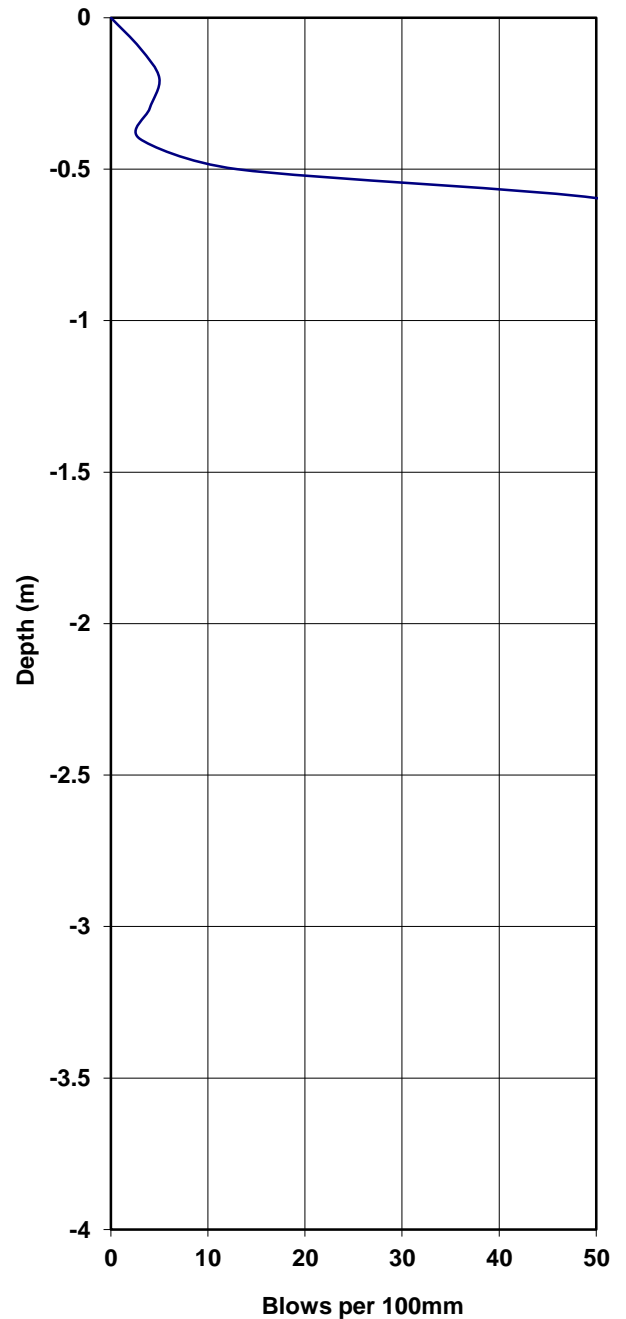
Depth (m)	Blows/100mm	Inferred Consistency	Shear Strength	CBR %
0				
0.1	3	Loose	<30 deg	5
0.2	5	Med.Dense	32 deg	8
0.3	4	Med.Dense	30 deg	7
0.4	3	Loose	<30 deg	5
0.5	13	Dense	37 deg	23
	Refusal

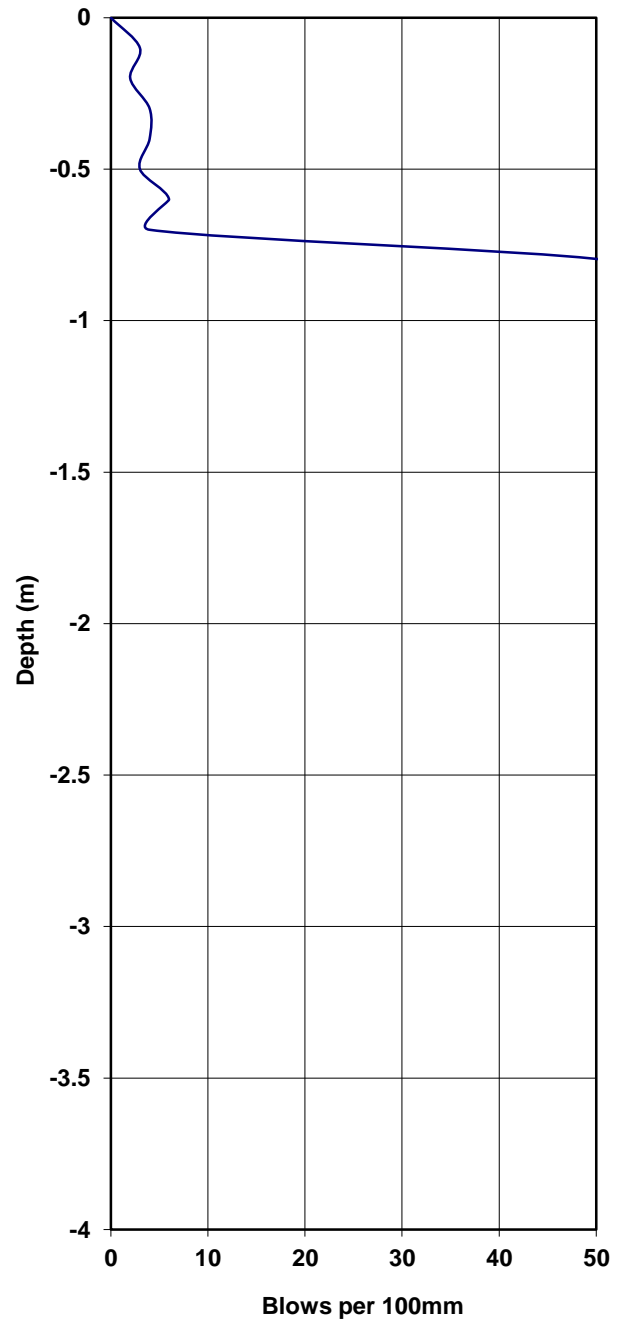
Depth (m)	Blows/100mm	Inferred Consistency	Shear Strength	CBR %
0				
0.1	3	Soft	25 kPa	5
0.2	2	Soft	20 kPa	3
0.3	4	Soft	35 kPa	7
0.4	4	Soft	35 kPa	7
0.5	3	Soft	25 kPa	5
0.6	6	Firm	50 kPa	10
0.7	4	Soft	35 kPa	7
	Refusal

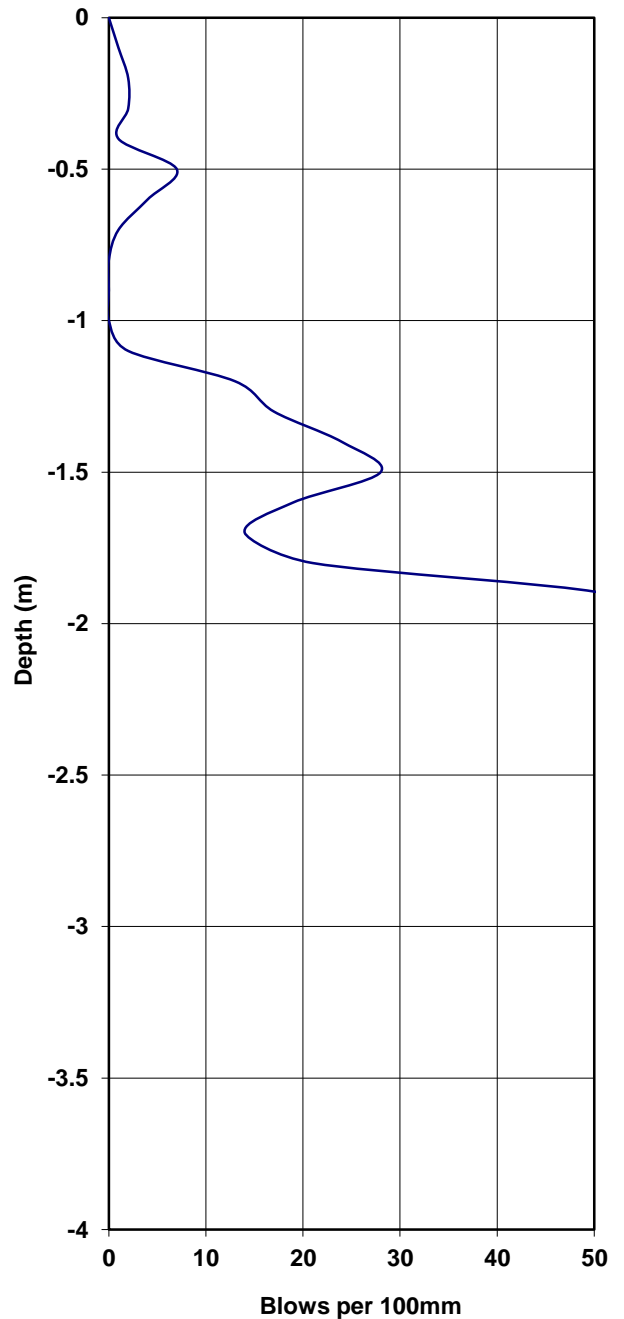
Depth (m)	Blows/100mm	Inferred Consistency	Shear Strength	CBR %
0				
0.1	1	Very Loose	<29 deg	2
0.2	2	Loose	<30 deg	3
0.3	2	Loose	<30 deg	3
0.4	1	Very Loose	<29 deg	2
0.5	7	Med.Dense	34 deg	12
0.6	4	Med.Dense	30 deg	7
0.7	1	Very Loose	<29 deg	2
0.8	0	V.V.Loose	<28 deg	<2
0.9	0	V.V.Loose	<28 deg	<2
1	0	V.V.Loose	<28 deg	<2
1.1	2	Loose	<30 deg	3
1.2	13	Dense	37 deg	23
1.3	17	Dense	37 deg	31
1.4	24	Dense	38 deg	47
1.5	28	Very Dense	>38 deg	>55
1.6	19	Dense	37 deg	35
1.7	14	Dense	37 deg	25
1.8	21	Dense	38 deg	40
	Refusal
