**GEOTECHNICAL INVESTIGATION REPORT FOR FILLING STATION AT MOKGANYAKA,
EPHRAIM MOKGALE LOCAL MUNICIPALITY (EMLM) OF SEKHUKHUNE DISTRICT
MUNICIPALITY (SDM), LIMPOPO PROVINCE**

PREPARED FOR: MOKGANYAKA TAXI ASSOCIATION (PTY) LTD

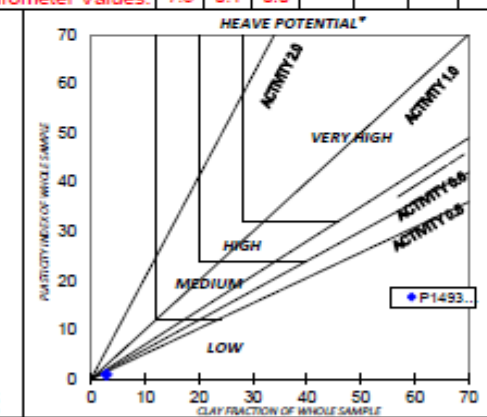
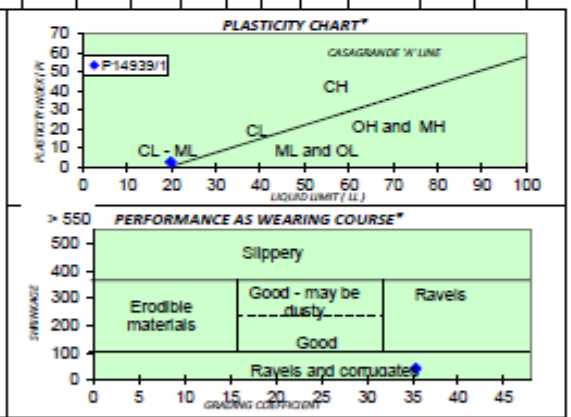
GRAVEL, SOIL AND SAND ANALYSIS : FOUNDATION INDICATOR TEST REPORT

Remarks:
The Shrinkage Product of this material was 43
***DOUBLE HYDROMETER RESULT : 3 %** If Double Hydrometer result is above 40%, the material is considered to be dispersive.

*pH = 6.6 , *Electrical Conductivity = 0.02 S/m, tested on the -5mm fraction

The laboratory report indicated that the site was comprised SM(d) material which are silty sands and silt mixtures according to UCS classification.

The soil predominantly consisted of coarse sand which comprises 36.4- 41.2% of the sample and was characterized by a low clay content of 9.7-10.7%. The soil had a plasticity index of 2-5% and low linear shrinkage of 1.2-1.3%, indicating the slight plastic nature of the soil thus slight heave potential. The material had a grading modulus of 1.9-2.1%, with 19-20 % liquid limit, and the material had a low plasticity potential. The soil was classified as A-1-b in accordance to AASHTO thus rated as excellent when used as subgrade, was also classified as G5 according to COLTO.

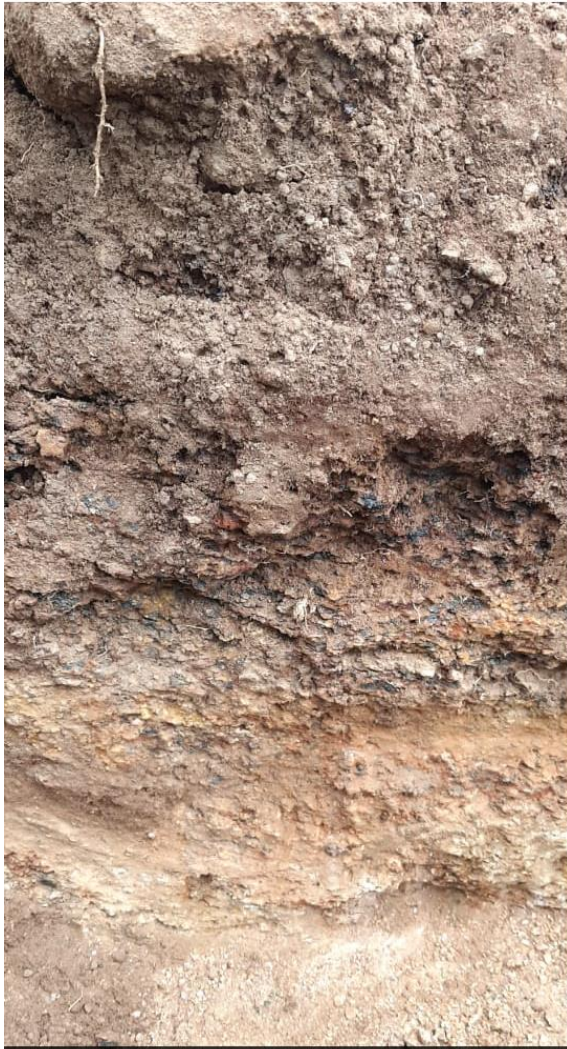
Trial Pit 1

24°59'15" S 29°23'24" E 23°NE COURSE 84° GPS
HUNADI STR, MOGANYAKA, 0459, SOUTH AFRICA
10:35:58 02.16.2021 ACCUR +/- 12.8 FT ALT 2926 FT

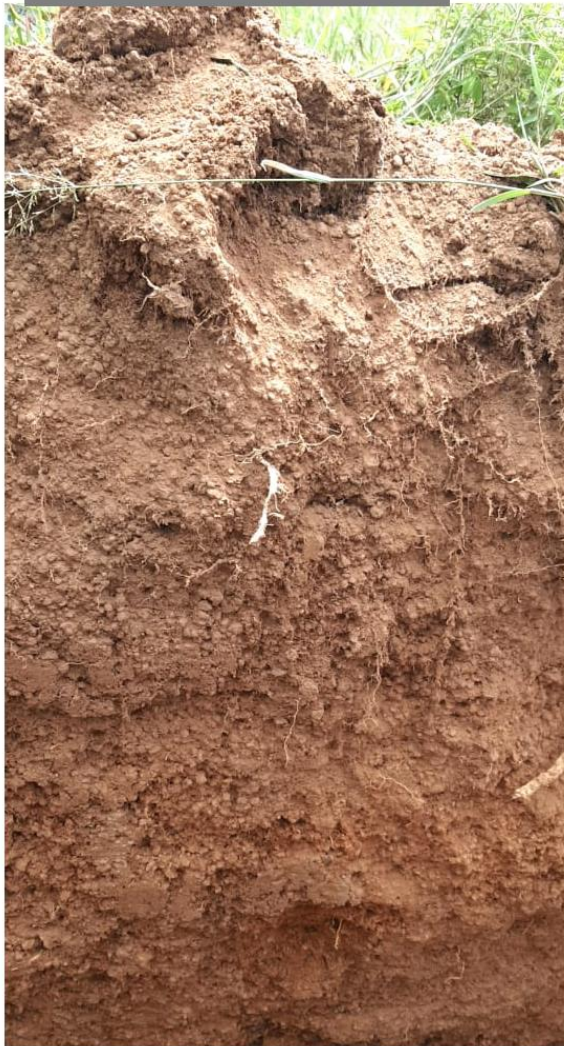
Trial Pit 2

24°59'16" S 29°23'24" E 56°NE COURSE 195° GPS
HUNADI STR, MOGANYAKA, 0459, SOUTH AFRICA
10:49:45 02.16.2021 ACCUR +/- 66.9 FT ALT 2924 FT

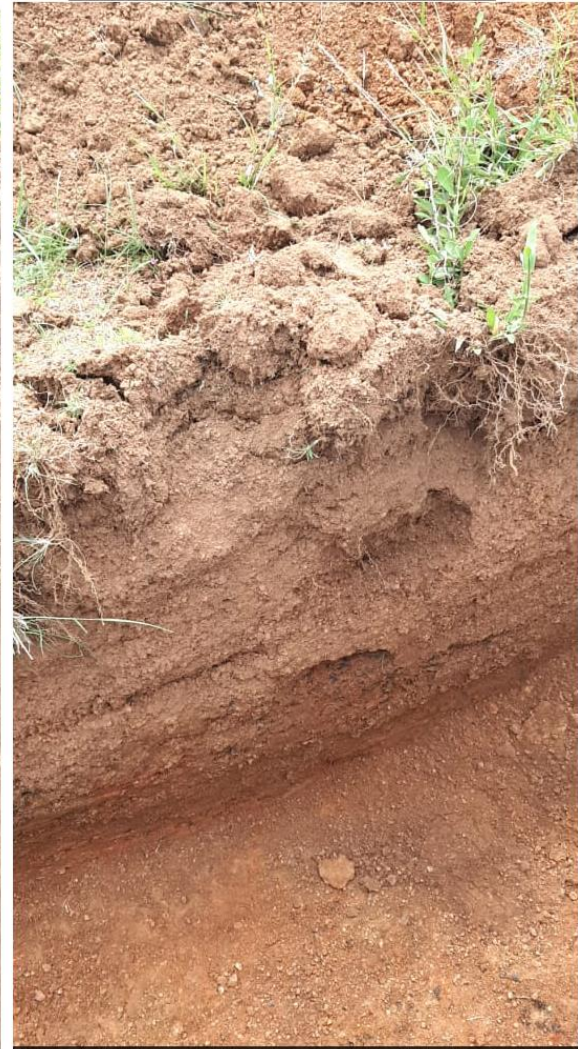
Trial Pit 3

24°59'17" S 29°23'24" E 53°NE COURSE 279° GPS
HUNADI STR, MOGANYAKA, 0459, SOUTH AFRICA
10:56:35 02.16.2021 ACCUR +/- 11.3 FT ALT 2925 FT
