**THE POPO MOLEFE DEVELOPMENT, BOITEKONG
EXTENSION 39, PAARDEKRAAL, RUSTENBURG**

**ENGINEERING GEOLOGICAL INVESTIGATION
to DETERMINE the POTENTIAL for TOWNSHIP DEVELOPMENT
for THE POPO MOLEFE DEVELOPMENT, BOITEKONG EXTENSION 39, on
PORTIONS of the FARM PAARDEKRAAL 279JQ,
RUSTENBURG, NORTHWEST PROVINCE.**

Report number: GS201908P

REPORT ON THE ENGINEERING GEOLOGICAL INVESTIGATION CONDUCTED FOR THE POPO MOLEFE DEVELOPMENT, BOITEKONG EXTENSION 39, PAARDEKRAAL 279JQ, RUSTENBURG, NORTHWEST PROVINCE.

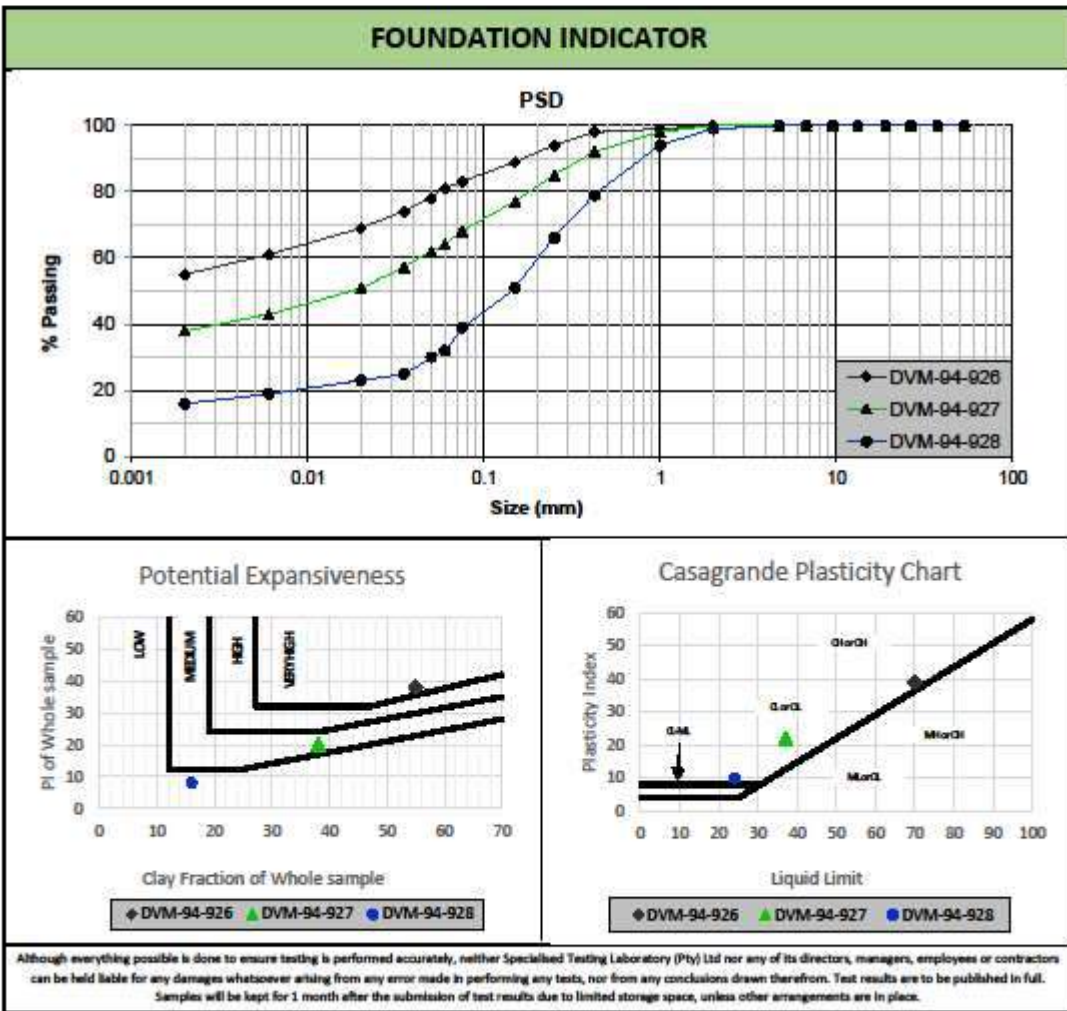
FOUNDATION INDICATOR							
Grading & Hydrometer Analysis (Particle Size (mm) & % Passing)				Atterberg Limits & Classification			
Sample	P3	P4	P5	Sample	P3	P4	P5
Depth (m)	2.0	0.4	0.4	Depth (m)	2.0	0.4	0.4
Lab No	DVM-94-926	DVM-94-927	DVM-94-928	Lab No	DVM-94-926	DVM-94-927	DVM-94-928

0.002	55	38	16	AASHTO (M145-91)	A - 7 - 5	A - 6	A - 4
Remarks: *: Assumed N / T: Not Tested							
<small>Although everything possible is done to ensure testing is performed accurately, neither Specialised Testing Laboratory (Pty) Ltd nor any of its directors, managers, employees or contractors can be held liable for any damages whatsoever arising from any error made in performing any tests, nor from any conclusions drawn therefrom. Test results are to be published in full. Samples will be kept for 1 month after the submission of test results due to limited storage space, unless other arrangements are in place.</small>
