Ref: PG19-090/541 Rev00
Date: 19 February 2020

MAMPA & SWAZI MNYAMANE ACCESS BRIDGES

GEOTECHNICAL INVESTIGATION REPORT

PREPARED FOR: **ILIFA AFRICA ENGINEERS (PTY) LTD**

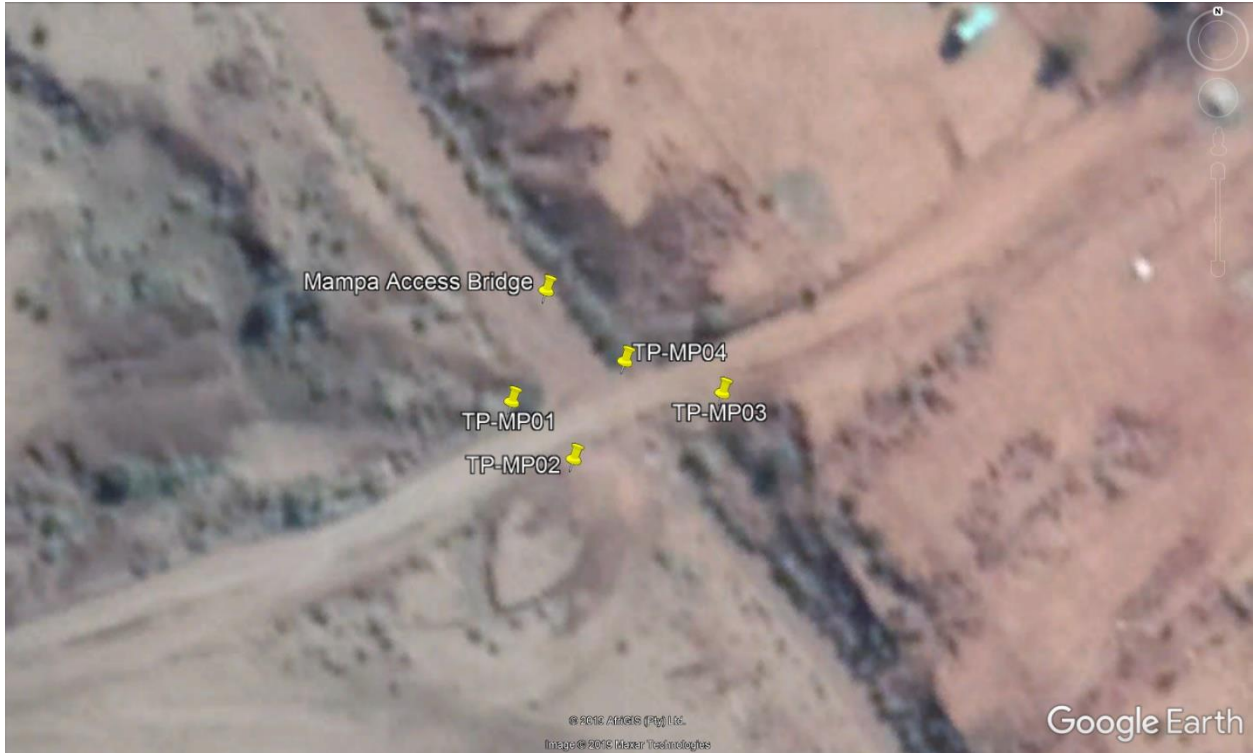
Figure 2-6: Layout of test pits on the Mampa site.

The fieldwork for the Mampa geotechnical investigation comprised the excavation of four test pits and a DCP test next to each hole. The hole positions were chosen so that both sides of the crossing and of the road could be investigated - see Figure 2-6. The planned excavation depth was 3.0m, which typically is the maximum reach of a TLB, or until effective refusal conditions are encountered.

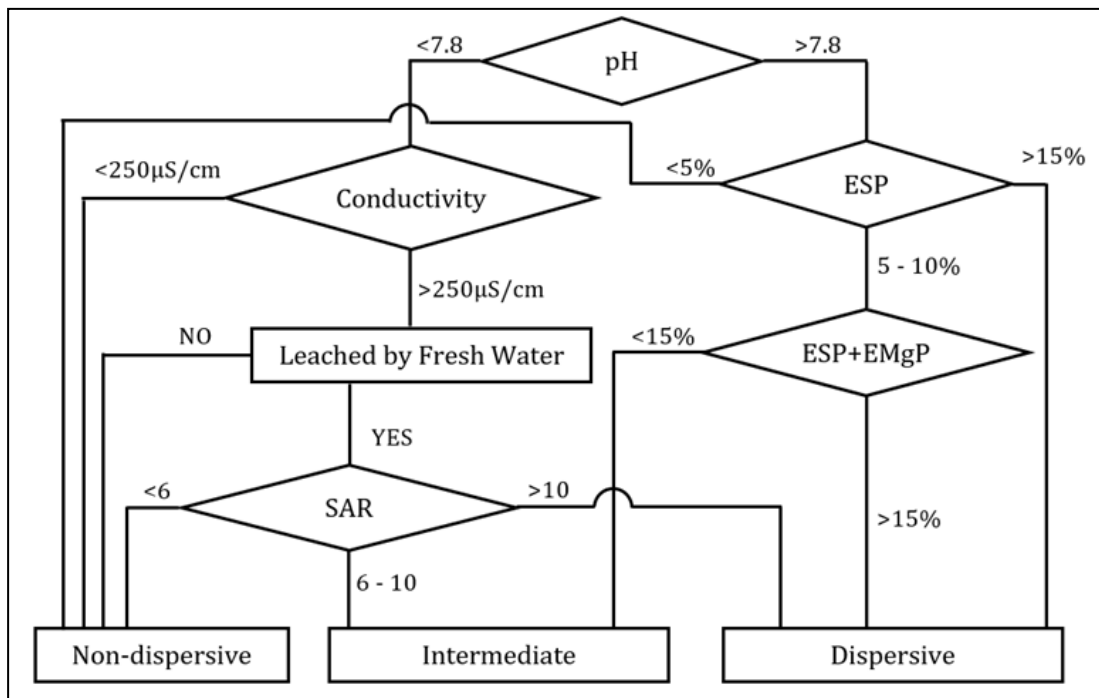
Figure 2-10: Chemical dispersivity evaluation (Gerber and Harmse, 1987)

As noted, the severe erosion dongas in the general site area suggest evidence of dispersive soils and it was hence decided to evaluate the dispersivity of the insitu alluvial and transported soils. A flow diagram for the evaluation of dispersive soils was prepared by Gerber and Harmse (1987) and is presented in Figure 2-10. The laboratory test results are summarised in Table 2-4 below.

Although initially thought to be a problem, the laboratory test results indicate that none of the insitu soils exhibit any tendency to be dispersive. Engineering problems are seldom caused by a single source acting in isolation and it is postulated that the erosion problem in this area is no different. It is, therefore, our belief that the erosion is mostly due to the combined effect of overgrazing, high temperatures, very high evaporation rates and sporadic high-intensity rainfall events resulting in washing away of the exposed soil.

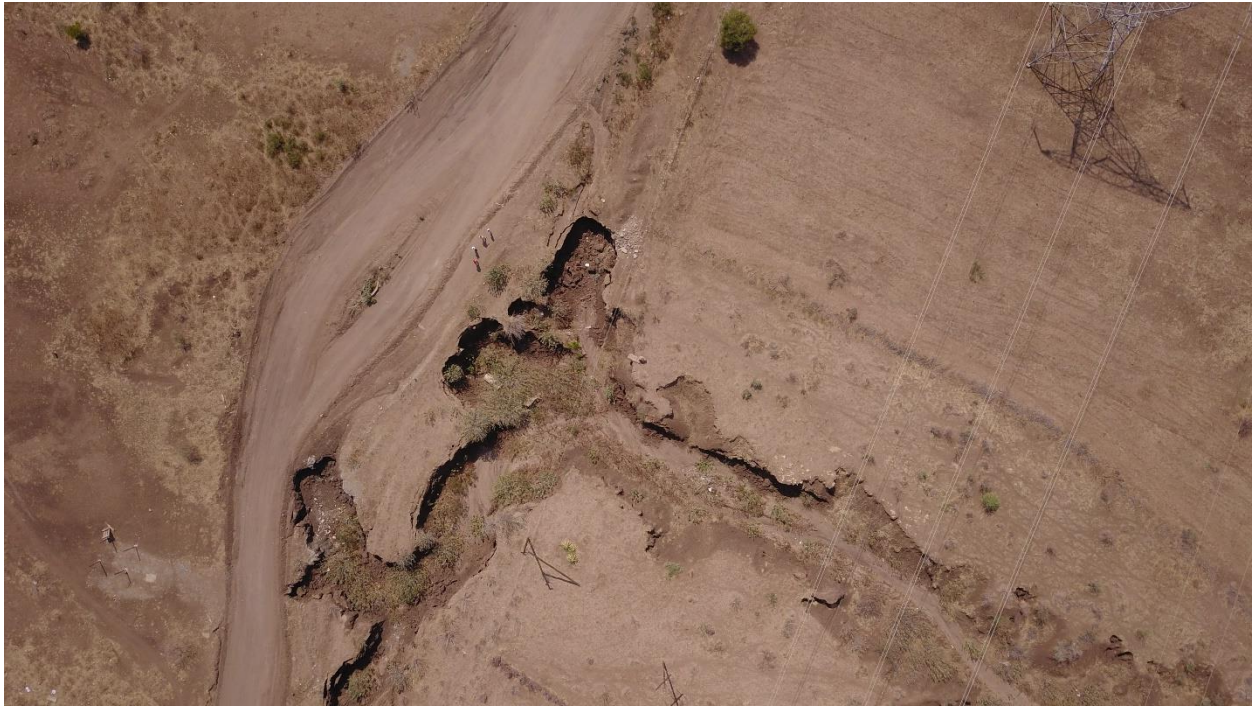
Figure 3-2: View of the existing stream crossing with severe erosion visible downstream (east).

Similar to Mampa, it is clear from the surrounding areas that the ground conditions are prone to severe erosion problems, possibly due to dispersive soils combined with overgrazing. There are severe erosion gulleys at the outlet of the culvert.

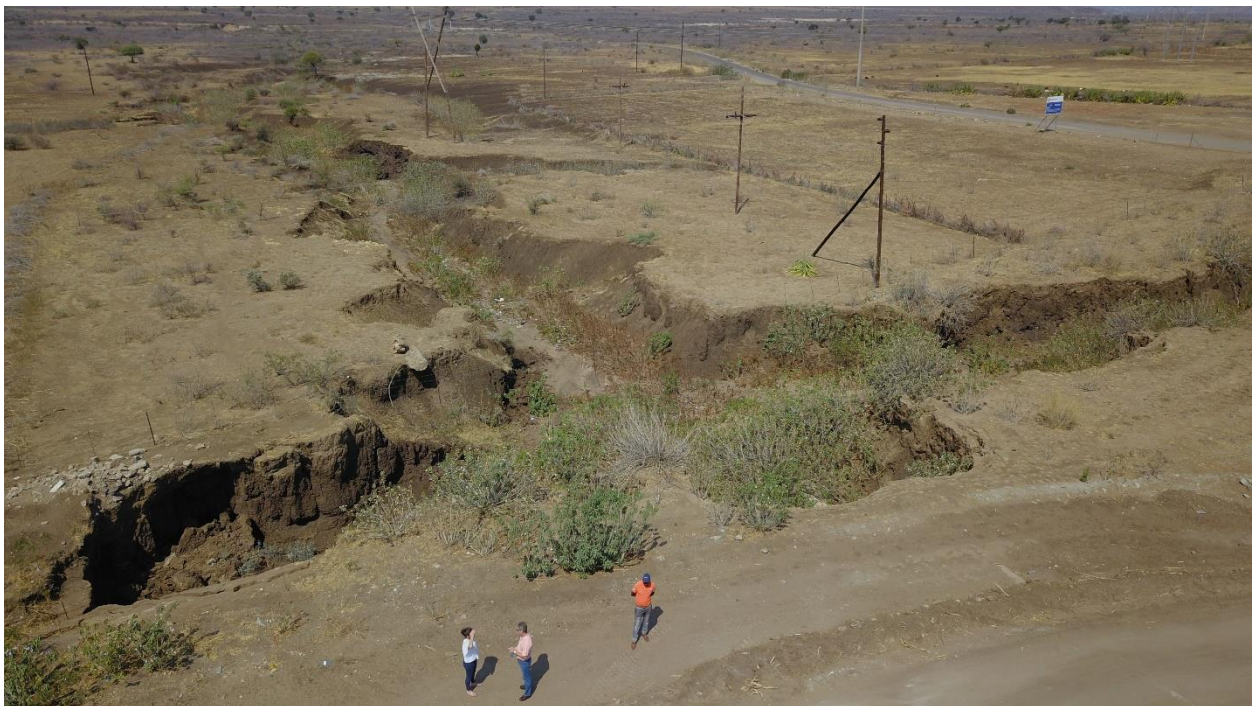
Figure 3-3: Sideways view of the existing stream crossing with severe erosion gulleys downstream.

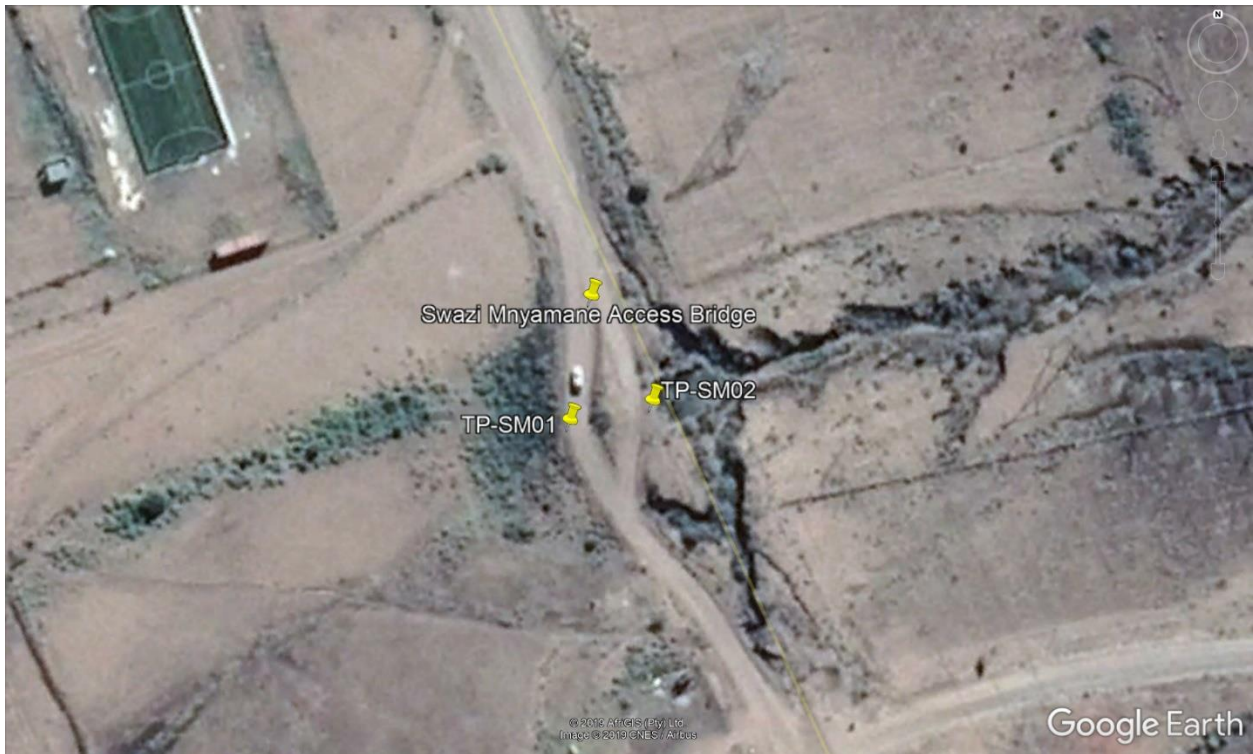
Figure 3-4: Layout of test pits on the Swazi Mnyamane site.

The fieldwork for the Swazi Mnyamane geotechnical investigation comprised the excavation of two test pits and a DCP test next to each hole. The hole positions were chosen so that both sides of the crossing and of the road could be investigated – see Figure 3-4. The planned excavation depth was 3.0m, which typically is the maximum reach of a TLB, or until effective refusal conditions are encountered.

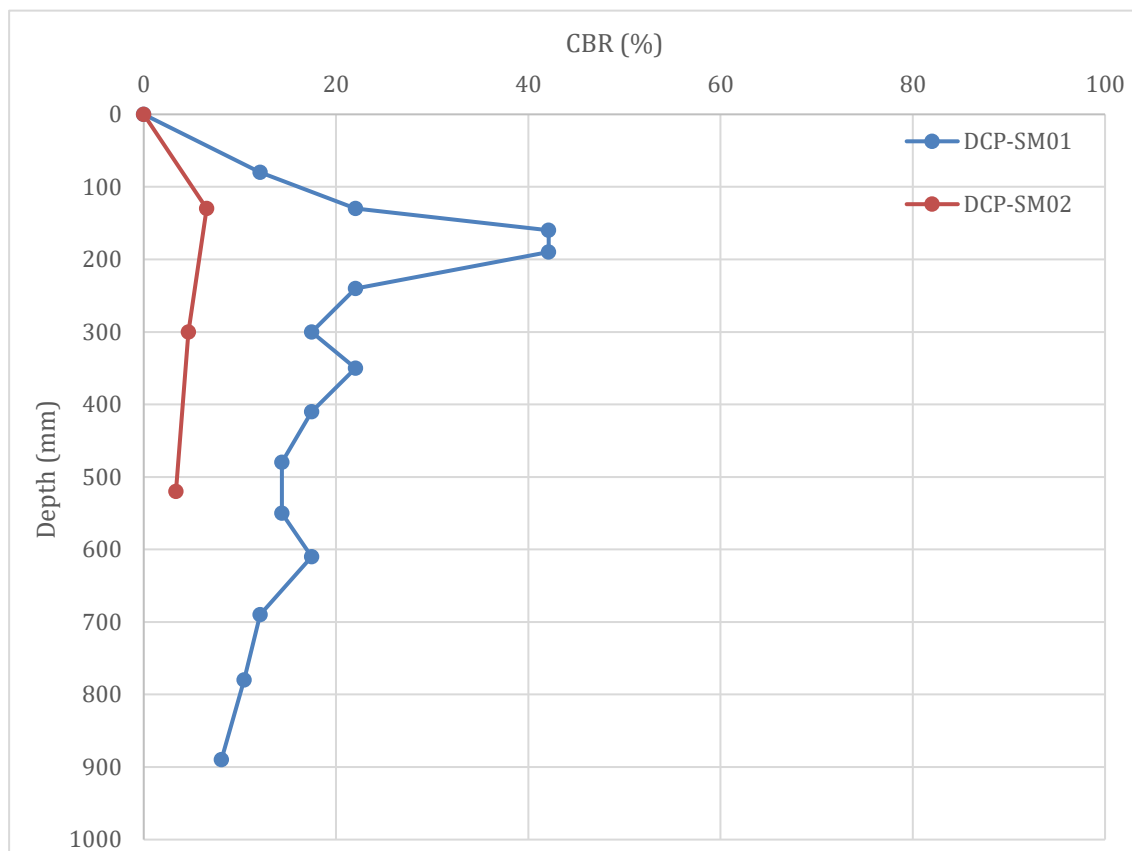
Figure 3-5: Summary of DCP results – Swazi Mnyamane.

Figure 3-5 summarises the DCP results in terms of DN values (mm/blow), which was translated to CBR values in Figure 3-6 using the formulations of Paige-Green and Du Plessis (2009). These CBR values can then be used to estimate stiffness values (Young’s Modulus, E’) using $E' = 0.7 \times \text{CBR}$, which is presented in Figure 3-7.

The results correlate well with the insitu consistency assessment of soft to firm soils.

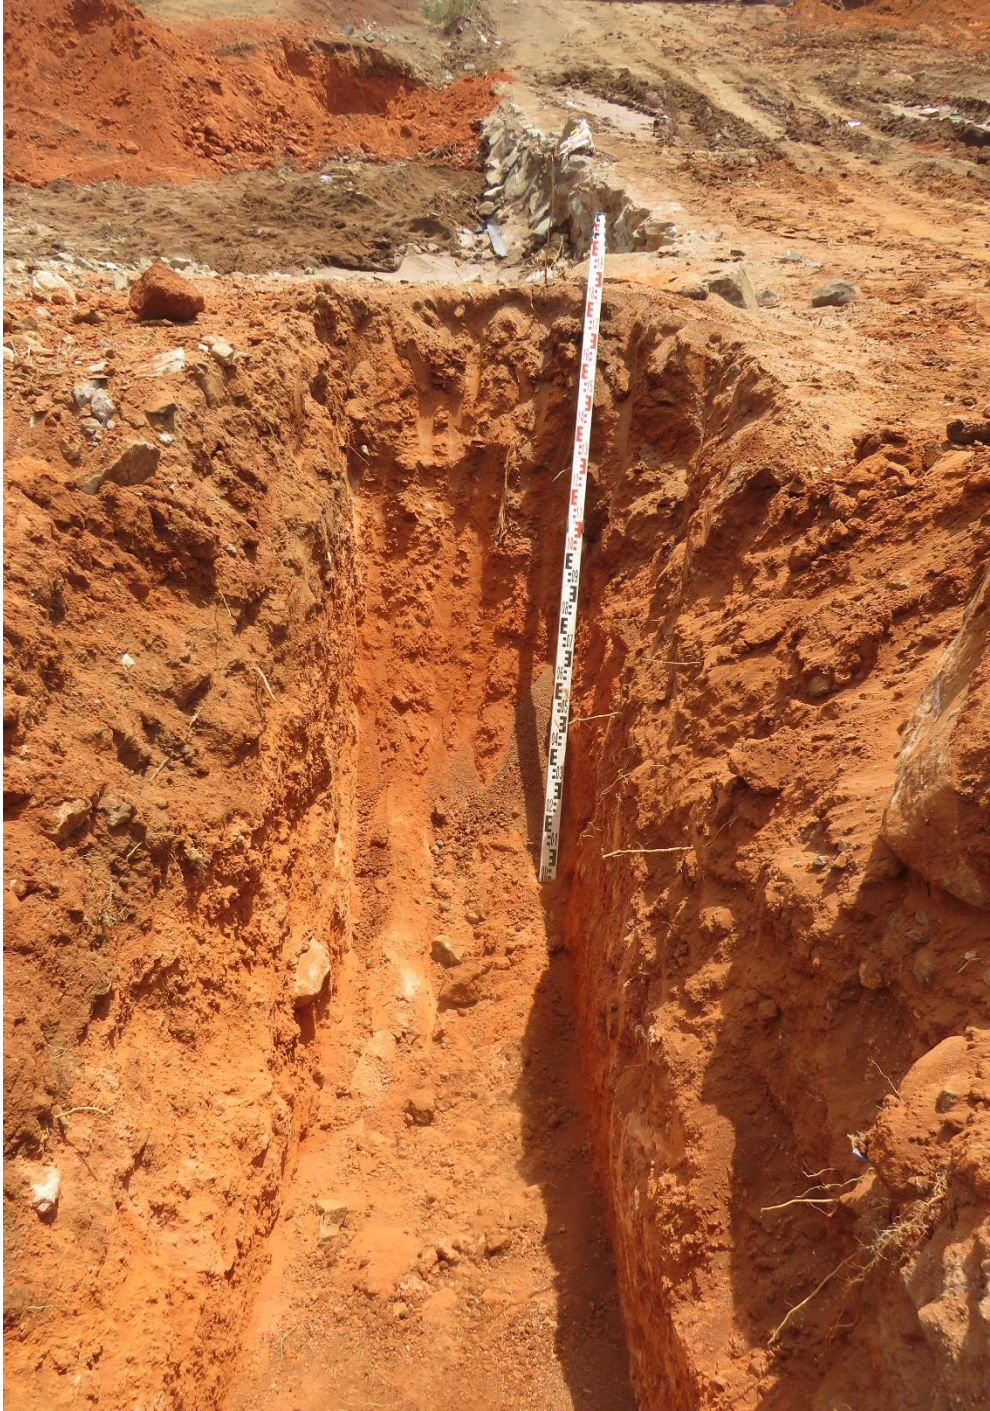
Note: Sidewall collapse was observed in the upper layer of two test pits. Refusal was only encountered in TP-MP04 at a depth of 1.70m on a large piece of concrete. It could not be determined whether this was an isolated piece of concrete, or whether it forms part of a larger buried structure.

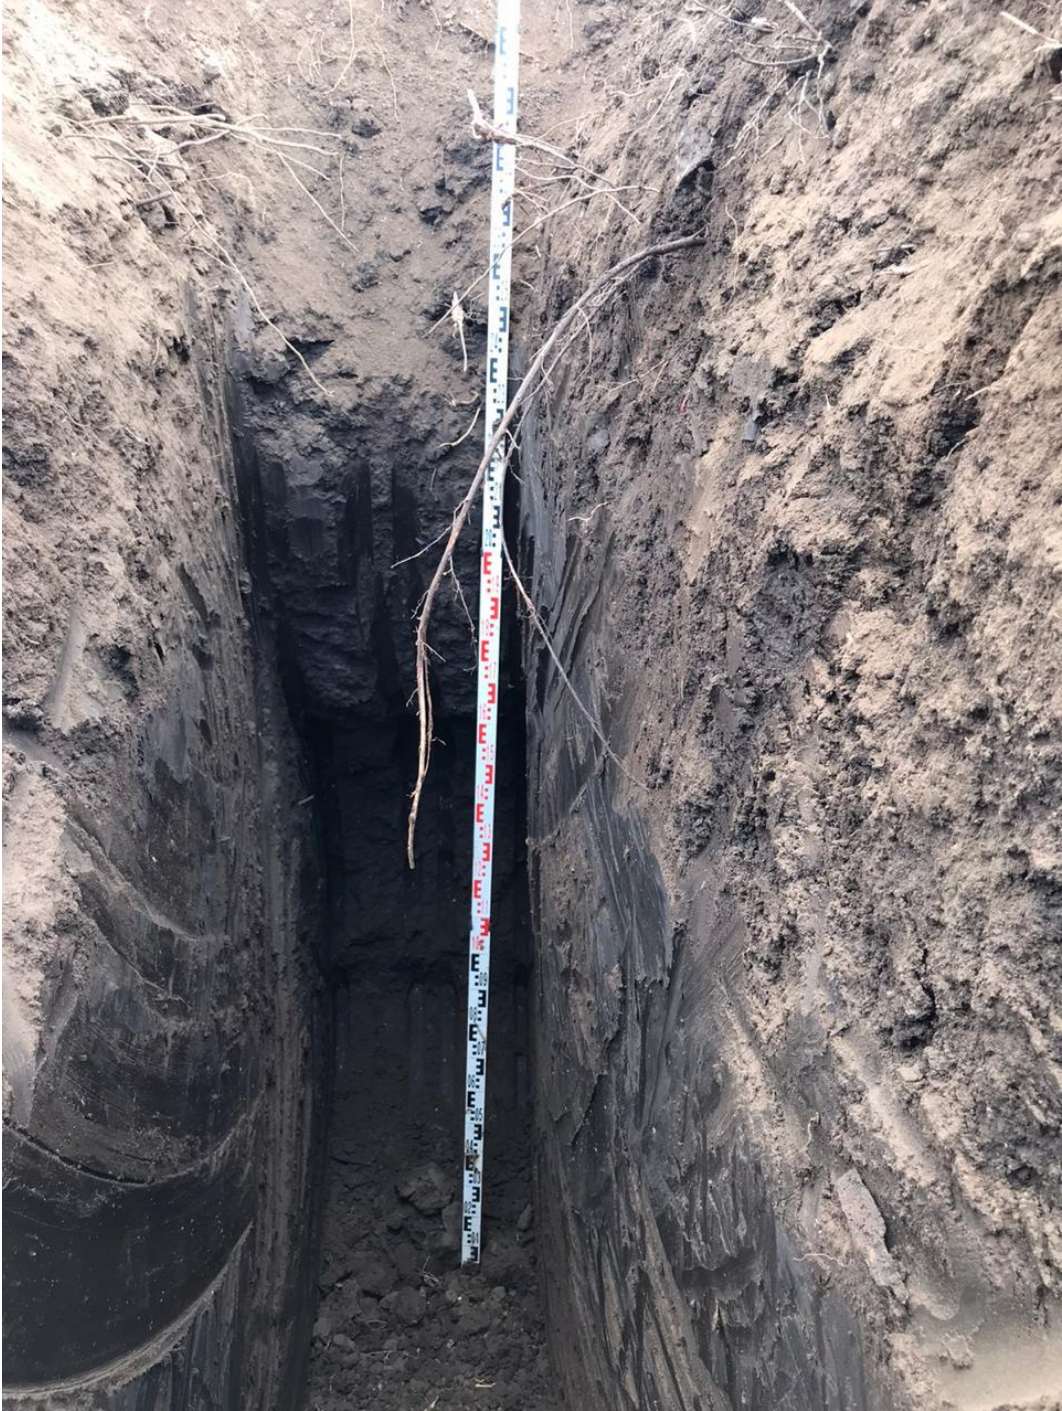
TP-SM01

A uniform moist alluvial horizon was found to cover the stream crossing site with a thickness up to 3.30m. This layer was typically described as light brown to grey, slickensided clay with a soft

It is important to note the slickensided structure of the clay material, as this is indicative of an active clay that historically has undergone significant heave and shrinkage movements with changes in the moisture regime.

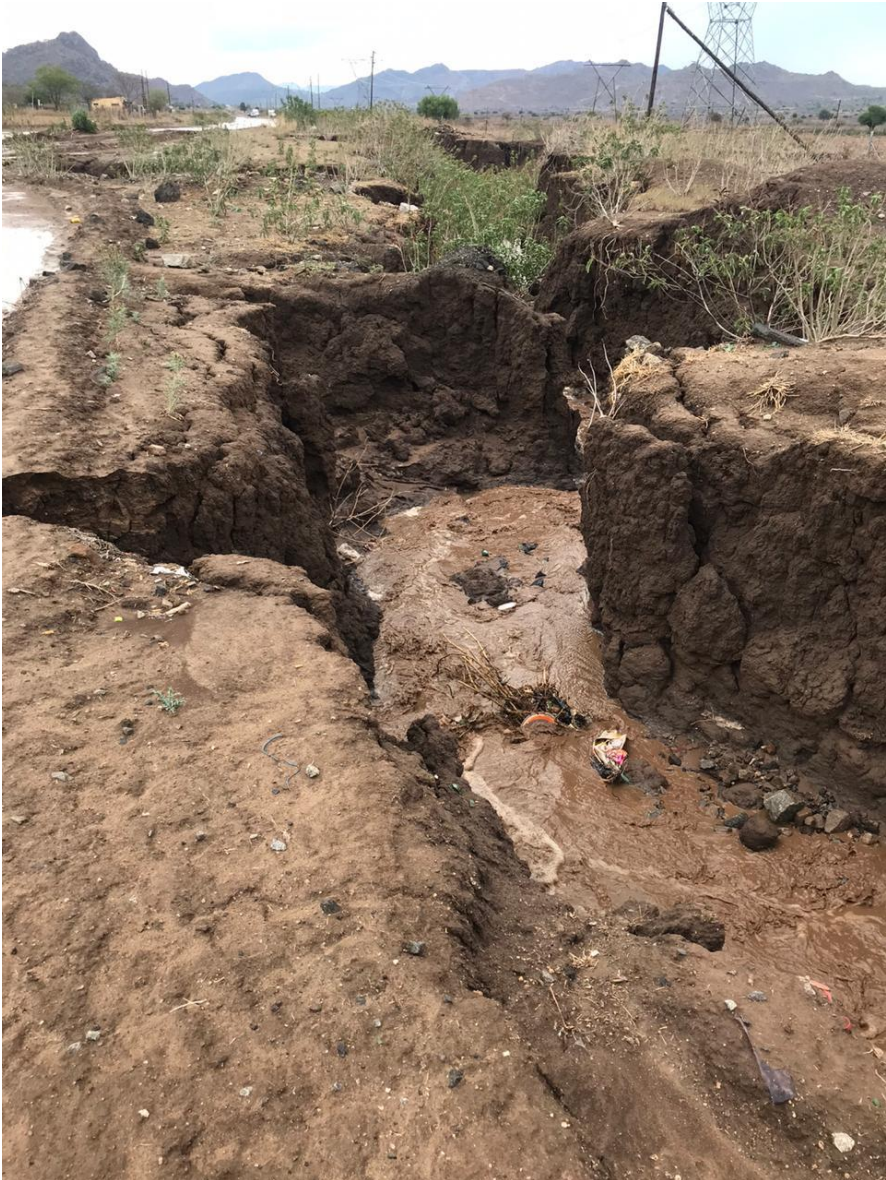
Figure D-4: Erosion dongas at outlet of Swazi Mnyamane.

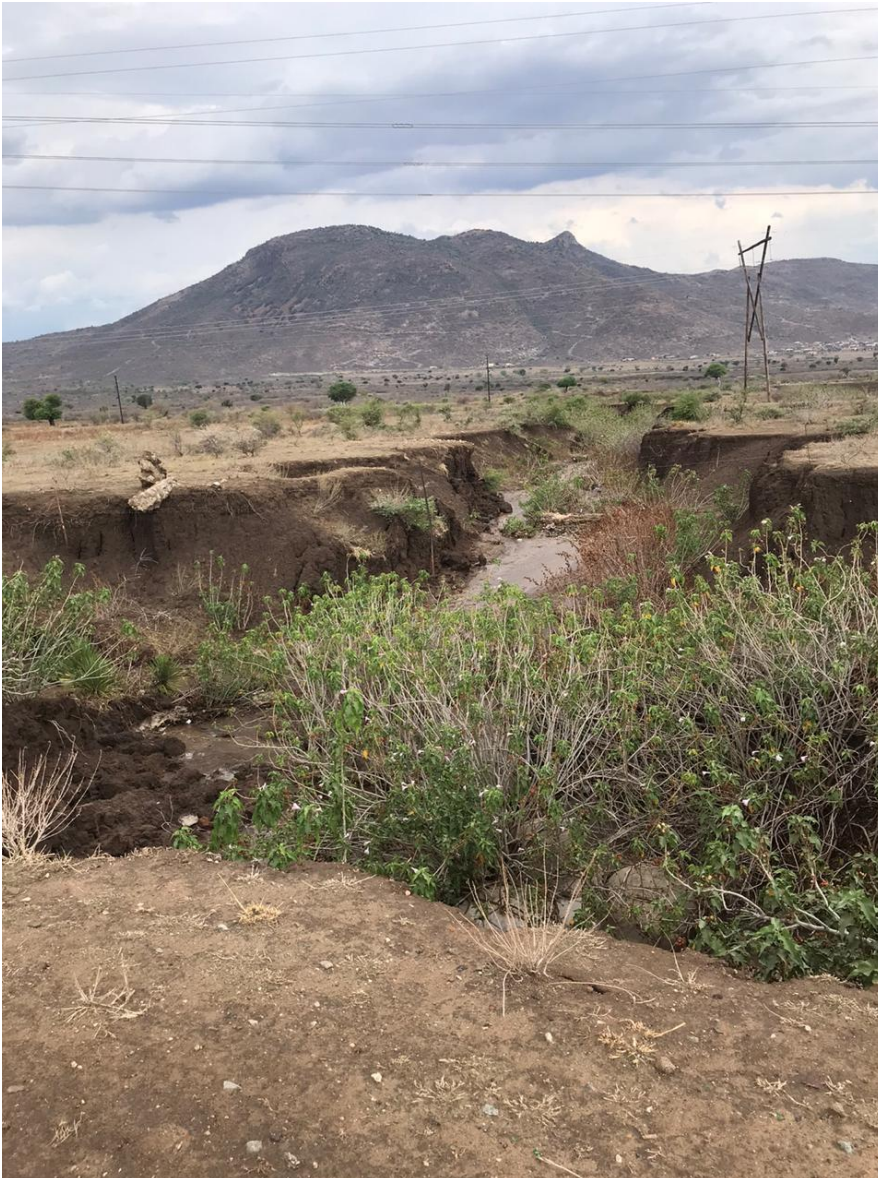
Figure D-5: View of erosion dongas downstream of Swazi Mnyamane.
