A PROVISIONAL REPORT

A GEOTECHNICAL INVESTIGATION
FOR THE PROPOSED TOWNSHIP OF JOHN DUBE EXTENSION 3
ON PORTIONS RE/1 AND 83 OF THE FARM GROOTFONTEIN 165-IR,
EKURHULENI METRO MUNICIPALITY,
GAUTENG.

RELLY, MILNER AND SHEDDEN
P R E T O R I A

DATE: June 2020

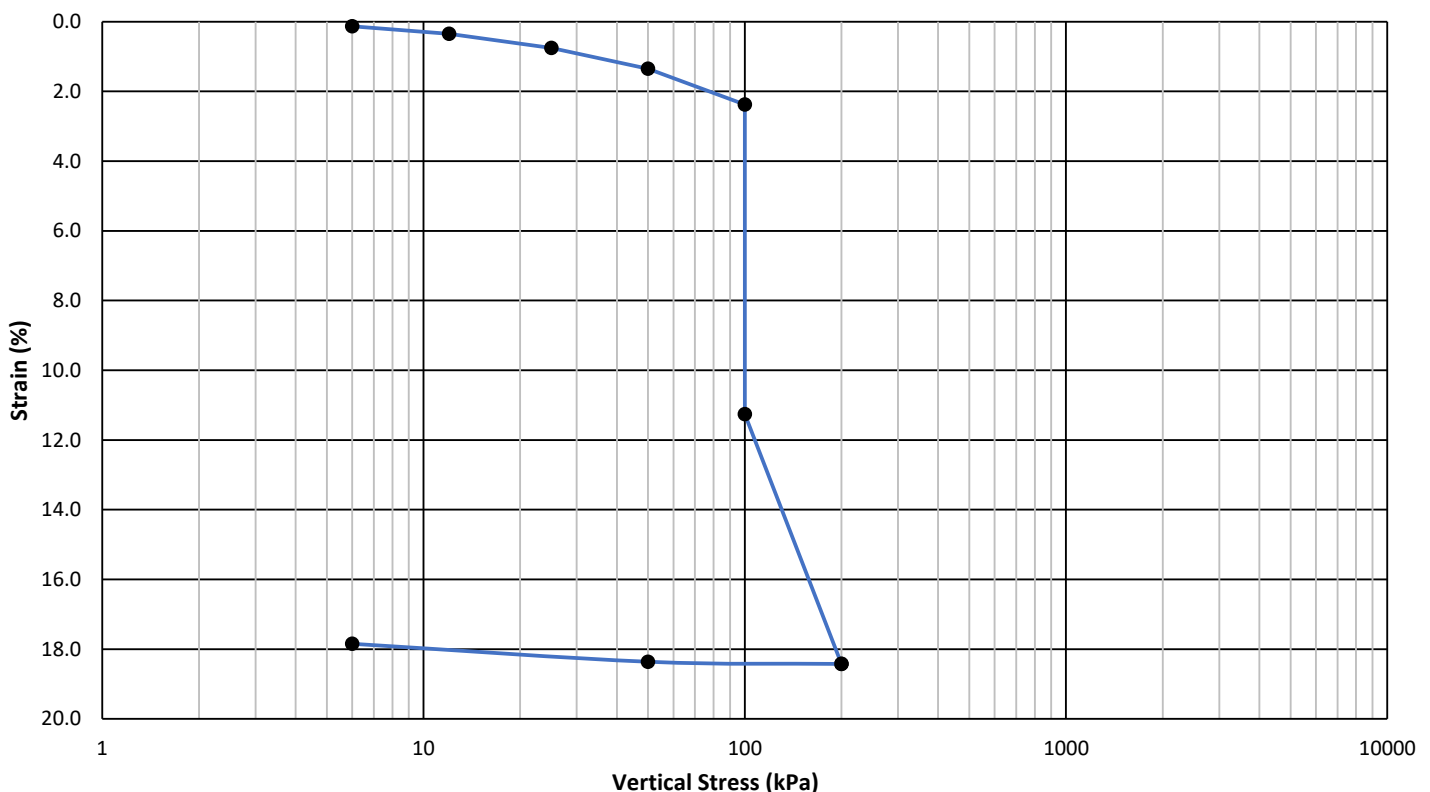
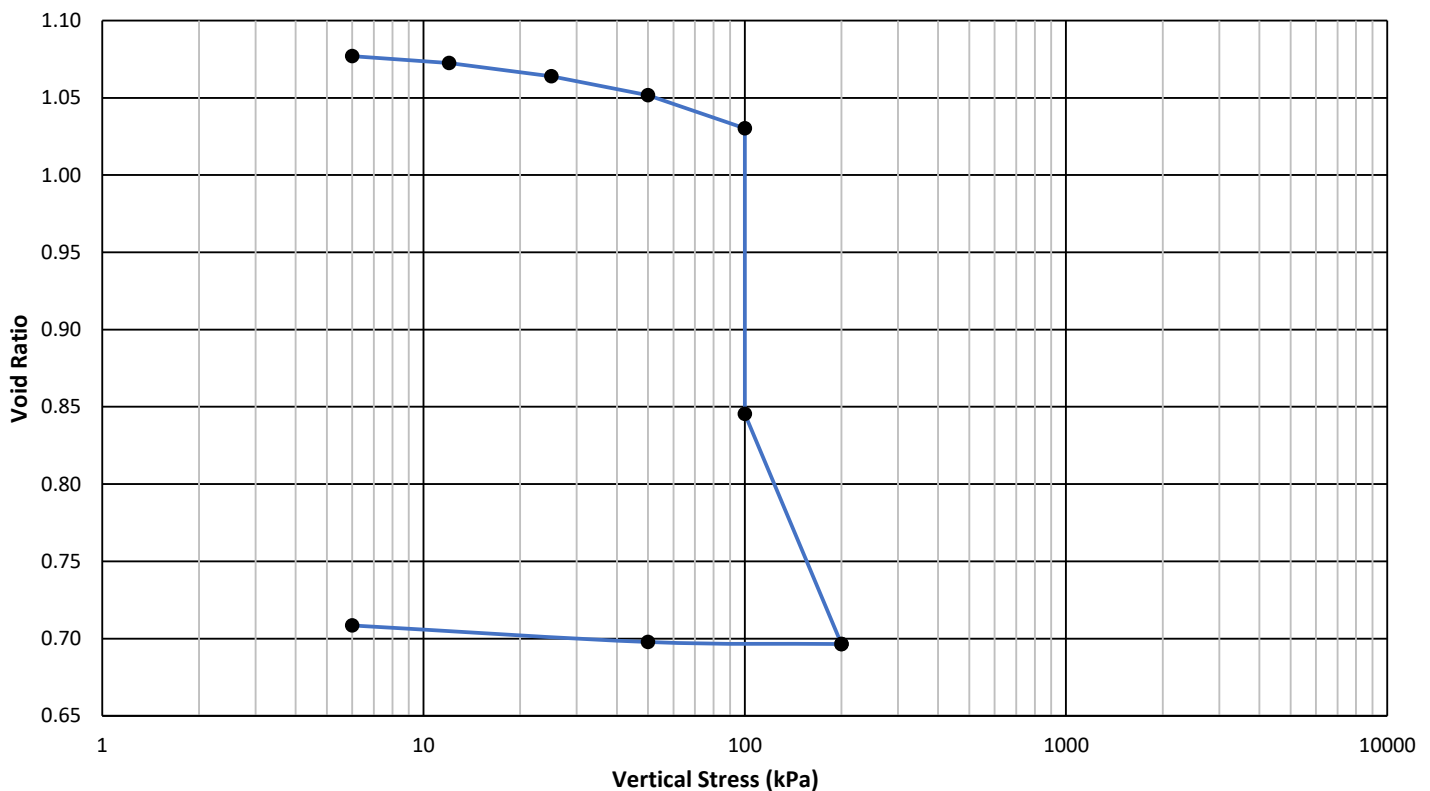
Client Name: Relly, Milner & Shedden
Project Name: John Dube X3
Sample: TP 20
Depth: (m) 0.9 - 1.1

Strain vs Log Stress

Void Ratio vs Log Stress

Using the method set out in Reference 10, the total settlement that may be expected for a single storey house founded on normal strip footings at a depth of 0,5 m below the surface in a layer of collapsible soil, exhibiting the properties measured in TP's 20, 43 and 51, is given below in Table 2.

- 10.4 Normal (Compressible) Settlement: Normal strip footings for structures should not be considered for use on this site because of the compressible nature of the colluvium when moist. The consolidometer curves (Appendix C) indicate that up to 26 mm of normal settlement can be expected for the colluvium for loads of 100 kPa when the in-situ degree of saturation exceeds about 50%. This value applies to fine silty sand (Reference 5).

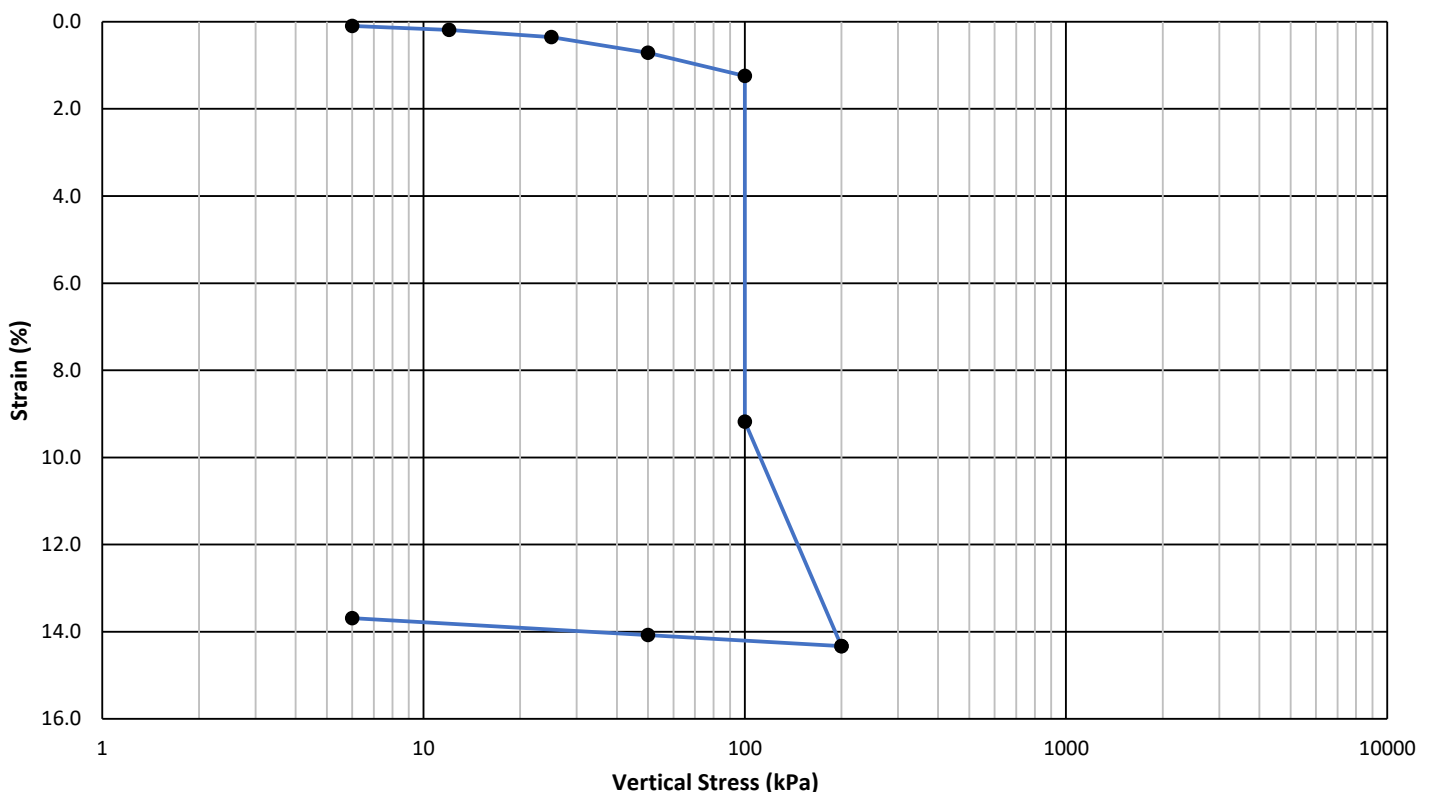
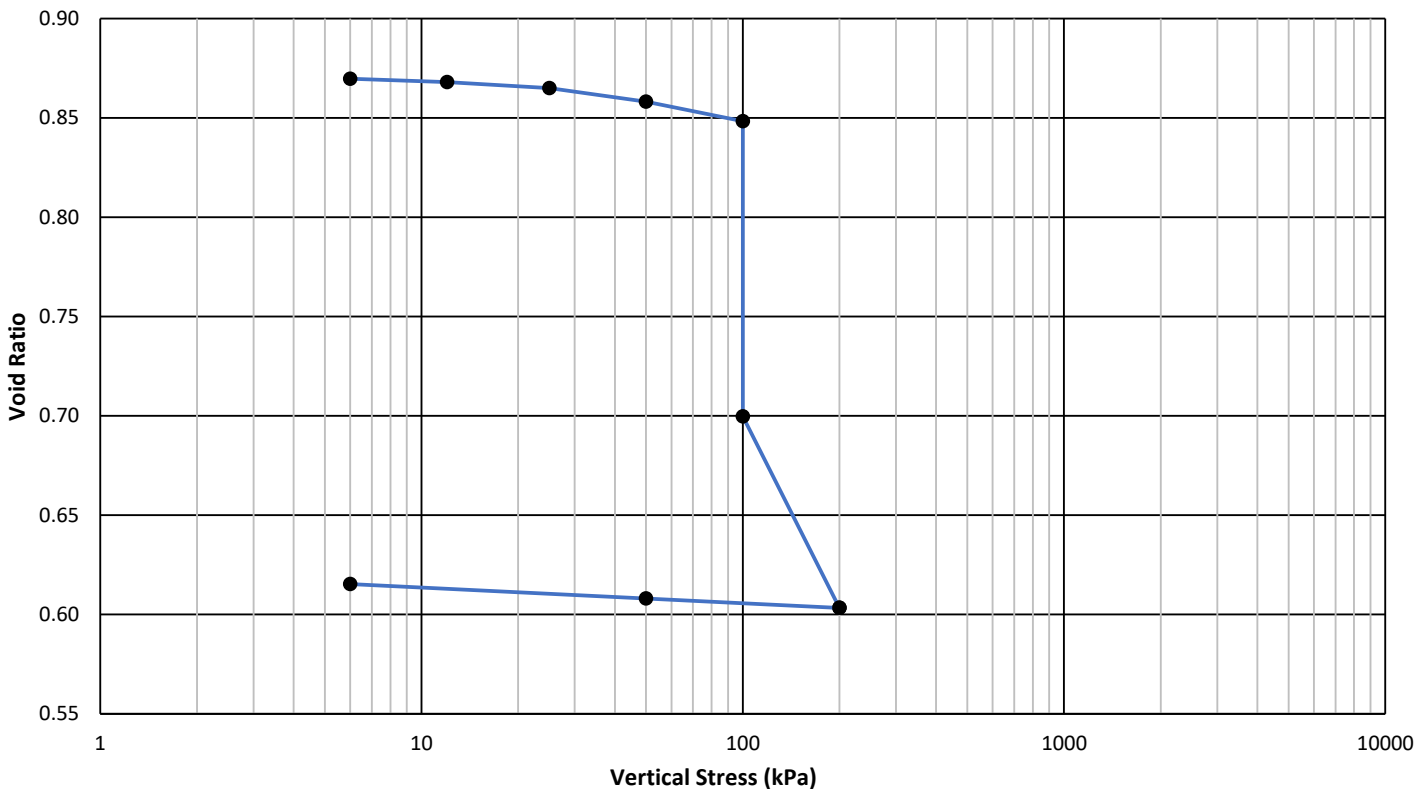
Client Name: Relly, Milner & Shedden
Project Name: John Dube X3
Sample: TP 43
Depth: (m) 0.9 - 1.1

Strain vs Log Stress

Void Ratio vs Log Stress

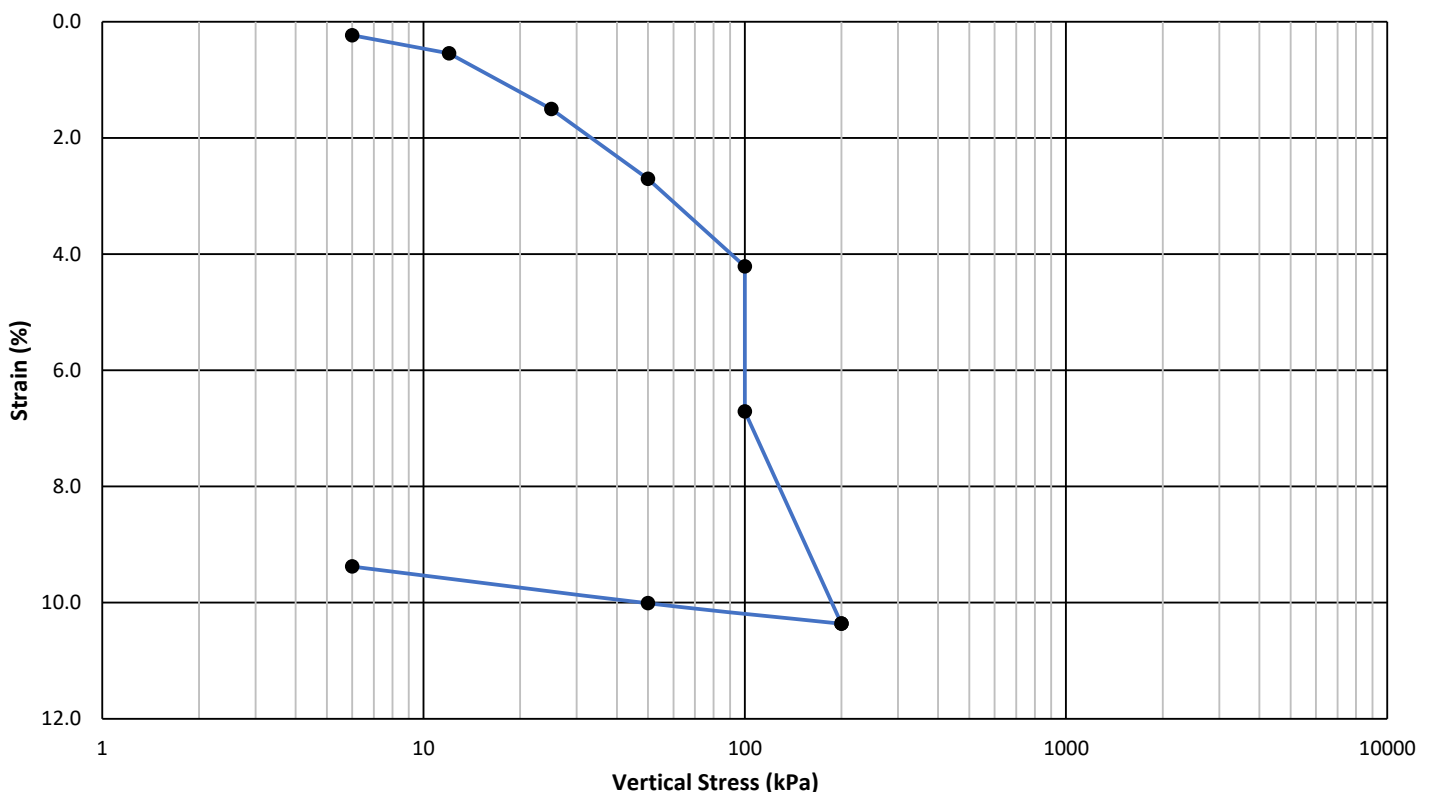
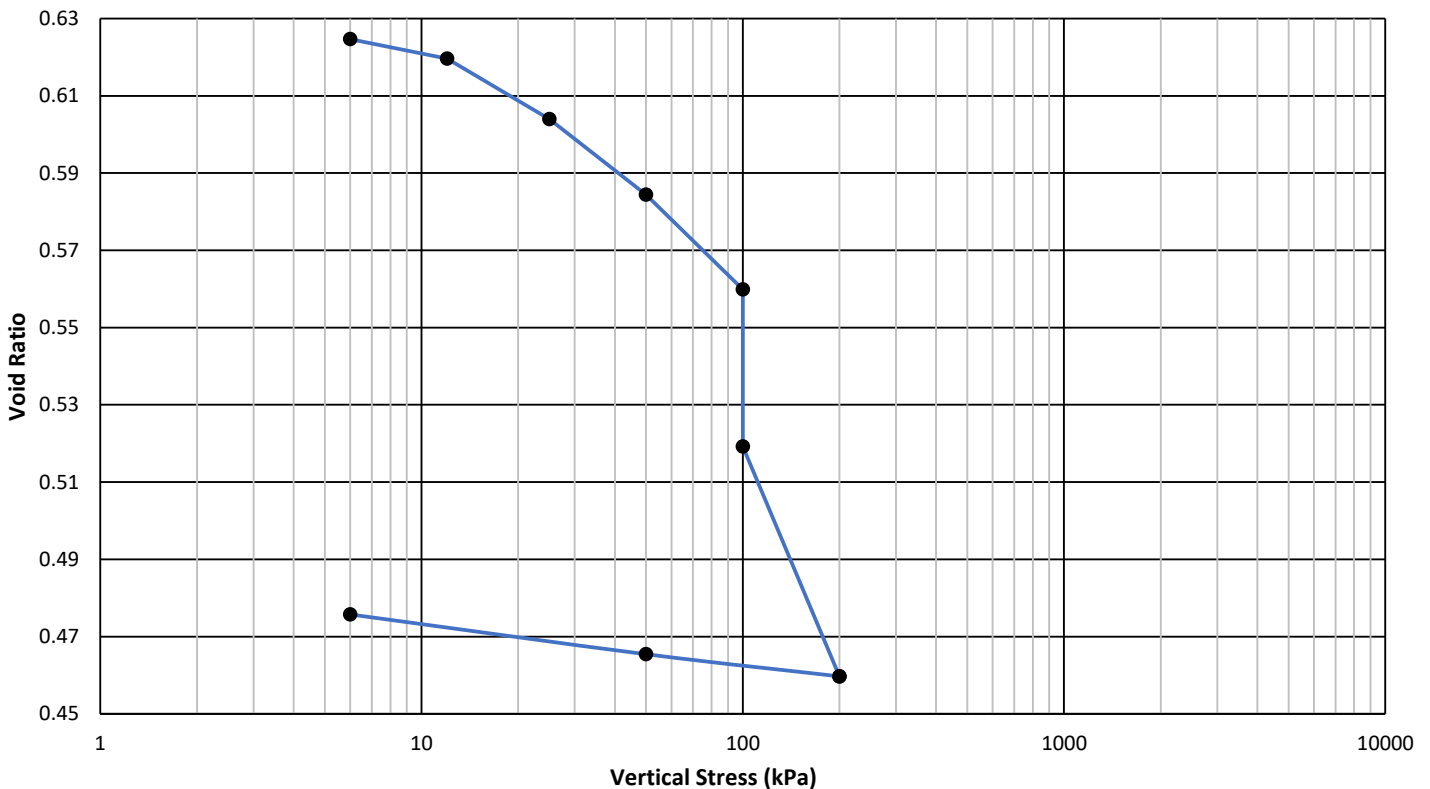
Client Name: Relly, Milner & Shedden
Project Name: John Dube X3
Sample: TP 51
Depth: (m) 0.9 - 1.1

Strain vs Log Stress

Void Ratio vs Log Stress
