FINAL REPORT

GEOTECHNICAL INVESTIGATION STUDY FOR THE PROPOSED INTERGRATED HUMAN SETTLEMENT ON PORTION 3 OF THE FARM NABOOMSPRUIT 348 KR, MOOKGOPONG, LIMPOPO PROVINCE, SOUTH AFRICA

Report No. : **NTE22-03**

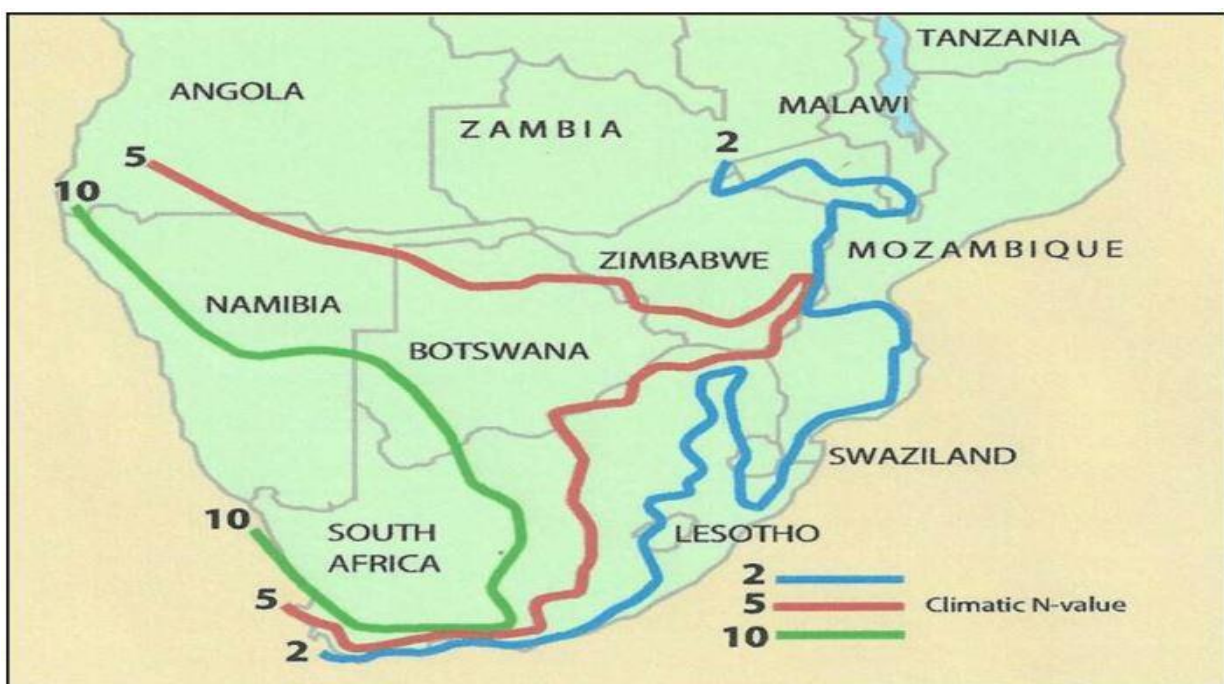
FIGURE 3-1 MOKGOPONG WEINERT N-VALUES

The site is located in the Southern Hemisphere which is characterised by warm to hot rainy summers and cold dry winters. Mookgopong receives approximately 599 mm of rain annually with most of the rainfall occurring during summer months and the winter months receiving the least rainfall. The average annual temperatures in Mookgopong are 19.5°C. According to Köppen and Geiger, this climate is classified as BSh. The site lies in an area with a Weinert N value that is less than 5, which indicates that chemical decomposition is the dominant form of weathering.

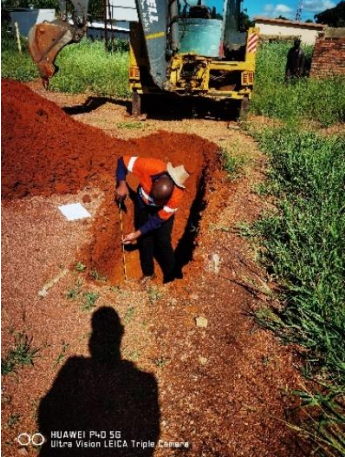
- **Top soil** - The colluvium encountered on site comprises dry to slightly moist, reddish brown, loose to medium dense, intact, silty sand. This material was encountered at depths between 0 to 1.1 mbgl. This horizon was encountered in eight (8) trial pits at TP1, TP2, TP3, TP4, TP7, TP8, TP9 and TP10.
- **Ironized ferricrete** – An ironized ferricrete material underlies the colluvium material. The ferricrete horizon comprises of dry to slightly moist, reddish brown, dense, intact, ironized sandy gravel. The material was encountered at depths between 0.2 to 1.5mbgl. This horizon was encountered in eight (8) trial pits at TP1, TP2, TP3, TP4, TP7, TP8, TP9 and TP10.

<p>PLATE 1: Trial pits 10 Soil profiling</p>	<p>PLATE 2: Trial Pit 6 Observed Uncontrolled fill (Old Dumping Site)</p>

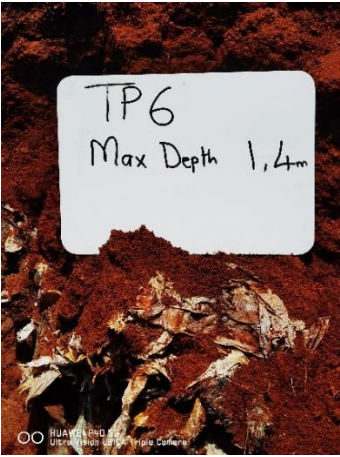
- **Uncontrolled fill-** The engineering fill encountered on site comprises of slightly moist, brown, loose, intact, silty sand with spotted roots in places, bottles, ash coal pebbles, boulders and bricks. This material was encountered at depths between 0 to 1.4 mbgl. This horizon was found in three (3) trial pits TP5, TP6 and TP11.

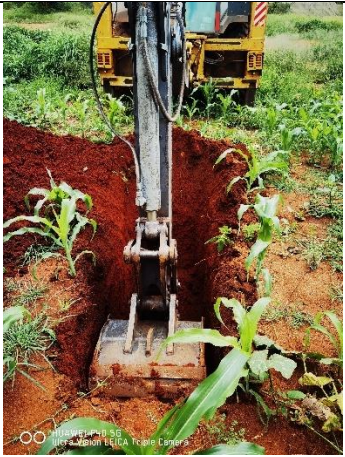
<p>PLATE 3: Trial pit 1 Soil Profiling</p>	<p>PLATE 4: Trial Pits 10 back filling</p>

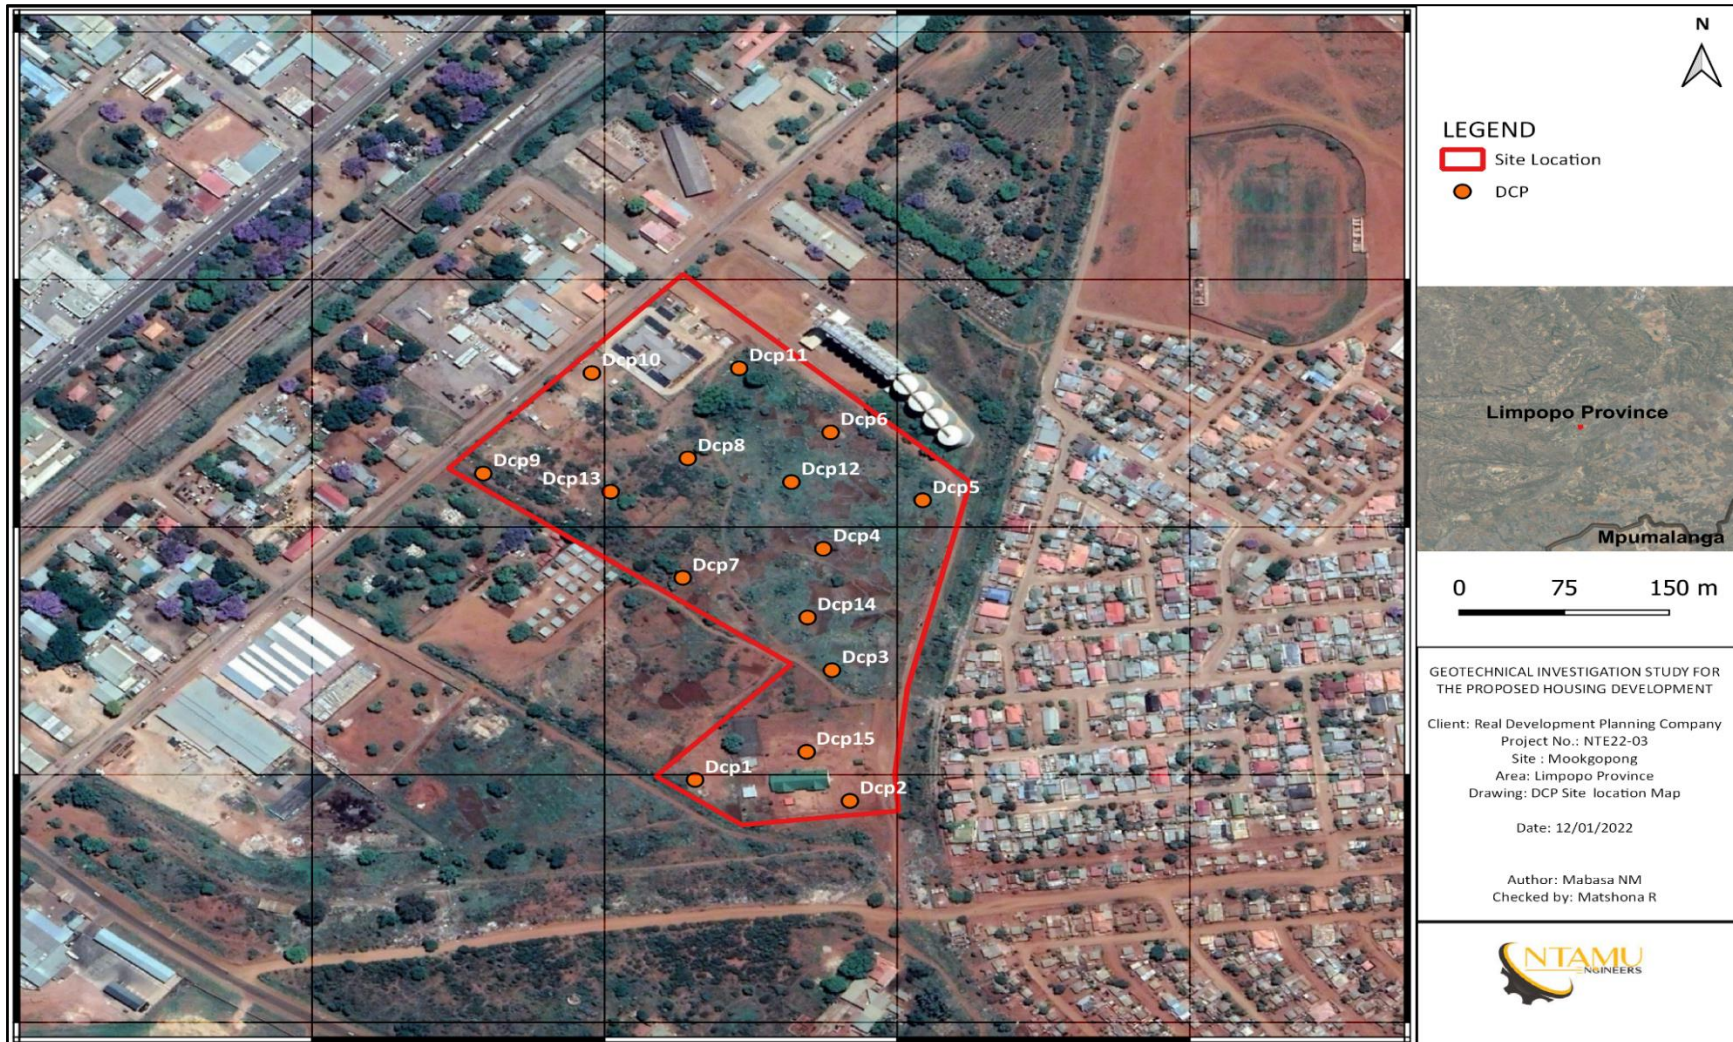
FIGURE 5-3 DCP LOCATION MAP

It should be noted that the results of DCP testing is affected by the moisture content of the soil profile, as well as any pebbles or cobbles that may be struck during the testing. A horizon saturated due to heavy rainfall will provide a lower set of results than a similar test in the dry season. Awkwardly oriented pebbles or cobbles struck may give false high readings. Coordinates and the results of the DCP conducted are shown in Table 5-4

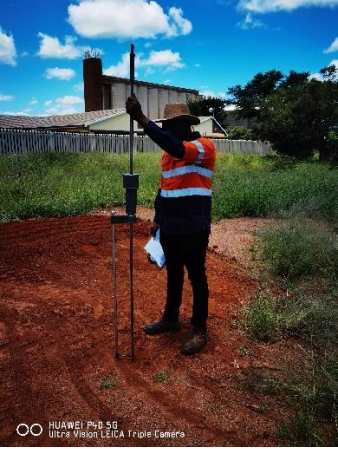
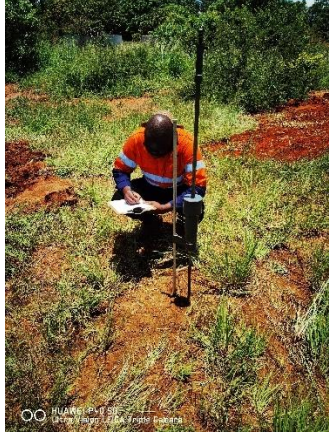
PLATE 1: Conducting DCP adjacent to TP10	PLATE 2: Conducting DCP adjacent to TP9

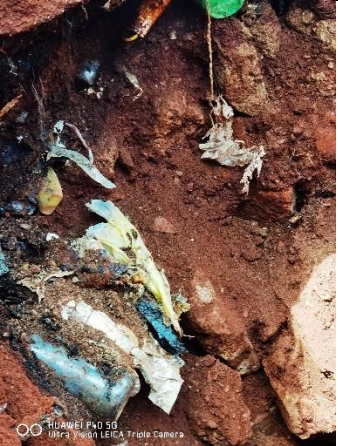
PLATE 3: boulders and Uncontrolled fill that can affect DCP reading	PLATE 4: Ironized ferricrete nodular

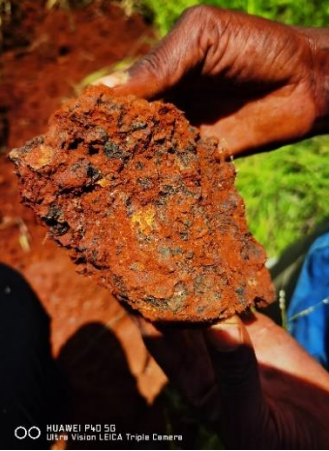
- **Ironized ferricrete** – An ironized ferricrete material underlies the colluvium material. The ferricrete horizon comprises of dry to slightly moist, reddish brown, dense, intact, ironized sandy gravel, ferricrete nodular. The material was encountered at depths between 0.5 to 1.2mbgl. This horizon was encountered in ten (2) trial pits (TP5 and TP11).

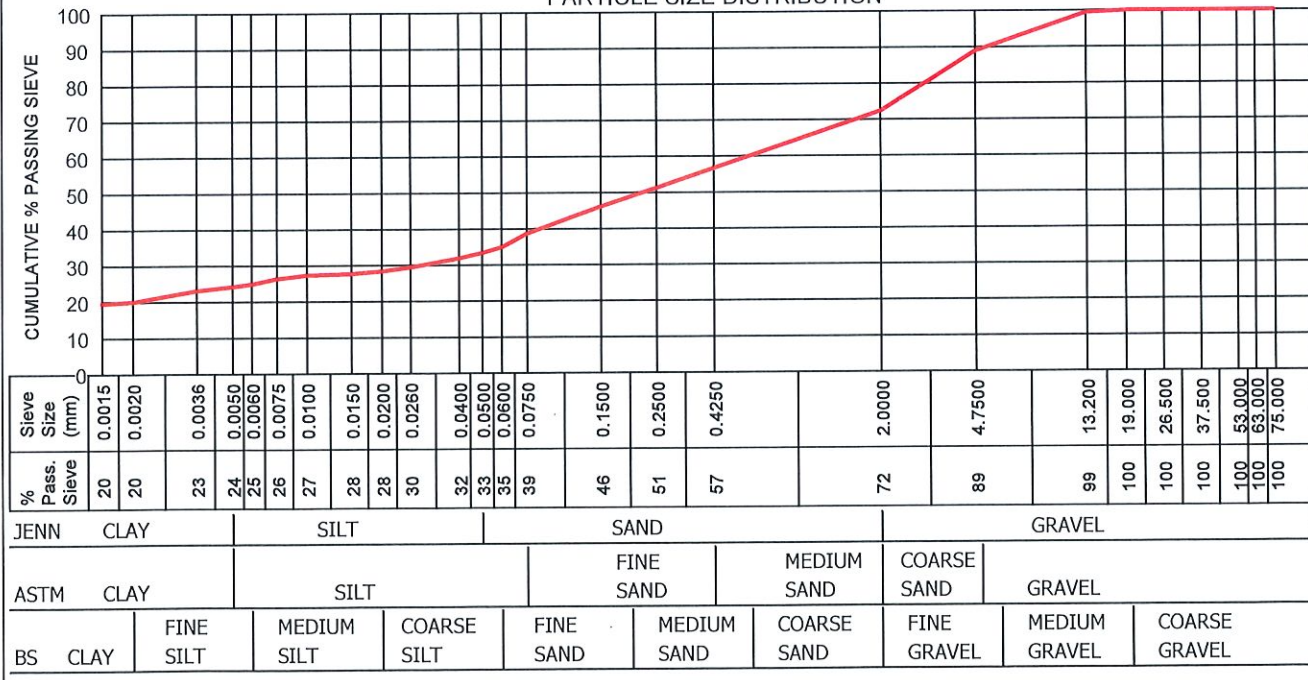
PARTICLE SIZE DISTRIBUTION

Sample No. : A22/0178
 Hole No. : TP2
 Depth : 100-400
 Liquid Limit (%) : 36
 Plasticity Index : 16
 Linear Shrinkage (%) : 8.0
 PI of Whole Sample : 9
 P.R.A. Classification : A-6(2)
 Unified Soil Classificat: SC
 Activity : 0.45
 Heave Classification : LOW
 Grading Modulus : 1.32
 Percentage (<0.002) : 20.0
 Moisture Content (%) : 12.5

Material Description : Dusky red CLAYEY SAND

Clay (%)	Silt (%)	Sand (%)	Gravel (%)	Classification
Jennings	24.2	9.2	39.1	27.5	SANDY CLAY
Astm	24.2	14.4	50.3	11.1	CLAYEY SAND
British Standard	20.1	14.8	37.5	27.5	CLAYEY SAND

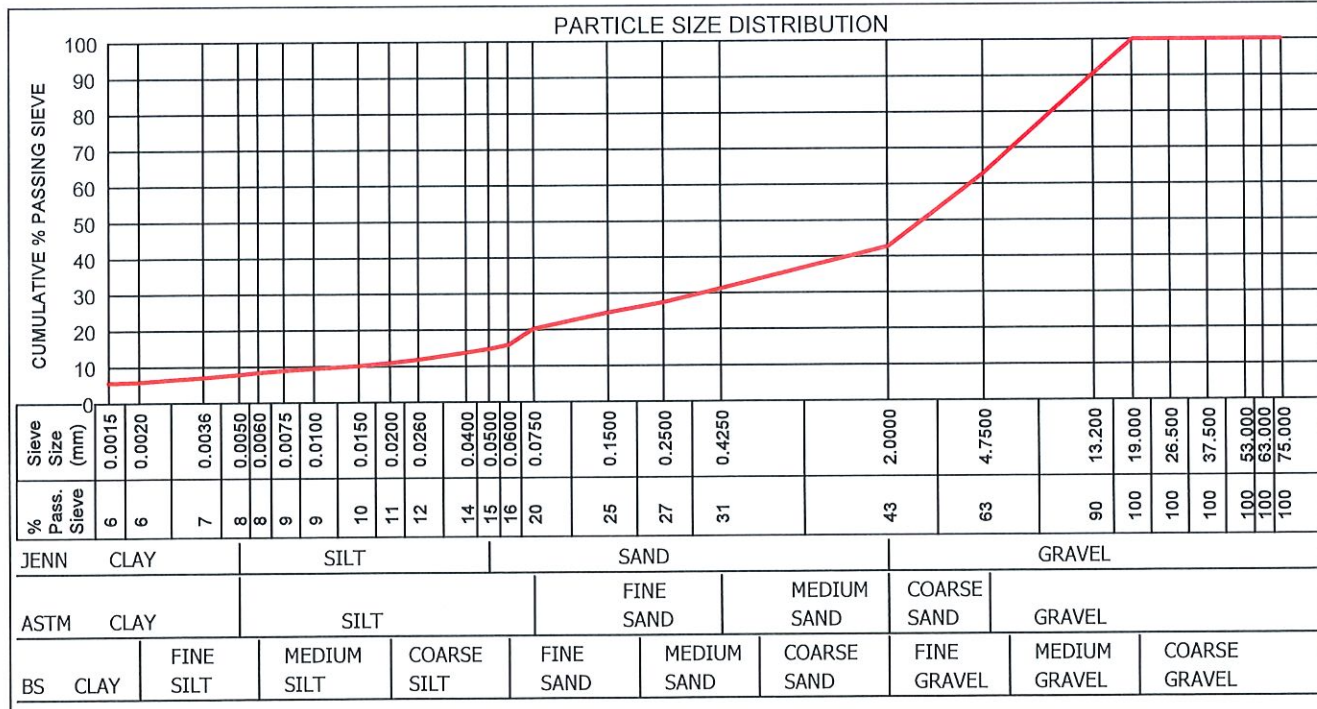
Sample No. : A22/0179
Hole No. : TP3
Depth : 0-200
Liquid Limit (%) : 34
Plasticity Index : 12
Linear Shrinkage (%) : 6.0
PI of Whole Sample : 4
P.R.A. Classification : A-2-6(0)
Unified Soil Classificatic: SC
Activity : 0.67
Heave Classification : LOW
Grading Modulus : 2.06
Percentage (<0.002) : 6.0
Moisture Content (%) : 8.7

Material Description : Dusky red SILTY SAND					
	Clay (%)	Silt (%)	Sand (%)	Gravel (%)	Classification
Jennings	7.9	6.9	28.0	57.2	SILTY SAND
Astm	7.9	12.3	42.7	37.2	SILTY SAND
British Standard	5.9	9.9	26.9	57.2	SILTY SAND

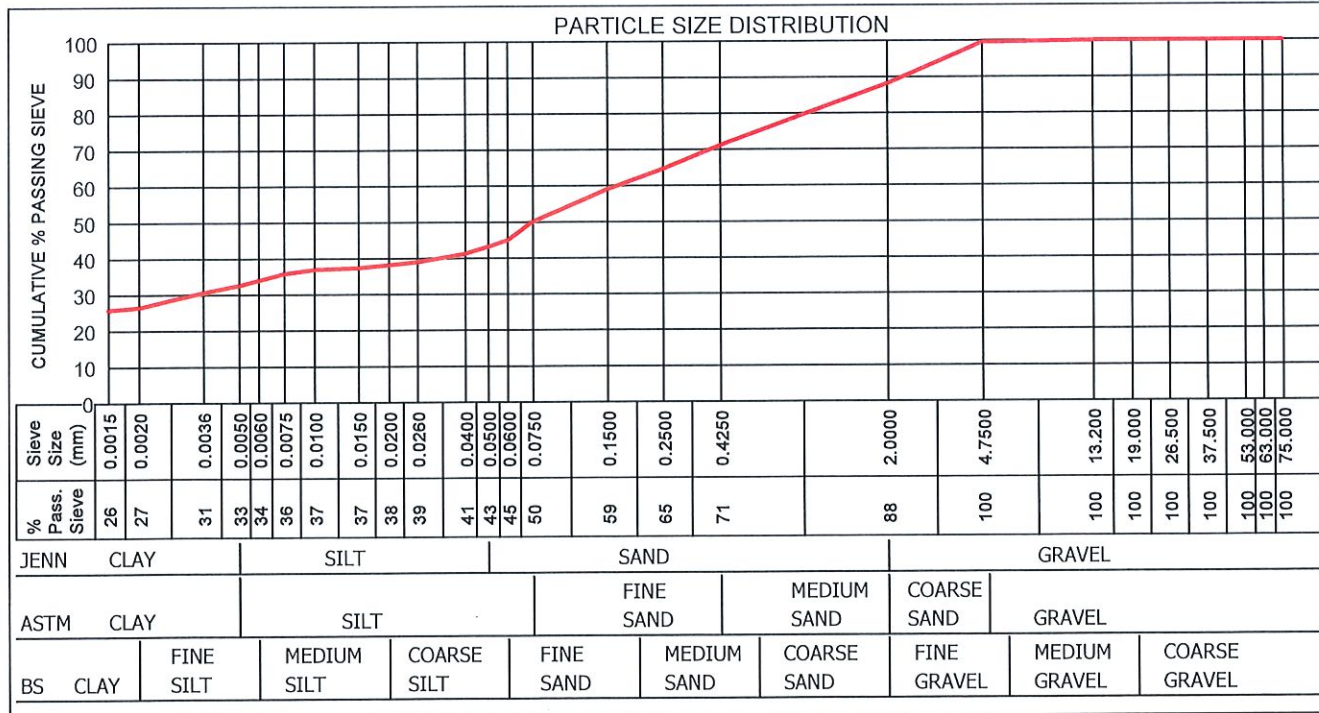
Sample No. : A22/0180
Hole No. : TP7
Depth : 700-1200
Liquid Limit (%) : 38
Plasticity Index : 17
Linear Shrinkage (%) : 9.0
PI of Whole Sample : 12
P.R.A. Classification : A-6(5)
Unified Soil Classificatic: SC
Activity : 0.44
Heave Classification : LOW
Grading Modulus : 0.91
Percentage (<0.002) : 27.0
Moisture Content (%) : 14.8

Material Description : Dark red SANDY CLAY					
	Clay (%)	Silt (%)	Sand (%)	Gravel (%)	Classification
Jennings	32.6	10.6	45.1	11.7	SANDY CLAY
Astm	32.6	17.5	49.4	0.4	SANDY CLAY
British Standard	26.5	18.5	43.2	11.7	SANDY CLAY

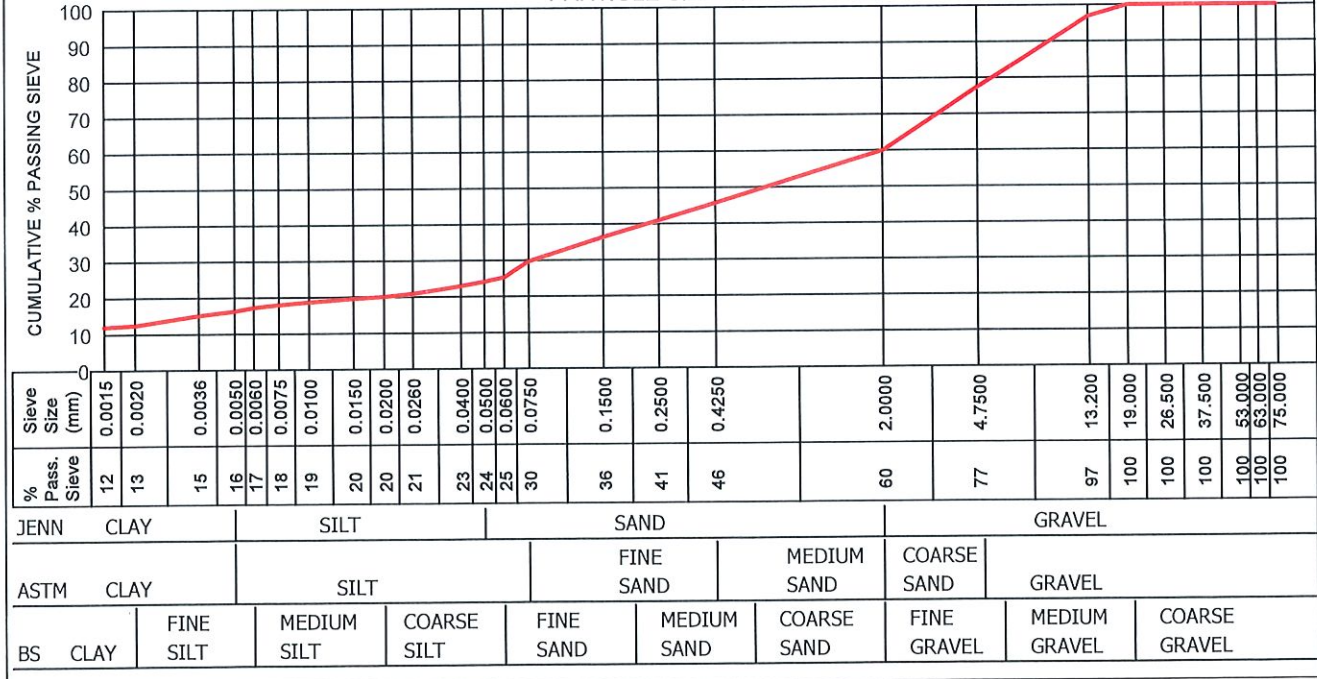
PARTICLE SIZE DISTRIBUTION

Sample No. : A22/0181
 Hole No. : TP9
 Depth : 700-1400
 Liquid Limit (%) : 34
 Plasticity Index : 18
 Linear Shrinkage (%) : 8.0
 PI of Whole Sample : 8
 P.R.A. Classification : A-2-6(1)
 Unified Soil Classificatic: SC
 Activity : 0.62
 Heave Classification : LOW
 Grading Modulus : 1.64
 Percentage (<0.002) : 13.0
 Moisture Content (%) : 6.6

Material Description : Dark red brown CLAYEY SAND					
	Clay (%)	Silt (%)	Sand (%)	Gravel (%)	Classification
Jennings	16.4	7.7	35.9	40.0	CLAYEY SAND
Astm	16.4	13.3	47.6	22.6	CLAYEY SAND
British Standard	12.5	12.8	34.7	40.0	CLAYEY SAND
