**PHASE 1 NEAR SURFACE GEOTECHNICAL INVESTIGATION FOR THE PROPOSED DEVELOPMENT OF 2008 SITES ON PORTION 24 & 28 OF THE FARM MOHLABA 567 LT (DAN EXT.3), LIMPOPO PROVINCE OF SOUTH AFRICA**

MGS/VC/02/02/2022

Final Report

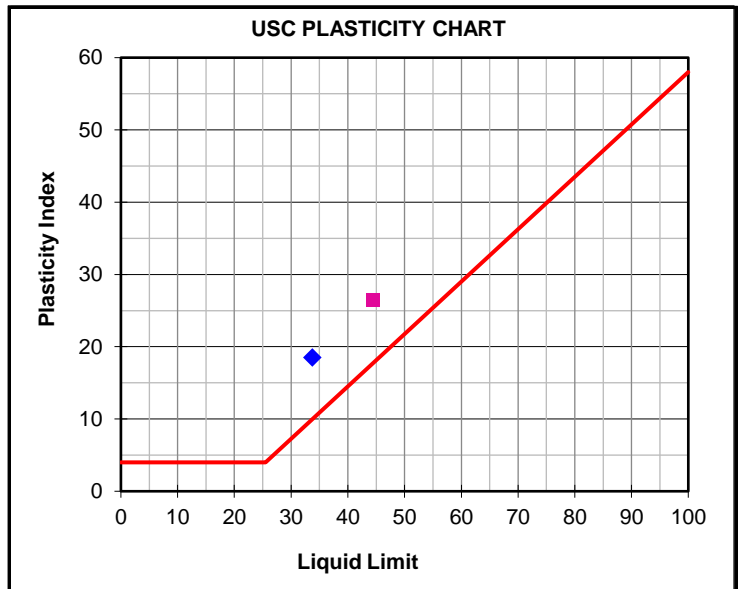
<b>Sieve Analysis (Wet Prep)</b>			
Percentage Passing	100 mm	100	100
	75 mm	100	100
	63 mm	100	100
	50 mm	100	100
	37.5 mm	100	100
	28 mm	100	100
	20 mm	100	100
	14 mm	97	100
	5 mm	89	98
	2 mm	75	93
	1 mm	58	81
	0.425 mm	39	56
	0.250 mm	32	48
0.150 mm	27	42	
0.075 mm	23	38	
Grading Modulus	1.63	1.13
