GEOTECHNICAL INVESTIGATION REPORT

THE REHABILITATION OF ROAD D192 IN THE MOKGALAKWENA MUNICIPALITY

Report No.: MAK0830203

MAKHUMA CONSULTING (Pty) Ltd

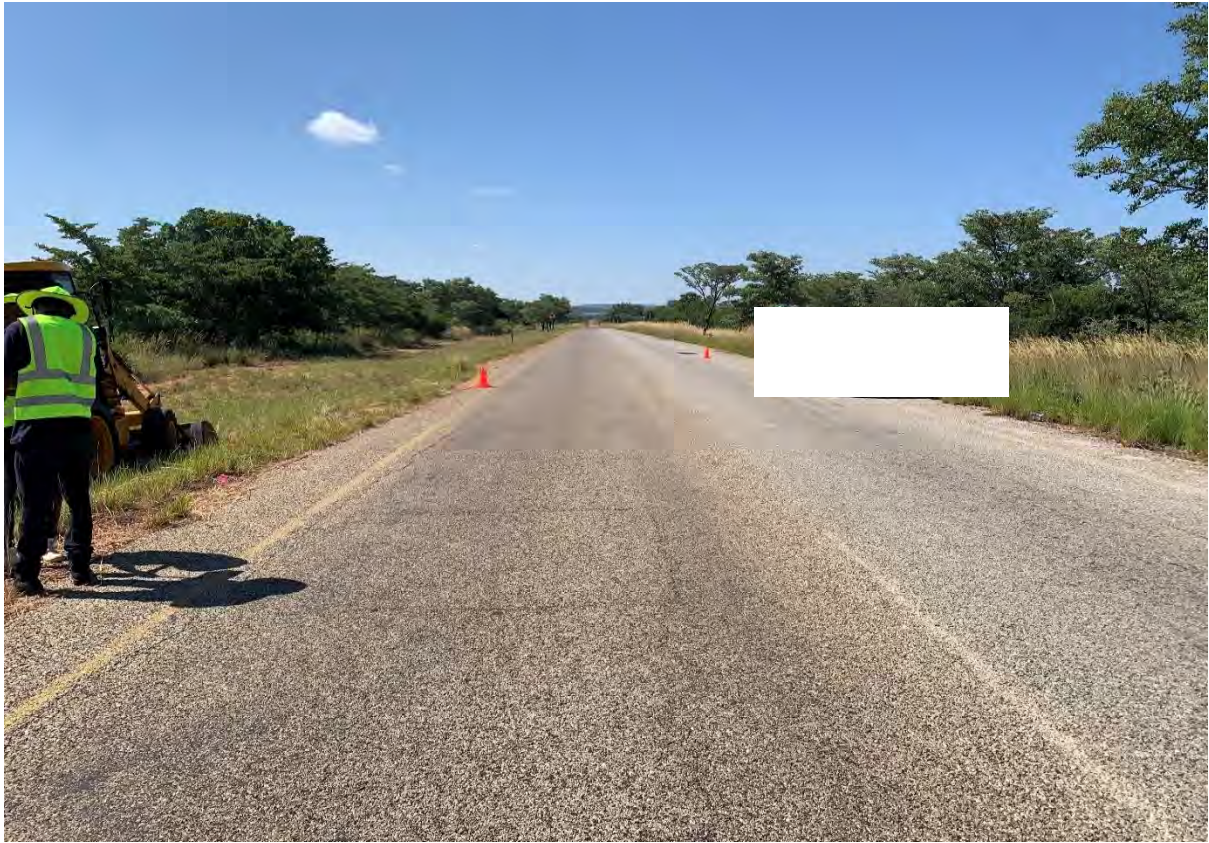
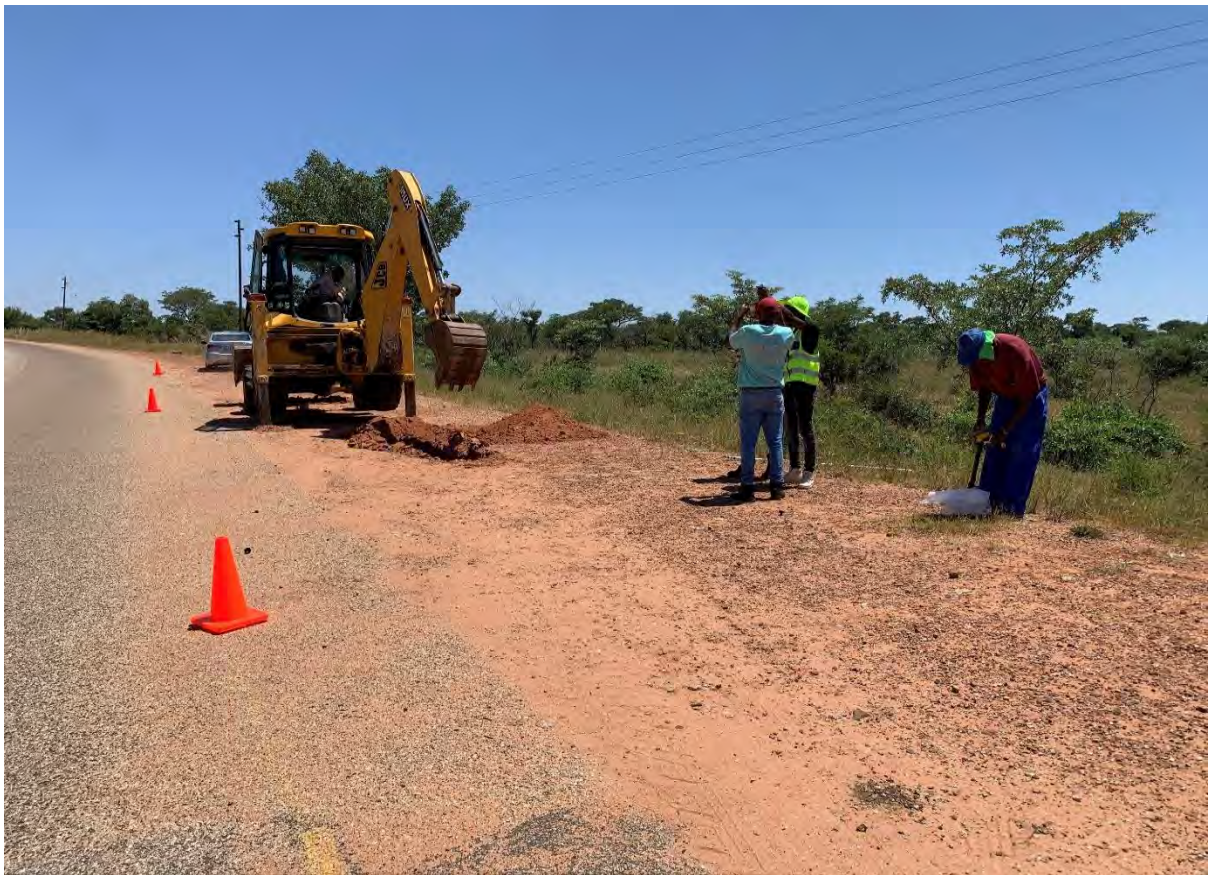
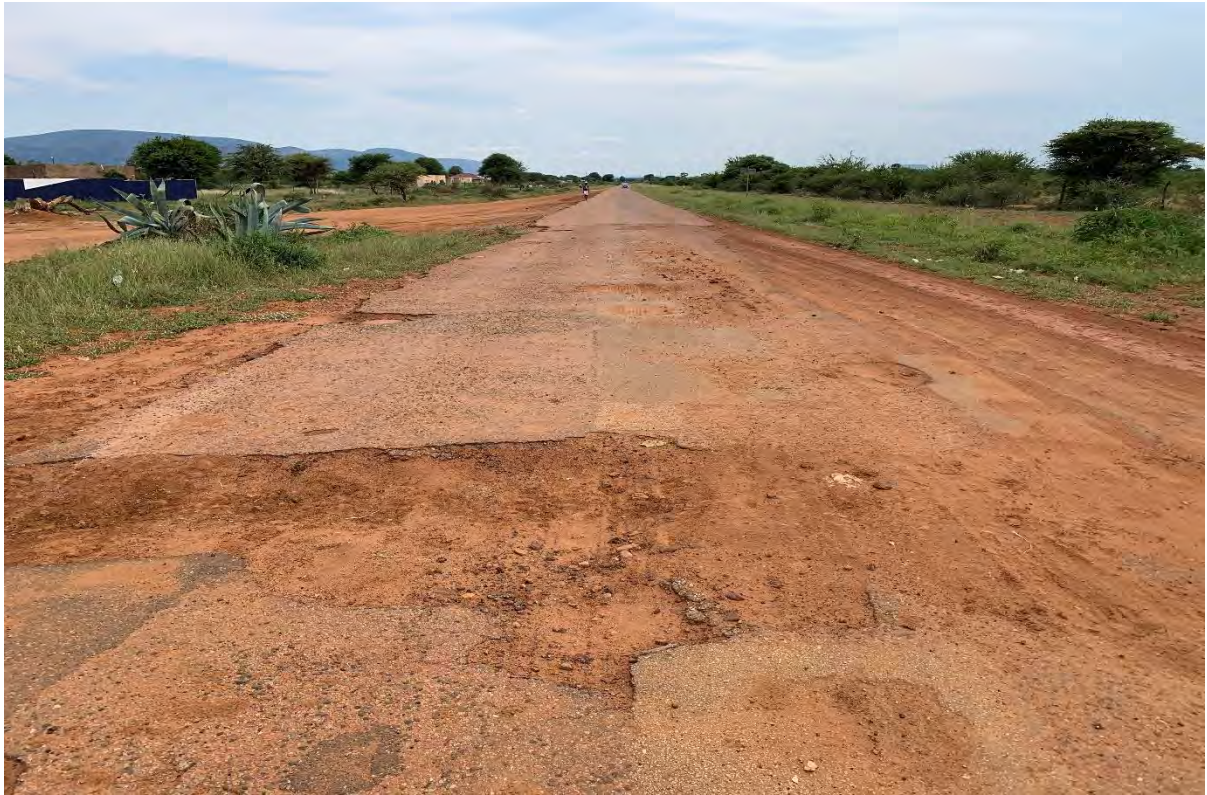
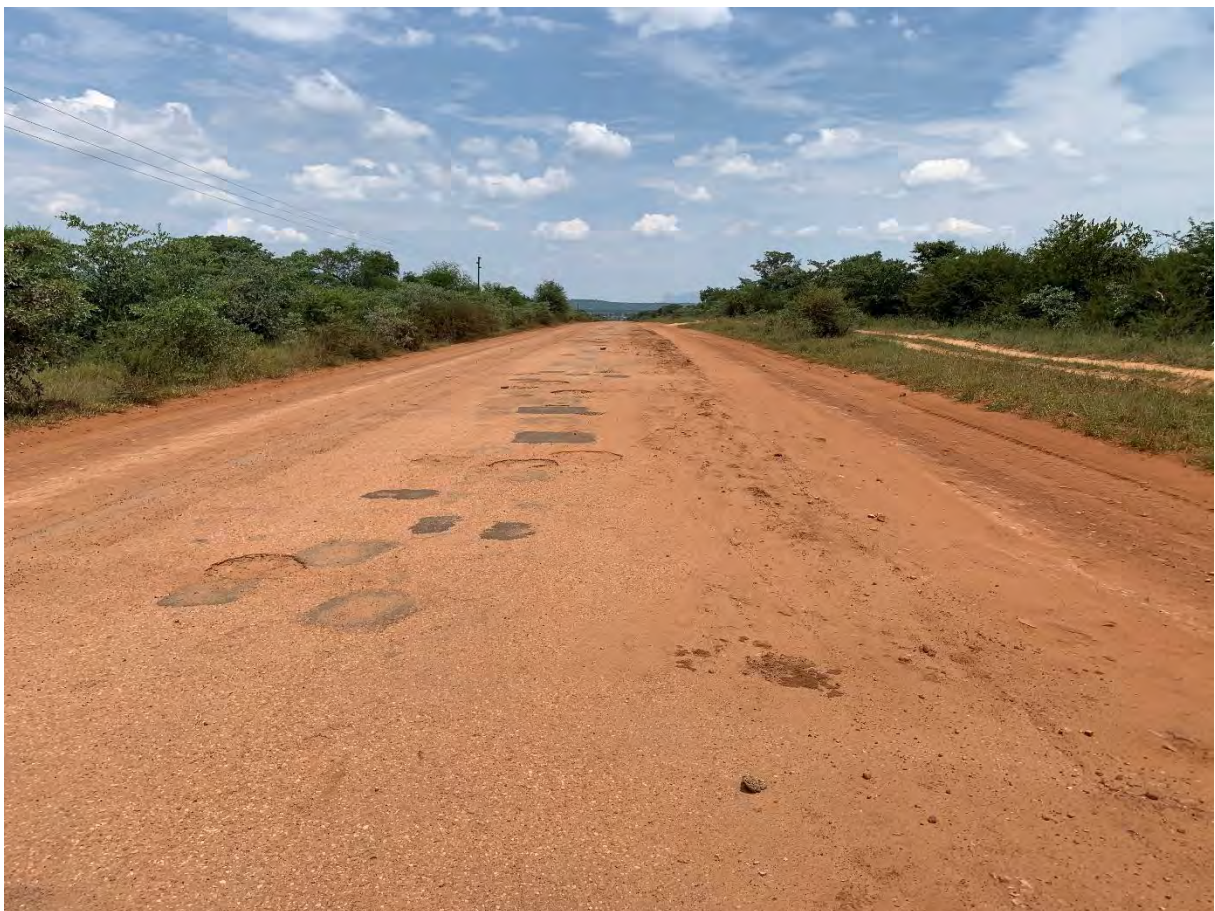
Plates 2-1: The current conditions of the road proposed for rehabilitation.

The site is accessible with 2-wheel drive vehicles. Locally, the area is characterised by near horizontal natural slopes with an average slope of between 1% – 3.0 % along the road alignment. The current condition of the proposed access roads is shown in Plates 2-1 below.

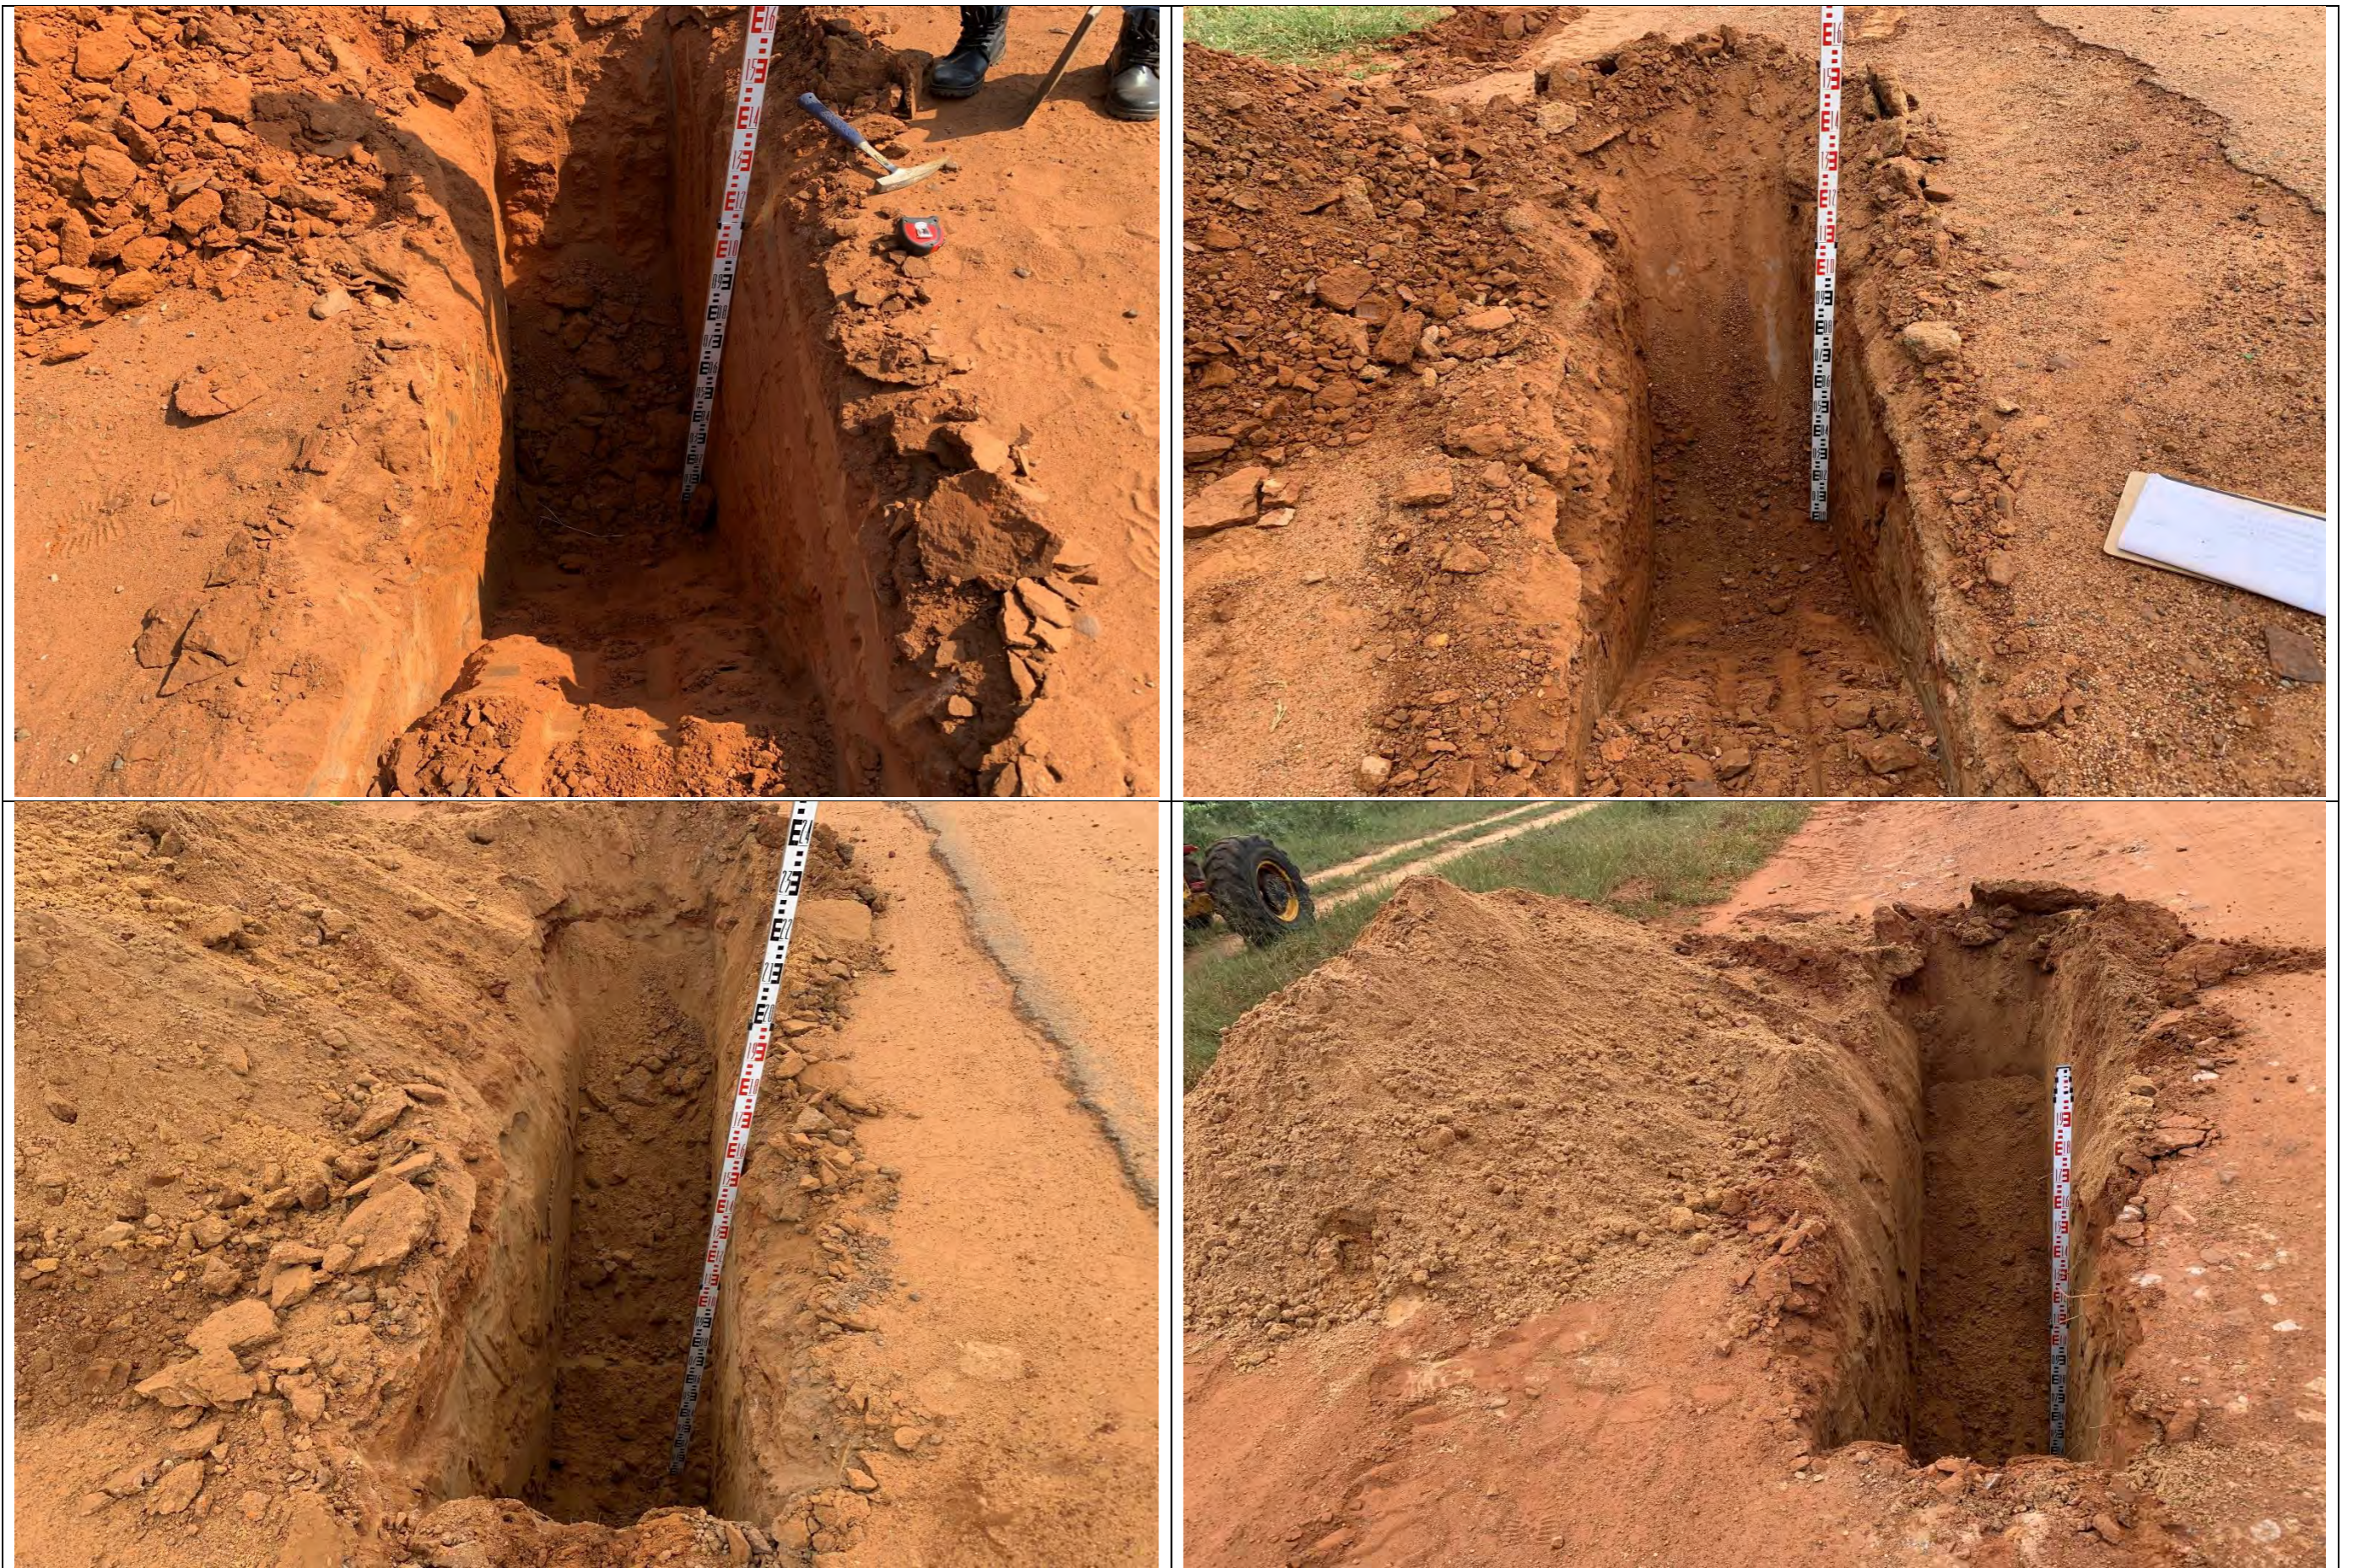
Plates 4-1: A pictorial view of materials encountered along the proposed access roads

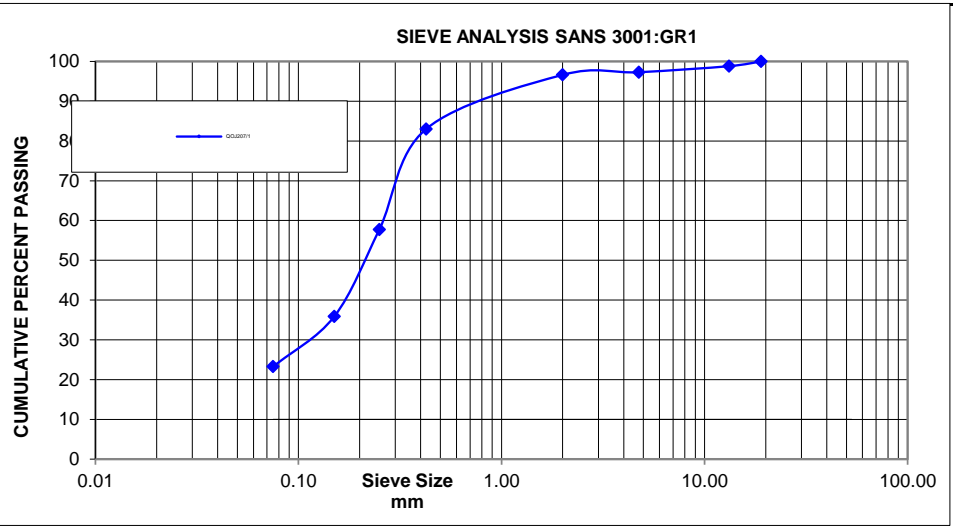
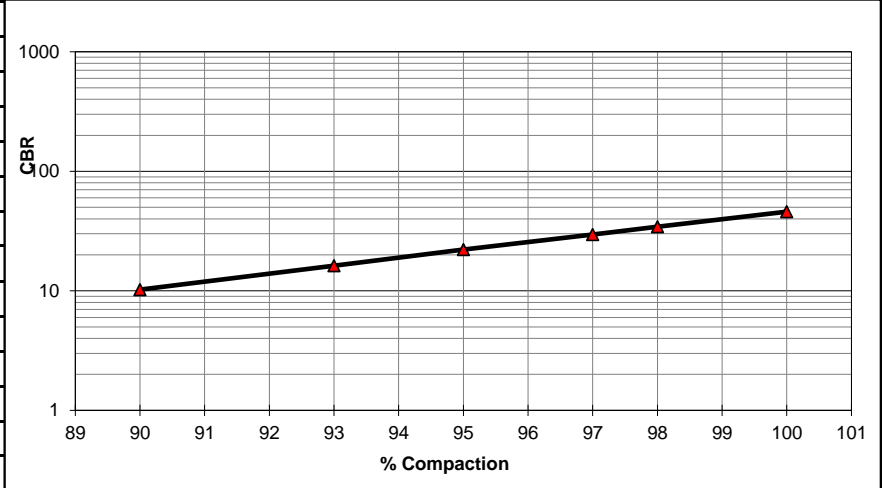
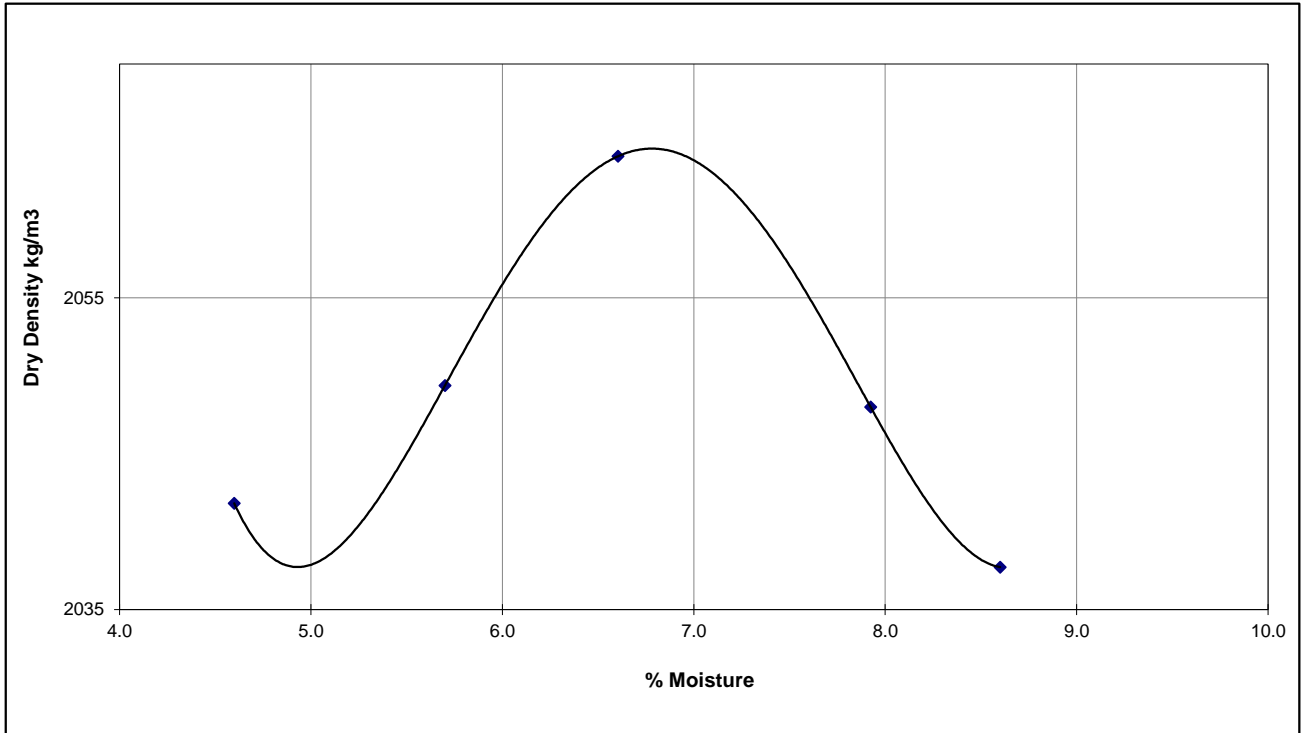
Sieve mm	% Passing
100.0	
75.0	
63.0	
50.0	
37.5	
28.0	
20.0	100
14.0	99
5.00	97
2.00	97
0.425	83
0.250	58
0.150	36
0.075	23

Soil Mortar % SANS 3001-PR5		Grading Modulus SANS 3001:PR5		*Classifications	
Coarse Sand	14	Grading Modulus	0.97	Unified Soil Classification	SM(d)
Coarse Fine Sand	26	Soil Constants SANS 3001:GR12		COLTO (1998)	G7
Medium Fine Sand	23	Liquid Limit (%)		US Highway	A-2-4
Fine Fine Sand	13	Plasticity Index (%)	NP	Group Index	0
Silt and Clay	24	Linear Shrinkage (%)	0.0

CBR SANS 3001:GR30,GR40			
MDD kg/m ³	2064		
OMC %	6.6		
Comp. Moisture %	6.6		
Dry Density kg/m ³	2062	1961	1857
Compaction %	99.9	95.0	90.0
% Swell	1.29	1.76	2.20
CBR @ % MDD			
@ 100% comp. :	46		
@ 98% comp. :	34		
@ 97% comp. :	30		
@ 95% comp. :	22		
@ 93% comp. :	16		
@ 90% comp. :	10

Maximum Dry Density MDD kg/m ³	2064
Optimum Moisture Content OMC %	6.6

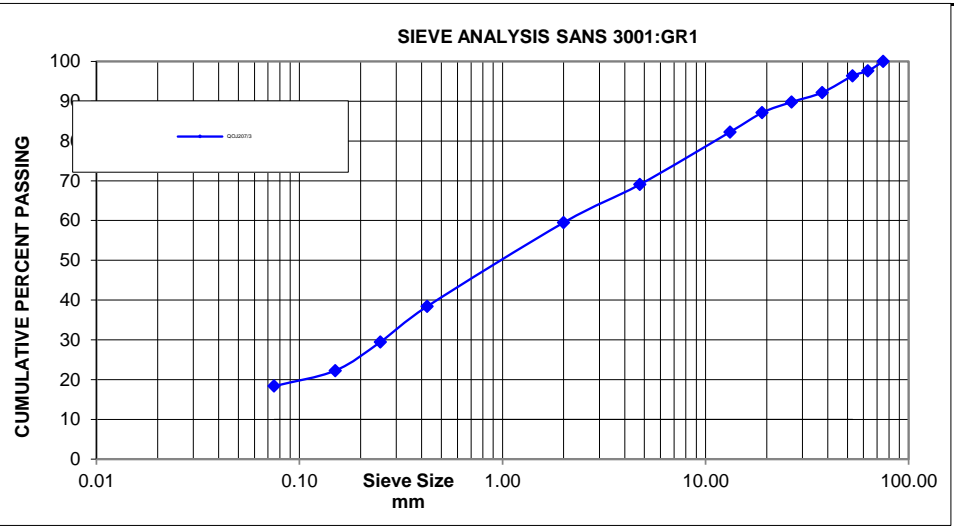
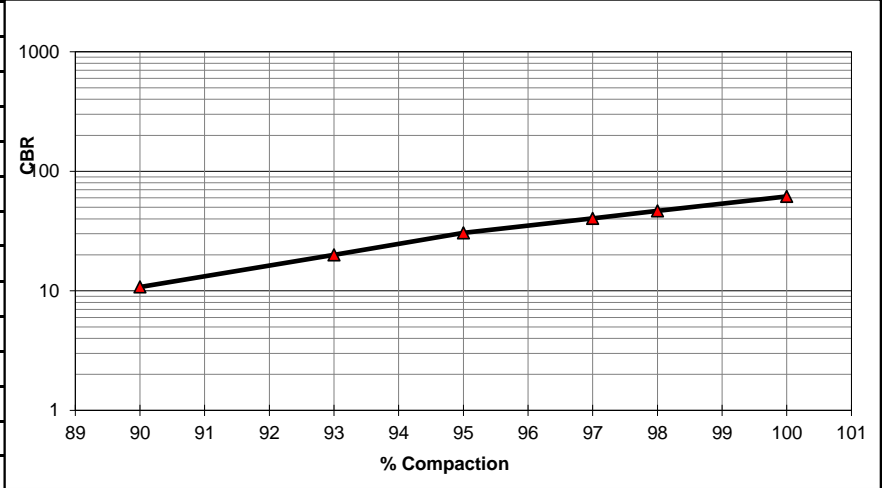
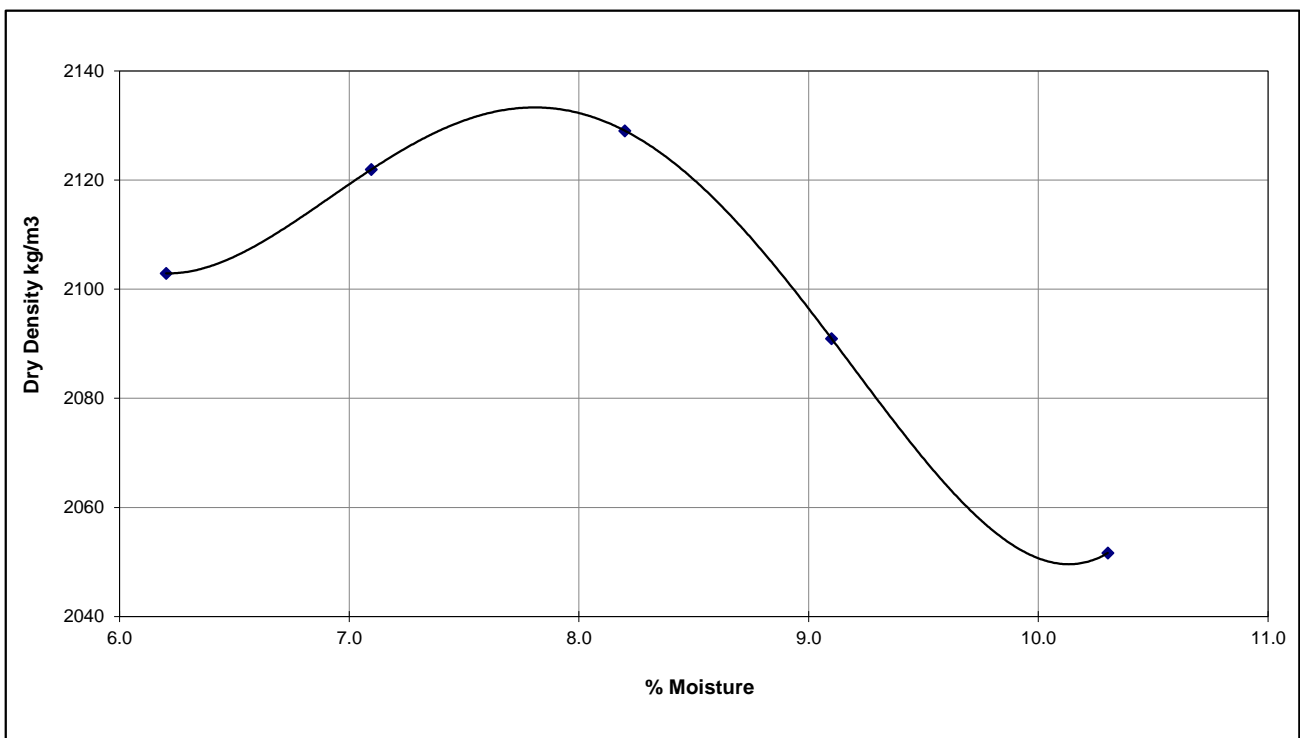
Sieve mm	% Passing
100.0	
75.0	100
63.0	98
50.0	96
37.5	92
28.0	90
20.0	87
14.0	82
5.00	69
2.00	59
0.425	38
0.250	29
0.150	22
0.075	18

Soil Mortar % SANS 3001-PR5		Grading Modulus SANS 3001:PR5		*Classifications	
Coarse Sand	35	Grading Modulus	1.84	Unified Soil Classification	SM(d)
Coarse Fine Sand	15	Soil Constants SANS 3001:GR12		COLTO (1998)	G6
Medium Fine Sand	12	Liquid Limit (%)		US Highway	A-1-b
Fine Fine Sand	7	Plasticity Index (%)	SP	Group Index	0
Silt and Clay	31	Linear Shrinkage (%)	1.0

CBR SANS 3001:GR30,GR40			
MDD kg/m ³	2128		
OMC %	8.0		
Comp. Moisture %	8.1		
Dry Density kg/m ³	2130	2025	1919
Compaction %	100.1	95.2	90.2
% Swell	0.28	0.35	0.39
CBR @ % MDD			
@ 100% comp. :	62		
@ 98% comp. :	47		
@ 97% comp. :	40		
@ 95% comp. :	31		
@ 93% comp. :	20		
@ 90% comp. :	11

Maximum Dry Density MDD kg/m ³	2128
Optimum Moisture Content OMC %	8

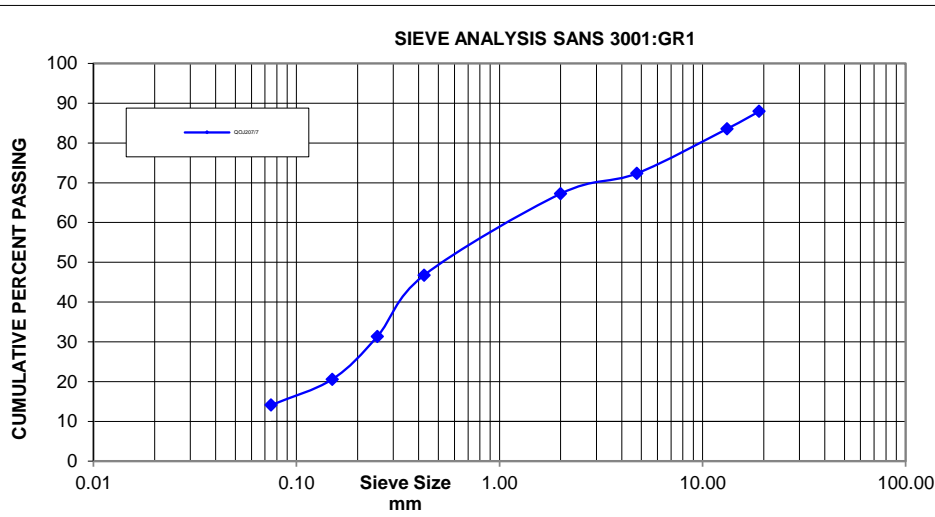
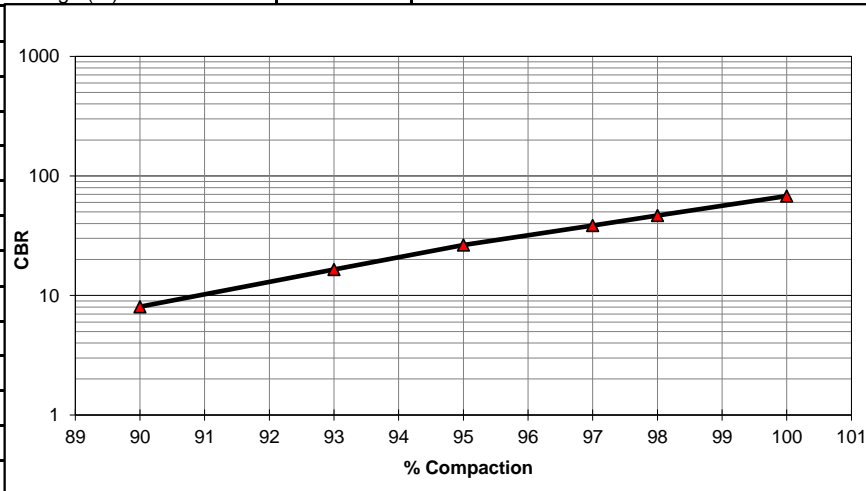
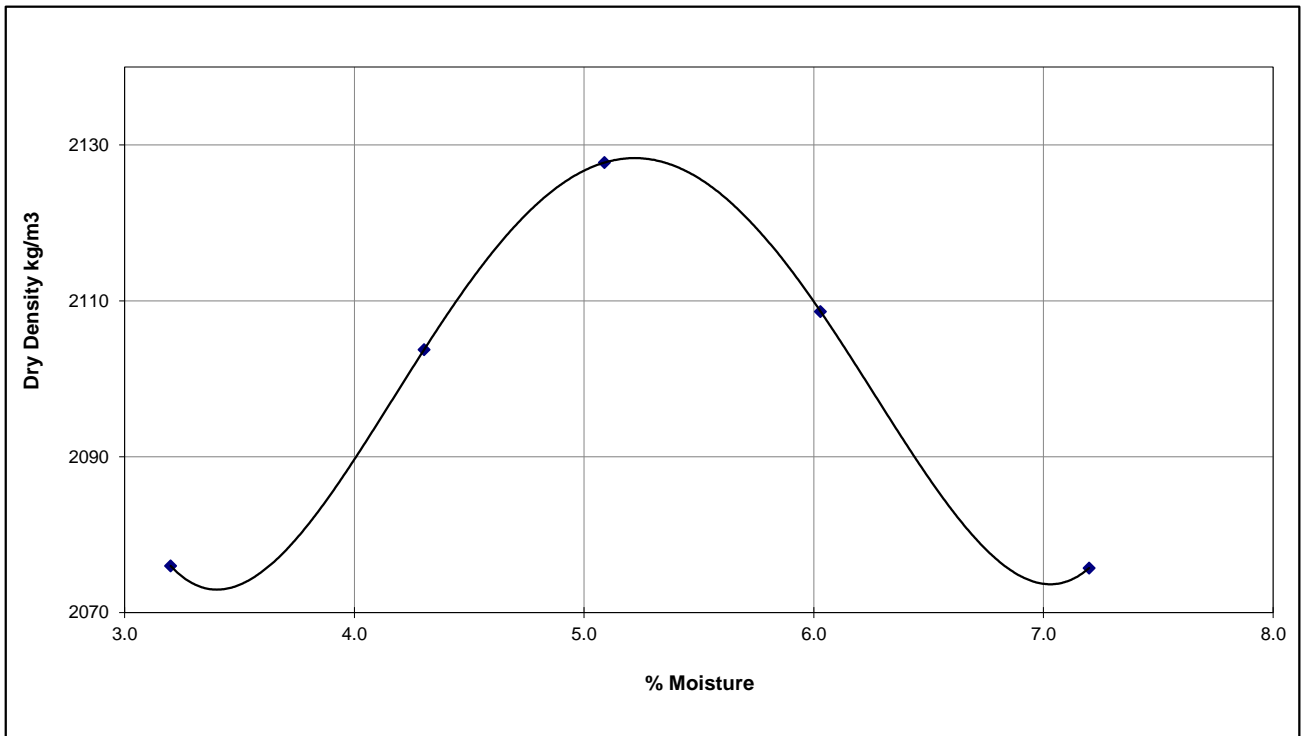
Sieve mm	% Passing
100.0	
75.0	
63.0	
50.0	
37.5	
28.0	
20.0	88
14.0	84
5.00	72
2.00	67
0.425	47
0.250	31
0.150	21
0.075	14

Soil Mortar % SANS 3001-PR5		Grading Modulus SANS 3001-PR5		*Classifications	
Coarse Sand	30	Grading Modulus	1.72	Unified Soil Classification	SM(d)
Coarse Fine Sand	23	Soil Constants SANS 3001:GR12		COLTO (1998)	G6
Medium Fine Sand	16	Liquid Limit (%)		US Highway	A-1-b
Fine Fine Sand	10	Plasticity Index (%)	NP	Group Index	0
Silt and Clay	21	Linear Shrinkage (%)	0.0

CBR SANS 3001:GR30,GR40			
MDD kg/m ³	2124		
OMC %	5.3		
Comp. Moisture %	5.4		
Dry Density kg/m ³	2120	2015	1909
Compaction %	99.8	94.9	89.9
% Swell	0.93	1.57	2.01
CBR @ % MDD			
@ 100% comp. :	68		
@ 98% comp. :	47		
@ 97% comp. :	39		
@ 95% comp. :	26		
@ 93% comp. :	17		
@ 90% comp. :	8

Maximum Dry Density MDD kg/m ³	2124
Optimum Moisture Content OMC %	5.3

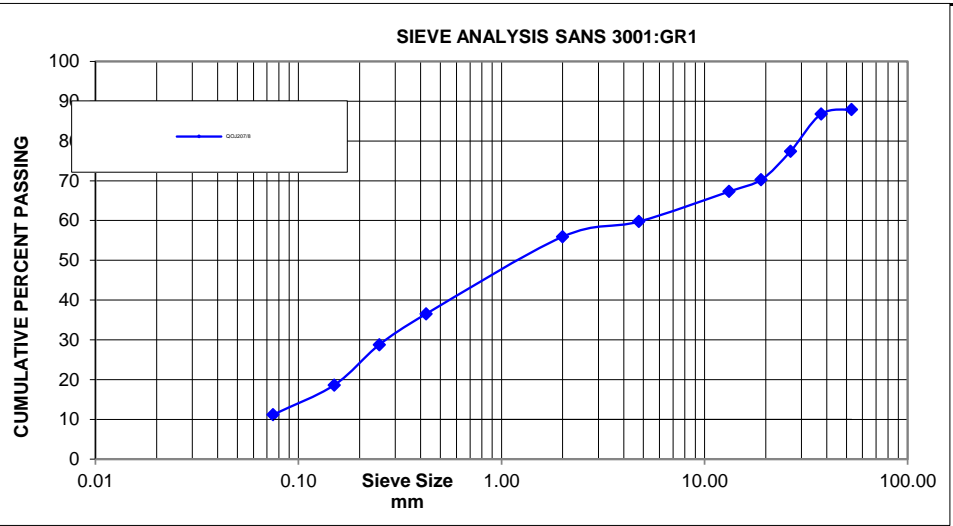
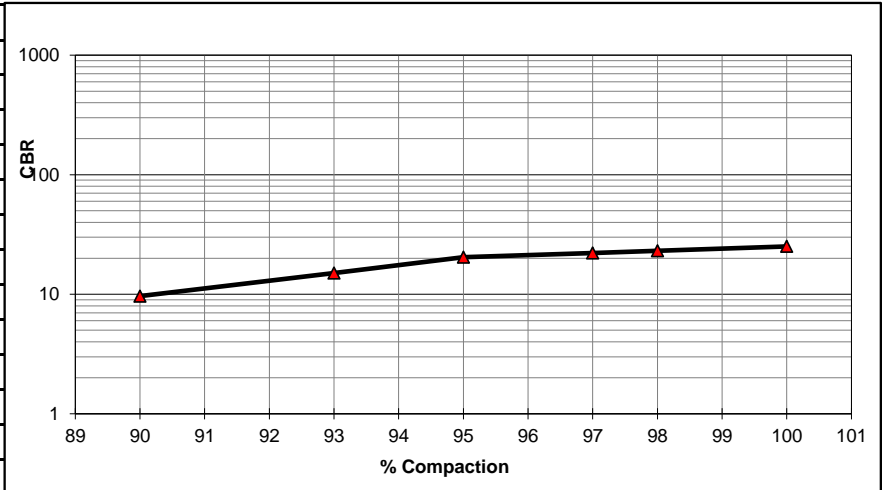
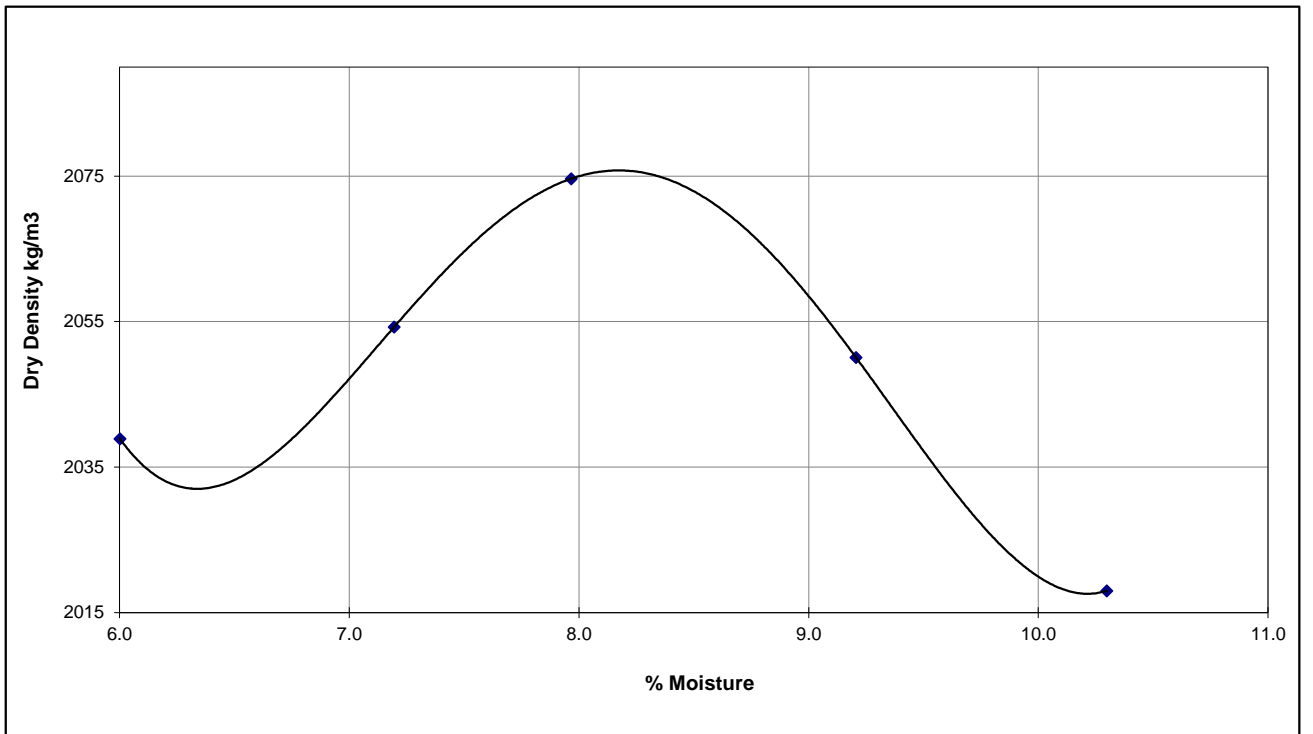
Sieve mm	% Passing
100.0	
75.0	
63.0	
50.0	88
37.5	87
28.0	77
20.0	70
14.0	67
5.00	60
2.00	56
0.425	37
0.250	29
0.150	19
0.075	11

Soil Mortar % SANS 3001-PR5		Grading Modulus SANS 3001:PR5		*Classifications	
Coarse Sand	35	Grading Modulus	1.96	Unified Soil Classification	sp/sm/sc
Coarse Fine Sand	14	Soil Constants SANS 3001:GR12		COLTO (1998)	G7
Medium Fine Sand	18	Liquid Limit (%)	20	US Highway	A-1-b
Fine Fine Sand	13	Plasticity Index (%)	5	Group Index	0

CBR SANS 3001:GR30,GR40			
MDD kg/m ³	2074		
OMC %	8.1		
Comp. Moisture %	7.9		
Dry Density kg/m ³	2074	1972	1868
Compaction %	100.0	95.1	90.1
% Swell	0.67	0.98	1.22
CBR @ % MDD			
@ 100% comp. :	25		
@ 98% comp. :	23		
@ 97% comp. :	22		
@ 95% comp. :	20		
@ 93% comp. :	15		
@ 90% comp. :	10

Maximum Dry Density MDD kg/m³	2074
Optimum Moisture Content OMC %	8.1

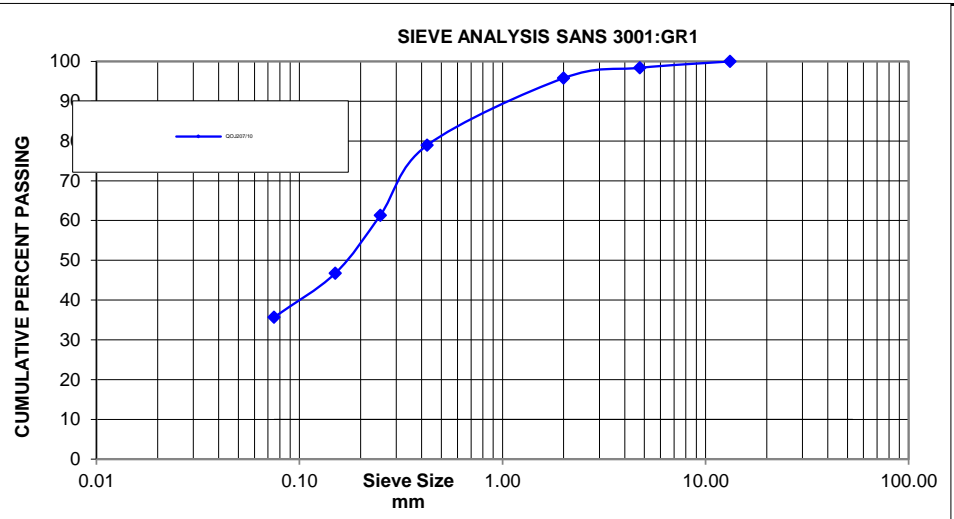
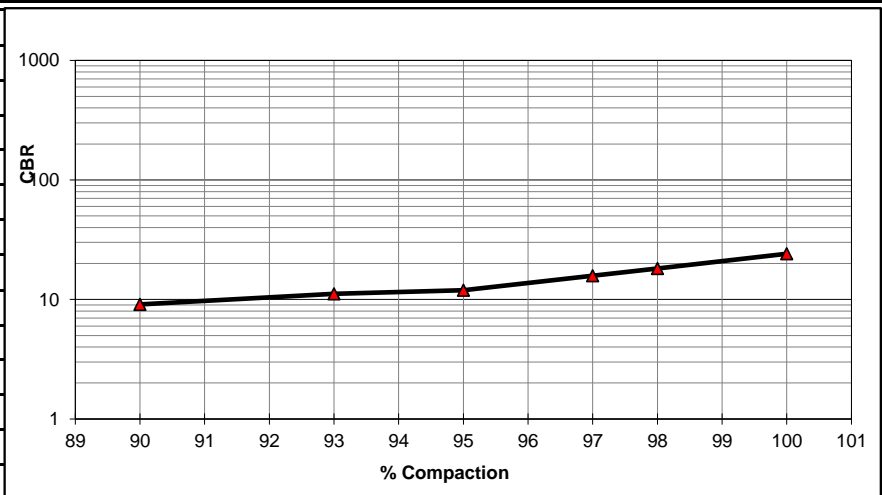
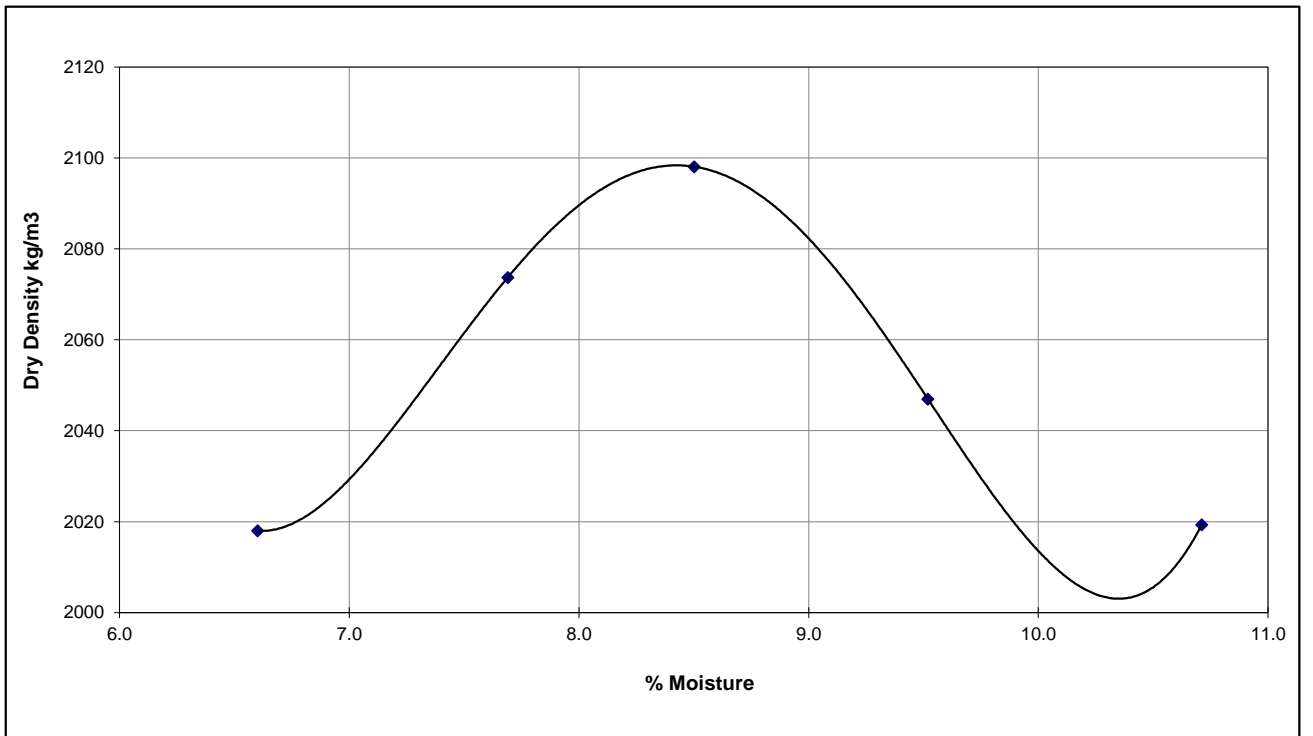
Sieve mm	% Passing
100.0	
75.0	
63.0	
50.0	
37.5	
28.0	
20.0	
14.0	100
5.00	98
2.00	96
0.425	79
0.250	61
0.150	47
0.075	36

Soil Mortar % SANS 3001-PR5		Grading Modulus SANS 3001:PR5		*Classifications	
Coarse Sand	18	Grading Modulus	0.90	Unified Soil Classification	sm/sc
Coarse Fine Sand	18	Soil Constants SANS 3001:GR12		COLTO (1998)	G8
Medium Fine Sand	15	Liquid Limit (%)	20	US Highway	A-4
Fine Fine Sand	12	Plasticity Index (%)	5	Group Index	0
Silt and Clay	37	Linear Shrinkage (%)	2.5

CBR SANS 3001:GR30,GR40			
MDD kg/m ³	2078		
OMC %	8.5		
Comp. Moisture %	8.5		
Dry Density kg/m ³	2096	1993	1888
Compaction %	100.9	95.9	90.8
% Swell	0.69	0.83	0.98
CBR @ % MDD			
@ 100% comp. :	24		
@ 98% comp. :	18		
@ 97% comp. :	16		
@ 95% comp. :	12		
@ 93% comp. :	11		
@ 90% comp. :	9

Maximum Dry Density MDD kg/m ³	2078
Optimum Moisture Content OMC %	8.5

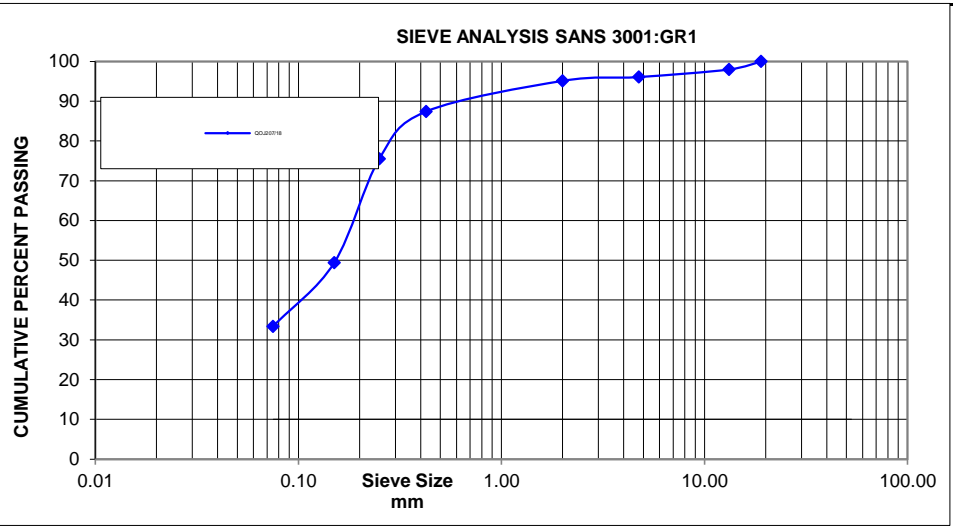
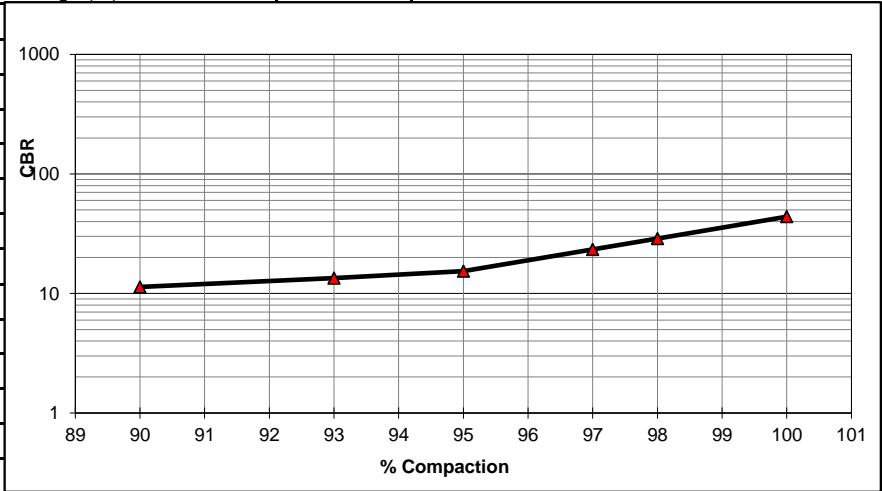
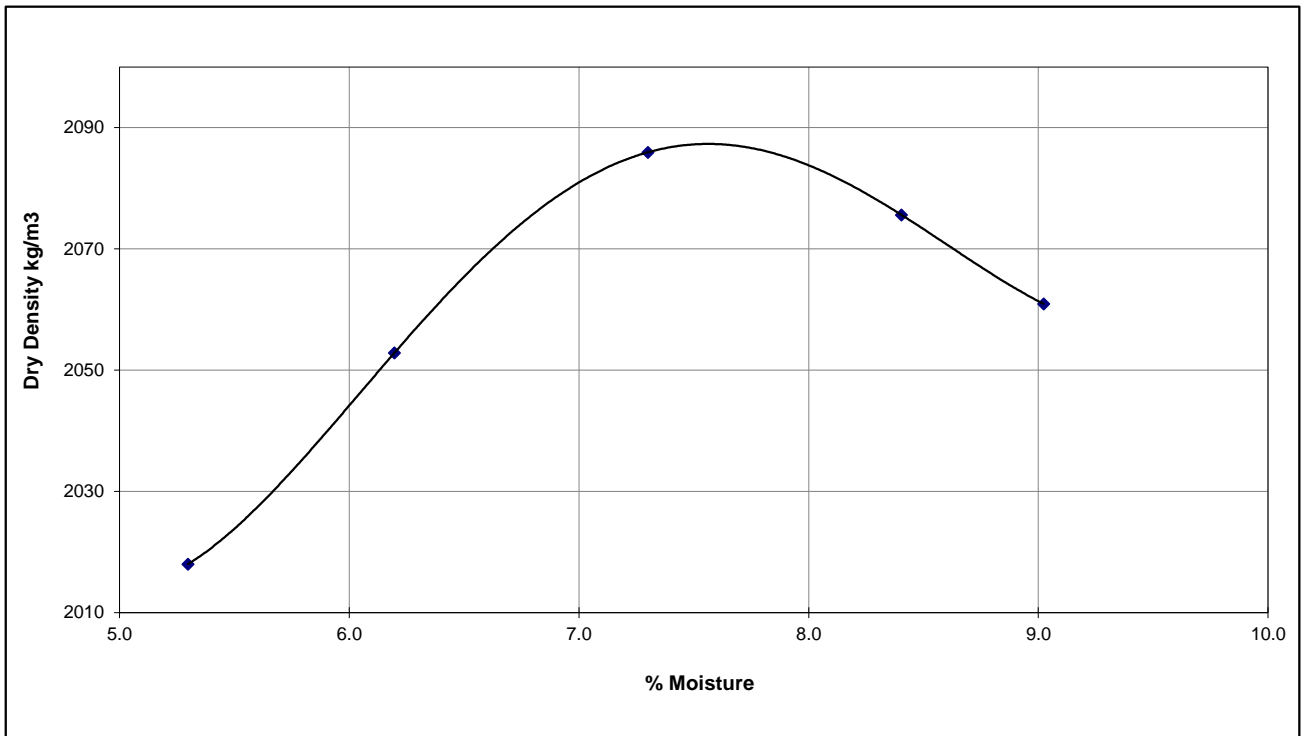
Sieve mm	% Passing
100.0	
75.0	
63.0	
50.0	
37.5	
28.0	
20.0	100
14.0	98
5.00	96
2.00	95
0.425	87
0.250	76
0.150	49
0.075	33

Soil Mortar % SANS 3001-PR5		Grading Modulus SANS 3001:PR5		*Classifications	
Coarse Sand	8	Grading Modulus	0.84	Unified Soil Classification	SM(d)
Coarse Fine Sand	12	Soil Constants SANS 3001:GR12		COLTO (1998)	G8
Medium Fine Sand	27	Liquid Limit (%)		US Highway	A-2-4
Fine Fine Sand	17	Plasticity Index (%)	NP	Group Index	0
Silt and Clay	35	Linear Shrinkage (%)	0.0

CBR SANS 3001:GR30,GR40			
MDD kg/m ³	2086		
OMC %	7.5		
Comp. Moisture %	7.4		
Dry Density kg/m ³	2080	1980	1875
Compaction %	99.7	94.9	89.9
% Swell	0.59	0.67	0.91
CBR @ % MDD			
@ 100% comp. :	44		
@ 98% comp. :	29		
@ 97% comp. :	23		
@ 95% comp. :	15		
@ 93% comp. :	13		
@ 90% comp. :	11

Maximum Dry Density MDD kg/m ³	2086
Optimum Moisture Content OMC %	7.5

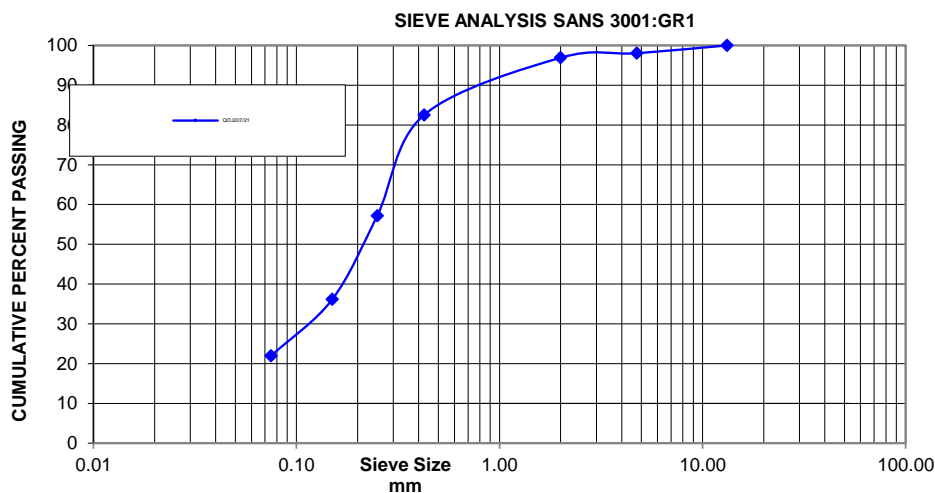
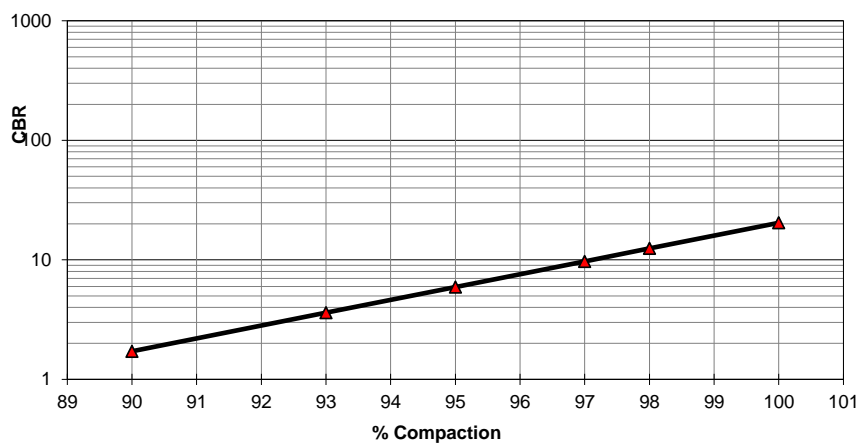
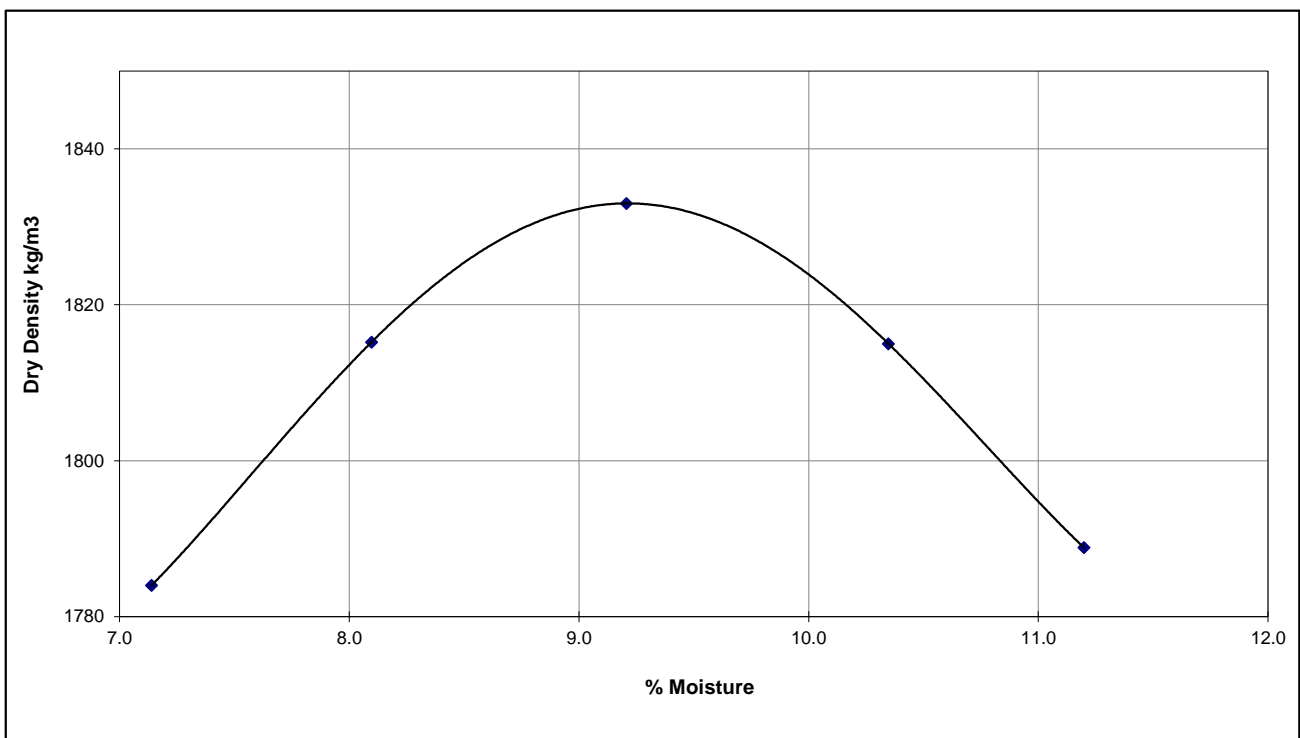
Sieve mm	% Passing
100.0	
75.0	
63.0	
50.0	
37.5	
28.0	
20.0	
14.0	100
5.00	98
2.00	97
0.425	83
0.250	57
0.150	36
0.075	22

Soil Mortar % SANS 3001-PR5		Grading Modulus SANS 3001:PR5		*Classifications	
Coarse Sand	15	Grading Modulus	0.99	Unified Soil Classification	SM(d)
Coarse Fine Sand	26	Soil Constants SANS 3001:GR12		COLTO (1998)	<G9
Medium Fine Sand	22	Liquid Limit (%)		US Highway	A-2-4
Fine Fine Sand	15	Plasticity Index (%)	NP	Group Index	0
Silt and Clay	23	Linear Shrinkage (%)	0.0

CBR SANS 3001:GR30,GR40			
MDD kg/m ³	1835		
OMC %	9.2		
Comp. Moisture %	9.3		
Dry Density kg/m ³	1829	1737	1649
Compaction %	99.7	94.6	89.8
% Swell	0.16	0.43	1.02
CBR @ % MDD			
@ 100% comp. :	20		
@ 98% comp. :	12		
@ 97% comp. :	10		
@ 95% comp. :	6		
@ 93% comp. :	4		
@ 90% comp. :	2

Maximum Dry Density MDD kg/m ³	1835
Optimum Moisture Content OMC %	9.2
