GEOTECHNICAL INVESTIGATION REPORT

THE REHABILITATION OF ROAD D192 IN THE MOKGALAKWENA MUNICIPALITY

Report No.: MAK0830203

MAKHUMA CONSULTING (Pty) Ltd

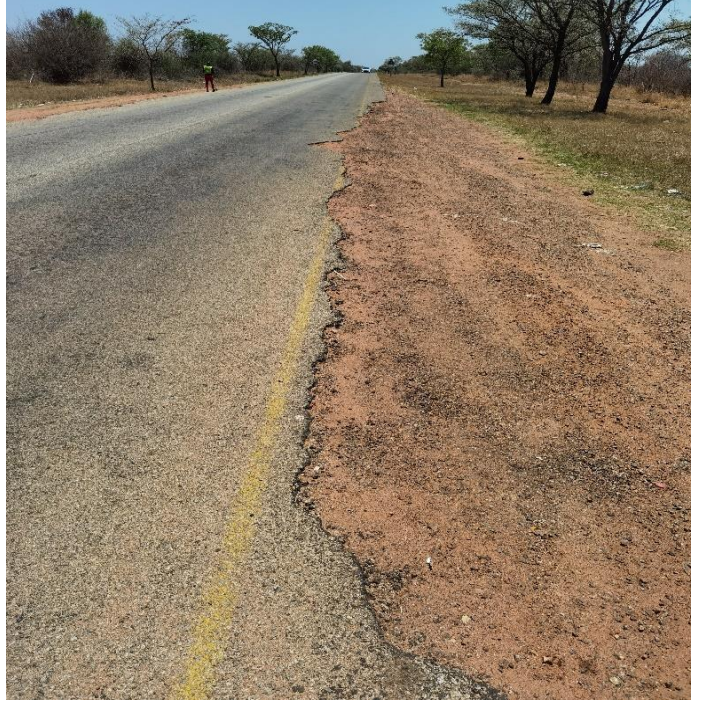
Km 2.95 – km 3.80(Damaged Base)

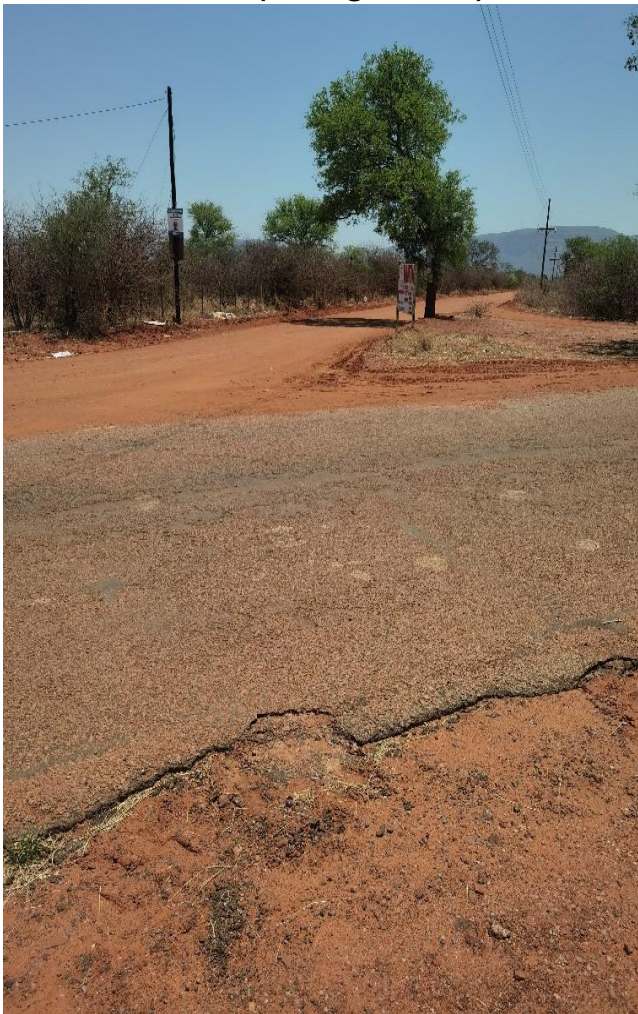
Km 3.8 – km 6.25(Potholes)
