**PHASE 1 NEAR SURFACE GEOTECHNICAL INVESTIGATION FOR THE PROPOSED
TOWNSHIP ESTABLISHMENT SITUATED ON THE REMAINDER OF PORTION 1 AND 2
OF THE FARM SEVILLE 224 KU**

MGS/Seville-3/001

Final Report

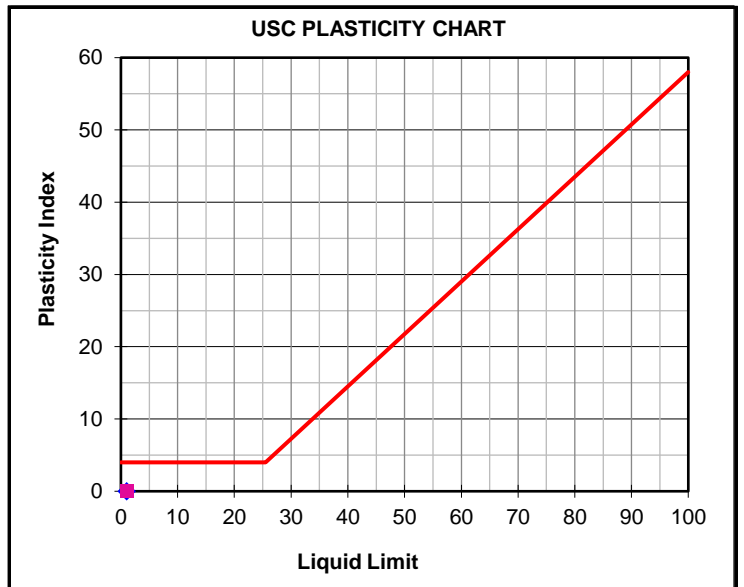
Sieve Analysis (Wet Prep)			
Percentage Passing	100 mm	100	100
	75 mm	100	100
	63 mm	100	100
	50 mm	100	100
	37.5 mm	100	100
	28 mm	100	100
	20 mm	100	100
	14 mm	98	99
	5 mm	72	87
	2 mm	45	72
	1 mm	37	49
	0.425 mm	25	32
	0.250 mm	16	23
0.150 mm	11	16	
0.075 mm	8	12	
Grading Modulus	2.22	1.84
