## GEOTECHNICAL INVESTIGATION FOR THE PROPOSED REITZ CEMETERY

Document control			
<b>Report title</b>	Geotechnical Investigation for the proposed Reitz Cemetery.		
<b>Client</b>	Nketoana Local Municipality		
<b>Date</b>	<b>22 September 2021</b>	<b>Keywords</b>	
<b>Compiled by</b>	Sboniso Zondi	Excavatability	Suitability Assessment
<b>Checked &amp; Approved by</b>	Nhlanhla Magigaba	Refusal	Site Selection
Rev	00

Dwala Group (Pty) Ltd was appointed by Nketoana Local Municipality to conduct a geotechnical investigation for the proposed Reitz Cemetery in the Free State Province.

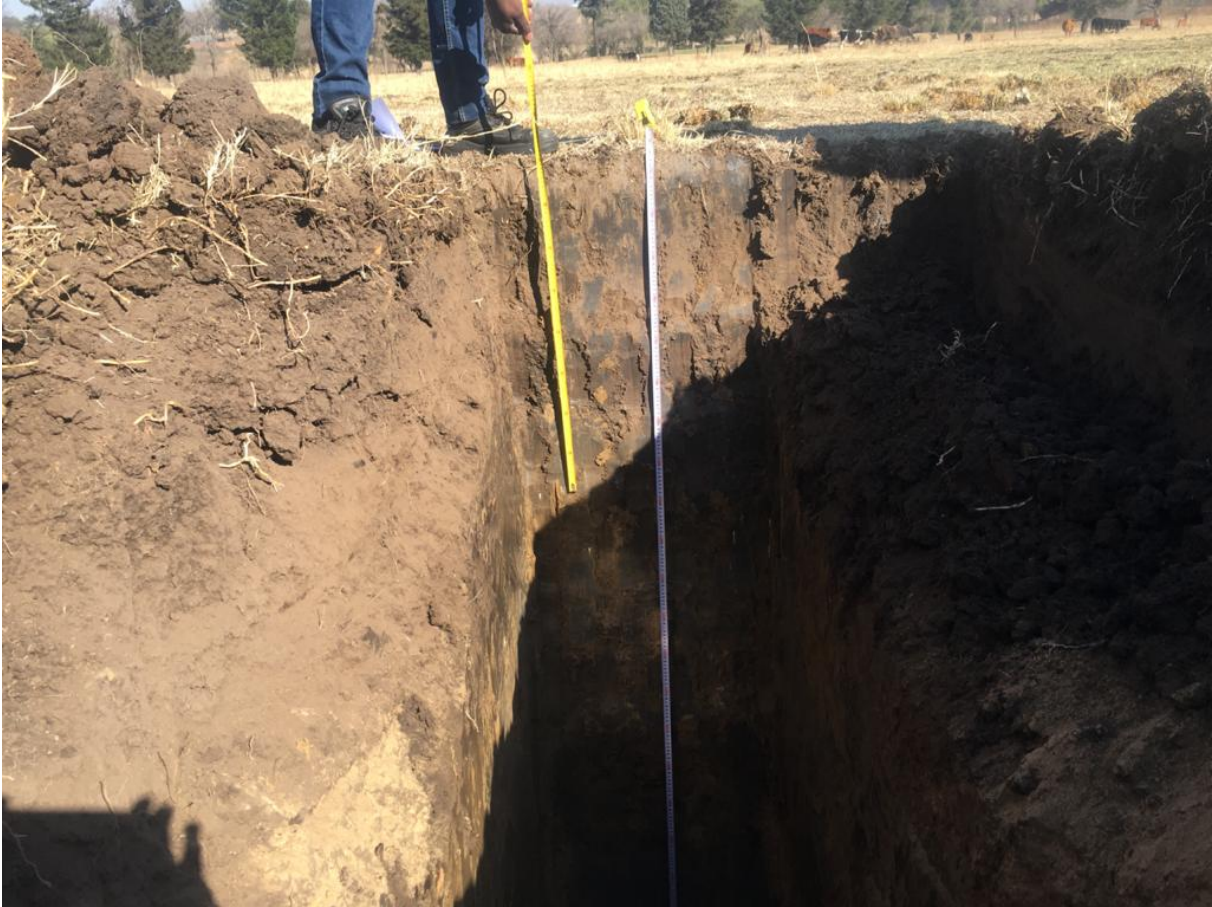
**Figure 3: Showing a typical test pit profiled on site.**

The geotechnical investigation revealed that the profile across the site is generally uniform, comprising of the following horizons:

- Transported horizon;
- Residual sandstone horizon;
- Residual mudrock horizon;
- Residual shale;
- Mudrock bedrock;
- Sandstone bedrock and
- Shale bedrock.
