BRYPAAL SOLAR POWER (PV) PROJECT APRIL 2018

Geotechnical Investigation

Remainder of Portion 4 of the
farm Brypaal No. 134

Project Name	EIA for the proposed development of a 100 MW PV Solar Facility on the farm Brypaal, Northern Cape Province.
Report Title	Geotechnical assessment for Kakamas Brypaal PV Solar System
Authority Reference	14/12/16/3/3/2/1019
Report Status	Final

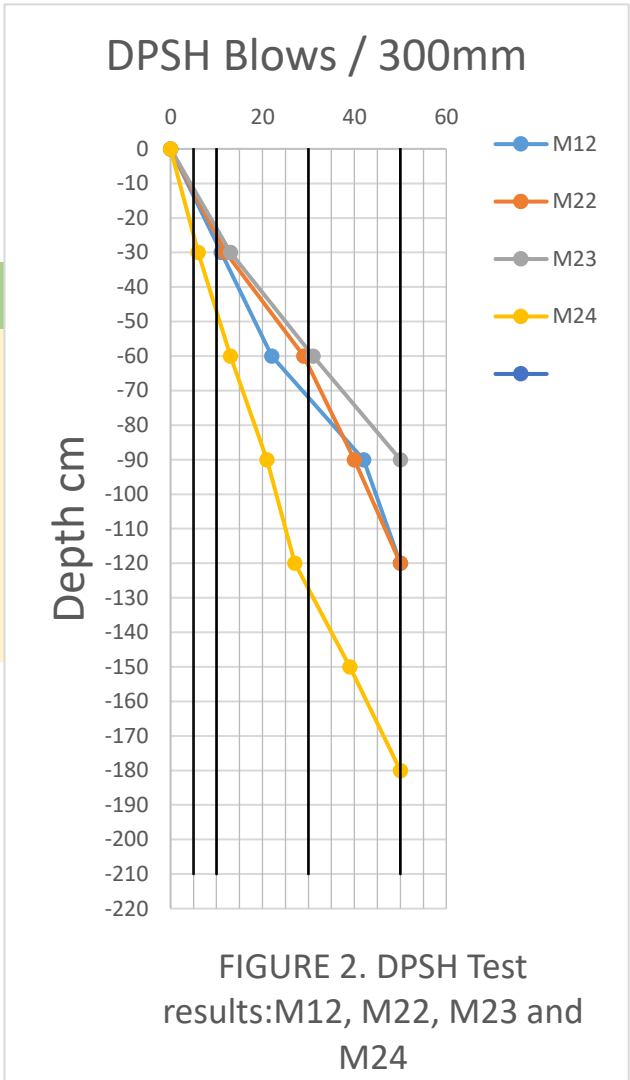
FIGURE 2. DPSH Test results: M12, M22, M23 and M24

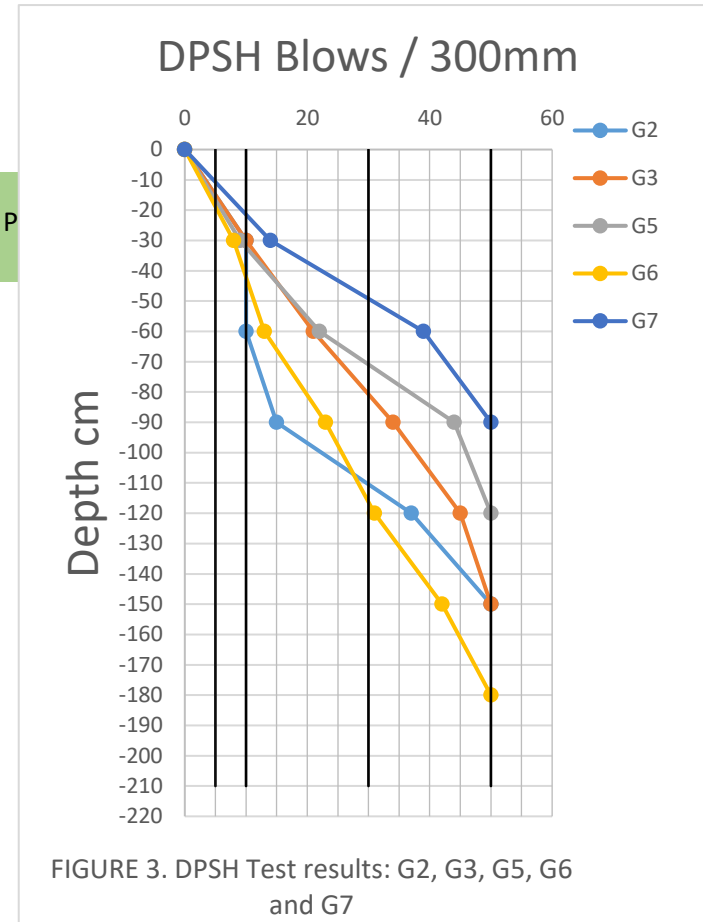
FIGURE 3. DPSH Test results: G2, G3, G5, G6 and G7

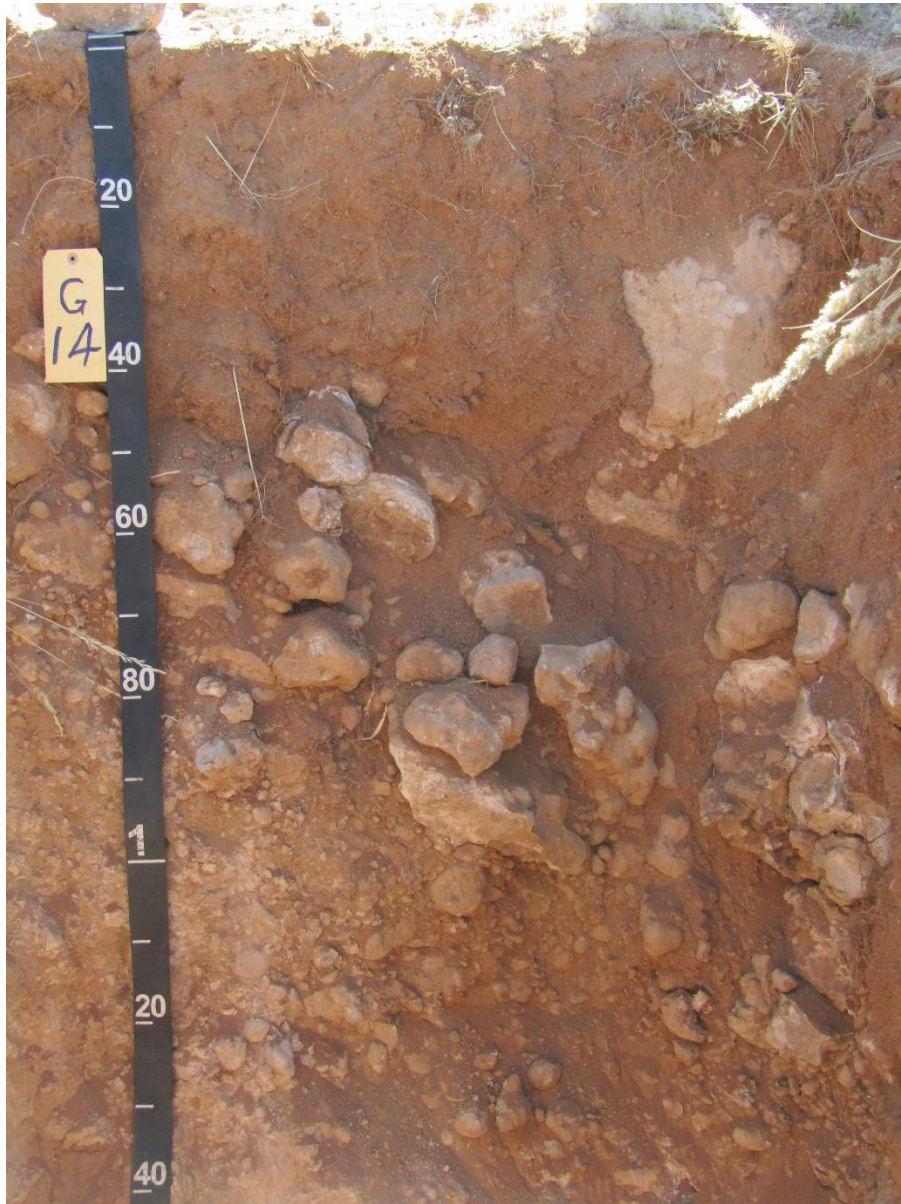
Photo 4. Profile G14. Soil of mixed origin on nodular calcrete on soft calcrete

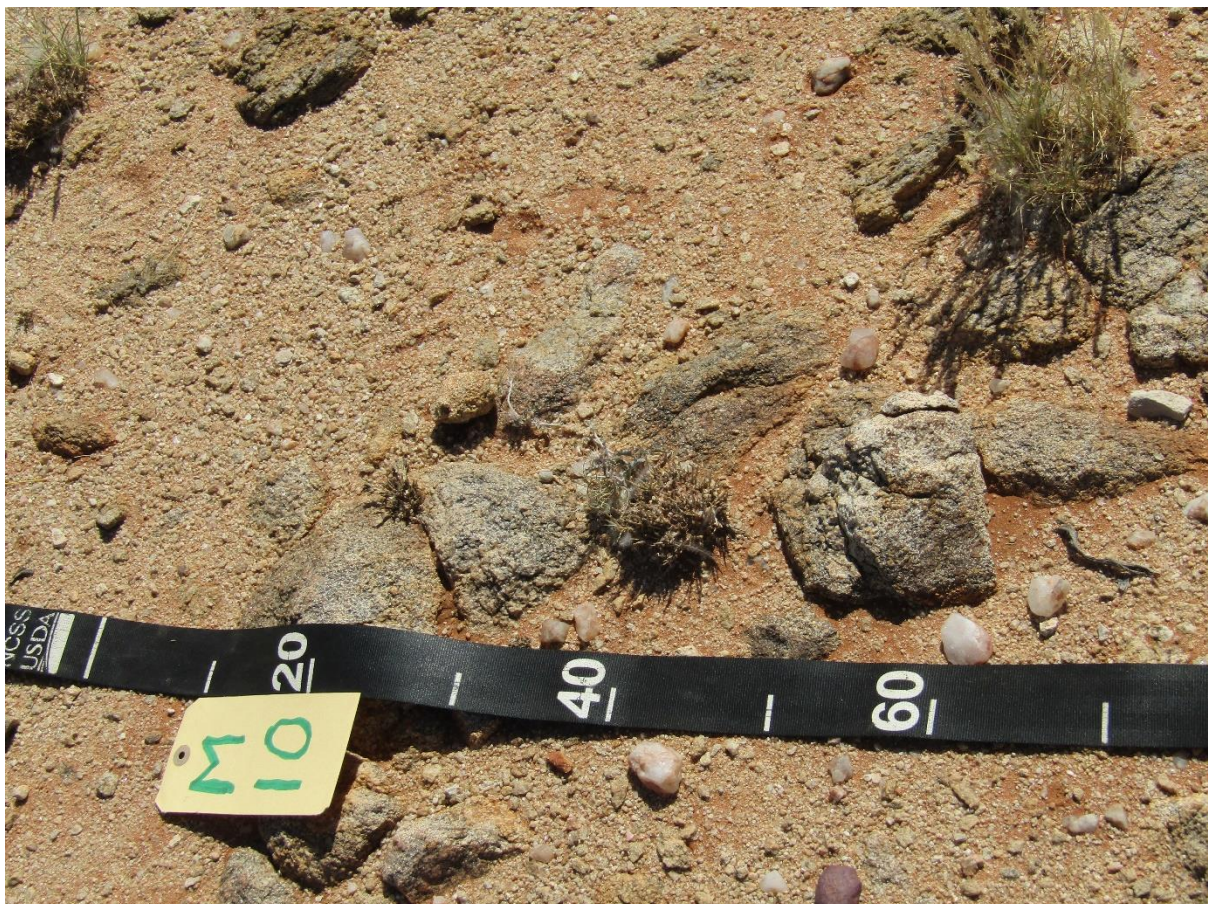
Photo 6. Profile M6. Gneiss outcrops

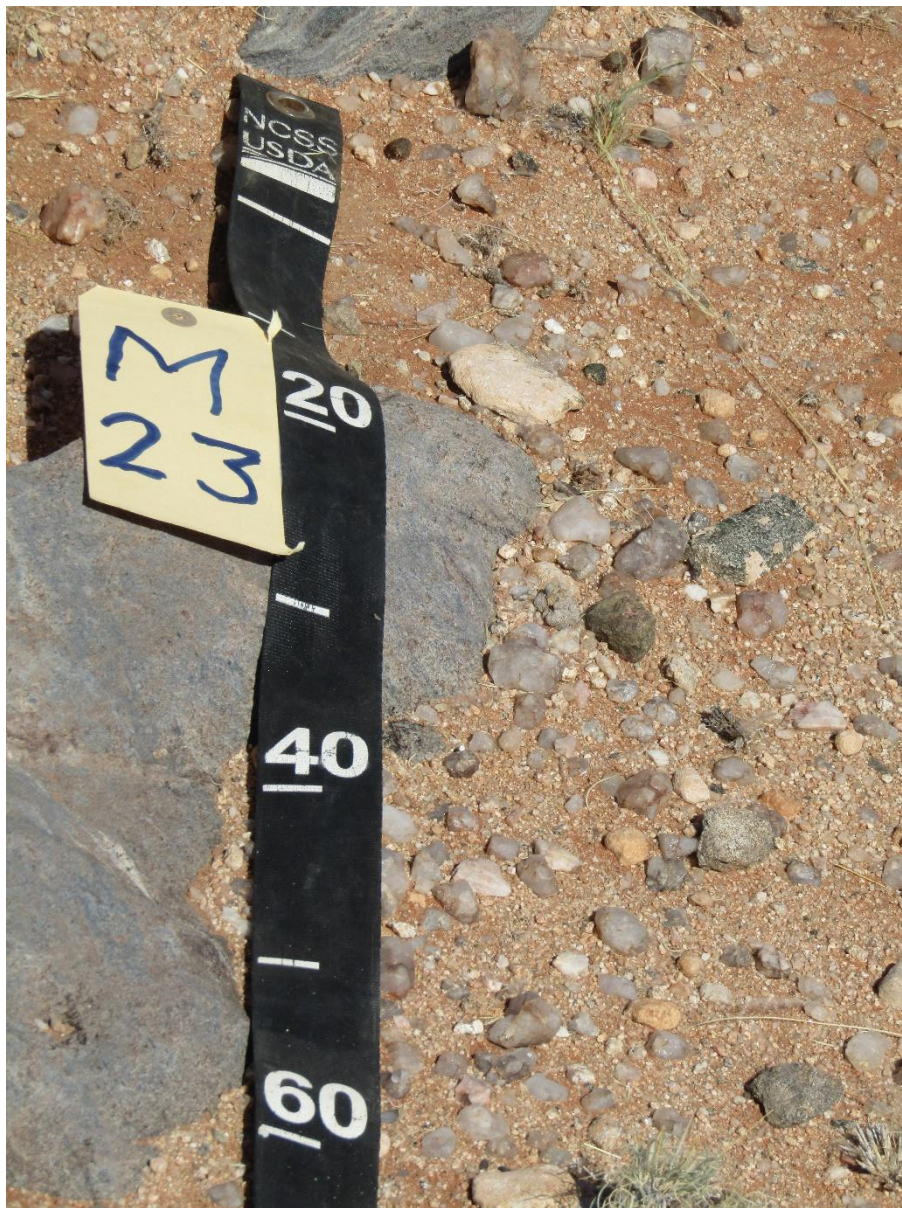
Photo 8. Profile M23. Metaquartzite outcrops with alluvial lag deposit next to outcrop
