**REPORT ON THE GEOTECHNICAL INVESTIGATION CARRIED OUT
ON PORTIONS 337 & 338 OF THE FARM ELANDSHEUVEL
NO 402-IP KLERKSDORP - NORTH WEST PROVINCE**

Detail reporting stage

Ref: G524-PVS-R01
May 2022

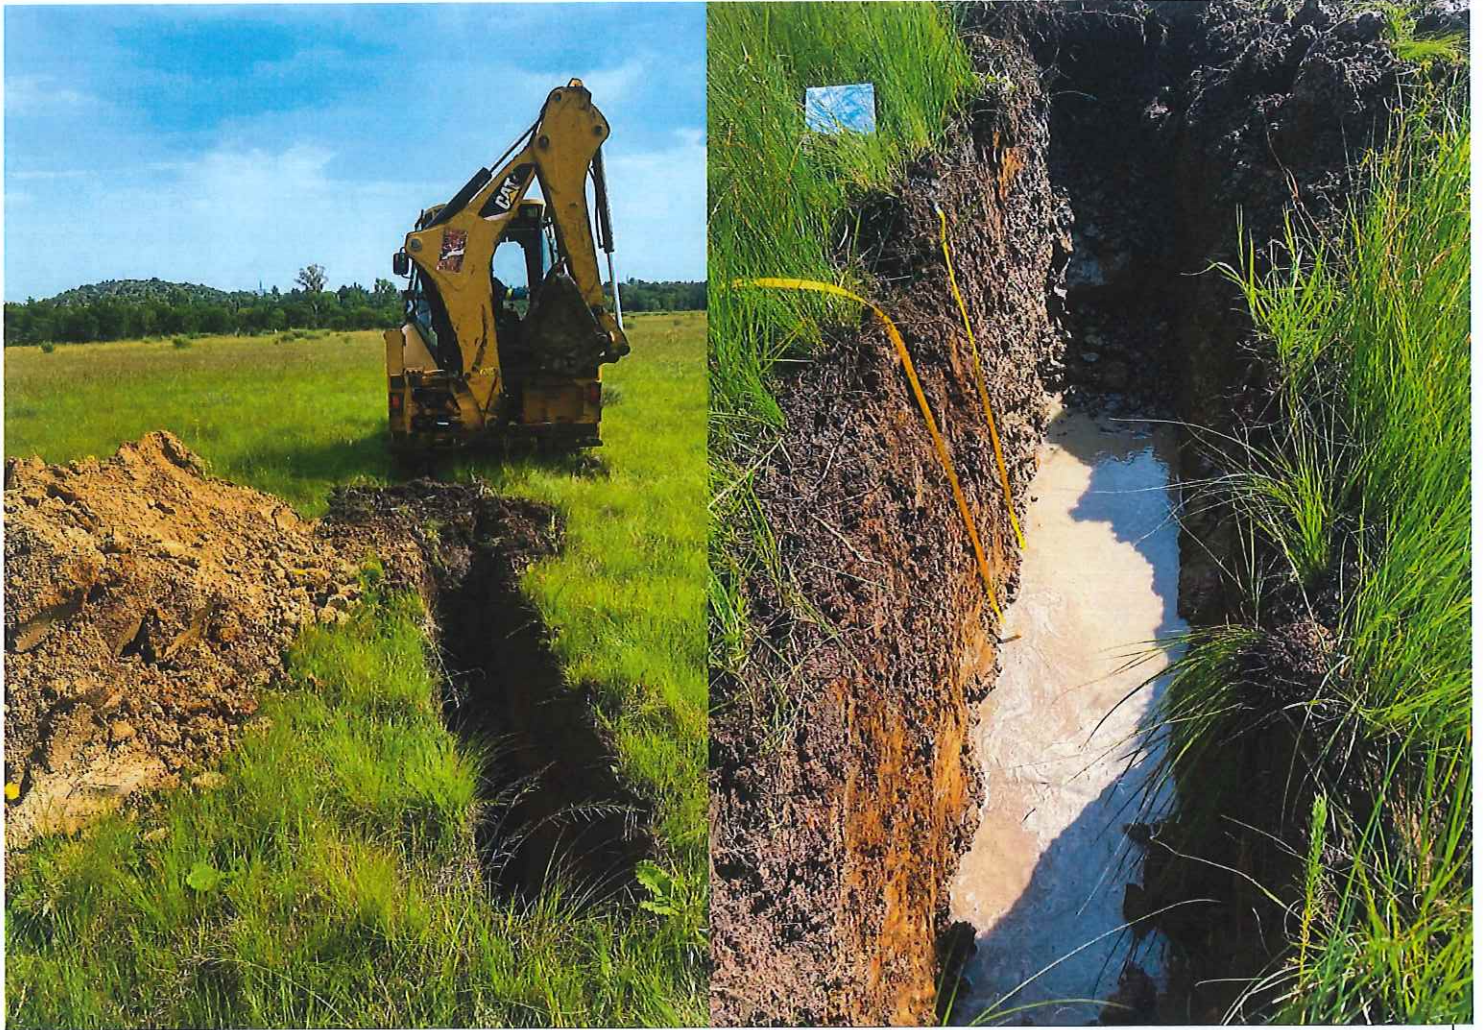
Digging of test hole TH01 and showing typical groundwater standing in test holes where encountered

In addition, groundwater seepage, ranging from localized pinhole seepage to strong groundwater flow were noted in 60% of the test holes dug. Saturated conditions negatively impact the stability of sidewalls, which generally result in flatter sidewall slopes to be implemented to allow safe working conditions.

Therefore, excavation sides from GLG where bouldery material occur or deeper than 1m in the remaining areas must either be battered back to 1:1,5 (vertical:horizontal) or shored; allowing safe working conditions for workers in these excavations.

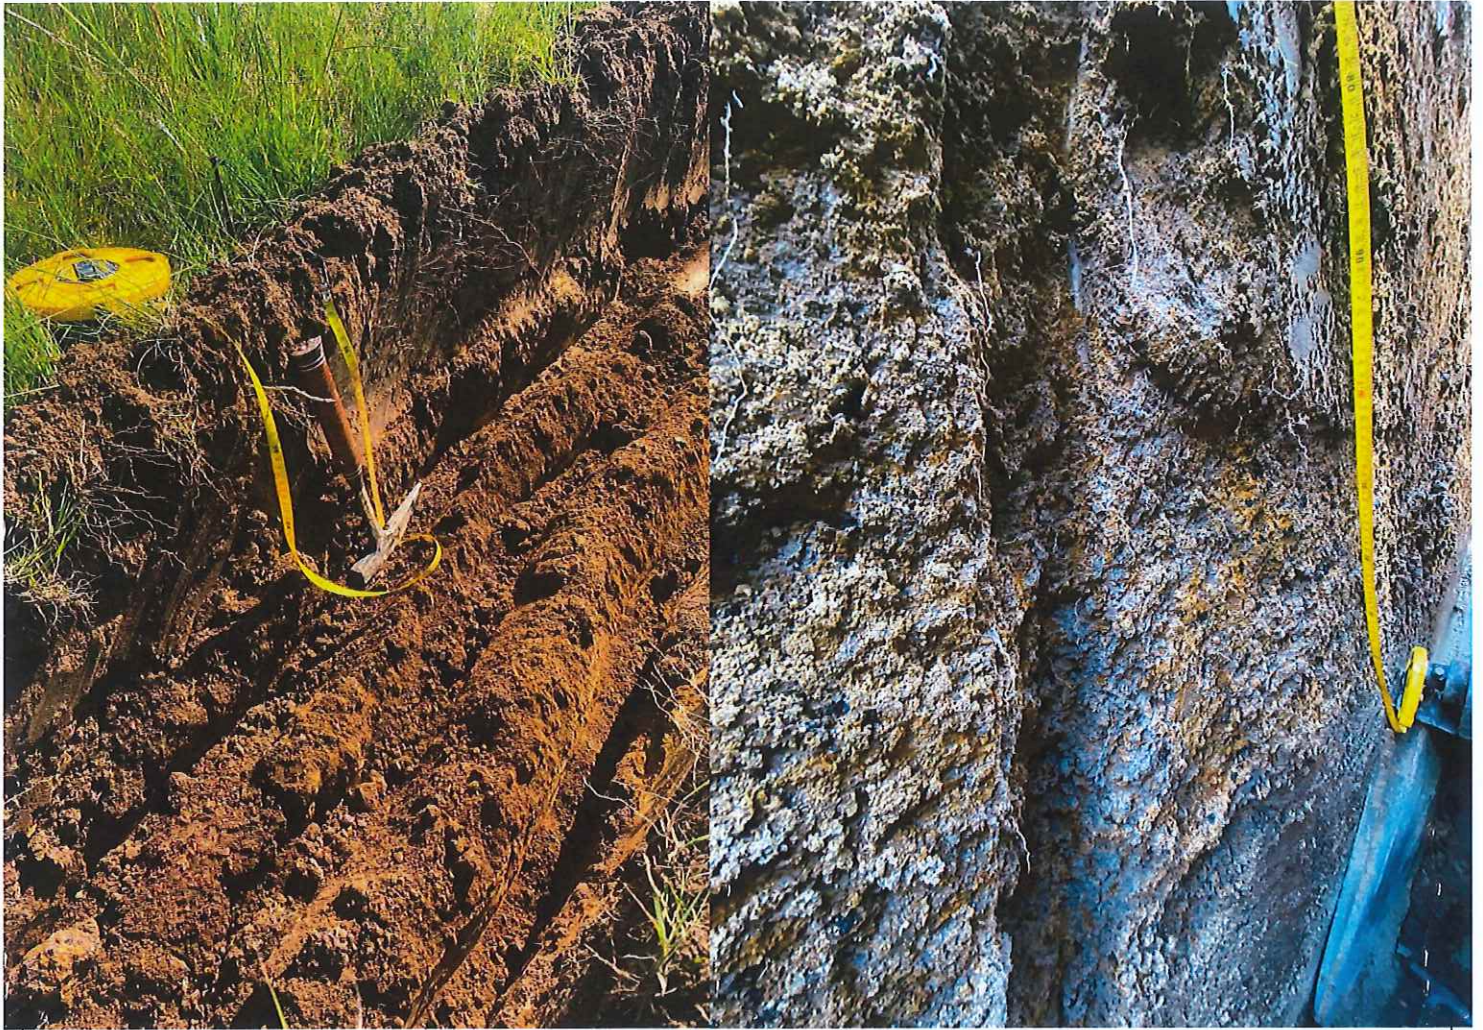
Typical alluvium transported (top left) and pedogenic (right) soil horizons encountered

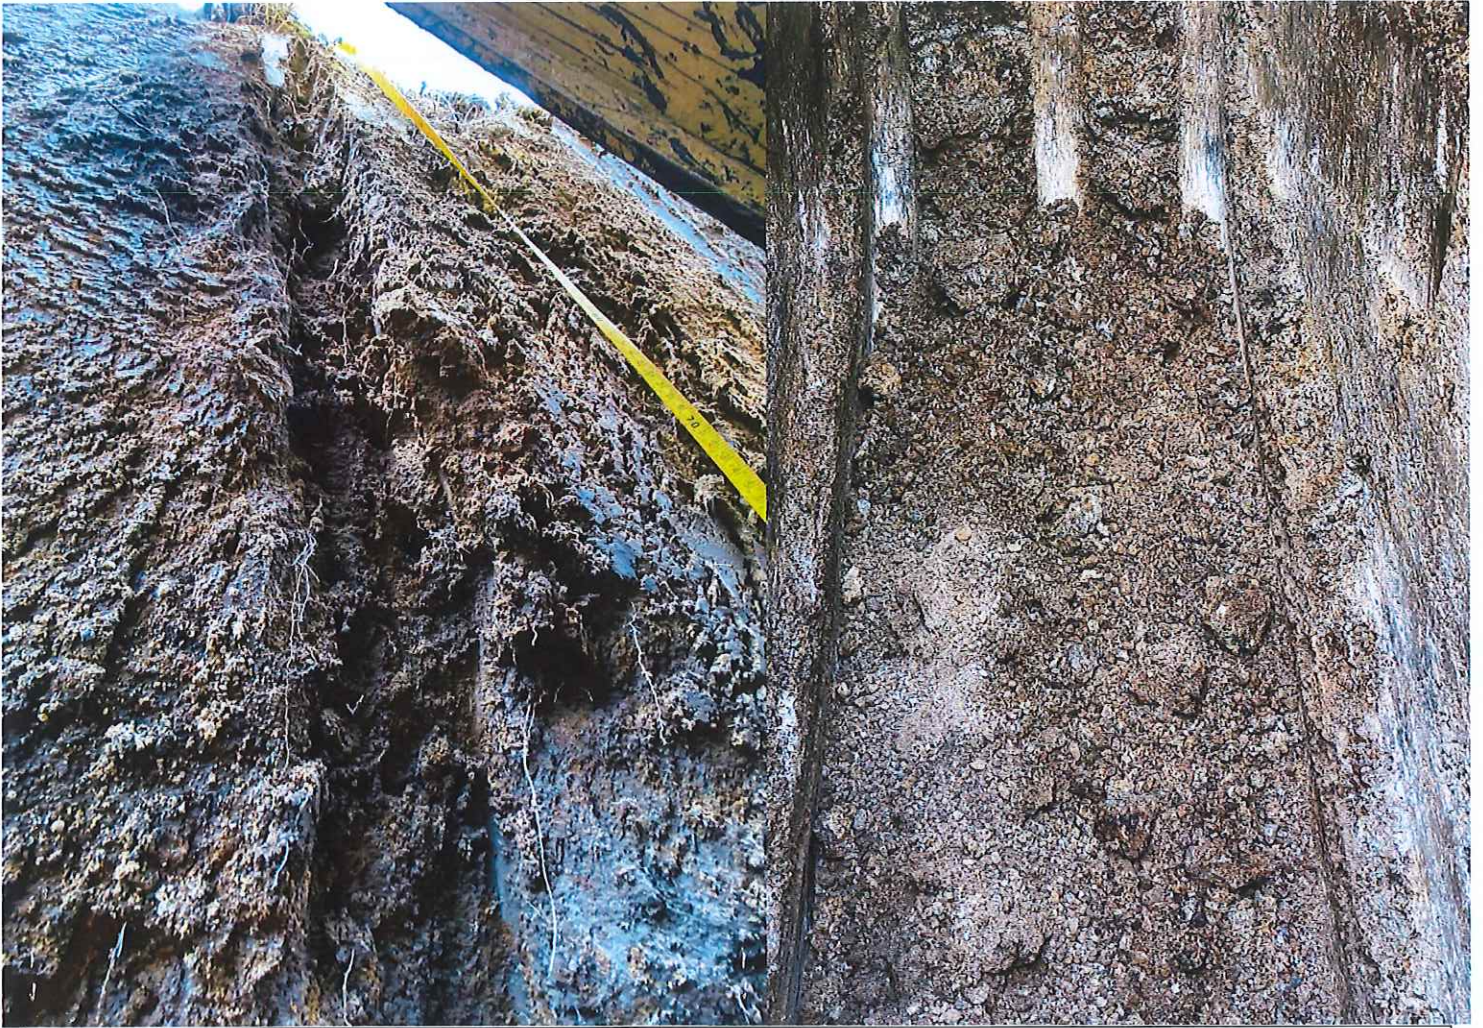
Typical alluvium transported and pedogenic soils shown from the bottom of a test holes (top left) and residual quartz porphyry horizon (right) encountered
