Geotechnical Investigation Eloff Erf 174 & 175, Delmas

Shangoni Management Services (Pty) Ltd

REPORT NO.: PJ096/KNP/2011/10/2349

OCTOBER 2011

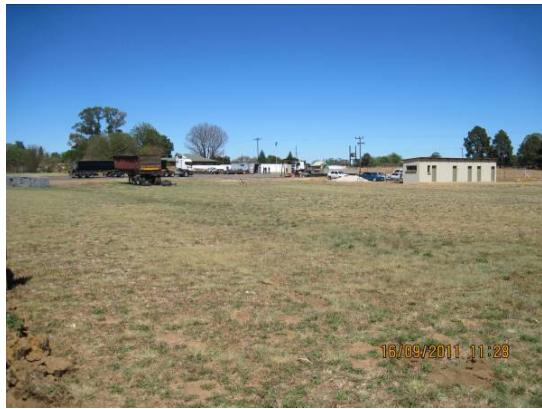
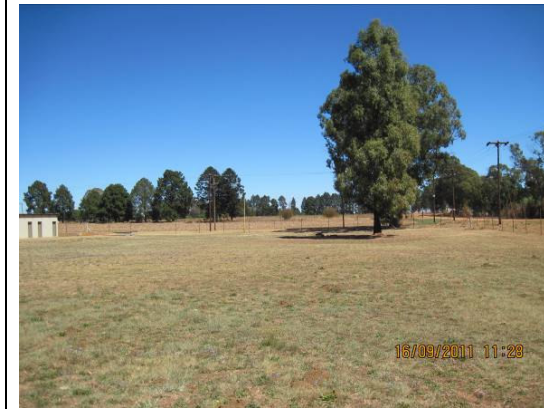
had been gravelled and was in use as a parking area for trucks. A container and ablution block were also present.

Southern part of site used for truck parking, workshop and ablution block (right)	Undeveloped northern part of site
