**Geotechnical Assessment Study for the development of a 400 MW Solar Photovoltaic (PV) facility (Phase 3) on the Remainder of Farm Goede Hoop 26C and Portion 3 of Farm Goede Hoop 26C, between De Aar & Hanover, Emthanjeni Local Municipality, Pixley Ka Seme District Municipality, Northern Cape Province, South Africa
(Including minor additions to phases 1&2 footprints & overhead powerline route)**

Project number: **COUNCIL FOR GEOSCIENCE
CO2017-5806 (Phase 80)**
Date: **2022.05.11**

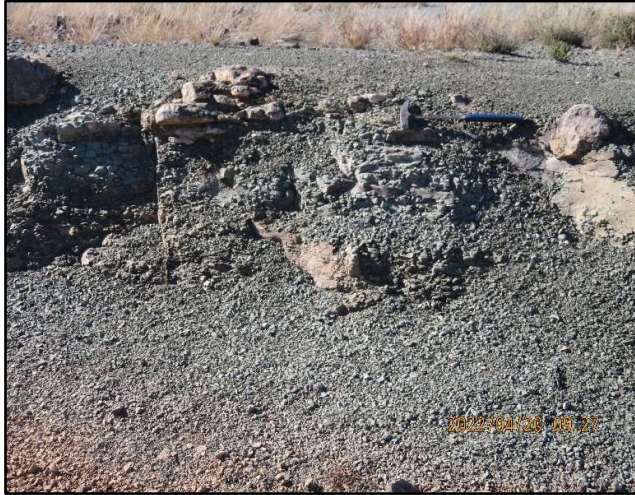
Photo 1: Lenses of slightly weathered fine grained sandstone (pinkish) in highly weathered siltstone (green) at position P4.

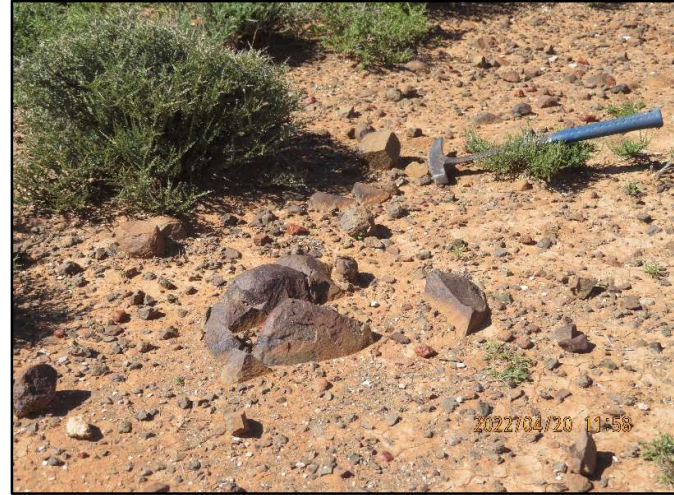
Photo 2: Dolerite gobbles in distributed outcrop at position P7.

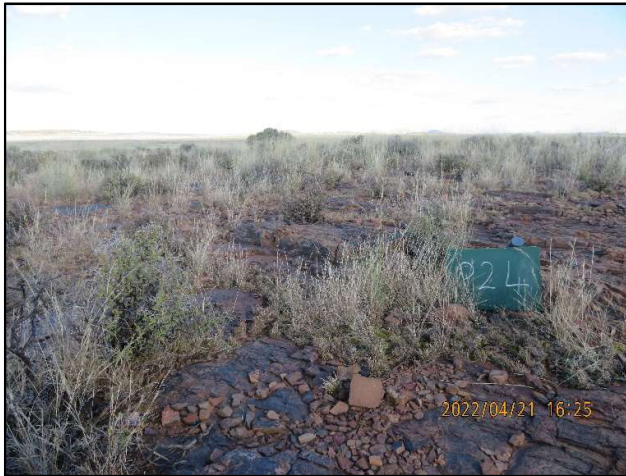
Photo 3: Baked sandstone at position P24 – possible quarry site.

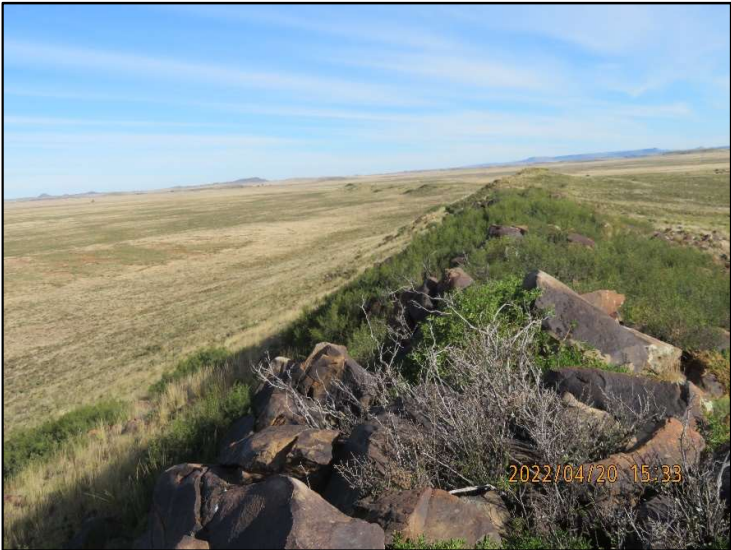
Photo 5: Steeply inclined dolerite ridge side slopes along part of planned Eskom power line route (on Phase 1 footprint)

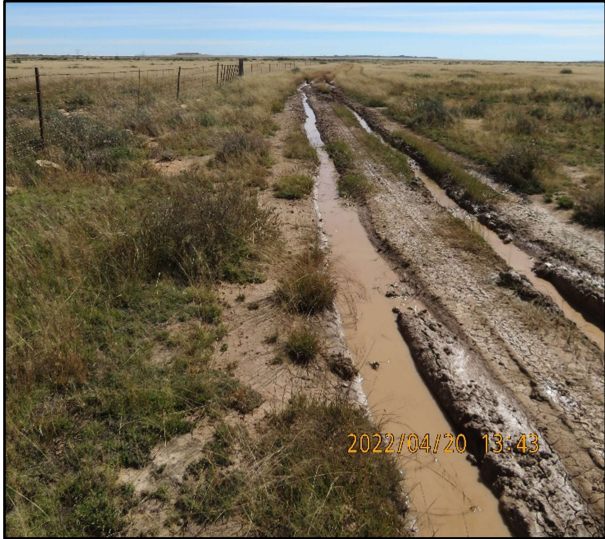
Photo 6: Surface runoff filled farm track along low-lying eastern bank of Brak River (proposed alternative access route crossing from staging area) terrain.

- If the alternative access road from the "Staging Area" to the Phase 1 area is to be used, laying of compacted gravel road layers will be required over a 1,8 kilometres distance to lift the road elevation

and increase surface traction. Due to erosive action, frequent upkeep of the 1,8 kilometres stretch of road is to be expected.
