Environmental Impact Assessment & Environmental Management Programme

**AFRISAM (SOUTH AFRICA) (PTY) LTD - ULCO
CEMENT OPERATION**

AFS-ULC_001-10 REV 0.1

JANUARY 2011

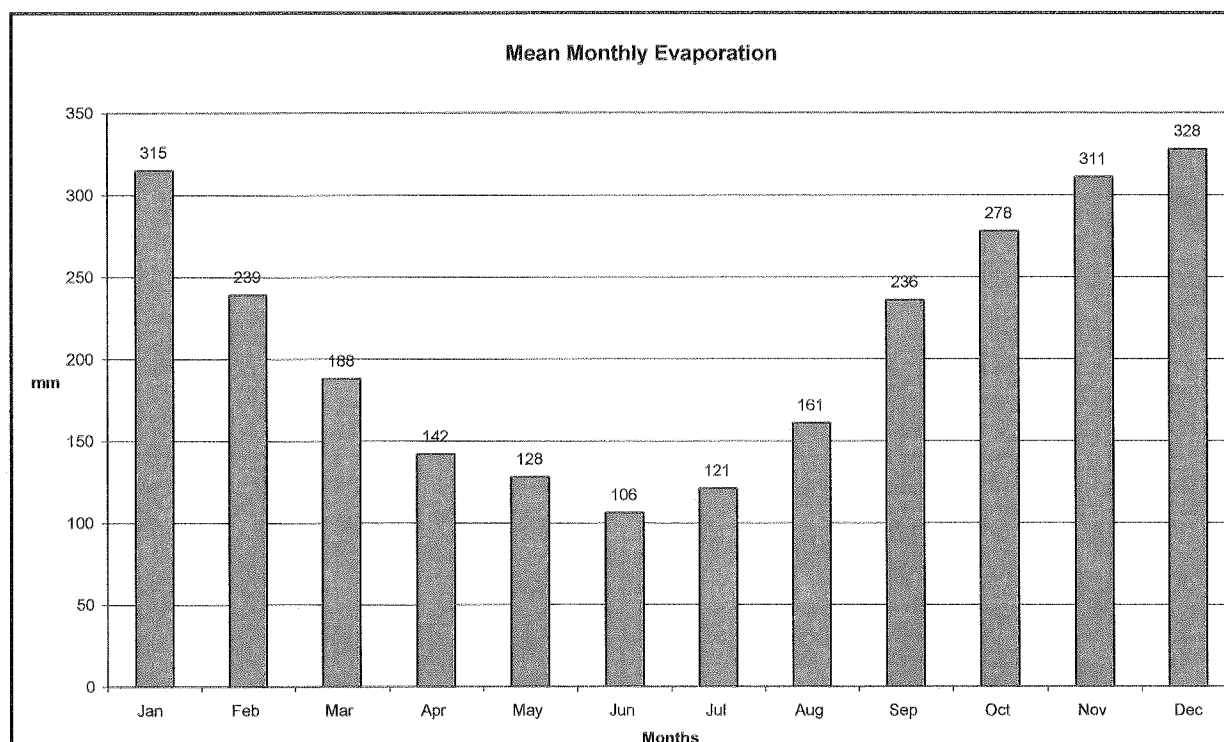
Figure 2-3: Mean monthly evaporation.

Monthly evaporation data has been obtained from the weather station located at Koopmansfontein. Evaporation has been measured by the Class-A-Pan Evaporation method. The mean annual evaporation is **2 553mm**. This figure exceeds the mean annual rainfall (457mm) by **2 096 mm**. This emphasises the fact that the area is very dry. Monthly evaporation data is provided in **Figure 2.3** below.

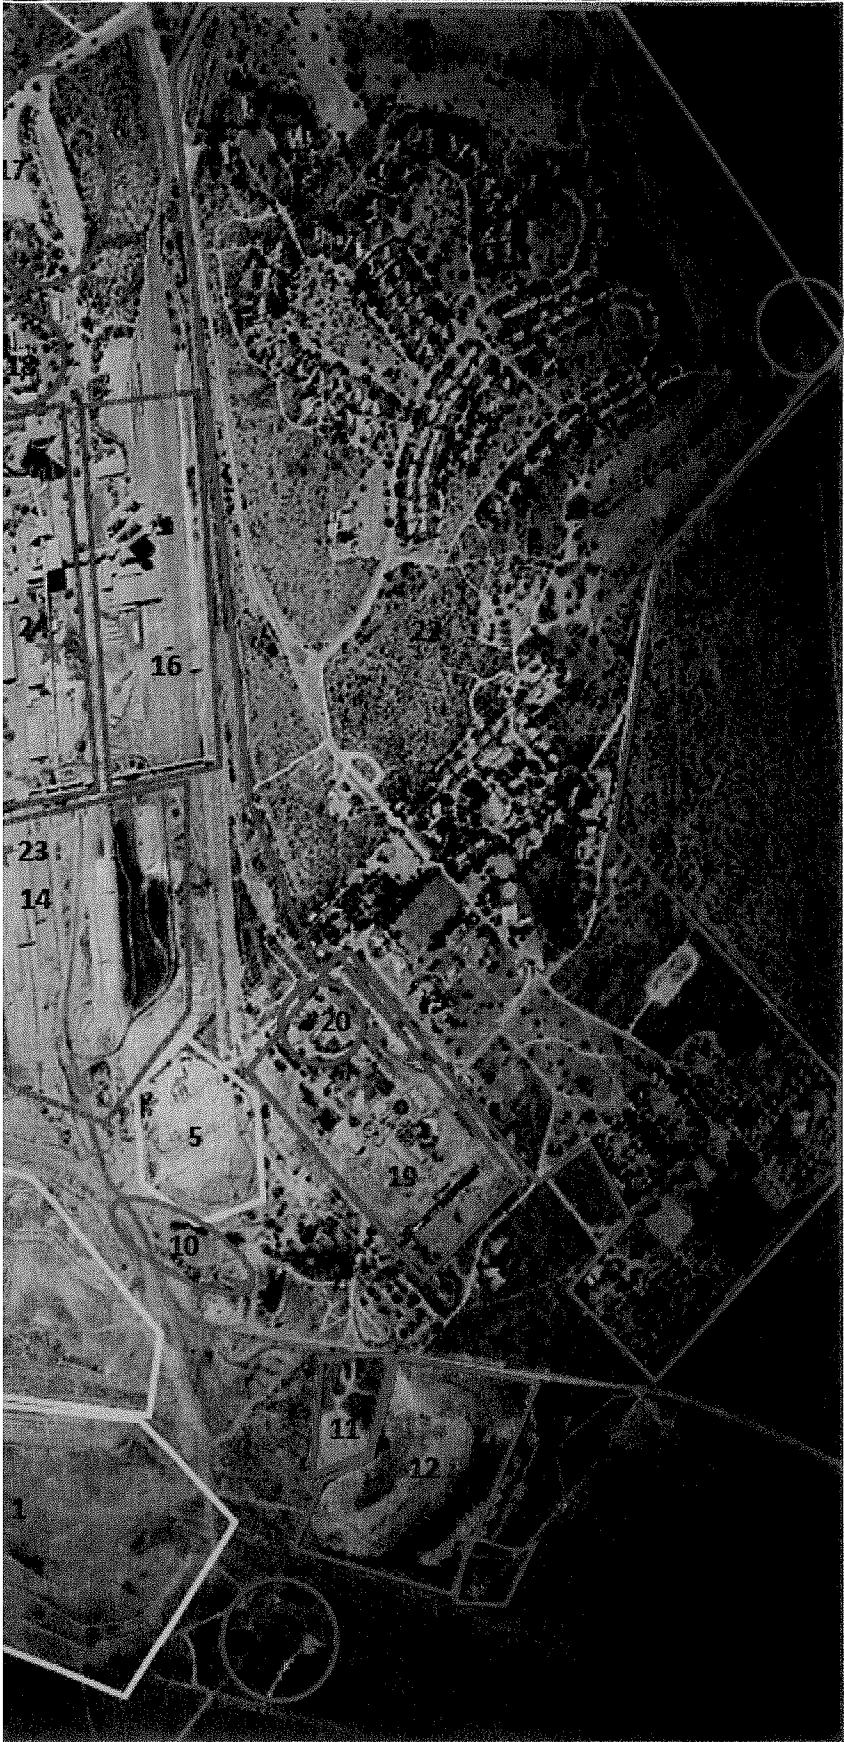
- 1 - Primary Limestone Quarry
- 2 - Secondary Limestone Quarry
- 3 - Dolomite and Shale Quarry
- 4 - Slough area
- 5 - SAQ dump as Agricultural Lime
- 6 - Topsoil storage
- 7 - Primary Crusher
- 8 - Conveyor to Stockpiles
- 9 - Historic SPL Storage Area
- 10 - Quarry Offices
- 11 - explosive magazines
- 12 - Waste Dump
- 13 - Water purification
- 14 - Stockpiles
- 15 - Cement plant
- 16 - Packing & Dispatch plant
- 17 - Vehicle parking area
- 18 - Main office
- 19 - Old plant
- 20 - Historic Vehicle Workshops
- 21 - Sewage plant
- 22 - Ulco Viallge
- 23 - New SPL Store
- 24 - New Vehicle Workshop

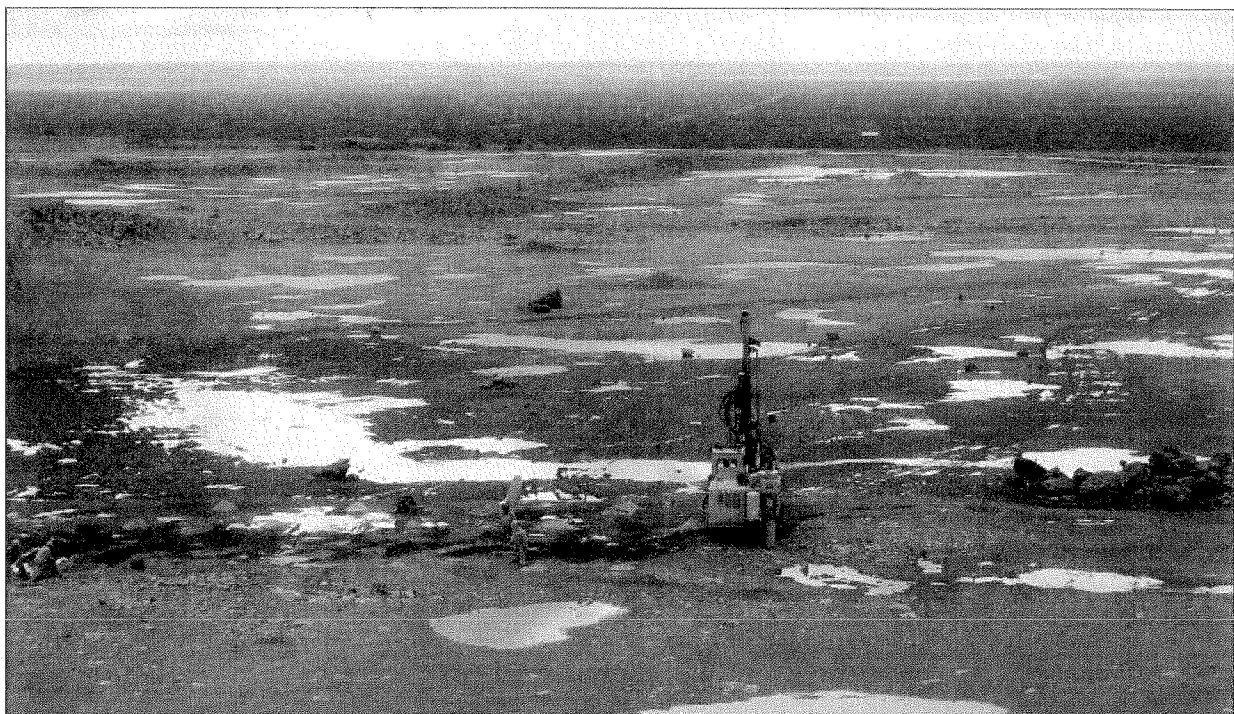
Figure 3-4: Example of drilling activities within the Secondary limestone Quarry

The drilling operations required for the blasting activity is currently subcontracted to a drilling company which make use of a drill rig fitted with a dust extraction unit. The current contractor delivers the explosives as and when required. Ulco has registered explosive magazines used to store accessories. Explosives are delivered on site on the day of the blast.

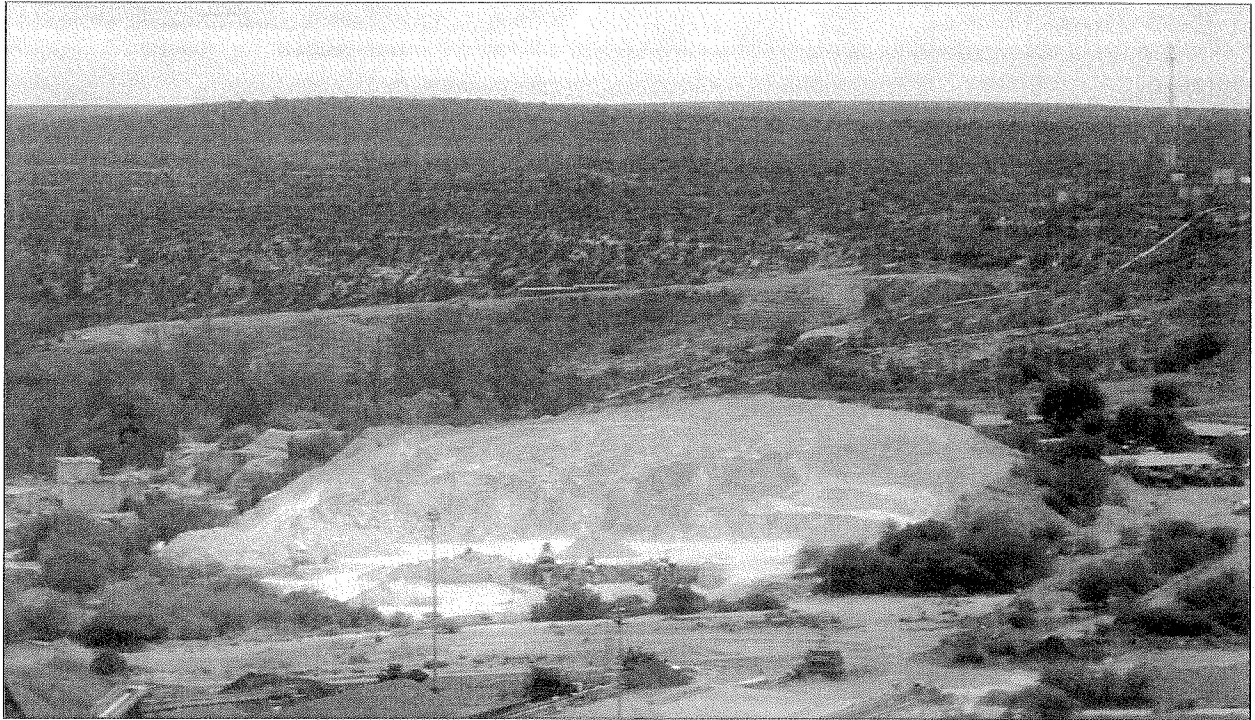
Figure 3-6: Mining of the SAQ dump

The SAQ Dump (See **Figure 3.2**) is mined by an excavator and placed in a screening plant to produce a product used as agricultural lime. There is a separate entrance through the Ulco village for the trucks used to dispatch the agricultural lime from the site.

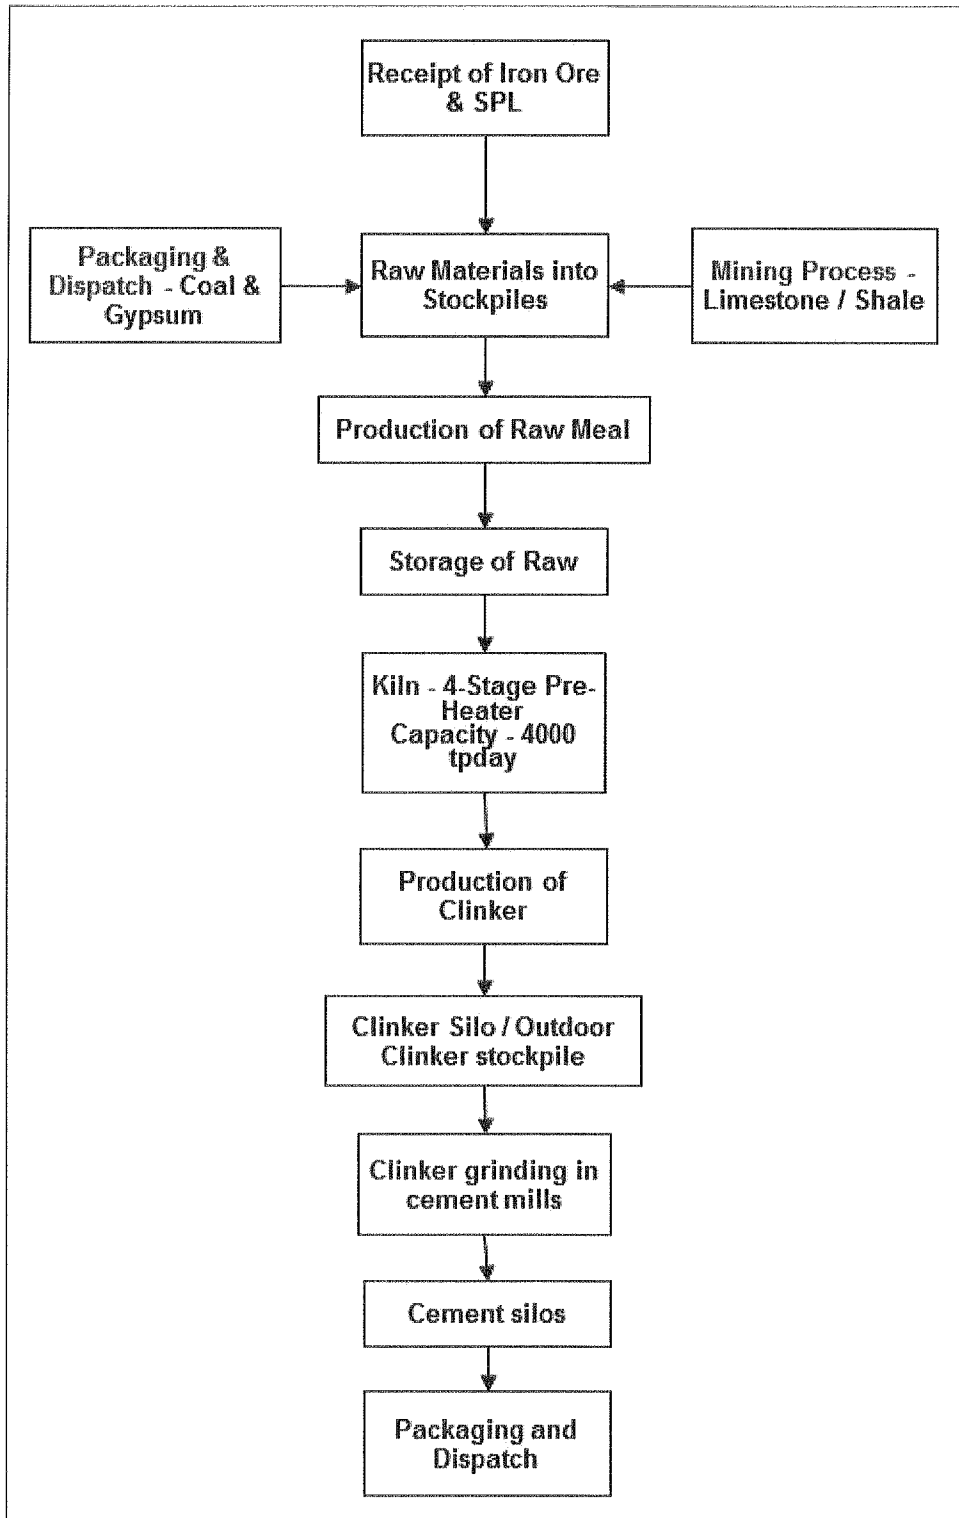
Figure 3-7: Production process.

The production department is responsible for the handling of the raw material from the stockpiles, followed by the processing of the raw material through the kiln to generate clinker. The permit allocation for Ulco is the generation of **4 000** tons of clinker per normal day and **4400 tons** of clinker per peak day. **Figure 3.7** provides an overview of the processing activities that take place at Ulco.

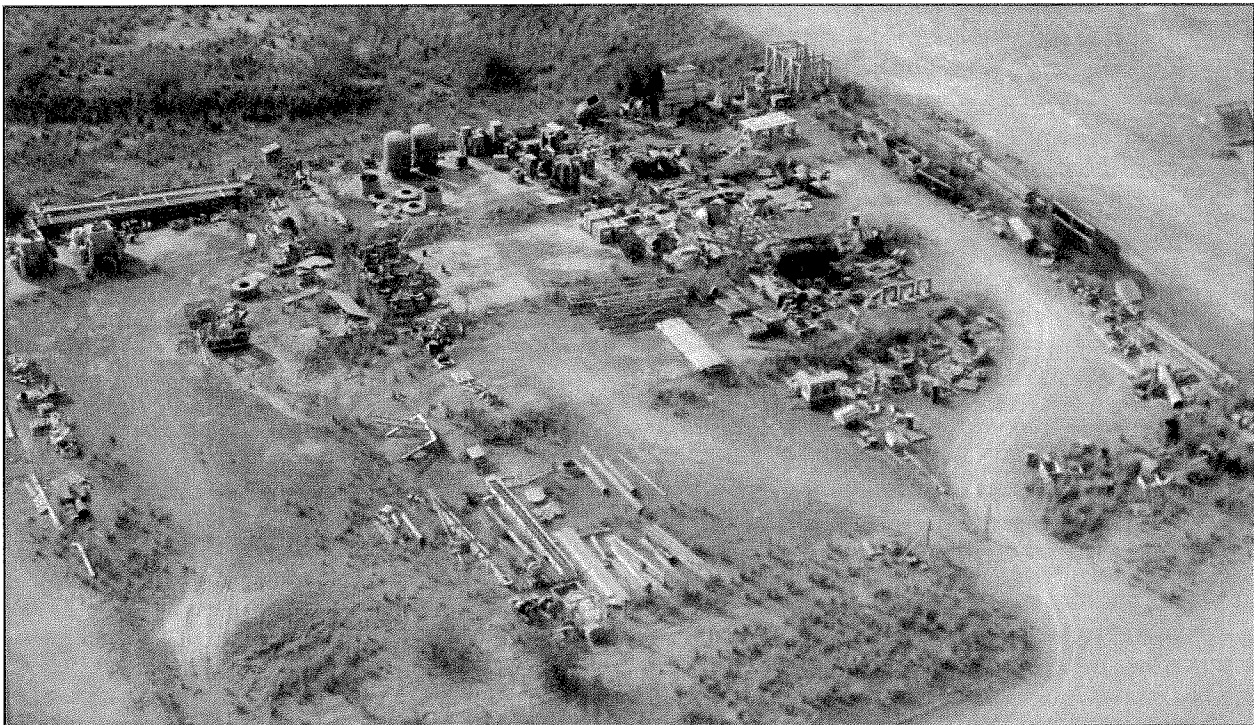
Figure 3-10: Salvage yard.

Scrap metal – Stored next to the salvage yard and sold when sufficient scrap metal (metal that cannot be salvaged for any purpose) has been collected (**Figure 3.10**).
