Wetland Assessment

WETLAND STUDY WITHIN THE EXXARO GROOTEGELUK COMPLEX - TURFVLAKTE

REPORT

NOVEMBER 2018

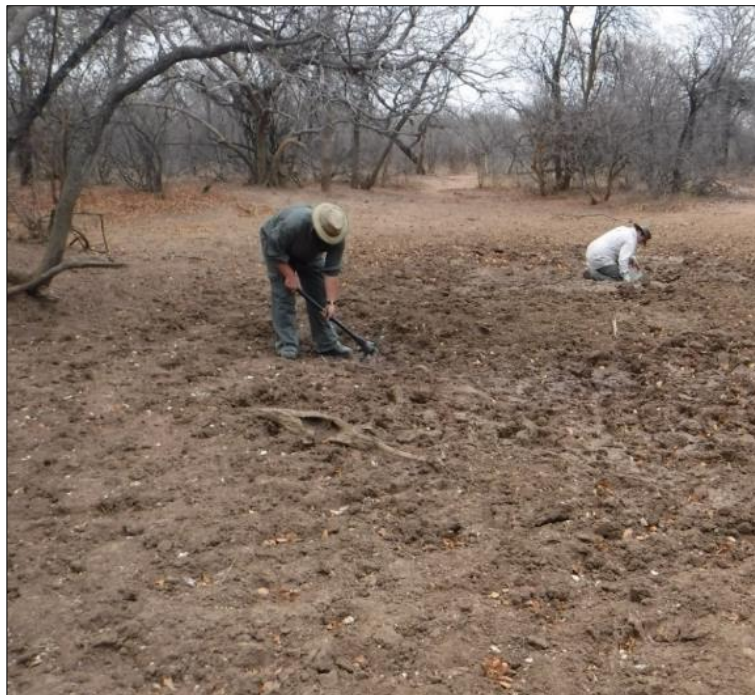
Figure 5-3 Collection of surface crusts and soils from the deepest parts of a temporary wetland at Grootegeeluk during the dry season. Hard soils in places necessitated the need for a pick-axe to be used to collect soils instead of an auger.

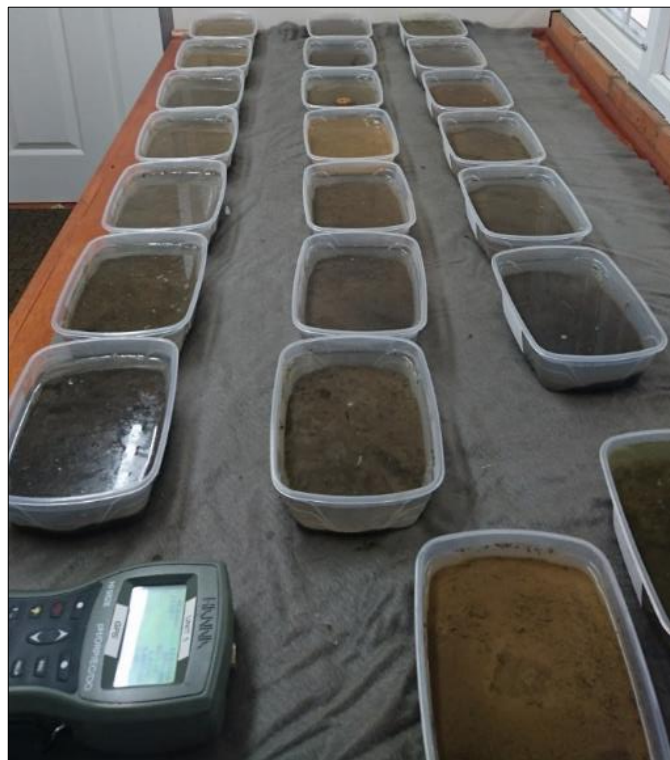
Figure 5-4 Incubation trials setup showing inundated sediment samples in a controlled environment room.

A conservative incubation period amounting to a total of 41 days was applied during which time all tubs were inspected daily for signs of hatchlings/nauplii and water levels were topped up (maintained at 25mm depth).

Frequent photographs were taken to record changes in water quality and visual characteristics (Figure 5-4), while a Yellow Springs International 556 (YSI) handheld probe was used to record water quality parameters (pH, electrical conductivity, dissolved oxygen and Oxidation Reduction Potential, Total Dissolved Solids).

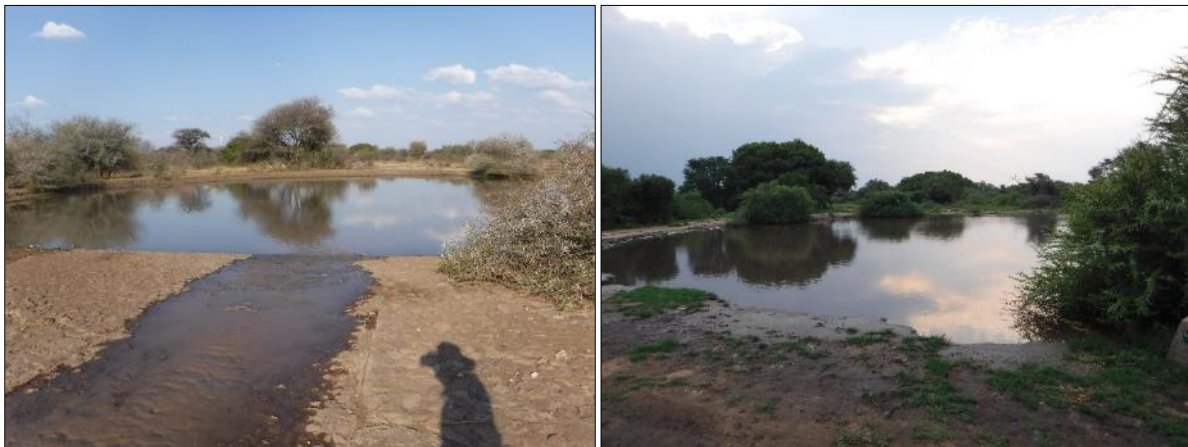
The watering hole is located to the east of the coal conveyor and is currently still being actively maintained as a source of water for the wildlife within that portion of the reserve (Figure 6-2). The system covers an area of approximately 0.12ha. This watering hole, other than the one located at the Lodge is the only source of water for the wildlife during the dry seasons, as the natural systems are considered to be seasonal in nature.

Figure 6-2 View of the watering hole during the dry season site visit (left) and the wet season site visit (right)

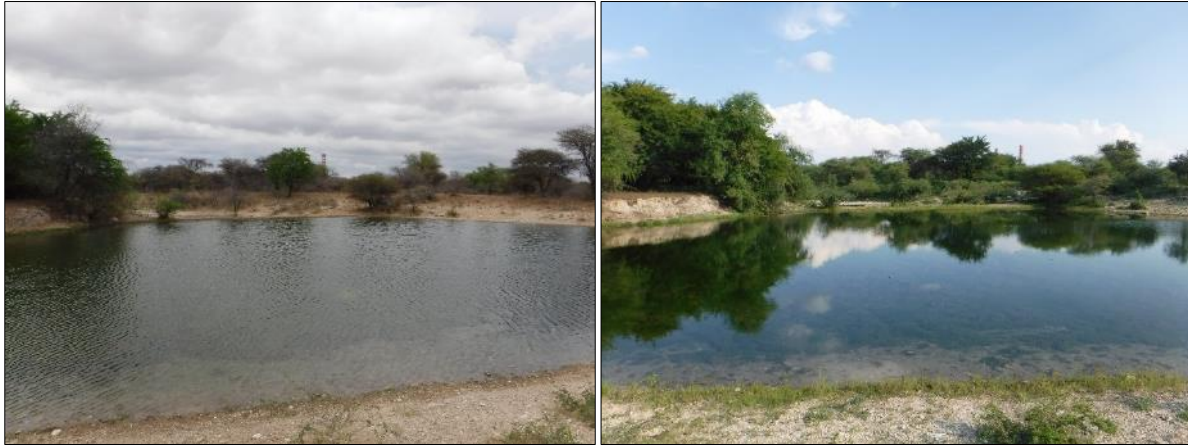
The borrow pit and Voëltjie dam are located to the west of the coal conveyor and cover an area of approximately 2.01ha. As with the watering hole, the Voëltjie dam is also artificially maintained through additional water inputs (Figure 6-3), whilst the calcrete borrow pit only receives through rainwater inputs. Voëltjie dam is maintained by Mokolo water being pumped to the facility. The turbidity within the dams was recorded as zero. Voëltjie dam is currently licensed as a clean water facility and serves as a potable source of water for the wildlife within the game reserve as per to the Grootegeeluk water license.

Figure 6-3 View of the dams during the dry season site visit (top left), the wet season site visit (top right),

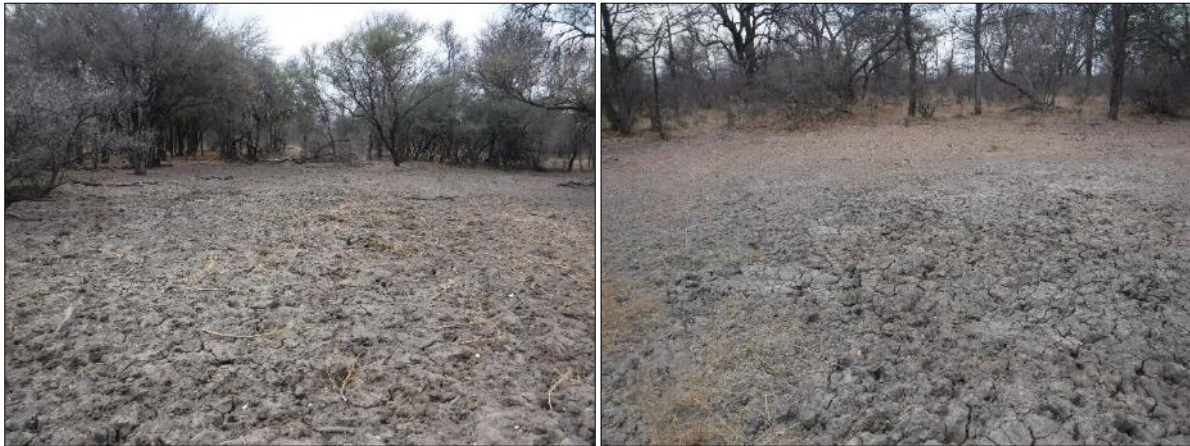
Figure 6-4 Examples of the desiccated soils of two of the wetlands during the dry season site visit

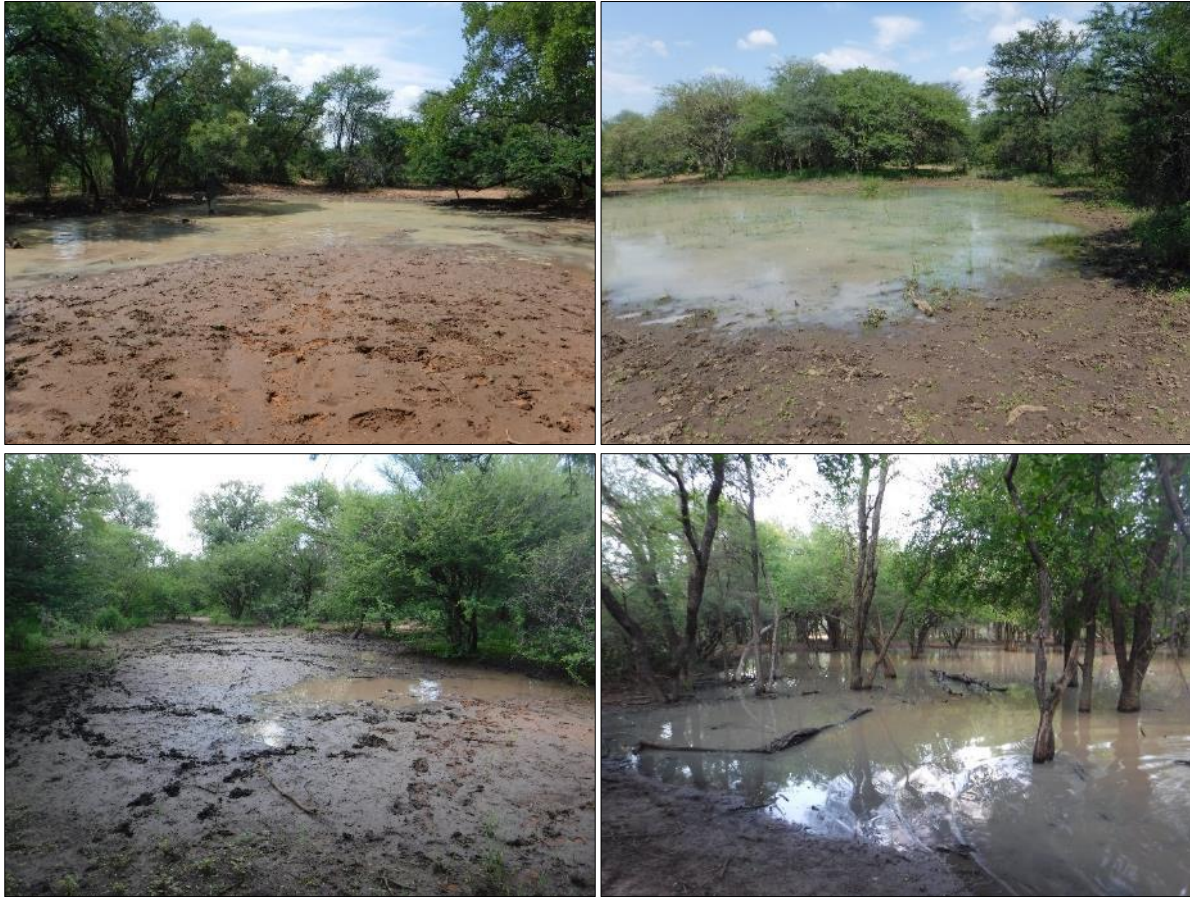
Figure 6-5 Examples of the some of the wetlands visited during the wet season site visit and the variable amount of water within the systems

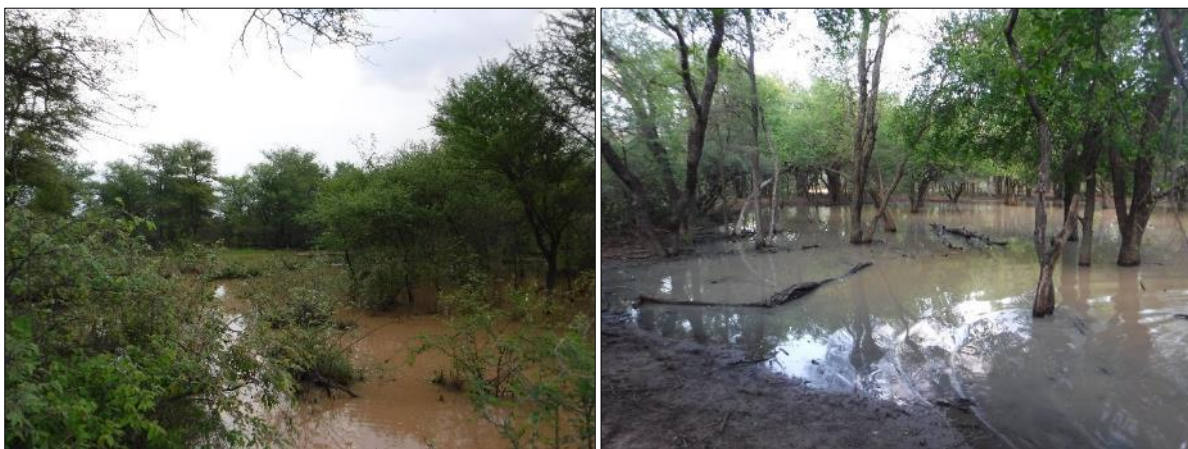
Figure 6-7 An example of trees within an inundated wetland

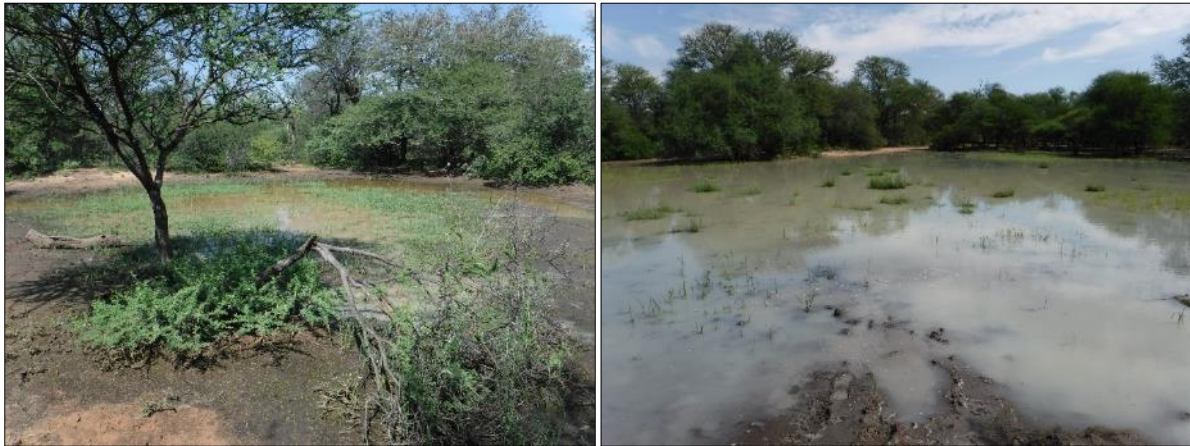
Figure 6-8 An example of two wetland systems containing seasonal wetland vegetation within the portions of the systems with sustained wet conditions

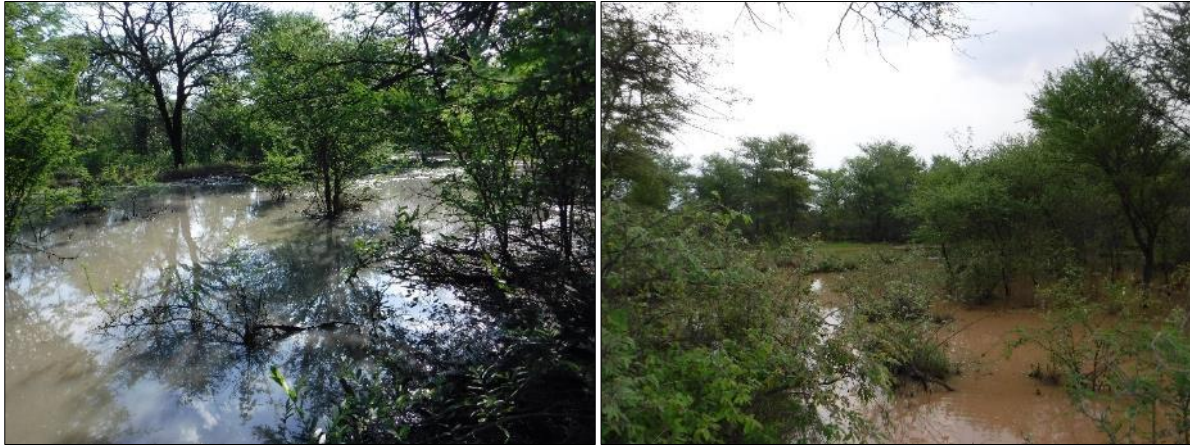
As described above, other than the larger wetland systems, the wetlands were considered to be predominantly mud-dominated systems. In many instances, it is anticipated that historical activities within the reserve, namely overstocking (Natural Scientific Services 2011; Digby Wells 2014), largely influenced the vegetation composition across the site. The majority of the study area is considered to be underlain by fertile soils, and as such the vegetation would most likely also be palatable to wildlife. Following the first rainfall events, the growth of new vegetation within the wetlands would attract grazers to these wetland areas. Intensive grazing of the systems would result in the reduction and/or loss of vegetation cover within these systems. This in conjunction with an extended drought would provide suitable conditions for the encroachment of shrubs into the drier portions of each system (Figure 6-9). Grass species would be easily out-competed by the shrubs, and consequently be limited in extent. Instances of bush encroachment was noted particularly in the smaller systems and/or the large shallower wetland systems.

Figure 6-9 Examples of bush encroachment into some of the wetlands identified within Turfvlakte

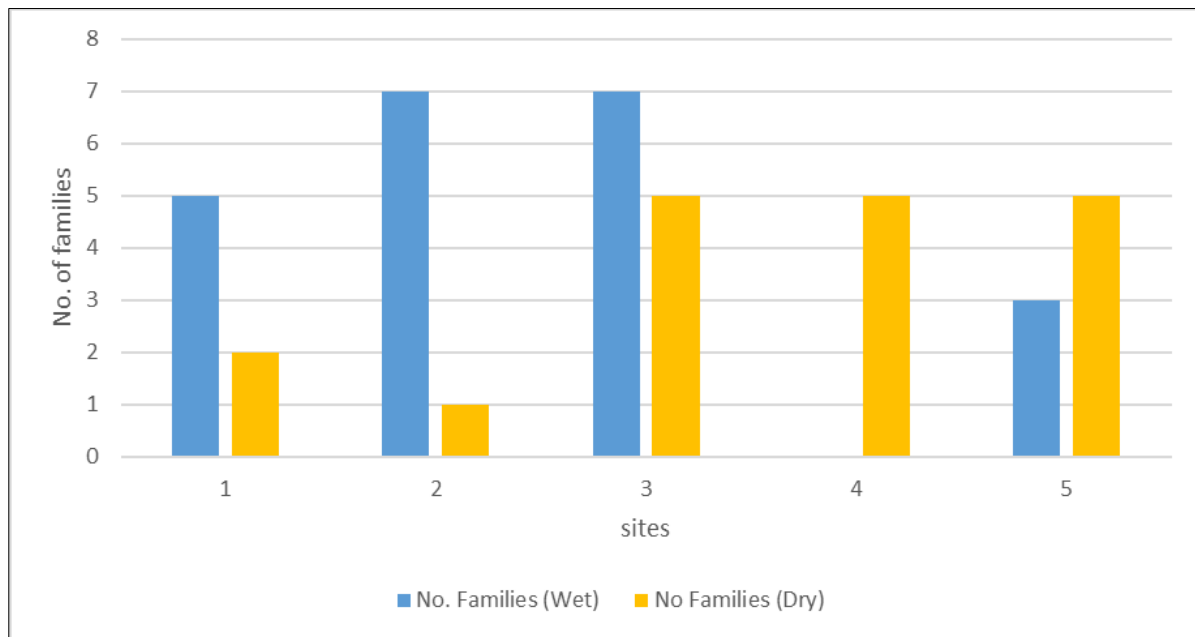
Figure 6-18 No of families recorded hatching from incubation experiments (dry season) and in-situ field sampling (wet season) of temporary wetlands located at Turfvlakte

The number of invertebrate families recorded per sample in both the wet and dry seasons are displayed in Figure 6-18 while species lists are presented in Appendix 4.

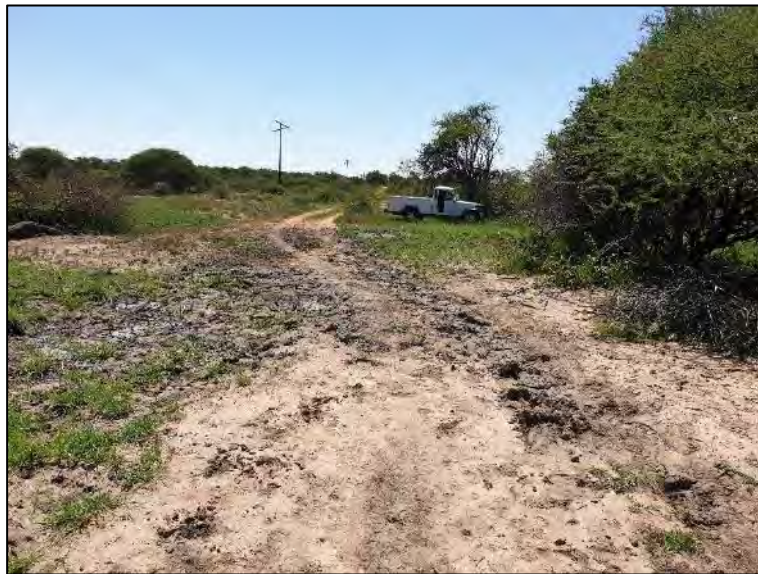
Rehabilitation Site 1 is located within the Thabametsi mining right area of the Exxaro property and spans a total length of approximately 340m with an area of 2.61ha. This wetland is divided up into distinctive seasonal and temporary zones, with the seasonal zones being confined to the northern and southern-most sections of the wetland and the temporary zone covering the remainder of the delineated area (**Figure 6-2**). This wetland can therefore be defined as a series of seasonal wetlands within a larger drainage network as there is hydrological connectivity between the seasonal wetlands within the overall system. The HGM unit was in a relatively degraded state as evidence of heavy grazing was observed within the wetland extent itself. Old construction material was also observed in the wetland, and it was assumed that this material was left behind after the construction of the road that runs directly through the middle of the wetland, bisecting it (**Figure 6-3**). Based on the location of the road, it is anticipated that the road is having a negative impact on the drainage patterns and distribution of water within and through the system.

Figure 6-3 Photo of the road bisecting Rehabilitation Site 1 (photo taken facing east)

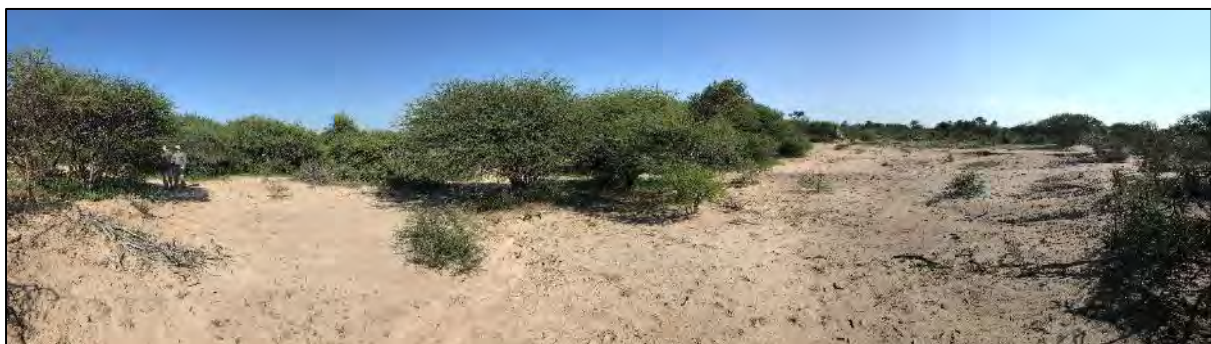
Rehabilitation Site 6 is approximately 0.79ha in size and consists of two distinctly different portions of the HGM unit, namely the seasonal wetland area which is located to the north-west of the HGM unit, at the lowest point in the wetland, and the more temporary wetland area located to the south (**Figure 6-8**). The seasonal zone receives the majority of the water in the wet season – as such a number of small puddles of water were observed in this section of the wetland in amongst a dense and healthy stand of *Eragrostis rotifer* and *Eragrostis acraea*. Despite the vegetation within the seasonal zone of the wetland being relatively healthy, there were erosion gullies and very bare areas of the wetland observed to the east of the seasonal zone (**Figure 6-9**). These areas appeared to have been eroded by a combination of intense animal hoof action and animal path creation and water and wind driven erosion. Through a combination of these processes, large areas of system have been cleared of vegetation and a very hard, impermeable soil cap has been created in these areas which prevents any type of vegetation from establishing –further exacerbating the erosion process. This process of erosion has also resulted in the deposition of sediment in the HGM unit, which has disturbed the natural vertical and horizontal pattern of water distribution within the wetland area.

Figure 6-9 The area of erosion to the east of the seasonal zone in Rehabilitation Site 6

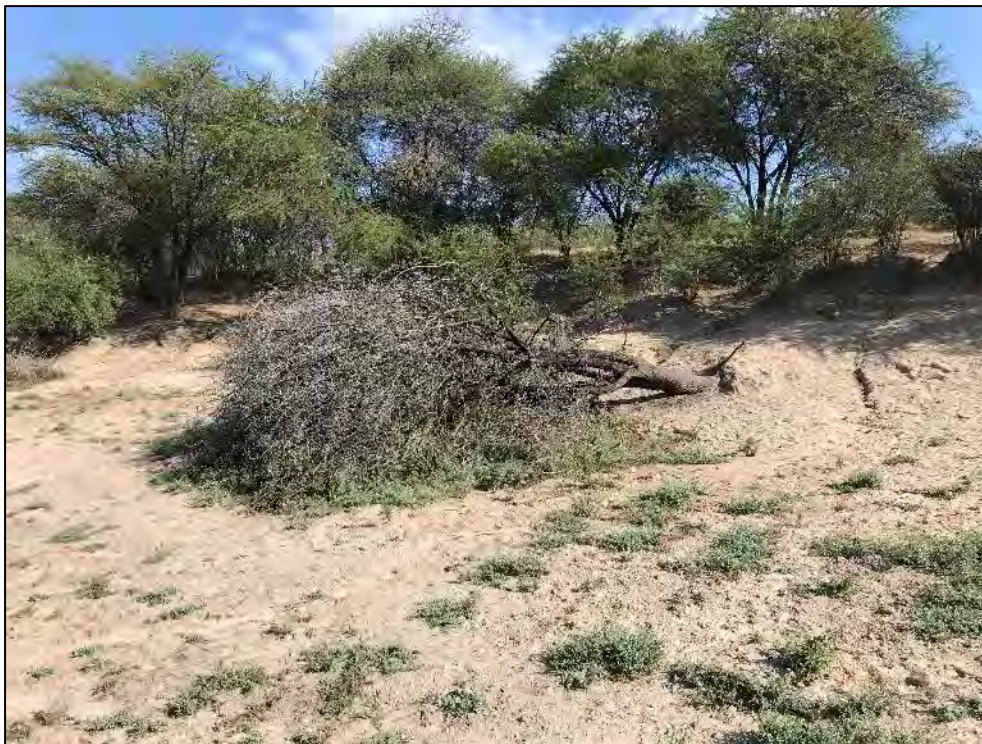
Figure 7-2 Example of the effects of brush-packing on a localised area

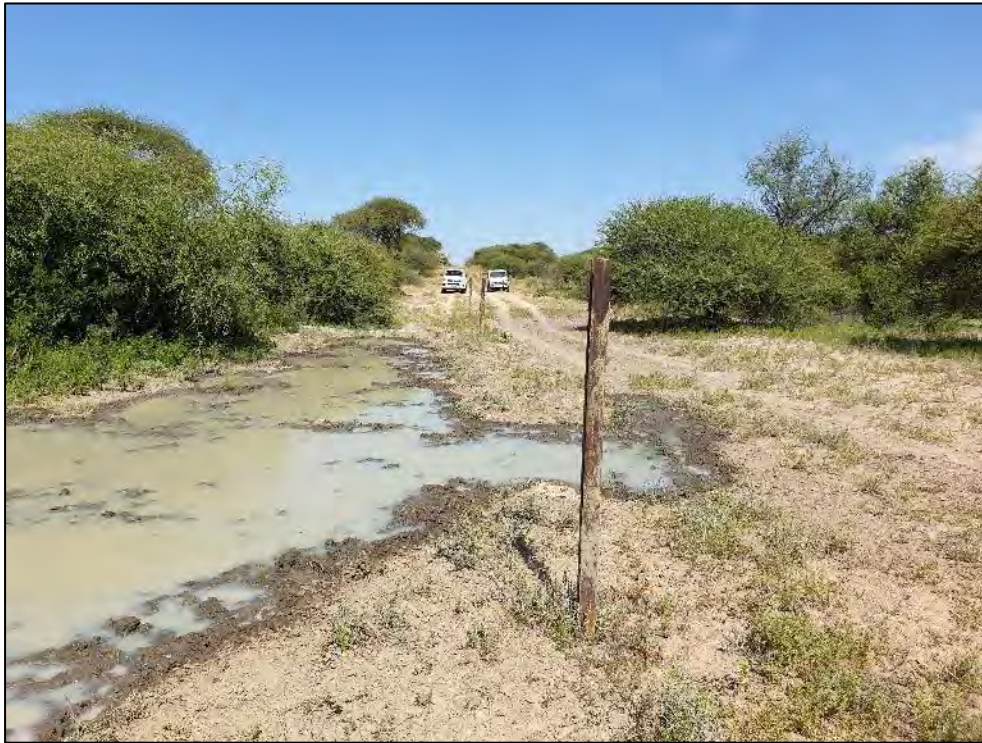
Figure 7-3 Example of a road crossing within Rehabilitation Site 4 and its effect on the hydrological connectivity within the wetland.

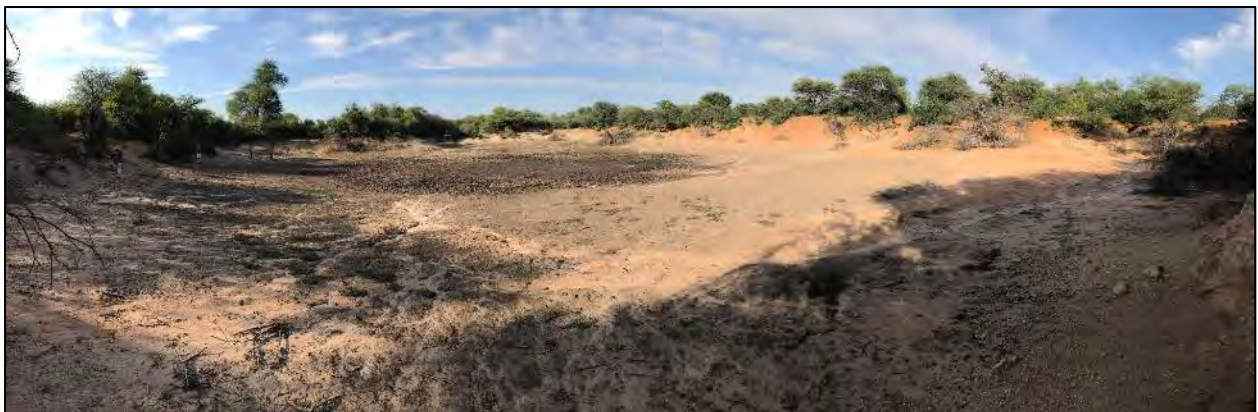
Borrow Pit 1 is a large and relatively deep disused borrow pit that spans 0.36ha (**Figure 12-8**). It is located adjacent to the main road running through the Greater Manketti Game Reserve and was historically used as a borrow pit to provide material for road construction and maintenance. The centre of the pit is almost completely devoid of any vegetation and it is assumed that this is a result of the very hard cap that has formed on the surface of the majority of the pit. This cap is comprised of clay material that dries to become a very hard, impermeable layer that overlies a subsurface clay layer which is significantly softer and less impermeable. This pit was considered as a potential rehabilitation site because it appeared to have a small catchment that it derived additional water from during the wet season. Evidence of water entering the pit from a surrounding catchment was observed as there were a number of small headcut erosional features running down the side walls of the pit, and many flow paths that originated outside of the pit walls were observed.

Figure 12-8 View of Borrow Pit 1. The dark area in the centre being the lowest point of the pit and the lighter areas to the right being the impermeable capped material.

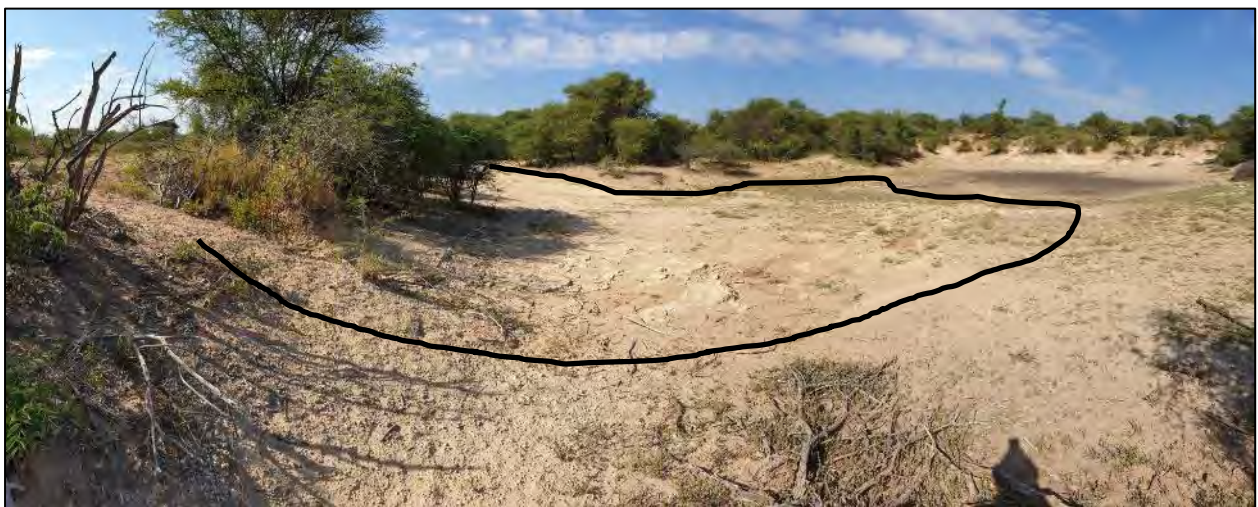
Figure 12-9 View of Borrow Pit 2. Black lines represent approximate sediment mound generated by sand washed in from the adjacent road.

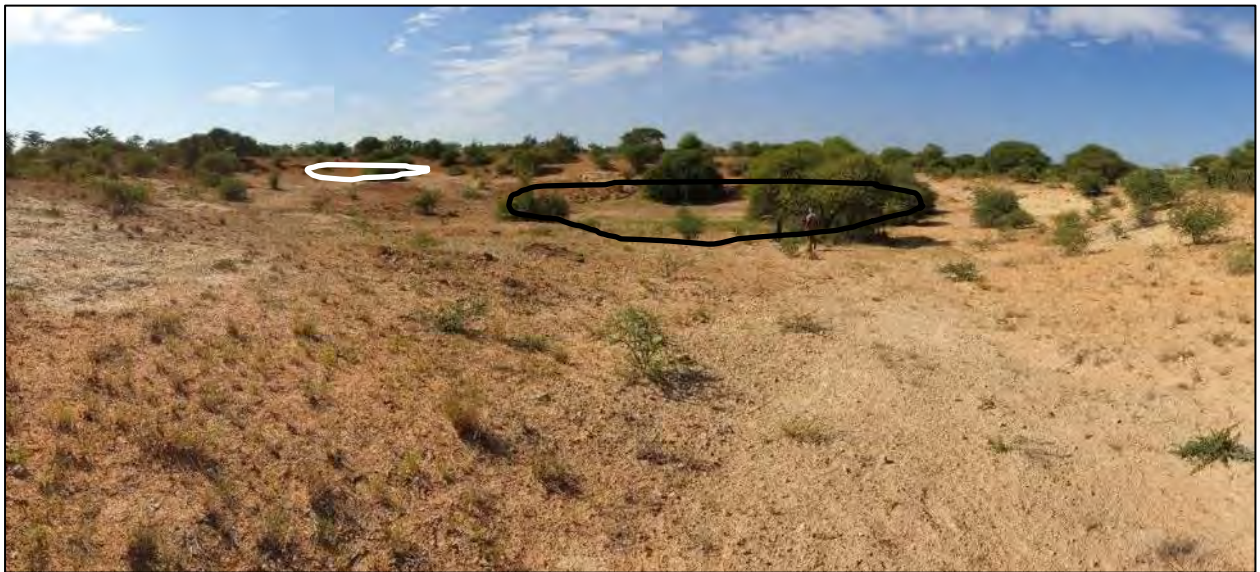
Borrow Pit 3 was the final disused borrow pit that was specified for rehabilitation. The total size of the borrow pit was much larger than the other two borrow pits, but the opportunity for wetland creation is fairly limited by the topography of the borrow pit and as such, two smaller wetland areas of 0.12ha and 0.018ha will be created within this particular pit. The sides of Site 3 slope much more gently than the other two borrow pits and as such, there are much smaller bowls in the middle of the pit. The pit consists of two bowls – one main bowl in the centre and another smaller bowl in a raised section of the pit located to the east of the main bowl (**Figure 12-10**). Site 3 is characterised by a different substrate to the other borrow pits as this borrow pit appears to be much more recently excavated and remnant sandstone parent material outcrops still extrude from the ground in multiple locations within the pit. Therefore, the nature of the clay within the bowls of the pit is slightly coarser than, and not as heavy as, the clay found in the other two borrow pits.

Figure 12-10 View of Borrow Pit 3. The large bowl is encircled in the black and the secondary smaller bowl for wetland creation is encircled in the white.
