Proposed new causeway on Local Road 311 (L311)

Site Investigation Report

Reference No.: L311/SIR/001

DOCUMENT CONTROL					
Report Title		Site Investigation Report for the construction of a causeway structure over the Mngwenya River (located along a portion of Local Road L311)			
Report Reference		L311/SIR/001	Responsible Person	Mr. Robert Ndlela	
Client Name		Department of Transport (KZN)	Client Contact Details	robert.ndlela@kzndot.gov.za	
Revision	Date	Revision Details/ Status	Author	Review No.01	Review No.02
0	29.07.2019	Site Investigation Report	C.E. Singh	J. Maharaj	L. Moodley
1					
Current Revision		Date			
01					
APPROVAL					
Responsibility	Name	Qualification	Contact Details	Signature	
Author	Cameron Singh	Bsc. Environmental Science (Biology & Environmental Systems)	cameron@hanslab.co.za Tel: 031 563 1978

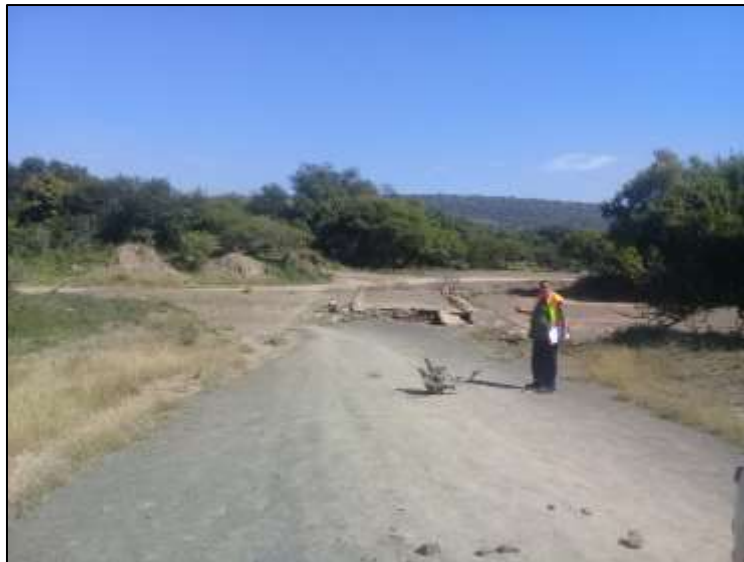
All roads leading to the site were accessible. The tracks that were observed on Google Earth and ArcGIS appeared to be created by locals wishing to gain access to more areas. The proposed location is situated on a gentle topographic gradient. Due to the position of the structure along L311, tying in of the road will be required.

Photograph 1: Showing the existing roads leading to the proposed causeway location.

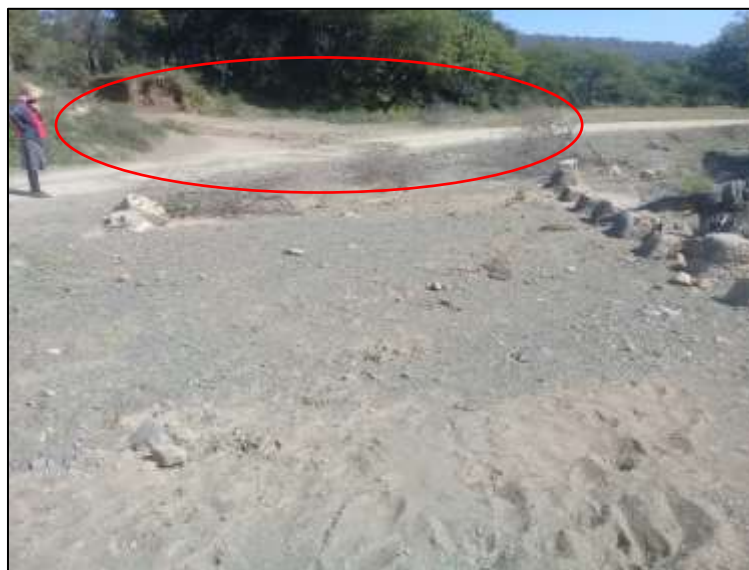
Photograph 2: Showing a footpath located adjacent to the proposed causeway location

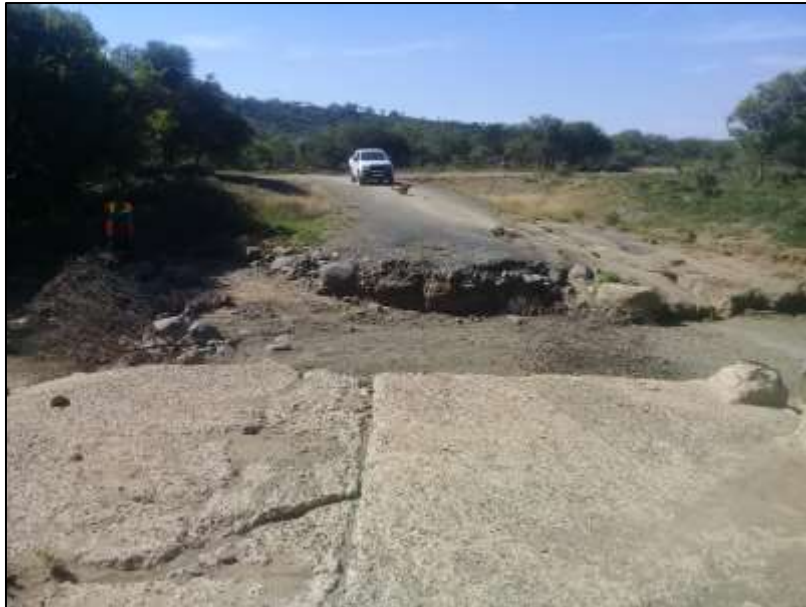
The existing slab structure present at the crossing point is damaged and eroded, which makes crossing very difficult.

Photograph 3: Showing the condition of the existing structure/

There is an existing structure slab structure located at the crossing point. The existing infrastructure is ineffective/ eroded and therefore needs to be upgraded to one that is more appropriate. The Applicant proposes to install a 14no. 2.4m x 2.4m box culvert structure with headwalls over the river. The upgrade will also include the tie-end of the roads on either side.

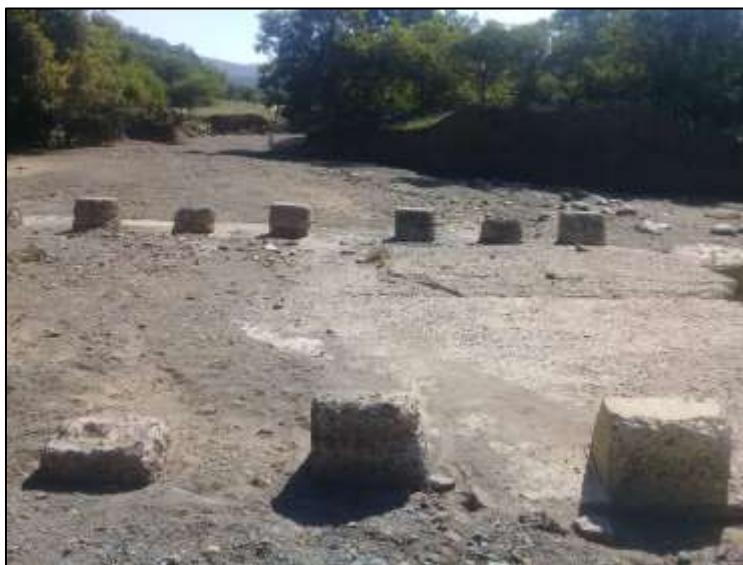
The watercourse was observed to have periodic flow (No.01 watercourse identified). Flow within the watercourse varies based on the rainfall duration and intensity. The watercourse extends further downstream, creating a larger habitat for both plant and animal life. Furthermore, there is a minor drainage line located approximately 50m before the identified watercourse.

Photograph 4: Showing the upstream view of the existing slab structure along L311.

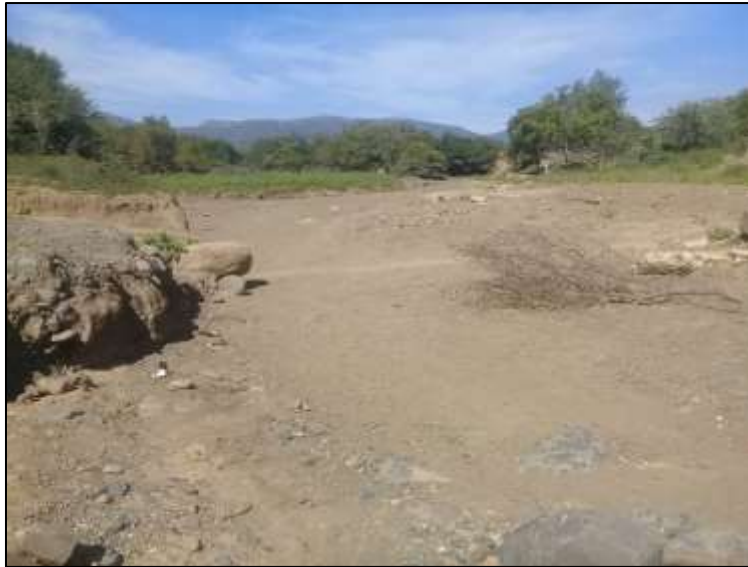
Photograph 5: Showing the downstream view of the existing slab structure along L311

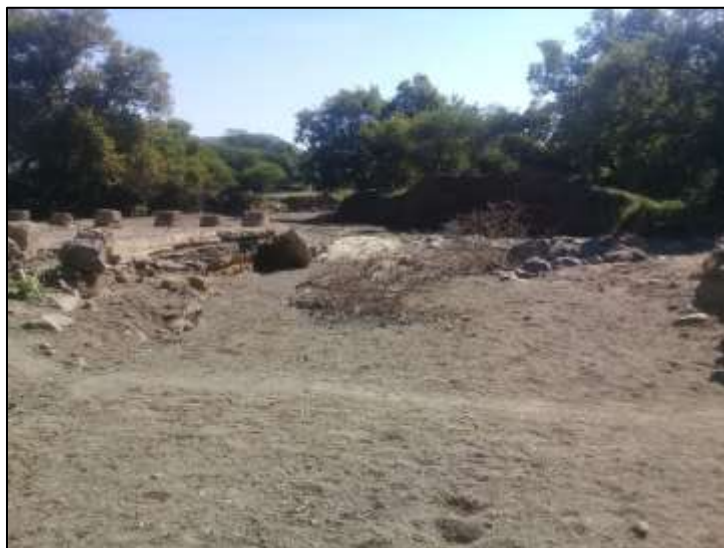
Riparian vegetation was observed on either side of the banks (both upstream and downstream).

Photograph 6: Showing the vegetation surrounding the proposed causeway on L311.

However, no vegetation removal is envisioned for the Construction Phase of the project.
