RE: Proposed Alterations and Additions to an Existing Private Residence that is older than 60 years

SUPPLEMENTARY DOCUMENTATION FOR THE PROPOSED DEMOLITION, ALTERATION OR ADDITION TO A STRUCTURE WHICH IS, OR WHICH MAY REASONABLY BE EXPECTED TO BE OLDER THAN 60 YEARS

<u>Name of property:</u>	Private Residence	<u>Title Deed No:</u>	T04 11720
<u>Erf/Lot/Farm No:</u>	PTN 3 of Erf 389, Duikerfontein		
<u>Street Address:</u>	319 Blackburn Road – Redhill, Durban North		
<u>Local Municipality:</u>	EThekweni Municipality		
<u>District Municipality:</u>	EThekweni Municipality - Central		
<u>Current zoning:</u>	Special Residential 650	<u>Present use:</u>	Residential Usage

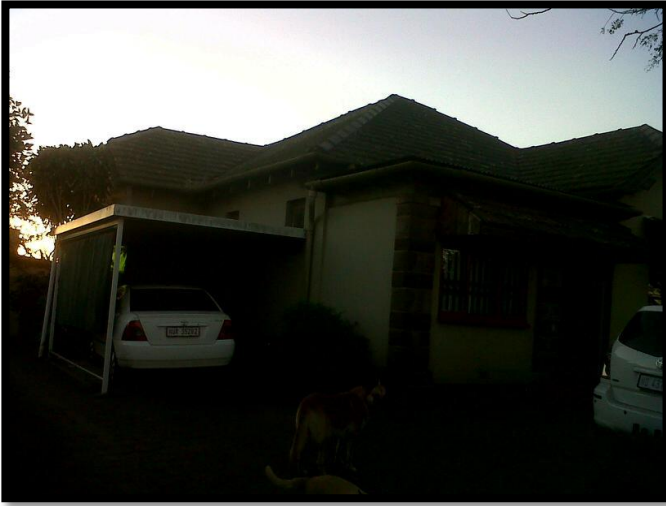
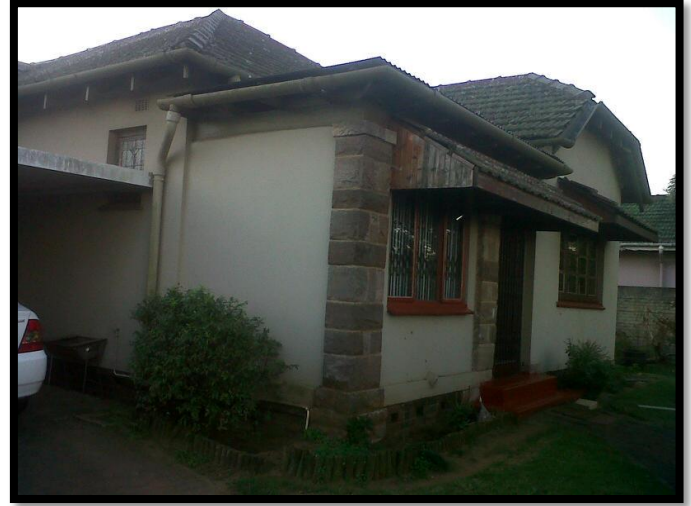
Damage through the years is evident, and since the property is old and many changes have been done as and when needed by previous owners. This has left the current house standing in a confused and character-less position. As indicated in the pictures along side, the roof system only serves as a means of coverage, and the constant add-ones of certain sections to the house has left it in a patch work state. The make shift carport detracts from the structure and does not blend in with the surroundings. The previously enclosed verandah is now wasted space internally, with the plaster and paint work needing to be revised and made good to create some sort of uniformity to give the house a proper identity.

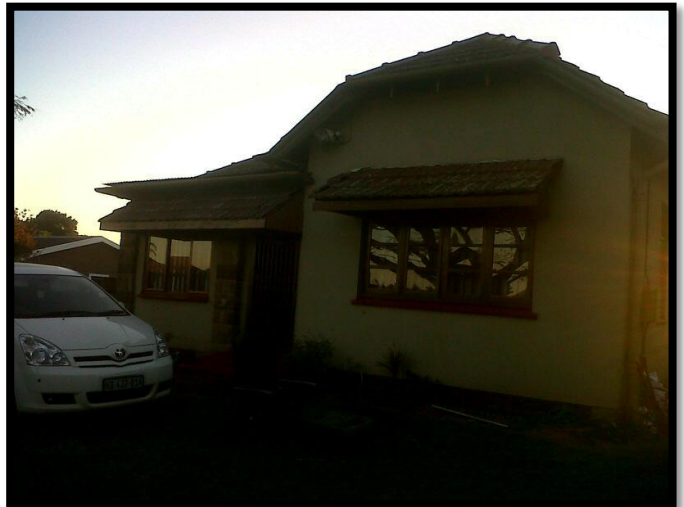
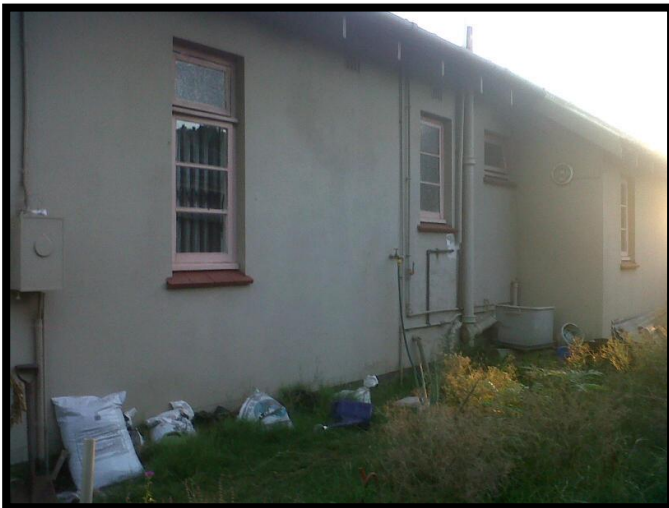
Different use of window treatments and profiles is present on the building, as well as the use of various building materials. The 2 side elevations as indicated below and to the side need to be updated, and form part of the structure aesthetically. The rear of the house, with a prefab awning structure for coverage for the outside pool patio area does not tie in with the house form, emphasising the lack of clarity in style and design. All views shown indicate a modest family home, which is in need of some critical care and design structure to create a more harmonious and livable environment.

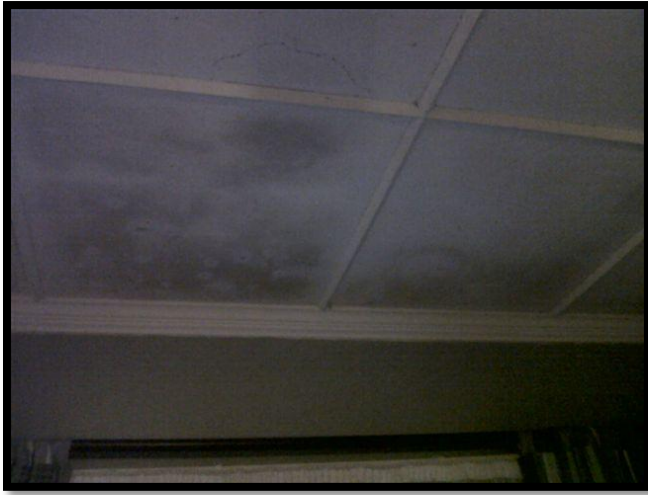
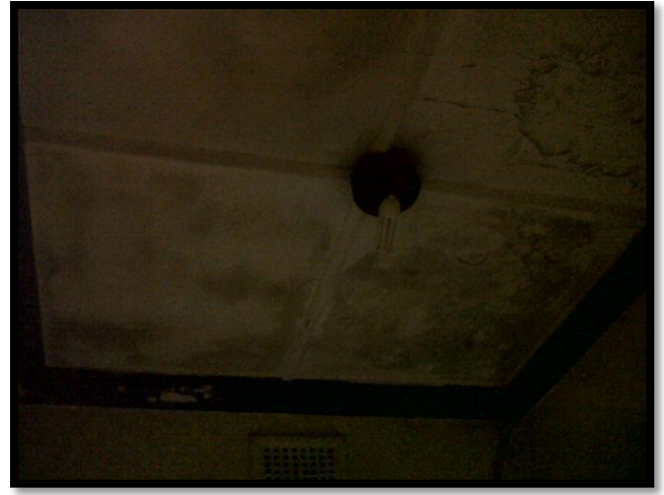
The above pictures show that water damage is evident under on the ceiling boards of the internal rooms of the house. These are the original ceiling boards and cornices that have been patched up time and time again, but the problem still prevails whenever there are heavy rains. Water has also penetrated through into the electrical cable-ling on the roof, and in the walls causing electrical malfunctions within the house. This is very dangerous as there are young children around that could hurt. Due to water entering the roof, the inside of the house is very damp and moldy, and if left untreated could cause various health complications.

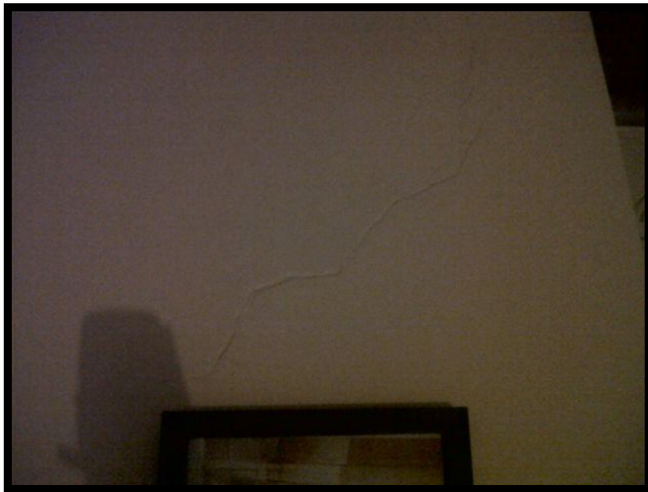
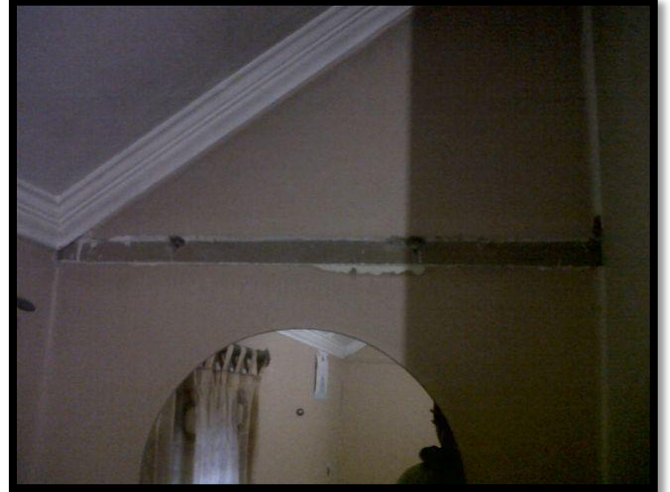
There are visible cracks on the surface of the walls, and various elements have fallen off due to movement and shifting of the building through time. A structural engineer has been appointed and has done an inspection on site, and has recommended that in some areas the foundations would have to be underpinned to provide the building with more structural stability, and also have the capacity to bear the load for the additions to be made to the existing structure.

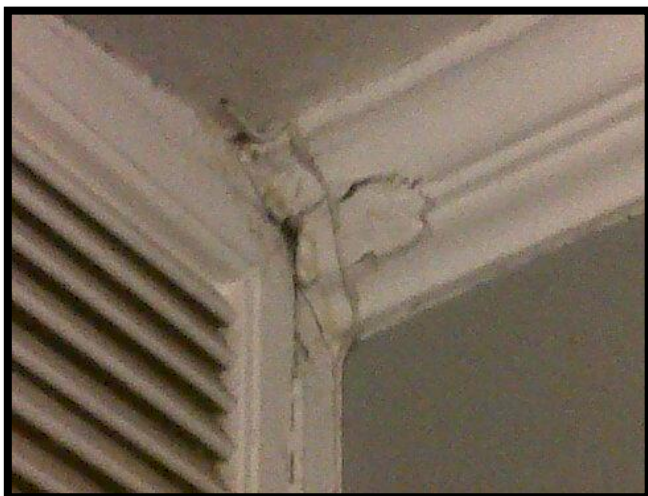
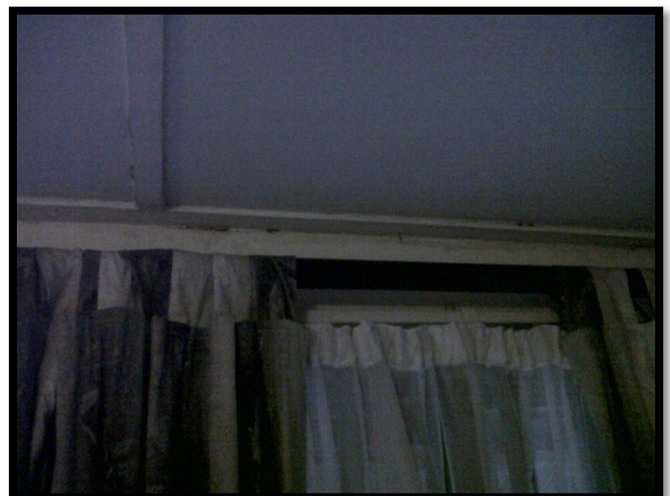
The pest infestation within the house has caused extensive damage to cornices, cupboards, ceilings, windows, and has compromised the structural integrity of the residence. All have these elements have to be treated, repaired and in some instances replaced to ensure that the same problem does not persist in the future life of the house.
