HERITAGE STATEMENT CLUB HOUSE

INTRODUCTION

The document is supplementary to the application for a permit by the Department of Public Works to the South African Heritage Resources Agency in terms section 27 of the National Heritage Resources Act, 25 of 1999.

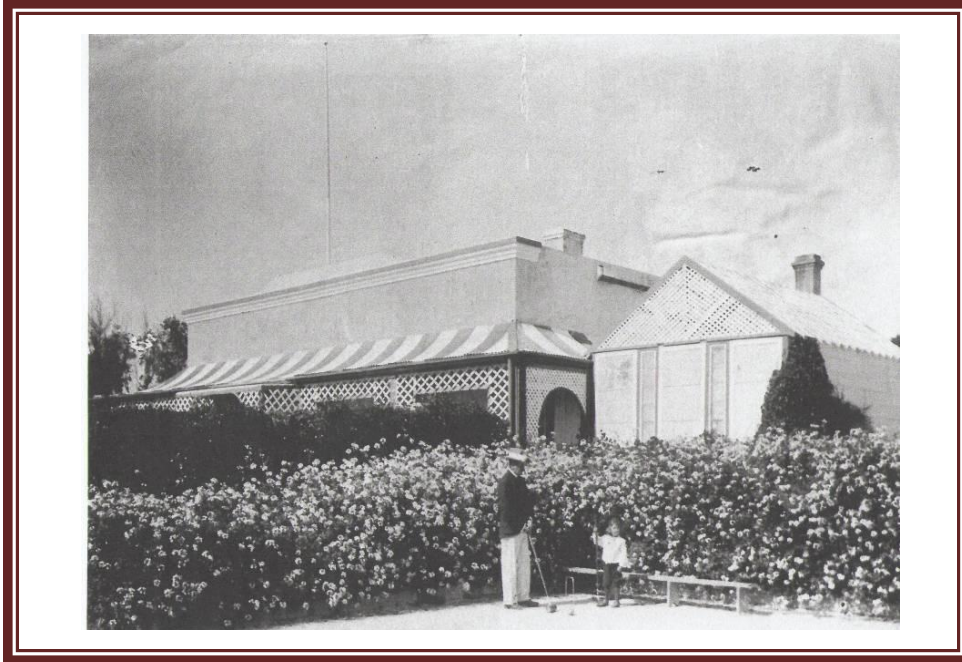
Fig. 2. Photo from 1920 showing the Victorian verandah. The structure next to it is a glass conservatory. A rambling rose hedge can be seen behind the man and child playing croquet.

The outbuildings were also extended during the late 1880's and the original courtyard wall became the outer walls of these buildings. The entrance to the courtyard moved to the northern side. The glass conservatory seen in Fig. 2. Appears on drawing from 1905. At the same time the first tennis court appears with its own dedicated structure as well as a croquet field and pavilion. The buildings were unharmed during the demolition of structures related to the leper period in the early 1930's but the separate conservatory has disappeared. It is shown as an addition to the structure from then on until 1962. By 1972 all of the outbuildings have disappeared but the small addition on the northern side remained and may still be part of the present structure.

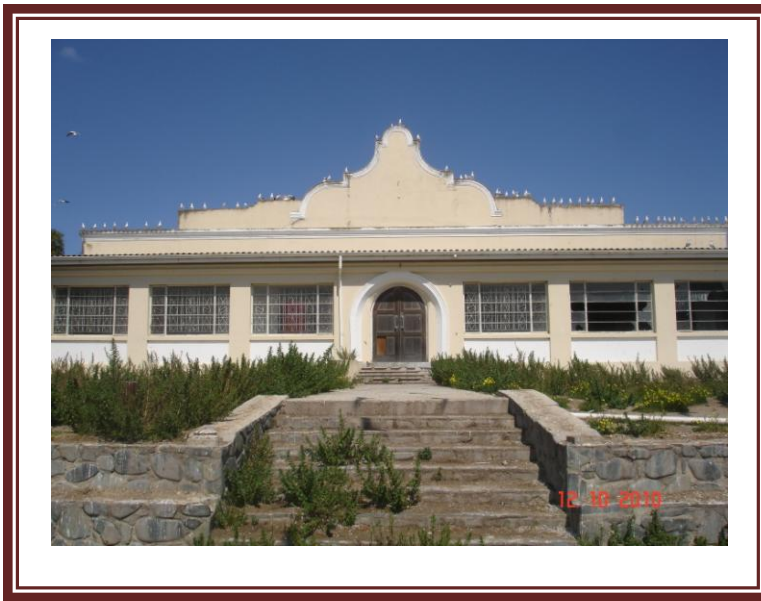
Fig. 4. Western Façade, facing Table Bay, of structure at present.

In 1964 the building took on its present form with the neo-Cape Dutch gable showing both 'hol-bol' and 'bol-bol' elements. The gable rests on the original Georgian parapet. The present enclosed verandah is more than likely the older Victorian verandah with the northern part being taken up by the snooker/ pool room. The original staircase balustrade to the western/ original front facade can just be seen below the present ones.

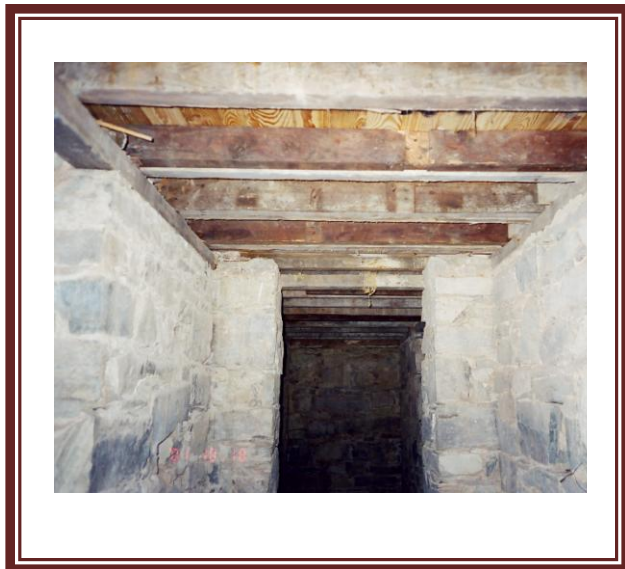
Fig. 5 & 6 Basement walls, ceiling [building floor] entrance and compacted earth floor. Ca 2001.

The basement dates from the 1840’s when the structure was built. An overlay with the 1946 plan with that of the recent architectural drawing shows the floor plan of the original dwelling. The basement is built with thick stone walling and forms the foundation for the building.

5. Plants and weeds must be removed from paving and attention must be given to the outdoor fixed furniture.
6. The contractor appointed to do the work must adhere to sound environmental practice for the disposal of waste and not damage culturally significant vegetation.
7. The entrance to the basement must be reinstated for easy access to inspect the area for damp, cracks or other damage.
8. Interior fixtures and fittings should be left intact and renovated as far as possible.

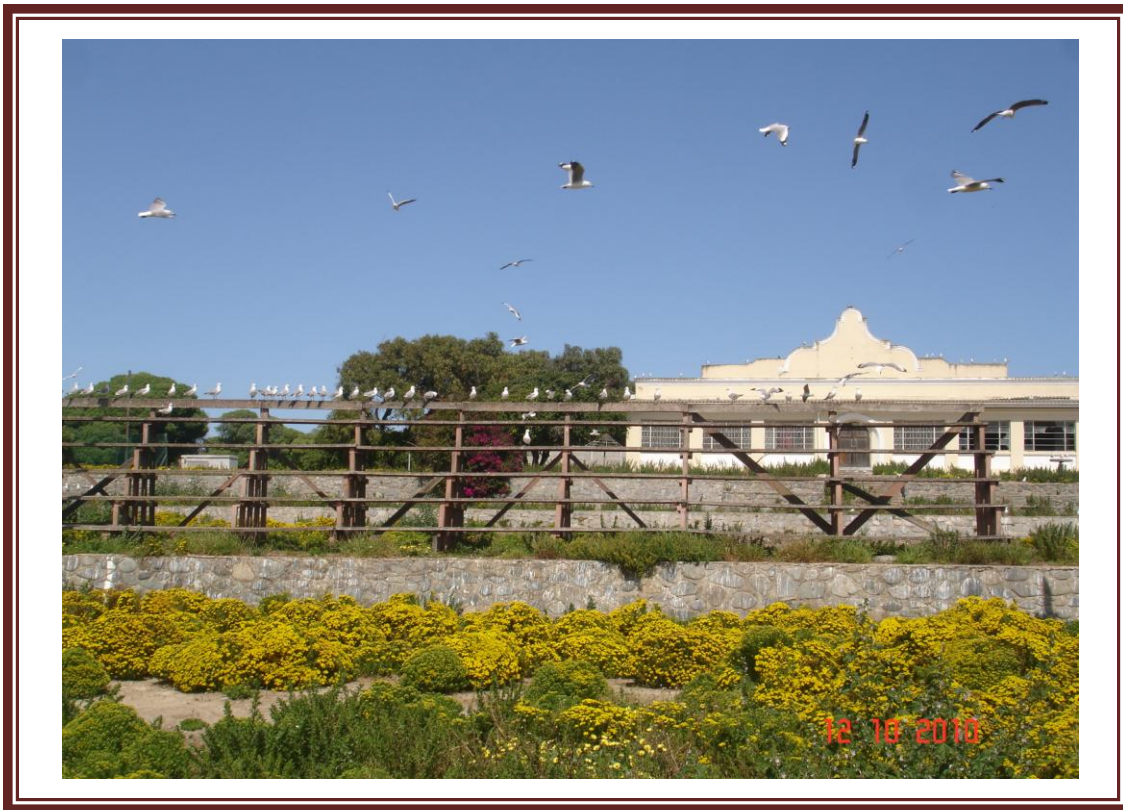
Fig. 7. A large colony of seagulls has taken over the landscape as a breeding site.

An urgent threat is the very large colony of seagulls that have invaded the sports fields and terraces over the last three years. Guano builds up into a very hard layer that becomes difficult to remove. It also contains chemicals such as urea and ammonia which corrode building materials.

1. A permit should be issued for the necessary repairs, alterations and maintenance on the structure and its associated components as specified by the project architects. The structure has through neglect over the last decade been allowed to deteriorate to such an extent that urgent work is required to save the historic fabric.
2. That the structure must not be treated in isolation but placed within its associated landscape. This will require a determined effort by Robben Island Museum and Department of Public Works to produce and implement a management plan for the entire sports and recreation precinct.
3. The seagulls need to be removed from the sports fields and terraces as a matter of urgency. The terraces and sports fields must then be cleaned up and maintained.
4. An alternate use strategy must be provided.
